NACA RM E9K17

TURBOJET-ENGINE EVALUATION OF AISI 321 AND AISI 347

STAINLESS STEELS AS NOZZLE-BLADE MATERIALS

By Floyd B. Garrett and Charles Yaker

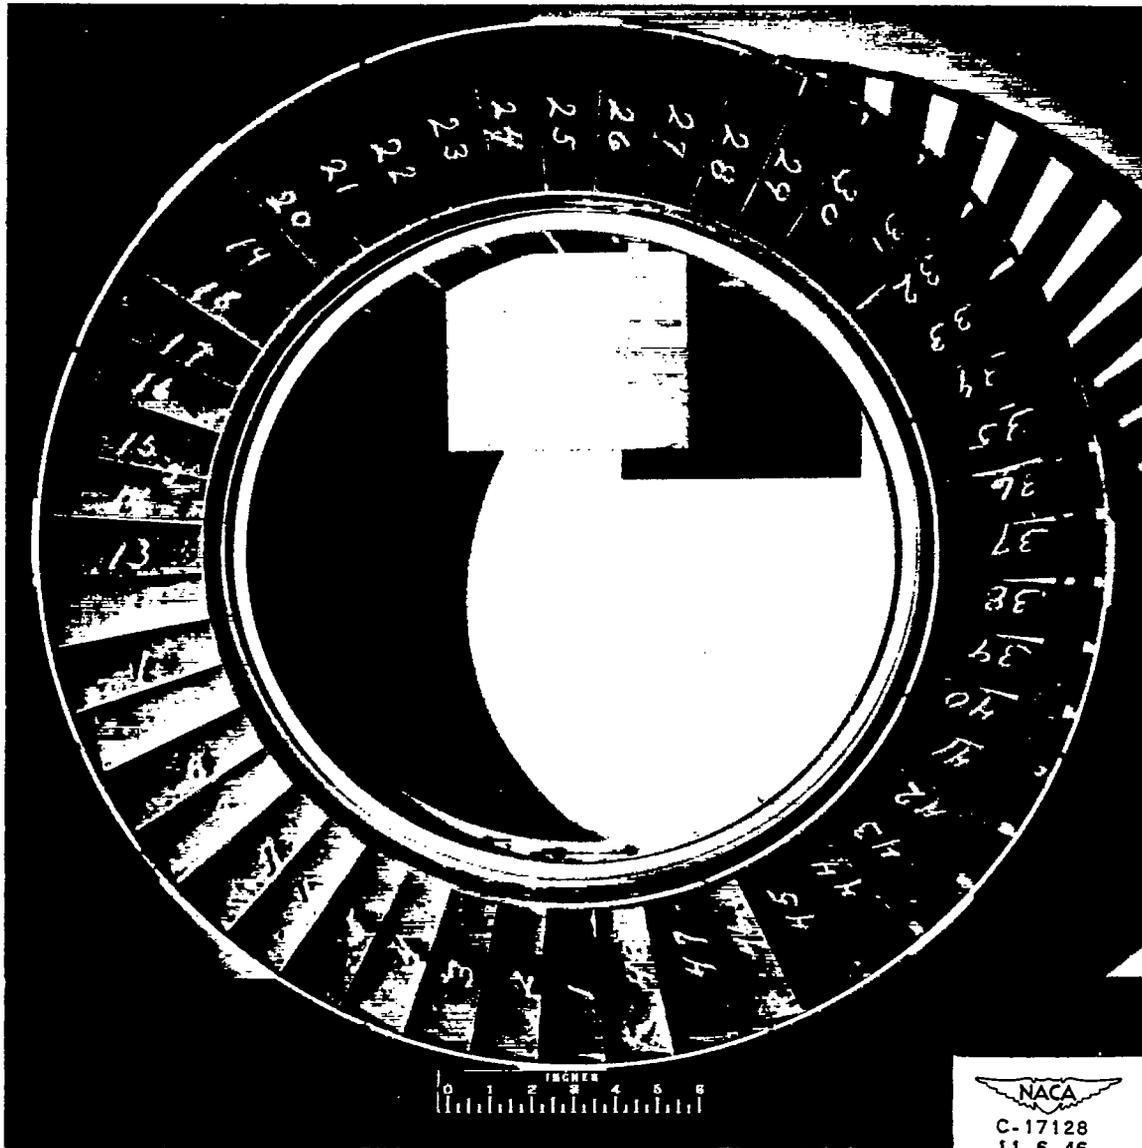
Cyclic engine evaluation was made of three nozzle diaphragms having odd numbered blades of AISI 321 stainless steel and even numbered blades of AISI 347 stainless steel. The downstream face of a diaphragm before operation is shown in figure 1.

Figure 1. - Downstream face of nozzle diaphragm before engine operation.
