RESEARCH MEMORANDUM

AERODYNAMIC CHARACTERISTICS OF A PORTION OF THE

HORIZONTAL TAIL FROM A DOUGLAS C-74 AIRPLANE

WITH FABRIC-COVERED ELEVATORS

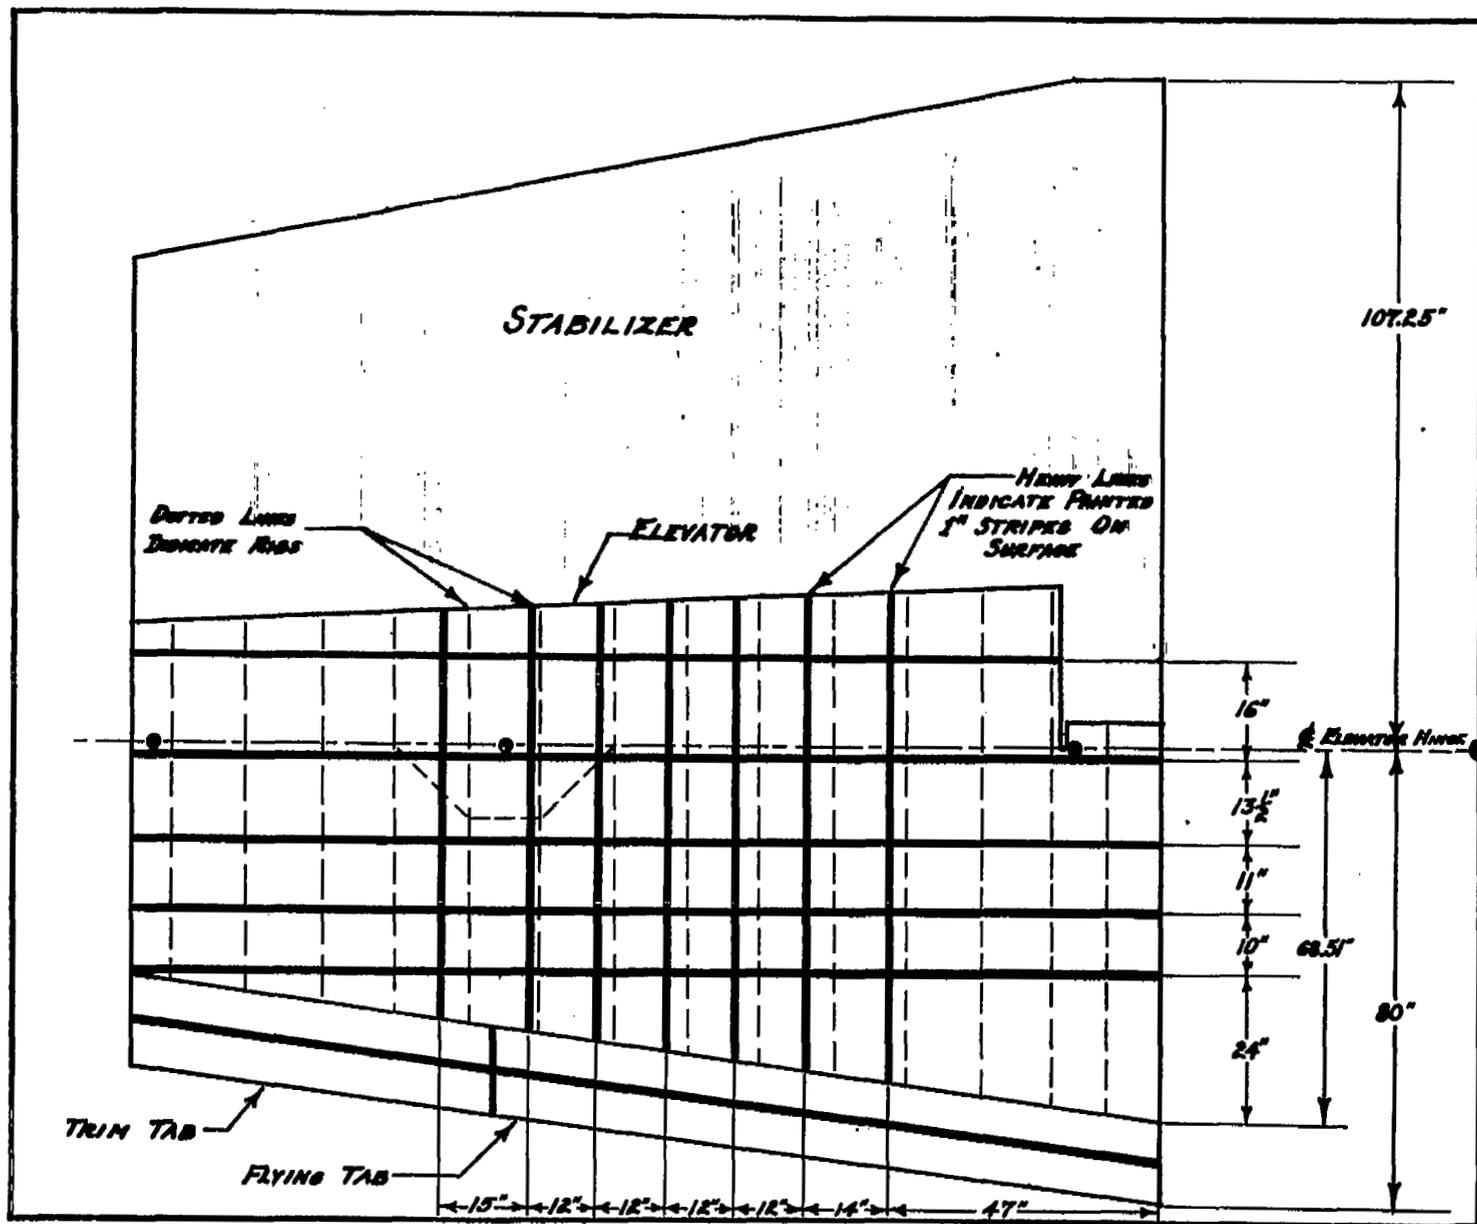
FIGURE 3.- LOCATION OF LINES TO SHOW DEFORMATION OF FABRIC ON C-74 ELEVATOR.

Figure 3.- Location of lines to show deformation of fabric on C-74 elevator.
