NACA

RESEARCH MEMORANDUM

INVESTIGATION OF RIM CRACKING IN TURBINE

WHEELS WITH WELDED BLADES

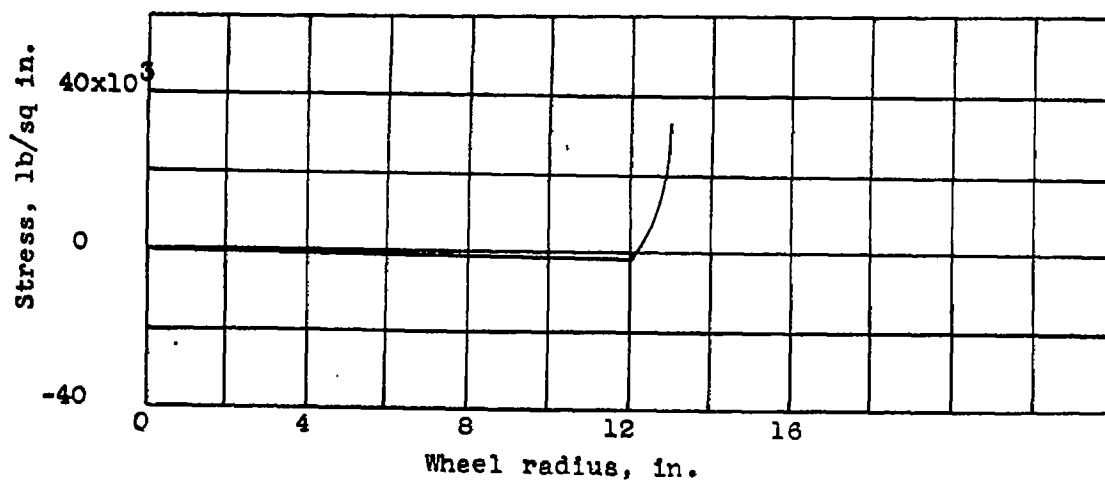
the effective diameter of the wheel and the residual stresses that
occur would hence be lower than in the unslotted disk. The elastic
and plastic tangential-stress distributions that would be present
in the slotted disk during the starting period are shown in figure 8.
The resulting elastic tangential residual stress is presented in
figure 9. The stress at the effective rim of the disk is lower than
in the unslotted disk and has been removed from the junction of blade
and weld metal, the region that is indicated as critical by British
investigators, to the region containing a stress-relieved hole.

Figure 8. - Computed nominal tangential stresses in slotted

composite welded wheel during starting period.

Drilling holes on the same wheel radius as the relief holes but
omitting the slots would allow cracks to progress into the holes and
have essentially the same effect as the slots. Although slots have
the advantage of preventing the crack from taking an arbitrary path
and possibly missing a hole, use of holes alone would permit easier
wheel fabrication and the irregular surface of the crack might also
provide friction damping in the event of blade vibration.
