# RESEARCH MEMORANDUM

PRELIMINARY TESTS OF A BUFFET STALL-WARNING DEVICE ON

A 1/5-SCALE MODEL OF THE REPUBLIC XP-84 AIRPLANE

October 30, 1946

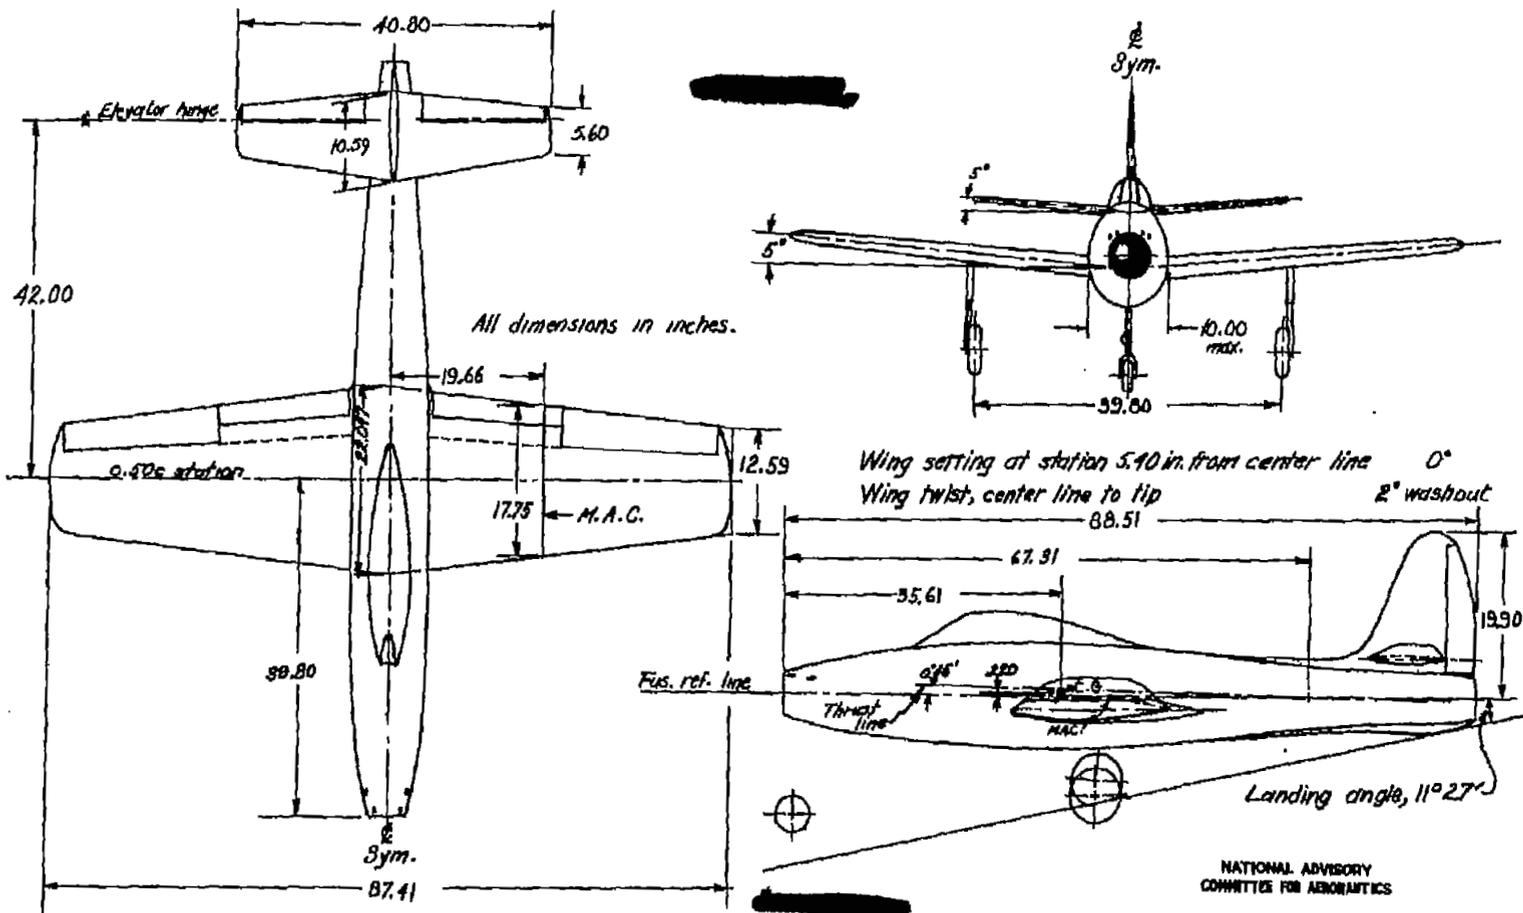
Figure 1.- The  $\frac{1}{8}$ -scale model of the Republic XP-64 airplane with the revised horizontal tail.

The results of the tests are presented as standard NACA coefficients of forces and moments. Pitching-moment coefficients are given about the center-of-gravity location shown in figure 1 (26.45 percent of the mean aerodynamic chord). The data are referred to the stability axes, which are a system of axes having their origin at the center of gravity and in which the Z-axis is in the plane of symmetry and perpendicular to the relative wind, the X-axis is in the plane of symmetry and perpendicular to the Z-axis, and the Y-axis is perpendicular to the plane of symmetry. The positive directions of the stability axes, of angular displacements of the airplane and control surfaces, and of forces and moments are shown in figure 2.

The 1/5-scale model has also been described in reference 2. For the present tests, the slotted flap was used, as was the revised horizontal tail, which was set at  $-1.0^\circ$  for all tests. The landing gear was retracted for all tests. All tests were made with the model blower unit inoperative and with the duct open. A three-view drawing of the model and a photograph of the model in the tunnel are shown in figures 1 and 3, respectively.

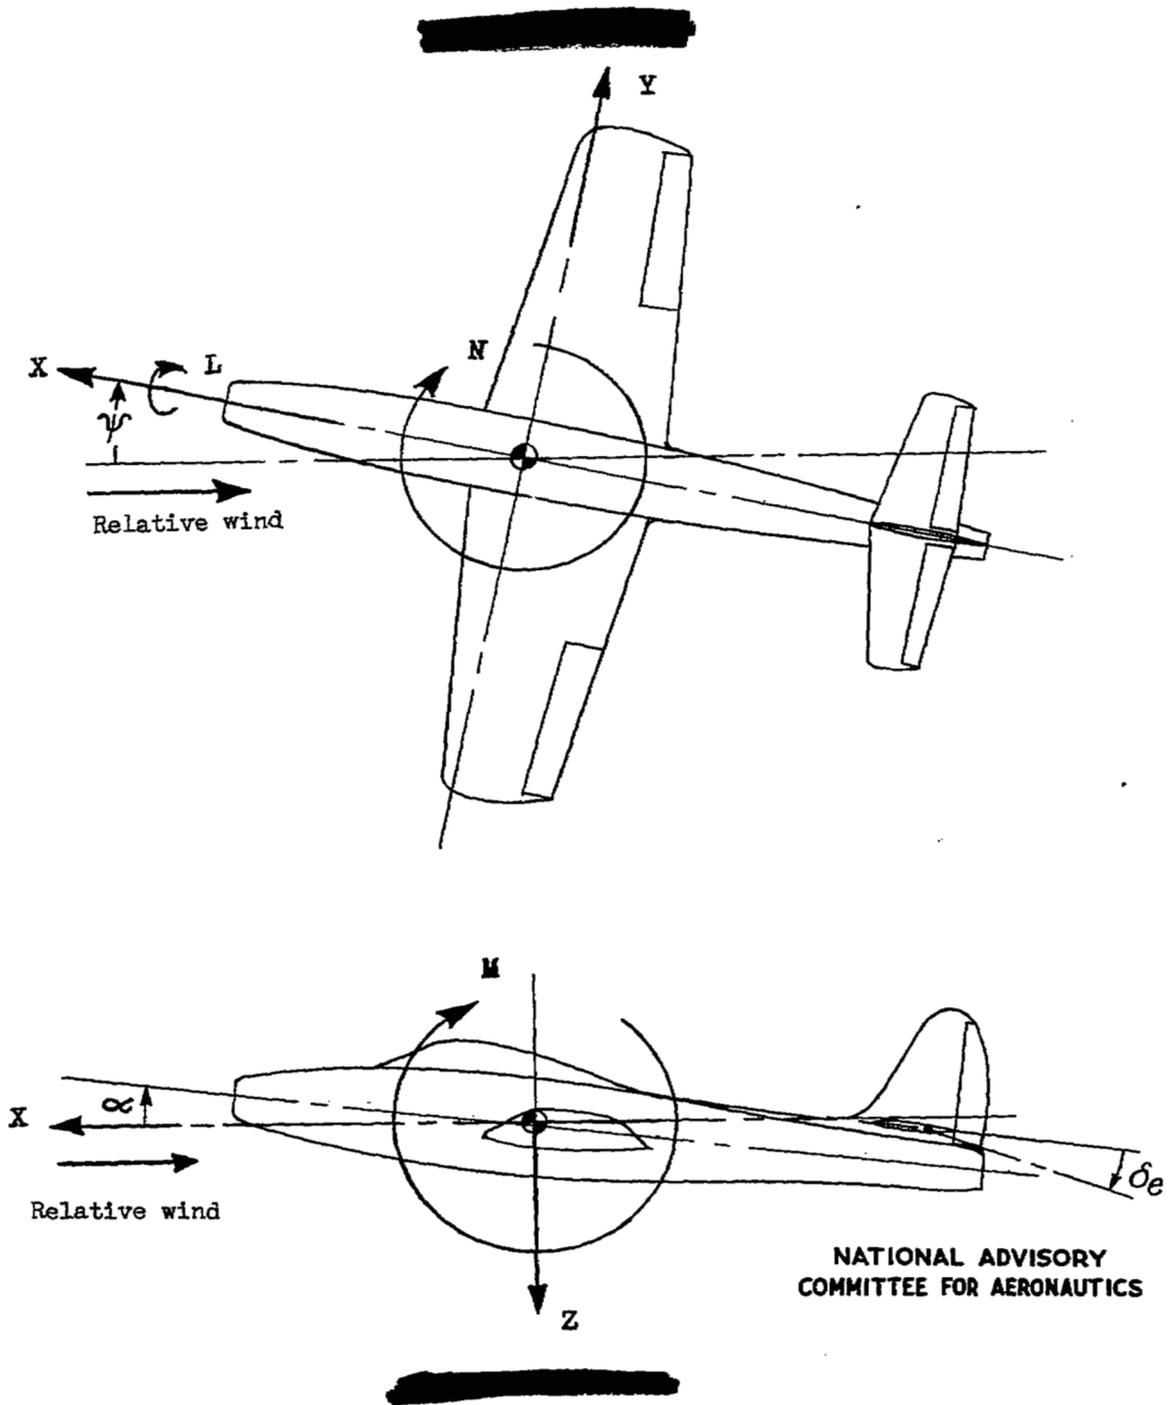
Figure 2.- System of axes. Positive values of forces, moments, and angles are indicated by arrows.

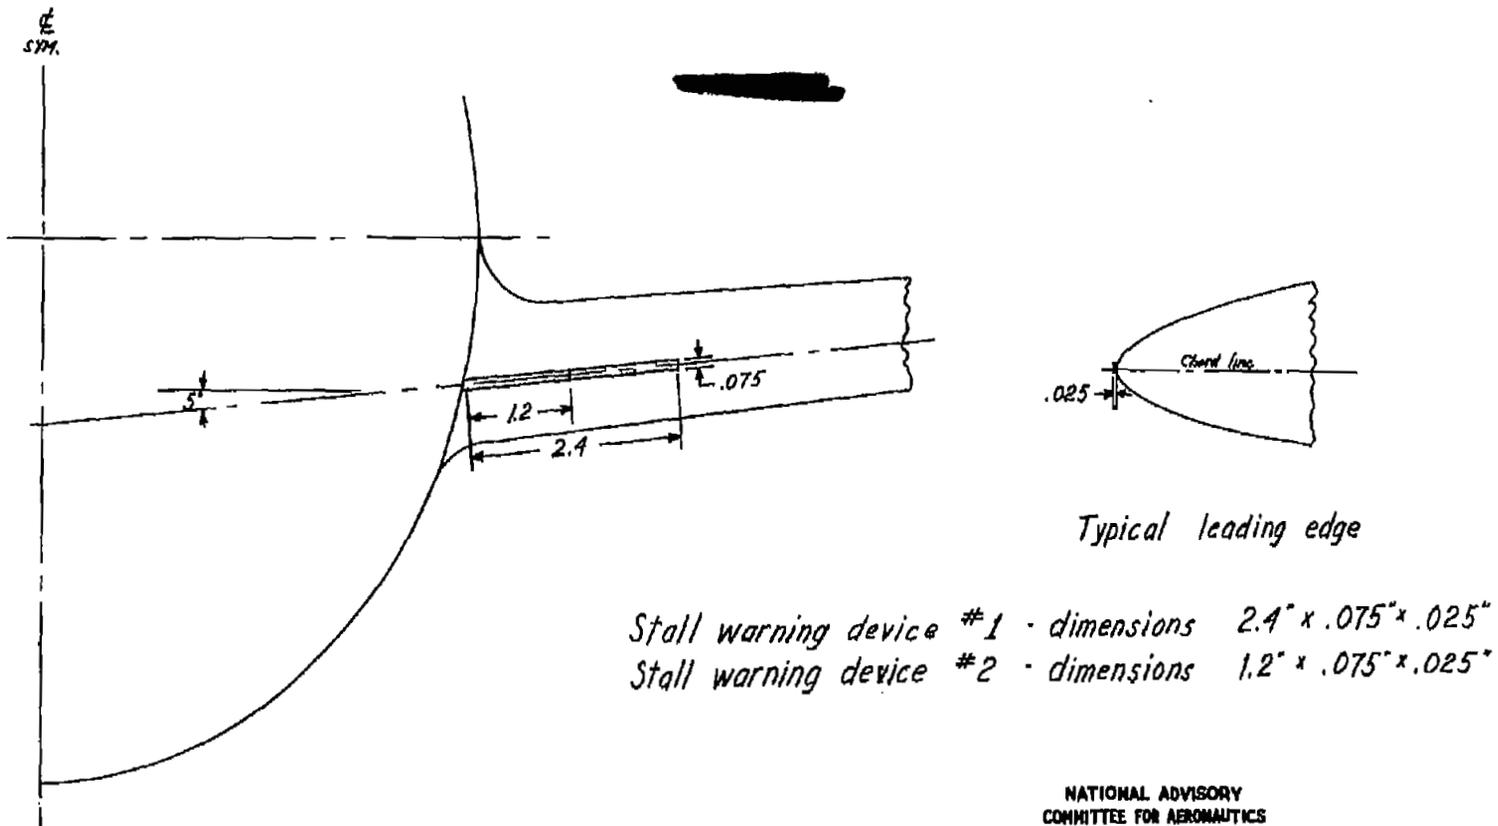
Figure 4.- Details of the stall-warning devices and location as tested on the  $\frac{1}{5}$ -scale model of the Republic XP-84 airplane.

The two stall-warning devices tested on the model are shown in figure 4. The data of references 3 and 4 were used as a basis for the design of the warning devices. It is thought that the high-speed performance of the airplane should be little affected by the devices, since in this flight condition the devices should be very near the stagnation point.

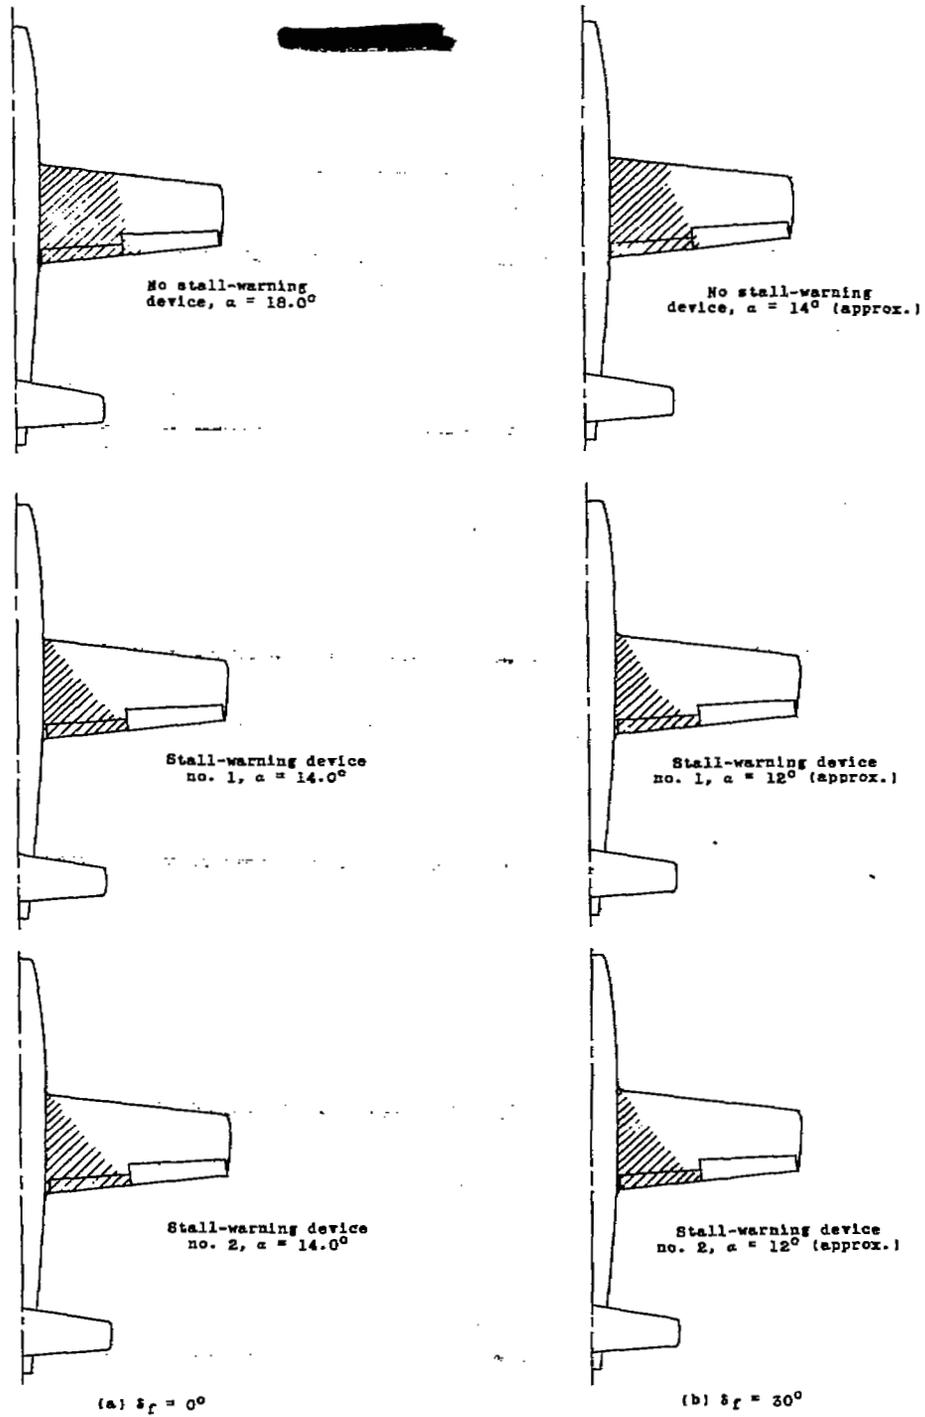
Figure 6.- Initial stall patterns observed in tuft studies on the  $\frac{1}{5}$ -scale model of the Republic XP-84 airplane.

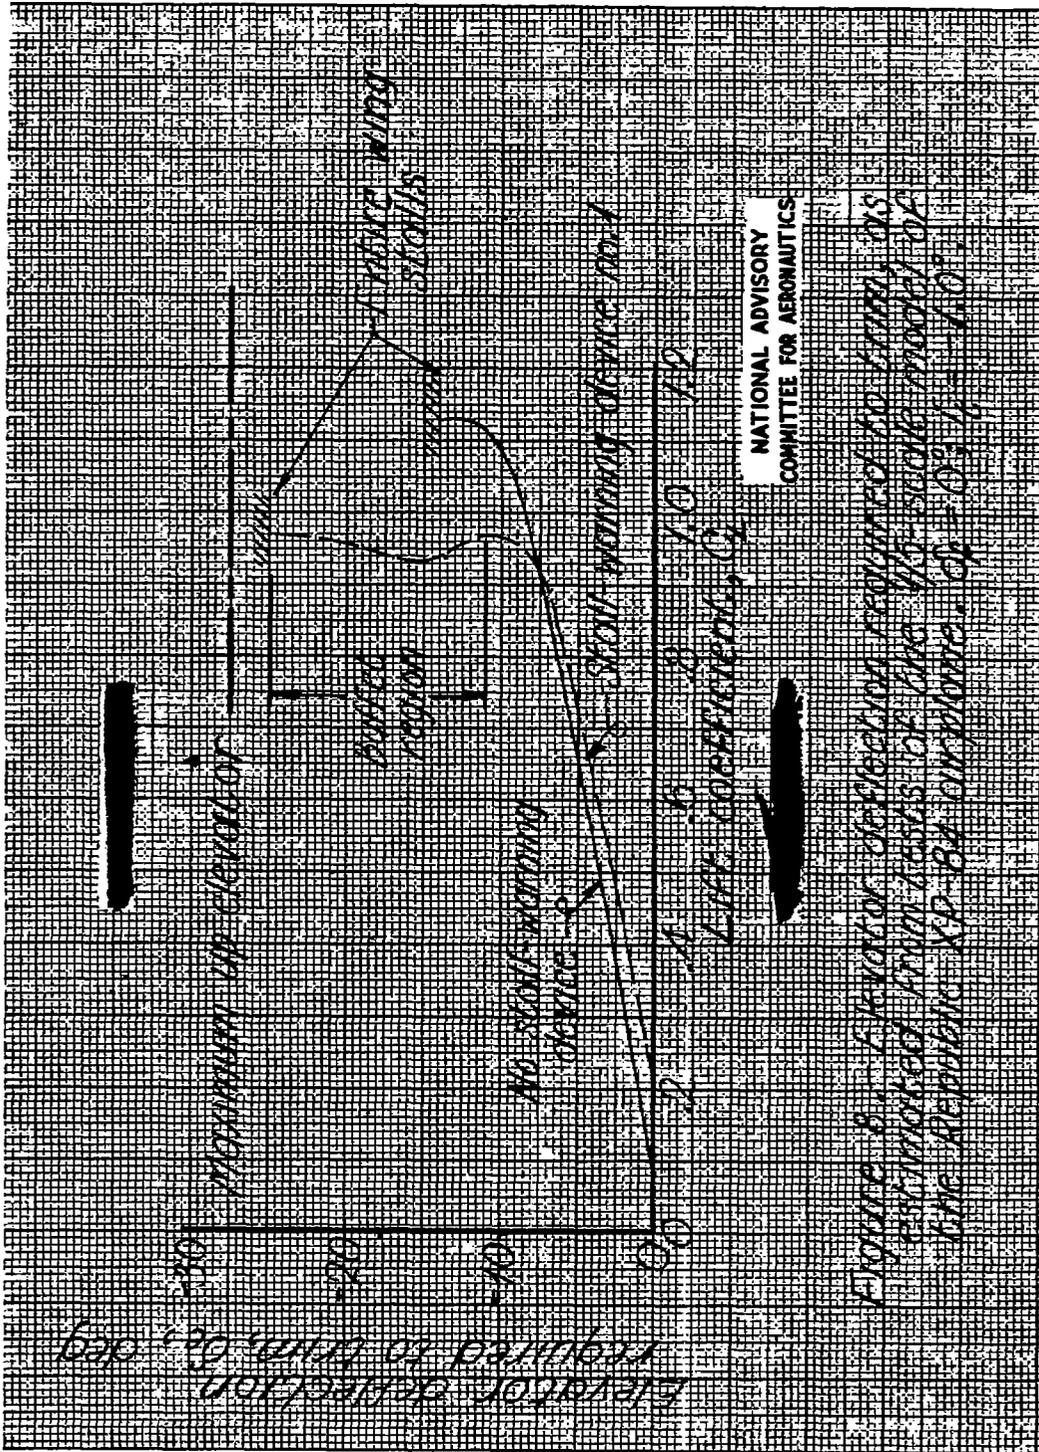
Figure 6. Elevator deflection required to trim, as estimated from tests of the 1/8-scale model of the Republic XP-84 airplane, at  $M = 0.9$  to  $1.0$ .

Flaps up, stall-warning device No. 1.— The type of stall warning that can be expected is shown by the estimated elevator-to-trim curves of figure 8 taken from the data of figure 6. The buffet region and the points of complete wing stall were estimated from the tuft studies. For the clean wing, the lack of stall warning is evident; as the stick is pulled back, practically the entire wing suddenly stalls with no preliminary buffeting or marked increase in stick travel. This behavior was noted in the flight tests reported in reference 1.

It will be noted from the curves of figure 8 that the elevator is sufficiently powerful to stall the airplane for the two cases presented. An inspection of the data of figures 6 and 7 shows that for all configurations tested, the airplane may be stalled by use of the elevator.
