NACA RM No. E8C17

ALTITUDE-WIND-TUNNEL INVESTIGATION OF A 3000-POUND-THRUST
AXIAL-FLOW TURBOJET ENGINE

VII - PRESSURE AND TEMPERATURE DISTRIBUTIONS

By Martin J. Saari and William R. Prince

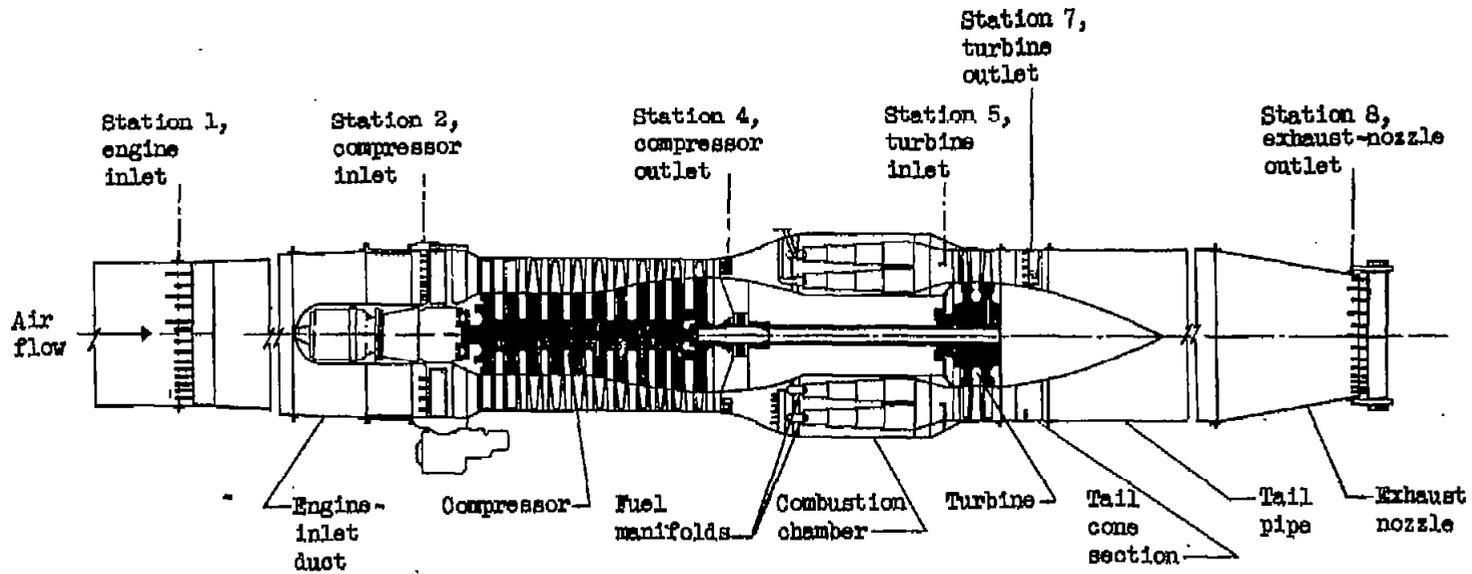
Figure 2. - Location of instrumentation installed in turbojet engine.

Temperature **and** pressure **measurements** were obtained at **several** stations through the **engine** (fig. 2). **Drawings** of the instrumentation at the compressor inlet, the **compressor** outlet, the **turbine** inlet, the turbine **stator** stages, the turbine outlet, and the exhaust-nozzle outlet are presented in figures 3 to 8, **respectively**.

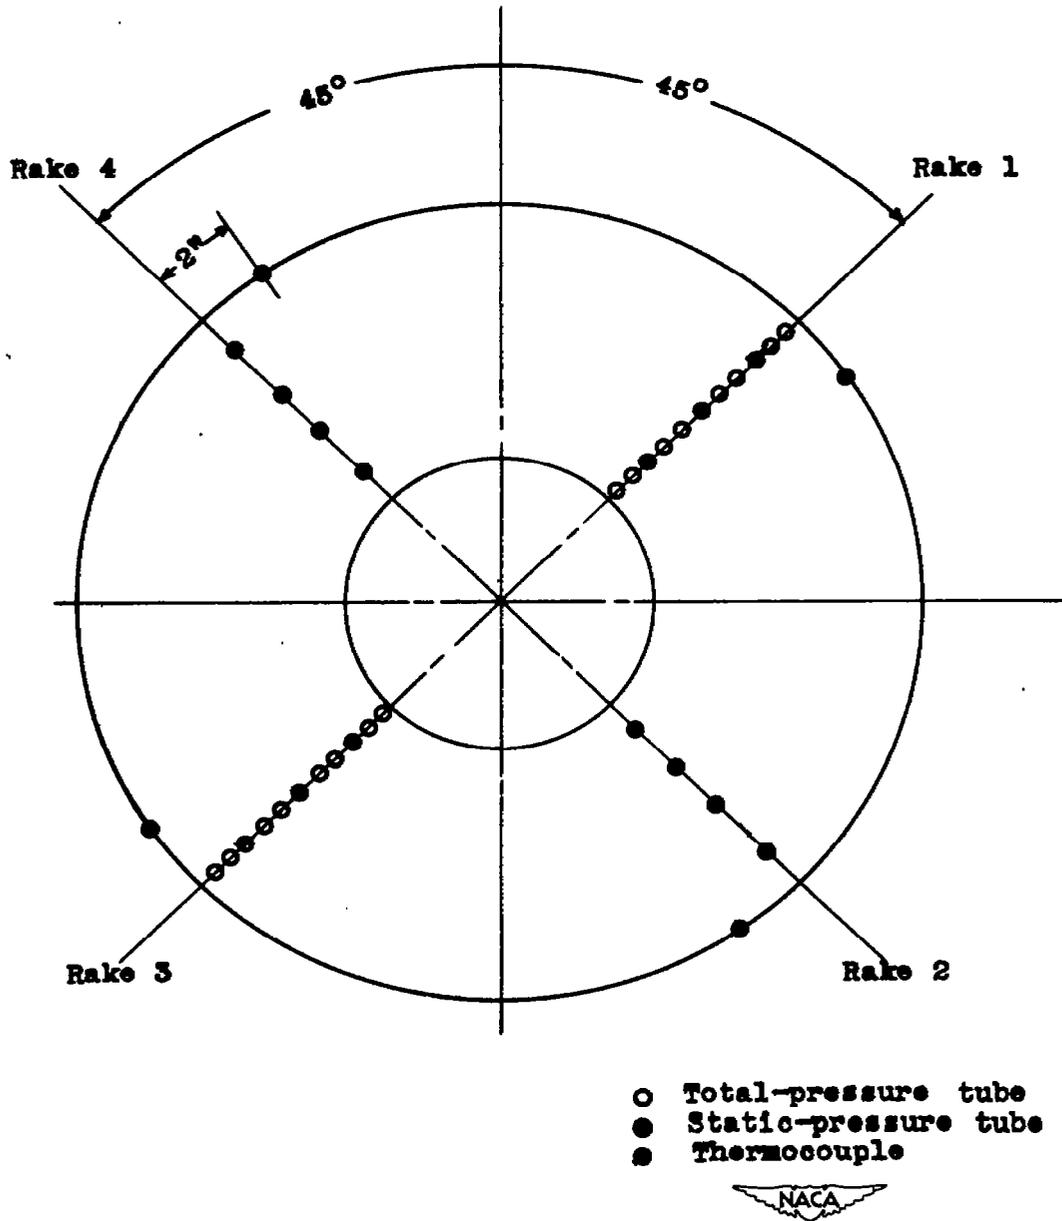
Figure 3. - Location of instrumentation at compressor inlet,

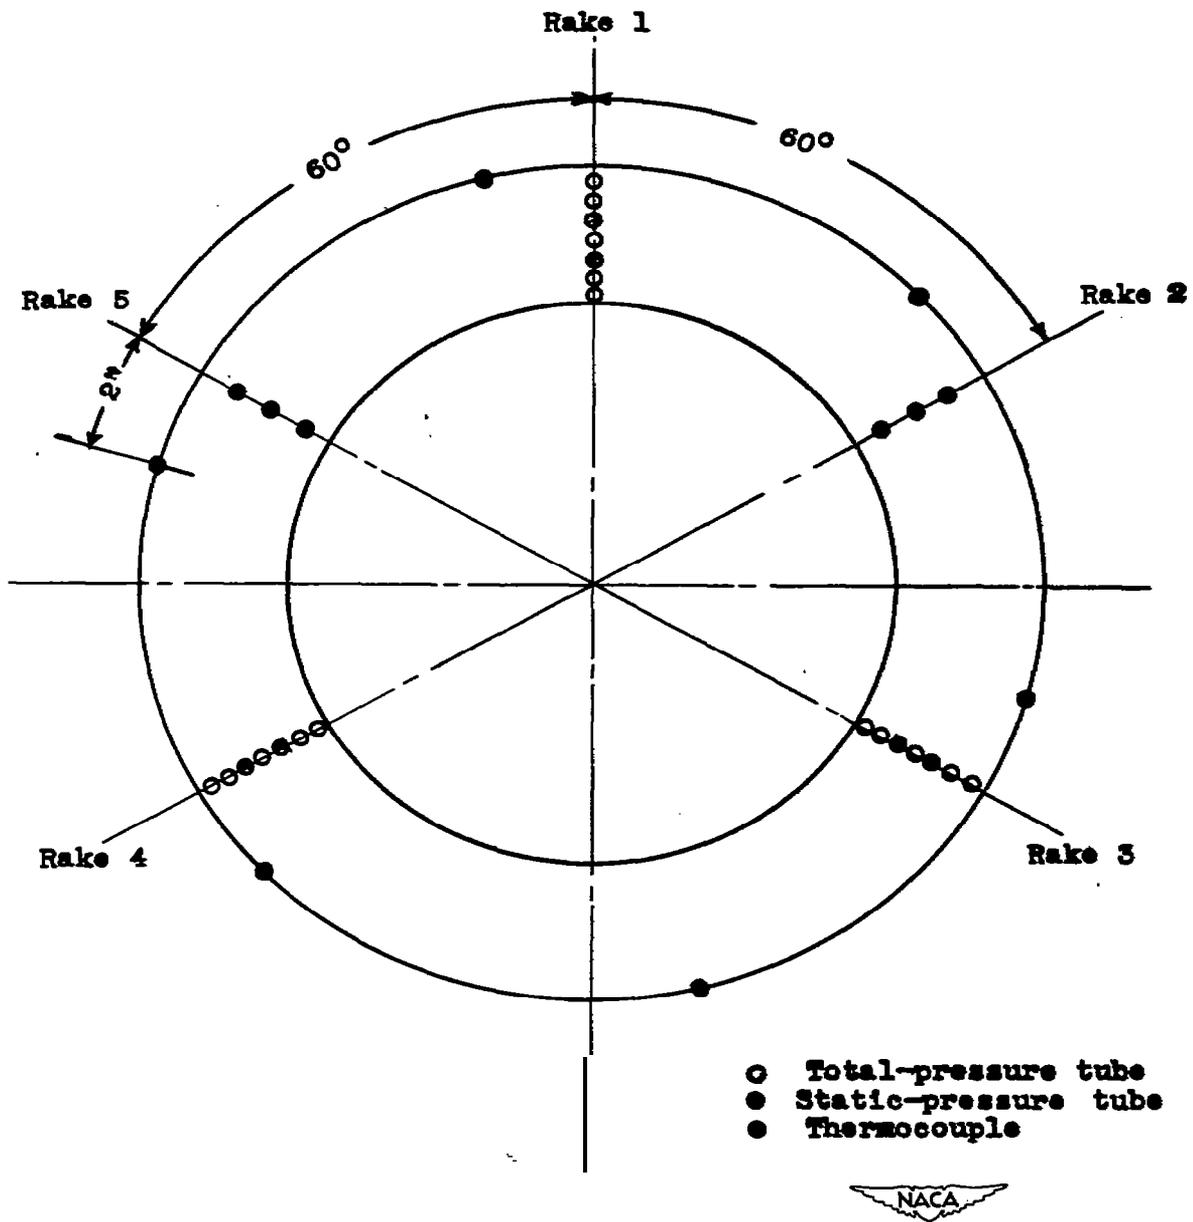
Figure 4, - Location of instrumentation at compressor outlet, station 4, $1\frac{1}{2}$ inches behind trailing edge of compressor-outlet straightening vanes.

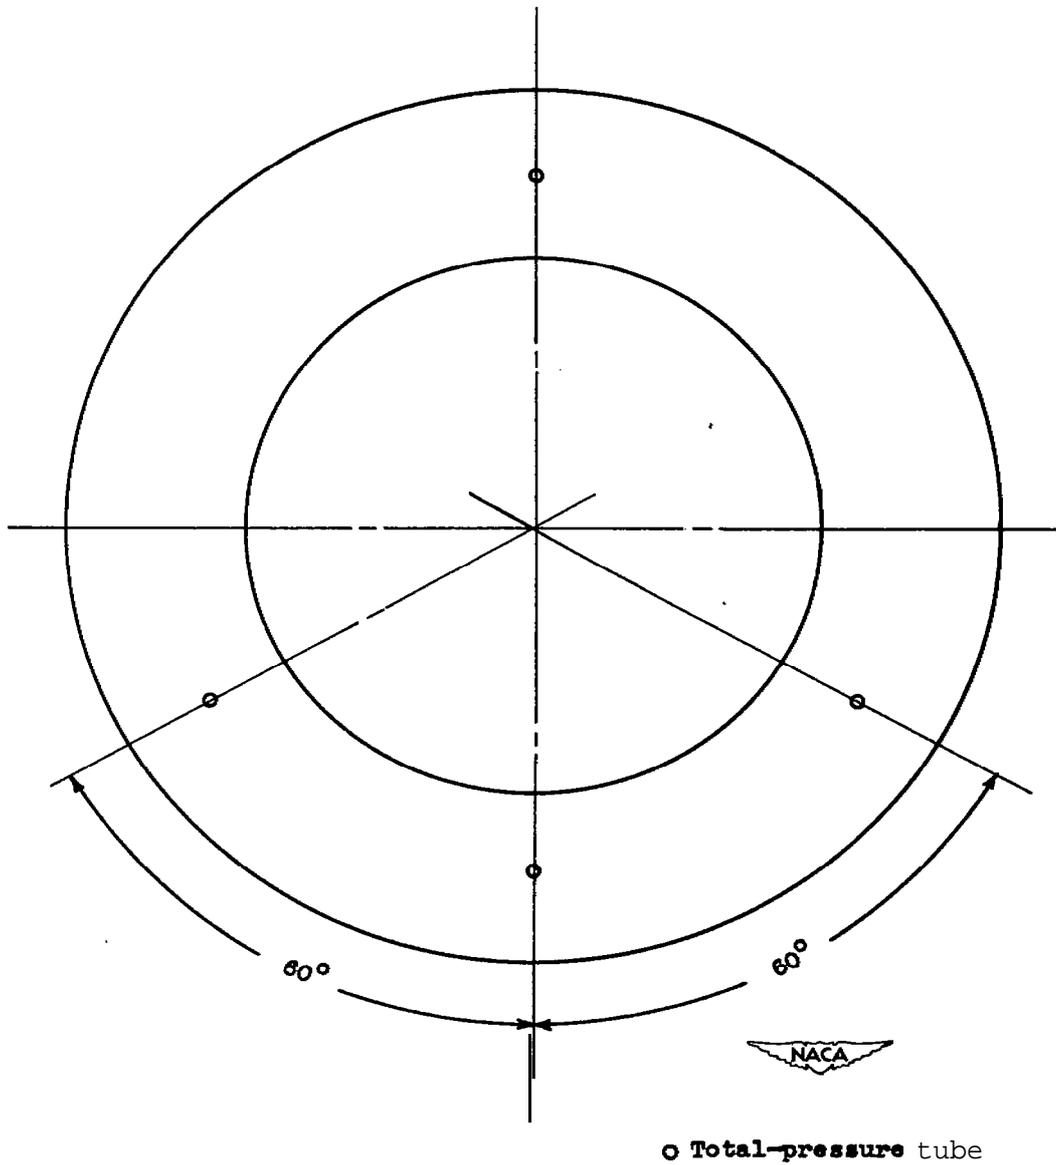
Figure 5. - Location of instrumentation at turbine inlet, station 5, $2\frac{3}{4}$ inches in front of center line of first-stage turbine stator blade,

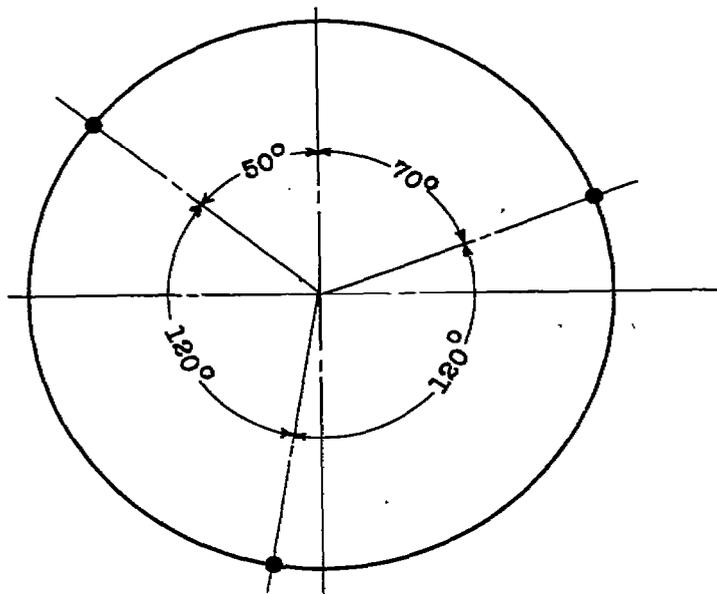
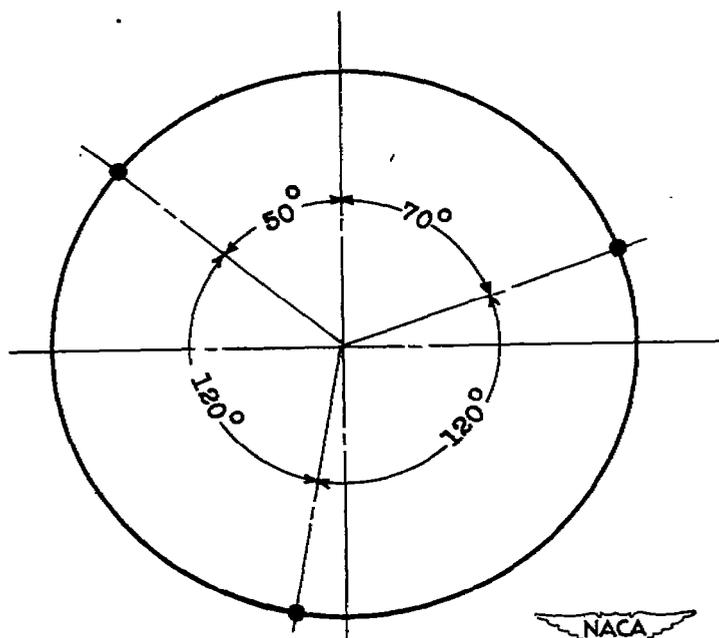
First stage

Second stage

Figure 6. - Location of static-pressure tubes at turbine stator stages, station 6, center line of each stator blade.

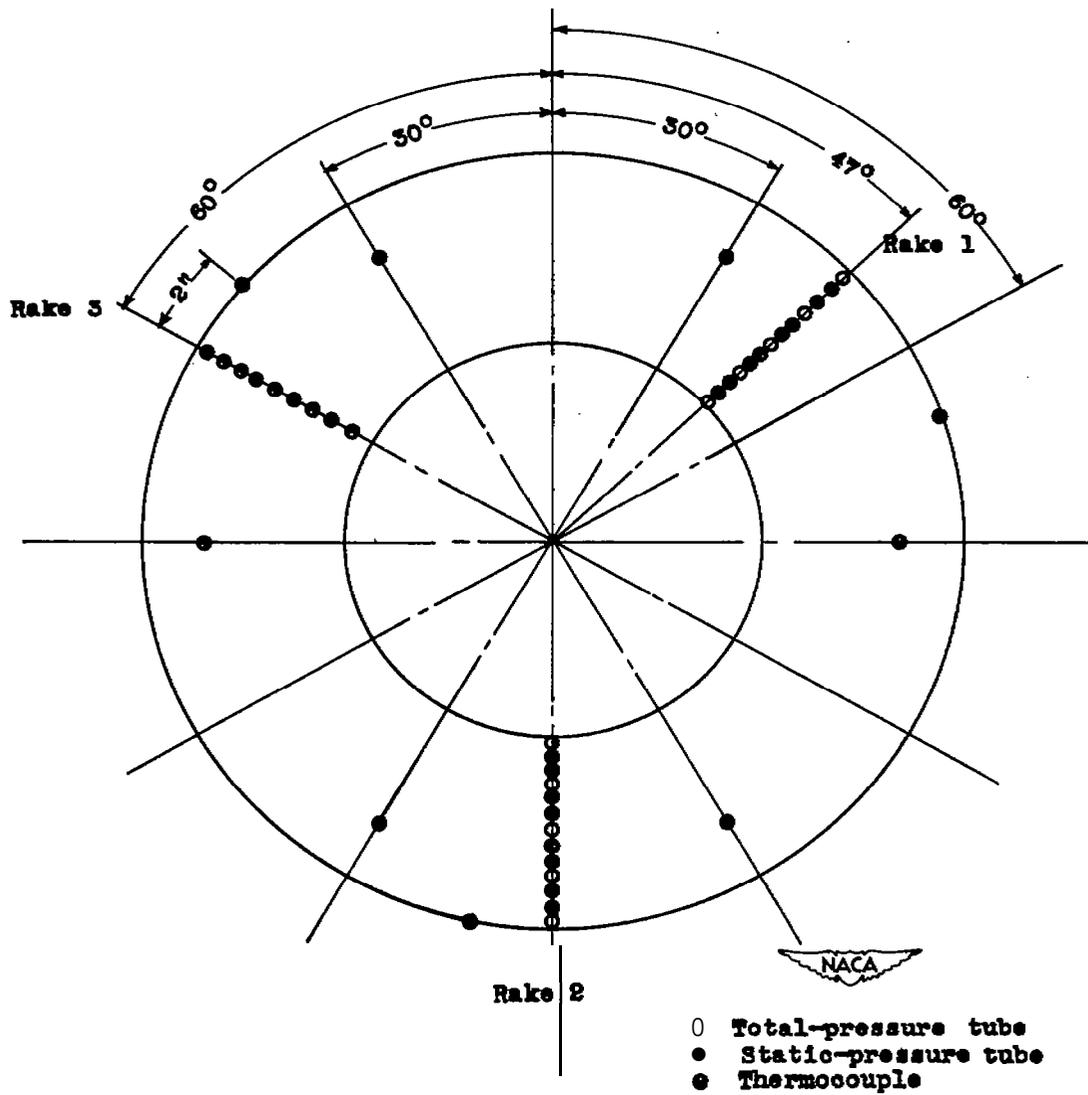
Figure 7. - Location of instrumentation at turbine outlet, $3\frac{3}{4}$ inches behind rear flange of turbine casing.

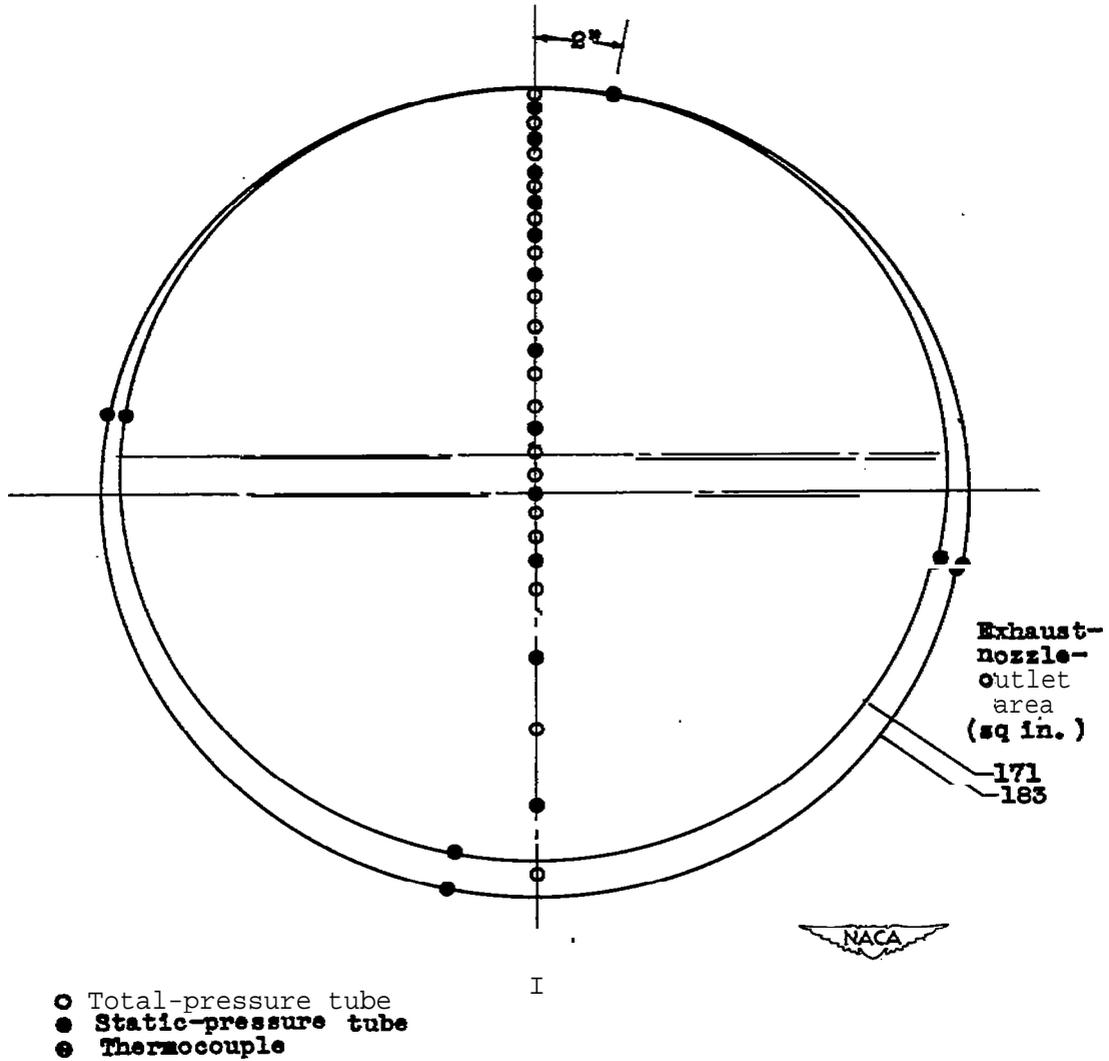
Figure 8. - Location of instrumentation in exhaust-nozzle outlet, station 8, 1 inch in front of rear edge of exhaust-nozzle outlet.

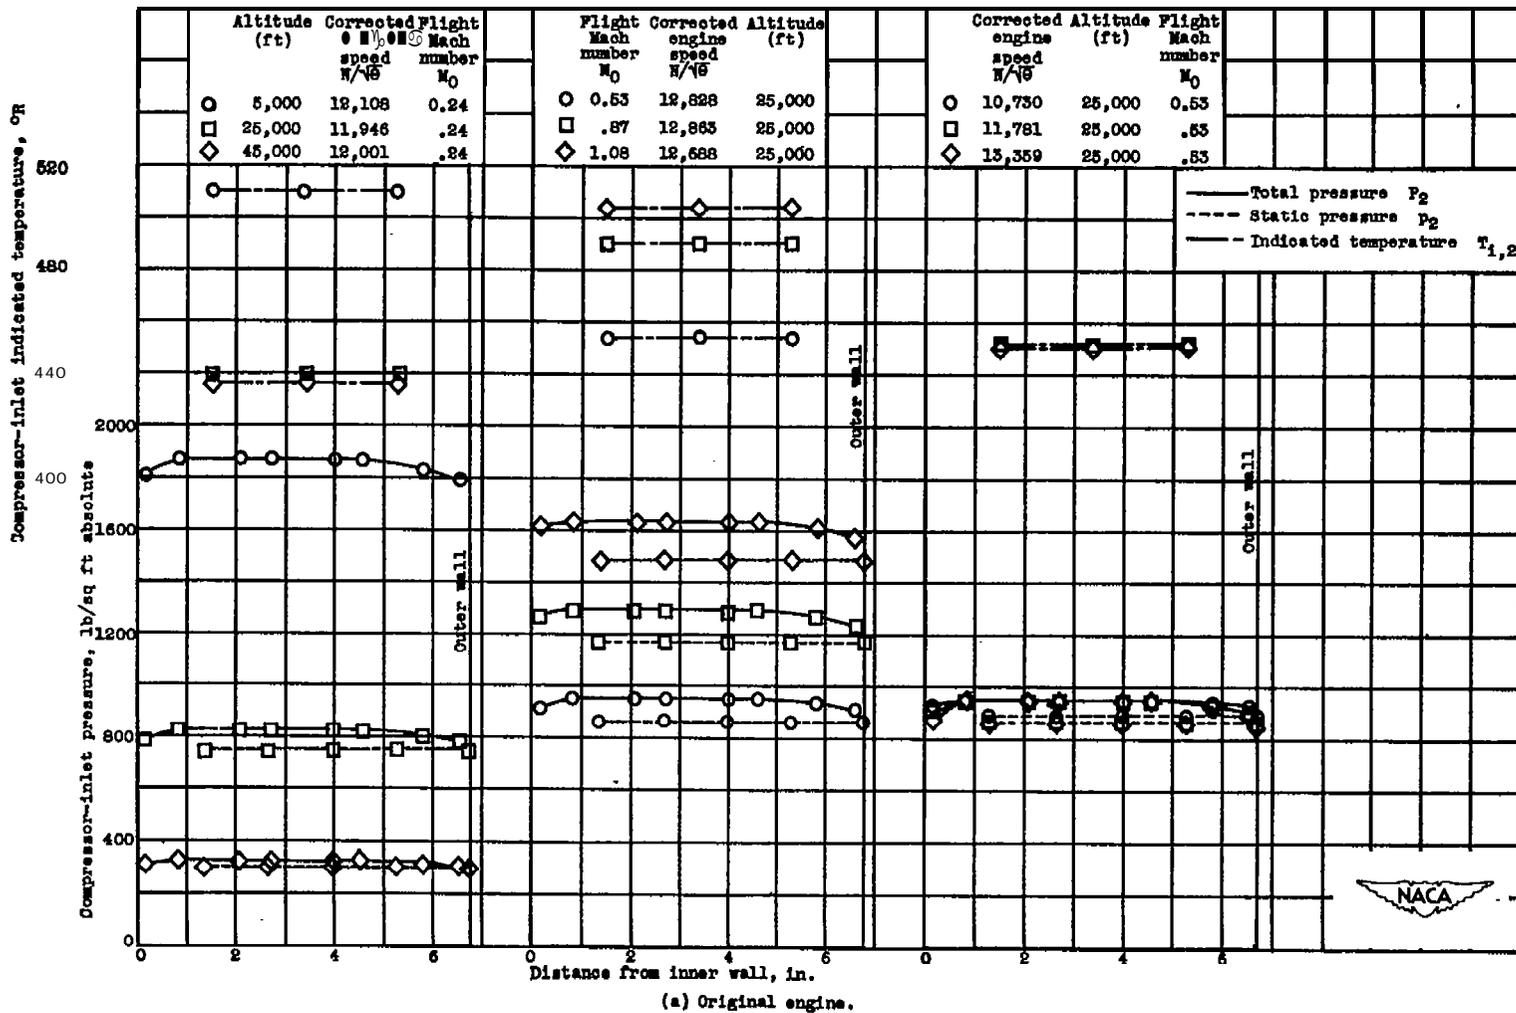
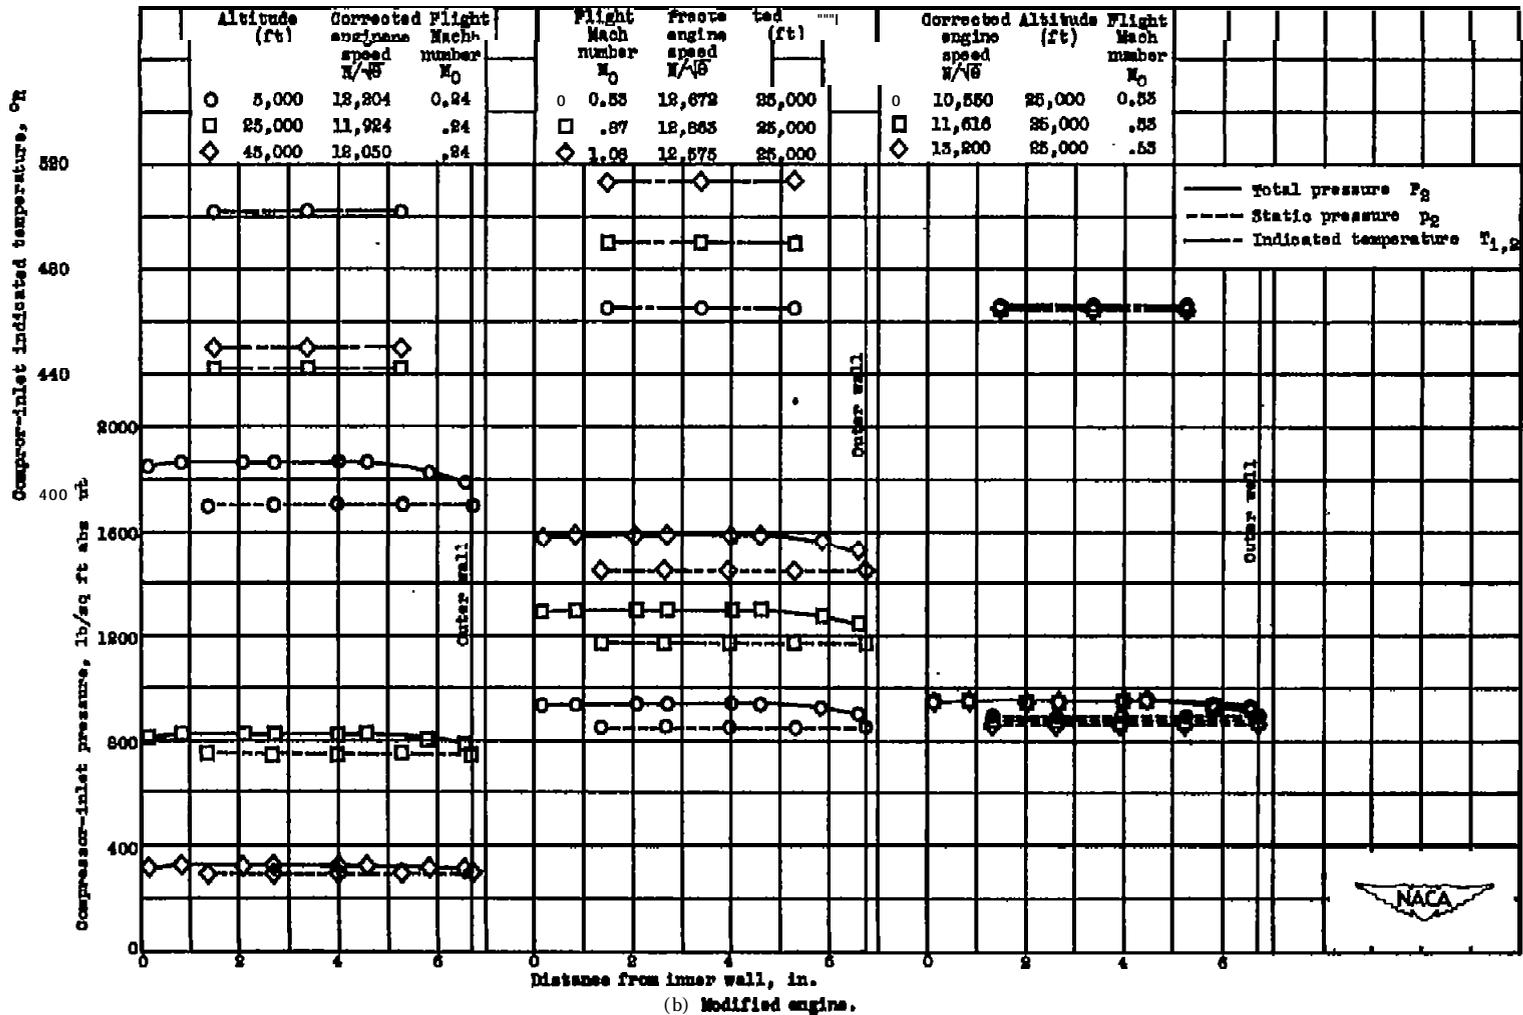
Figure 9. - Effect of altitude, flight Mach number, and engine speed on radial distribution of total pressure, static pressure, and indicated temperature at compressor inlet, station 2.

Figure 9. - Concluded. Effect of altitude, flight Mach number, and engine speed on radial distribution of total pressure, static pressure, and indicated temperature at compressor inlet, station 2.

The radial **distribution** of total pressure, static **pressure**, and Indicated **temperature** at the **compressor** inlet is shown in figure 9 for the original and modified **engines**. Total- and static-pressure levels for both engines were nearly the same at **each** operating **condition**. The **maximum variation** of temperature levels between the two engines at any operating **conditions** was about 15° F.

Total-pressure, **static-pressure**, and indicated-temperature distributions were uniform **across** the passage for both engines at all operating **conditions investigated**, with the **exception** of slightly lower total **pressures** near the wall due to the **boundary** layer.

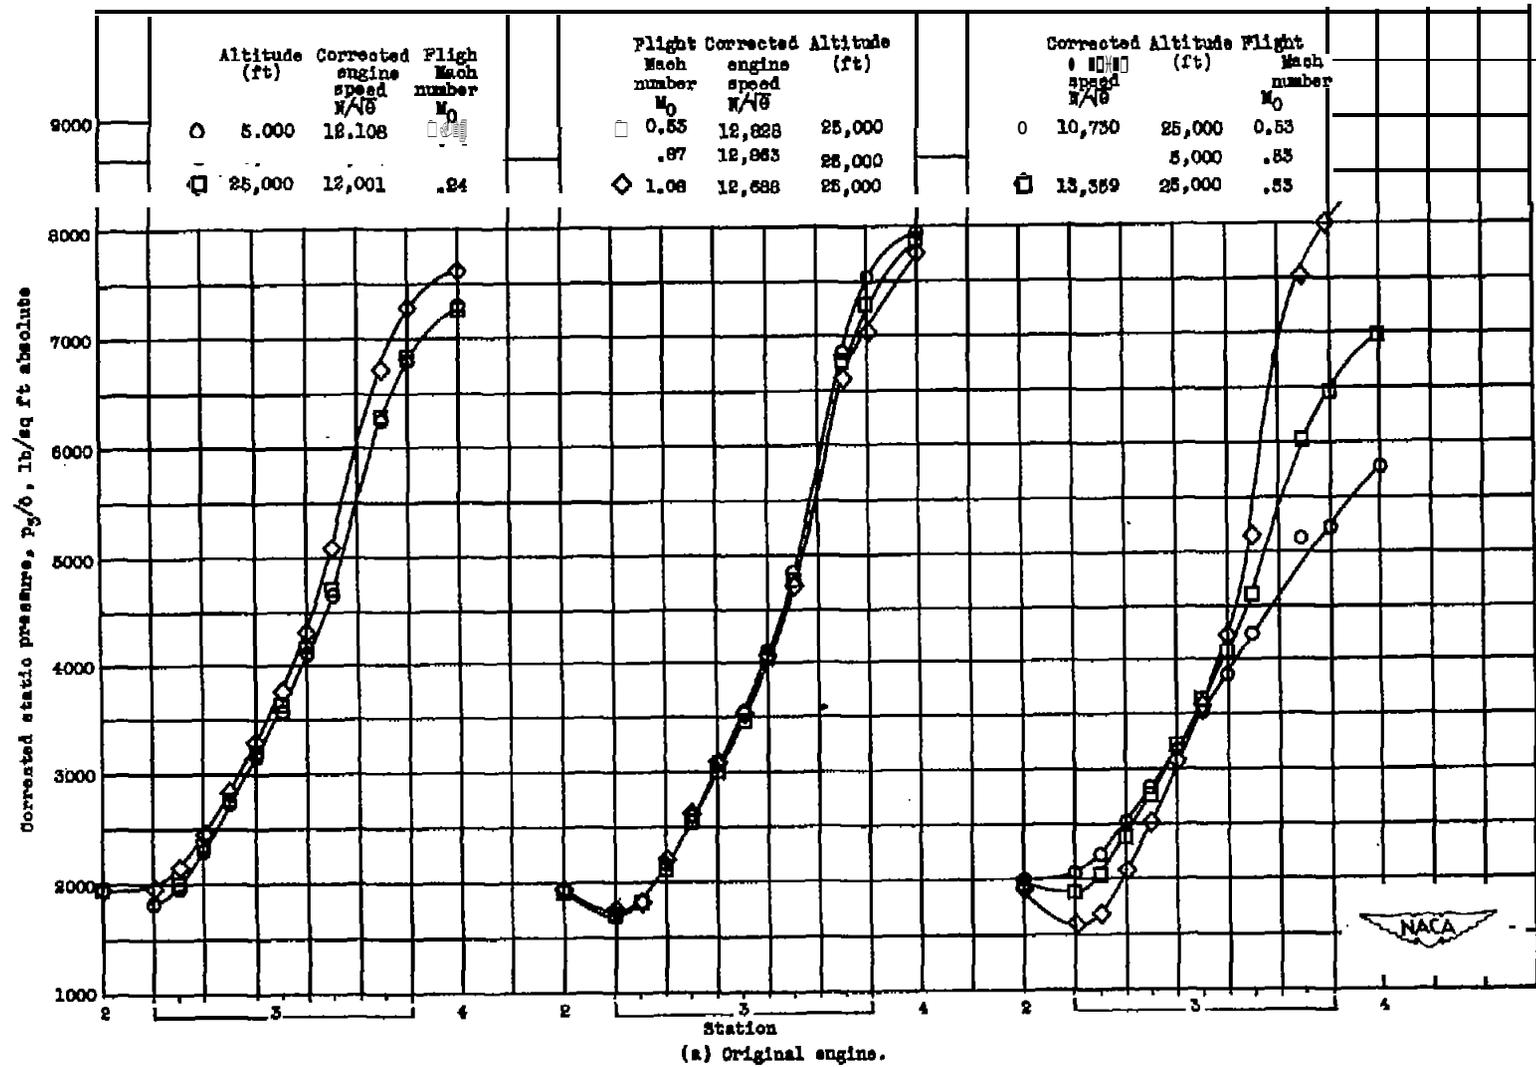
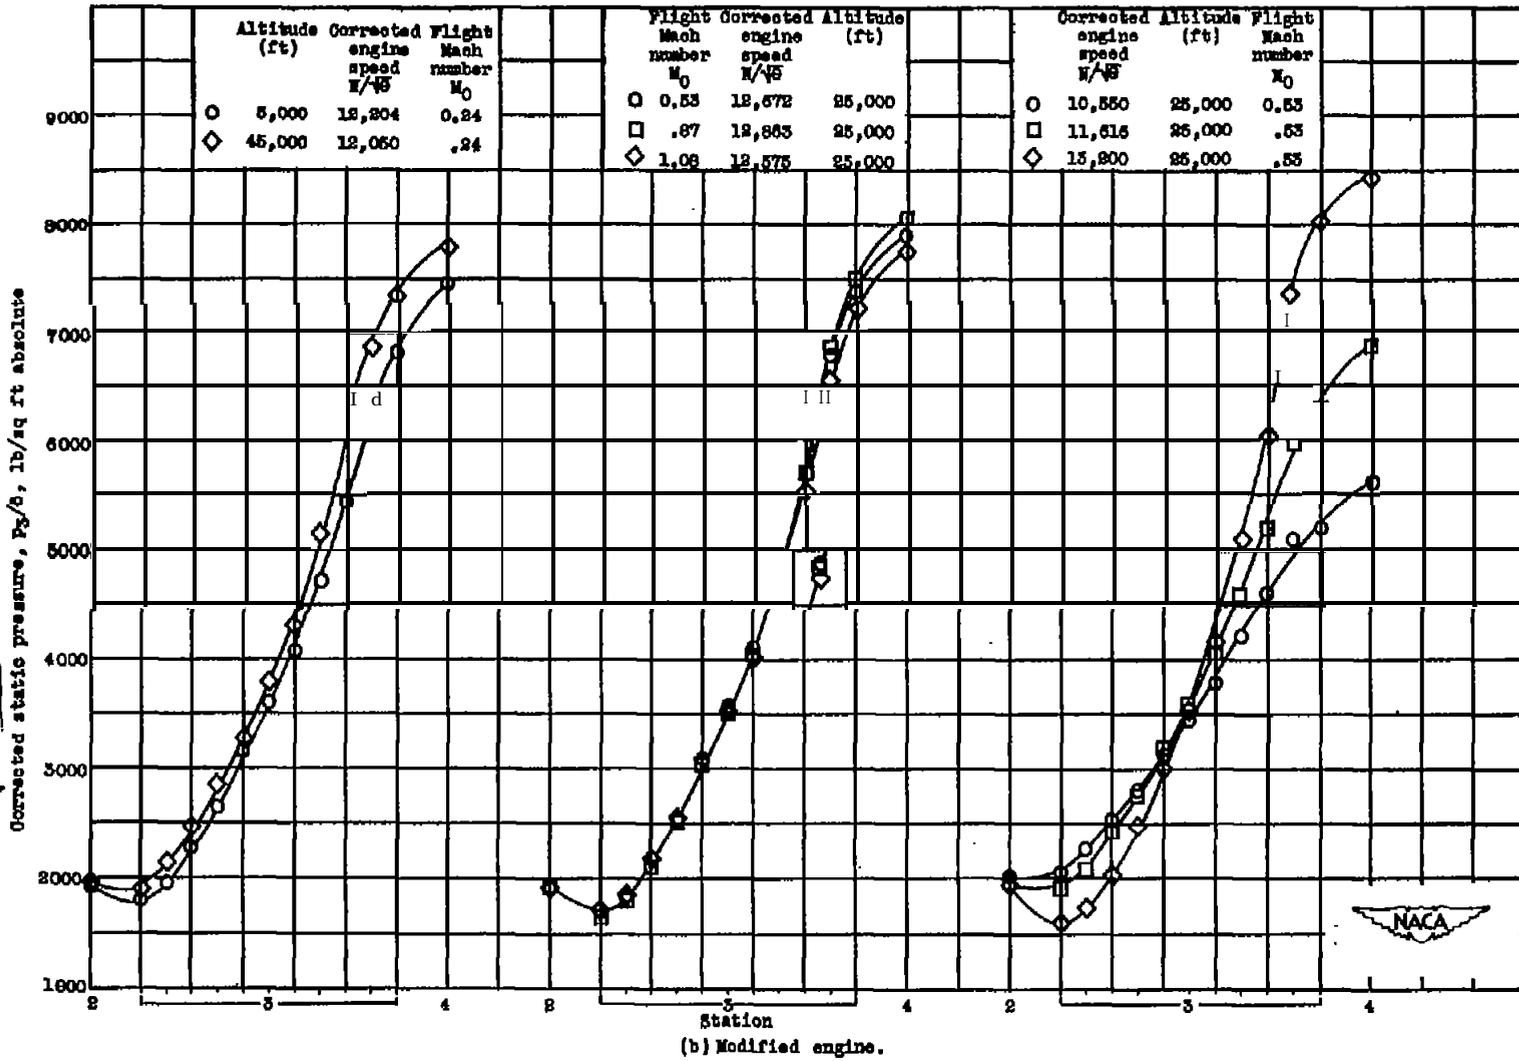
Figure 10. - Effect of altitude, flight Mach number, and engine speed on corrected static pressure at compressor stator stages, station 3.

Figure 10. - Concluded. Effect of altitude, flight Mach number, and engine speed on corrected static pressure at compressor stator stages, station 5.

The variation of corrected static pressure P_3/δ at the **compressor stator** stages is **shown** in figure 10 for the original and modified **engines**. **Continuous** pressure **rise** was **obtained** throughout the stages of the **compressor** of both engines for the operating

conditiona shown. An **increase** in altitude beyond 25,000 feet increased the over-all corrected pressure through the **compressor**. **Increasing** the flight Mach number **from** 0.53 to 1.08 did not **appreciably affect** the general pressure **distribution** through the first eight **compressor** stages; for the remaining stages, an increase in flight Mach number reduced the pressure level. For the modified engine (fig. 10(b)), the **corrected** engine speeds at flight Mach numbers of 0.53 and 1.08 were **scmewhat lower than** at the **comparable** conditions for the **original** engine, and consequently, the pressure levels are not in the same sequence with **increasing** flight Mach **number as shown for the** original engine. **Increasing** the corrected engine speed lowered the static pressure at the **first-stator** stage **as** a result of the increased velocities through the inlet guide **vanes**. Twisting the eleventh-stage rotor blades had no **appreciable** effect on the static-pressure rise across that stage. The **effects** of altitude, flight Mach number, and engine speed **on** the corrected atatio-pressure distributions through the **compressors** were similar for both engines.

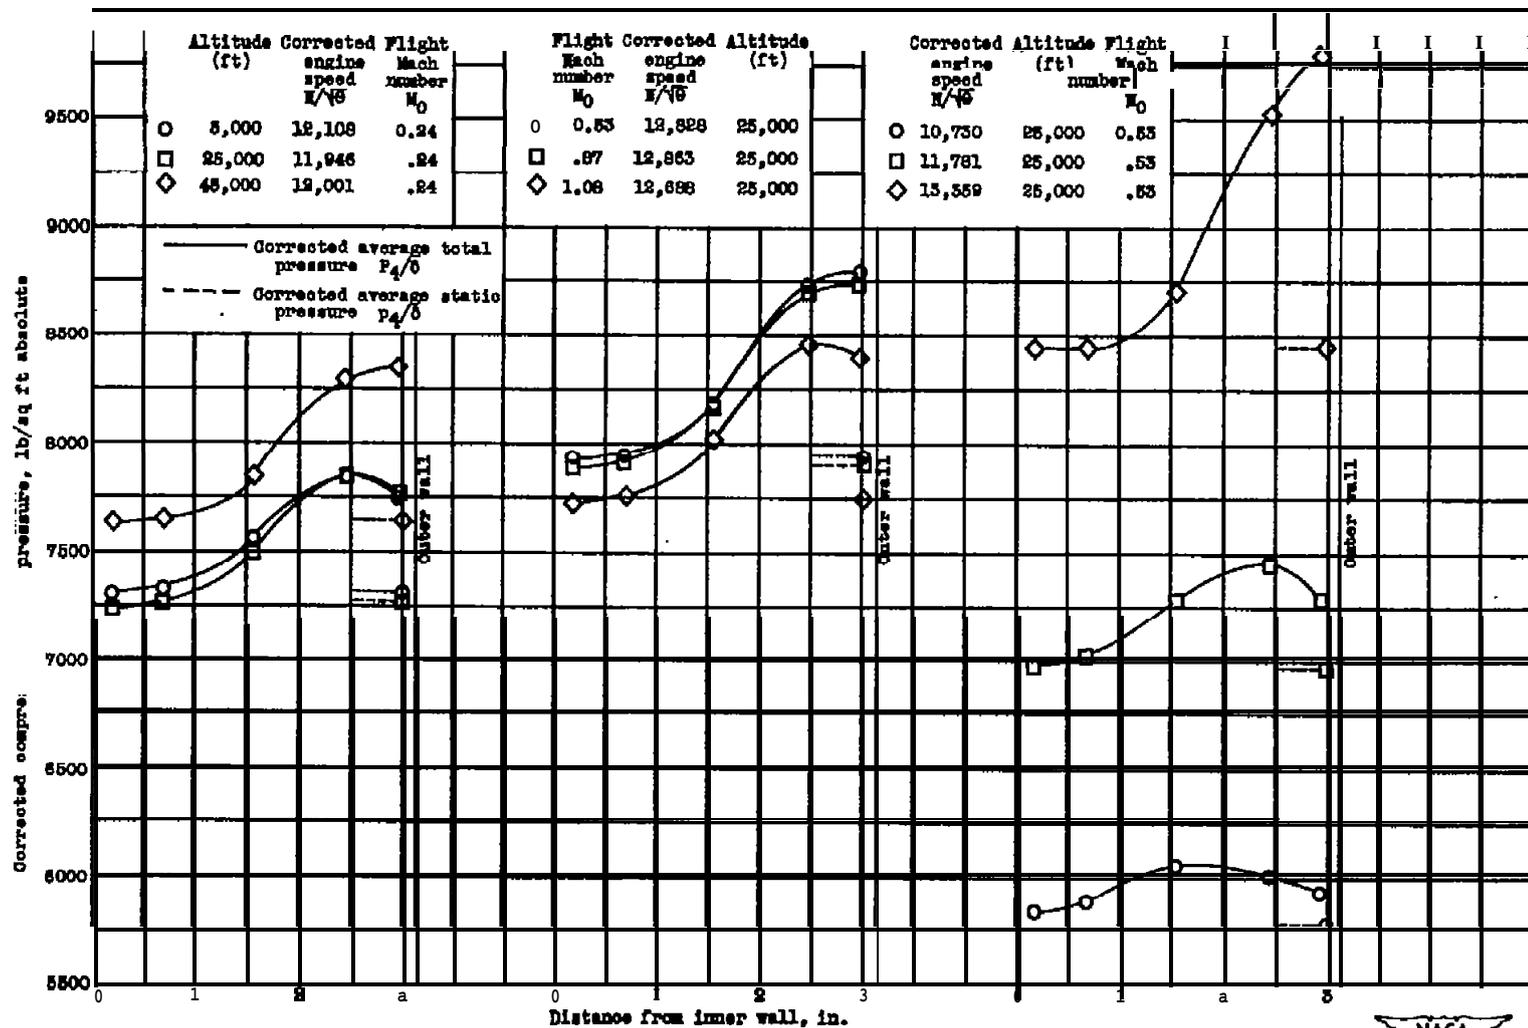
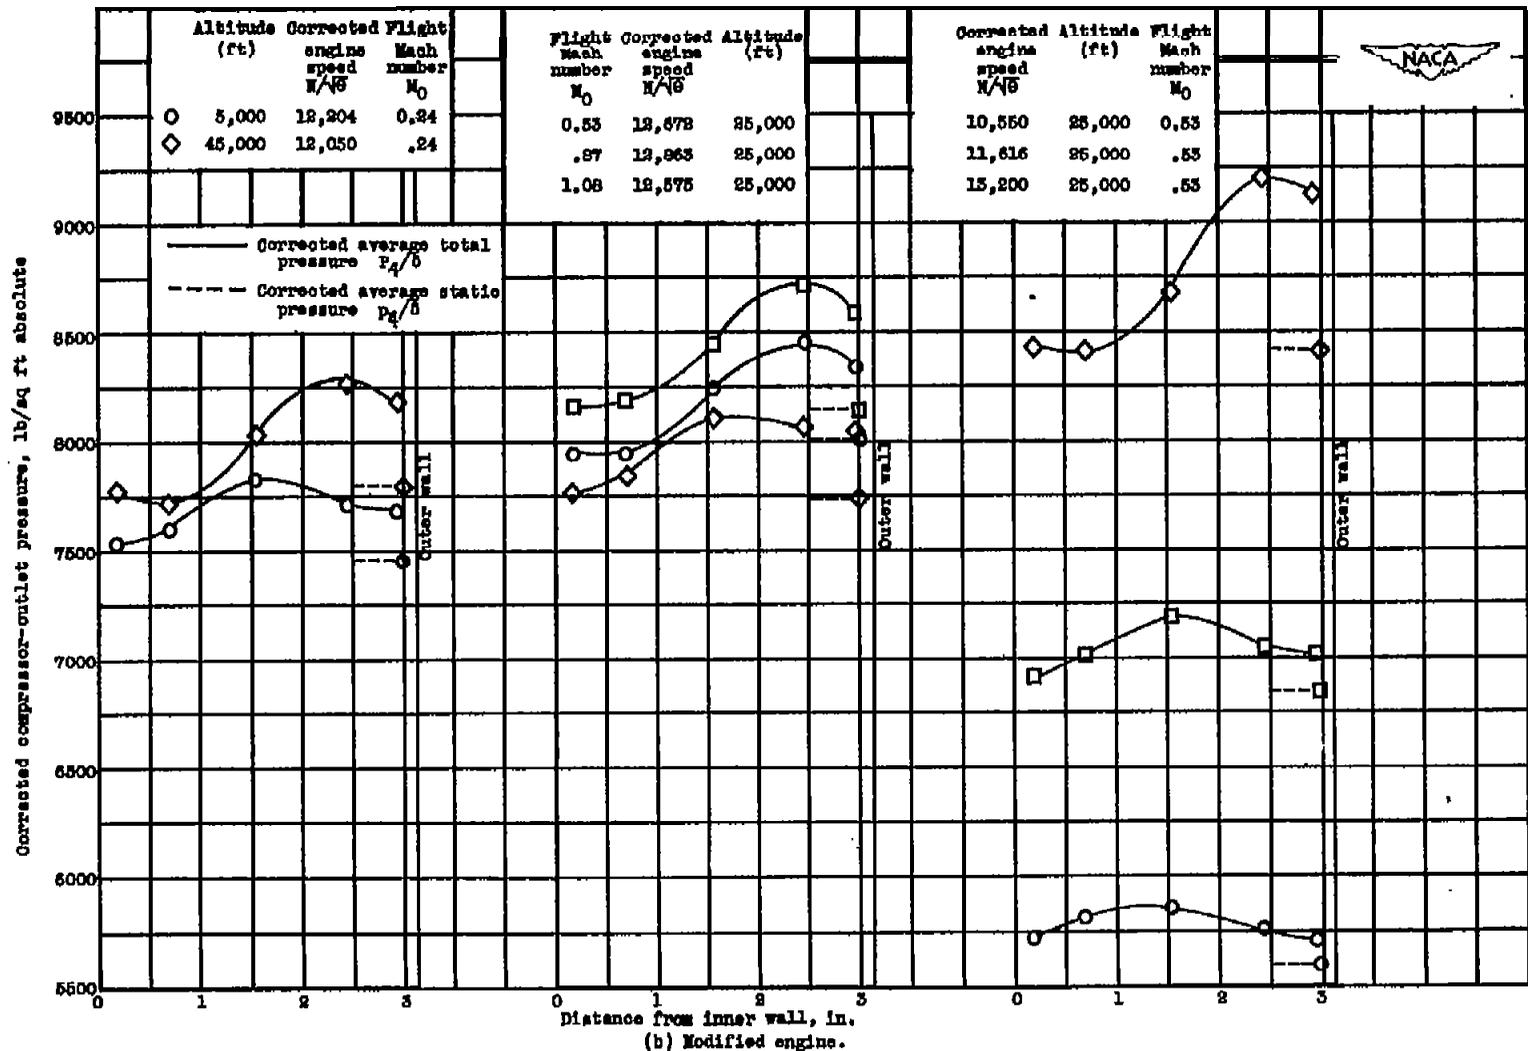
Figure 11. - Effect of altitude, flight Mach number, and engine speed on radial distribution of average corrected total pressure at compressor outlet, station 4.

Figure 11. - Concluded. Effect of altitude, flight Mach number, and engine speed on radial distribution of average corrected total pressure at compressor outlet, station 4.

Average radial distributicna of total pressure $P_4/8$ at the **compressor** outlet are shown in figure 11 for both engines. **Inas-much** as no **appreciable** radial or **circumferential variation in** static pressure **occurred** at **any operating condition**, only the average **corrected static** pressure $p_4/8$ is shown.

For the original engine (fig. 11(a)), the **corrected** total pressure and the average static pressure were **approximately** equal for a distance of **3/4 inch from** the inner wall of the passage at **each** altitude, which indicated low **velocity** and air flow. Fran this point, the **corrected** total pressure **increased** rapidly **across** the passage and, for altitudes up to 25,000 feet, peak total pressures were obtained at approximately **3/4 inch from** the outer wall. At an altitude of 45,000 feet, the total-pressure peak **increased in** magnitude and moved nearer the outer wall. For the modified engine (fig. 11(b)), the tot&-pressure peak at an altitude of 5000 feet **occurred** in the **central** part of the **compressor-outlet** passage and at an altitude of 45,000 feet the total-pressure peak moved outward to approximately **3/4 inch from** the outer wall. The total and static pressures near the inner wall, however, were **approximately** equal, as in the original **engine**.

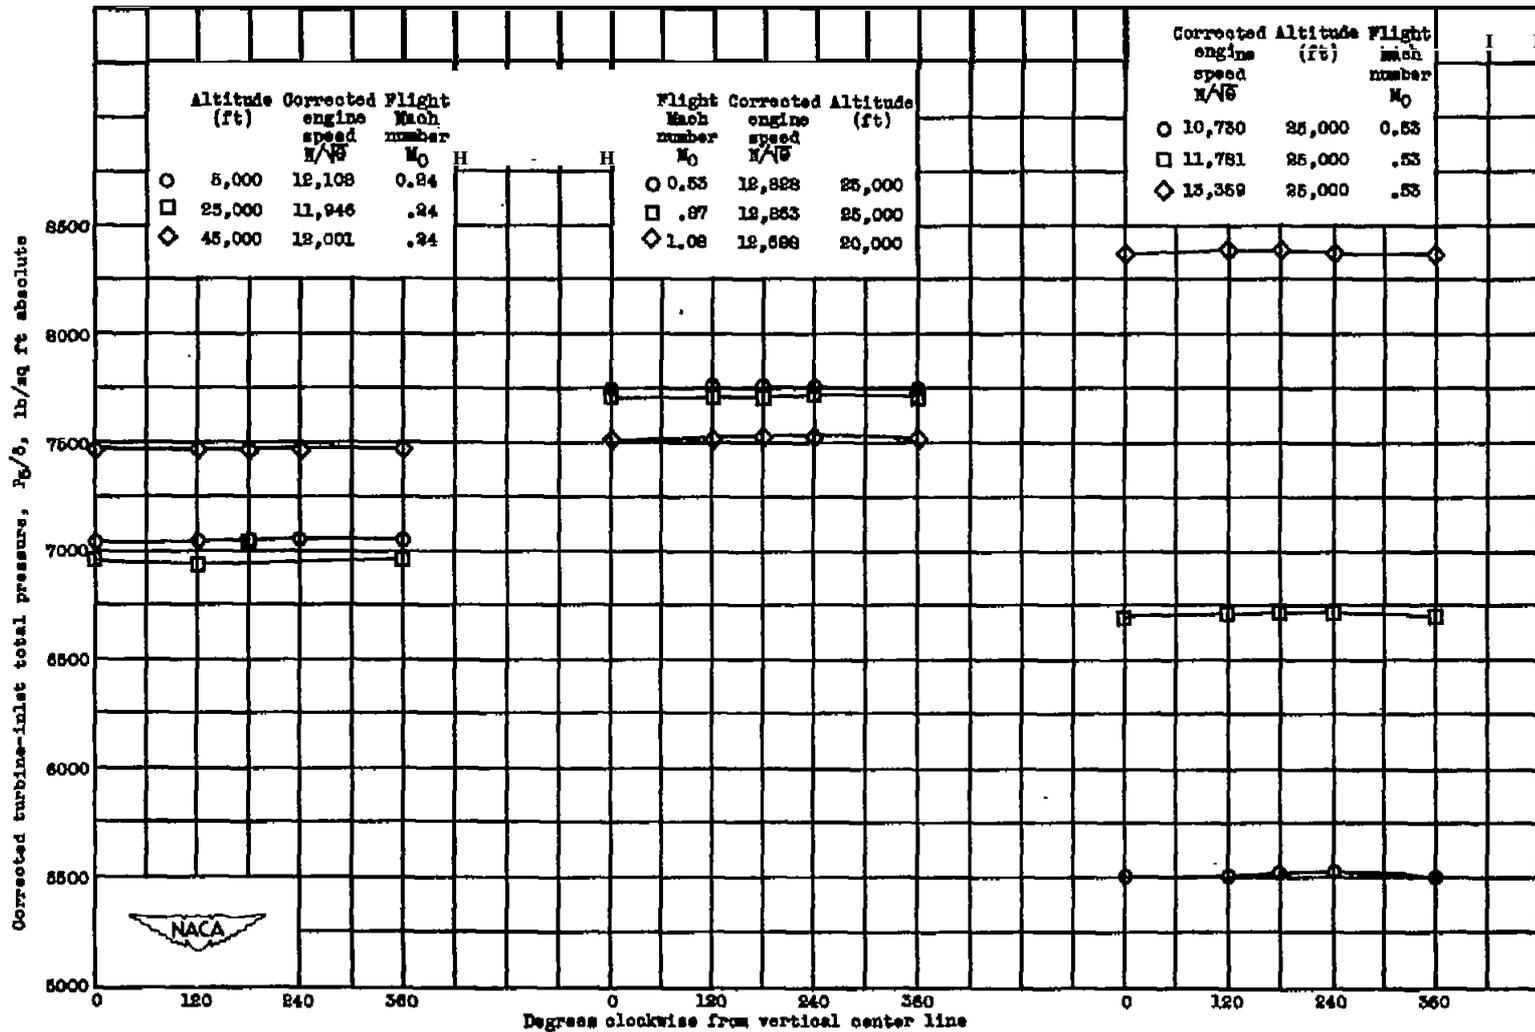
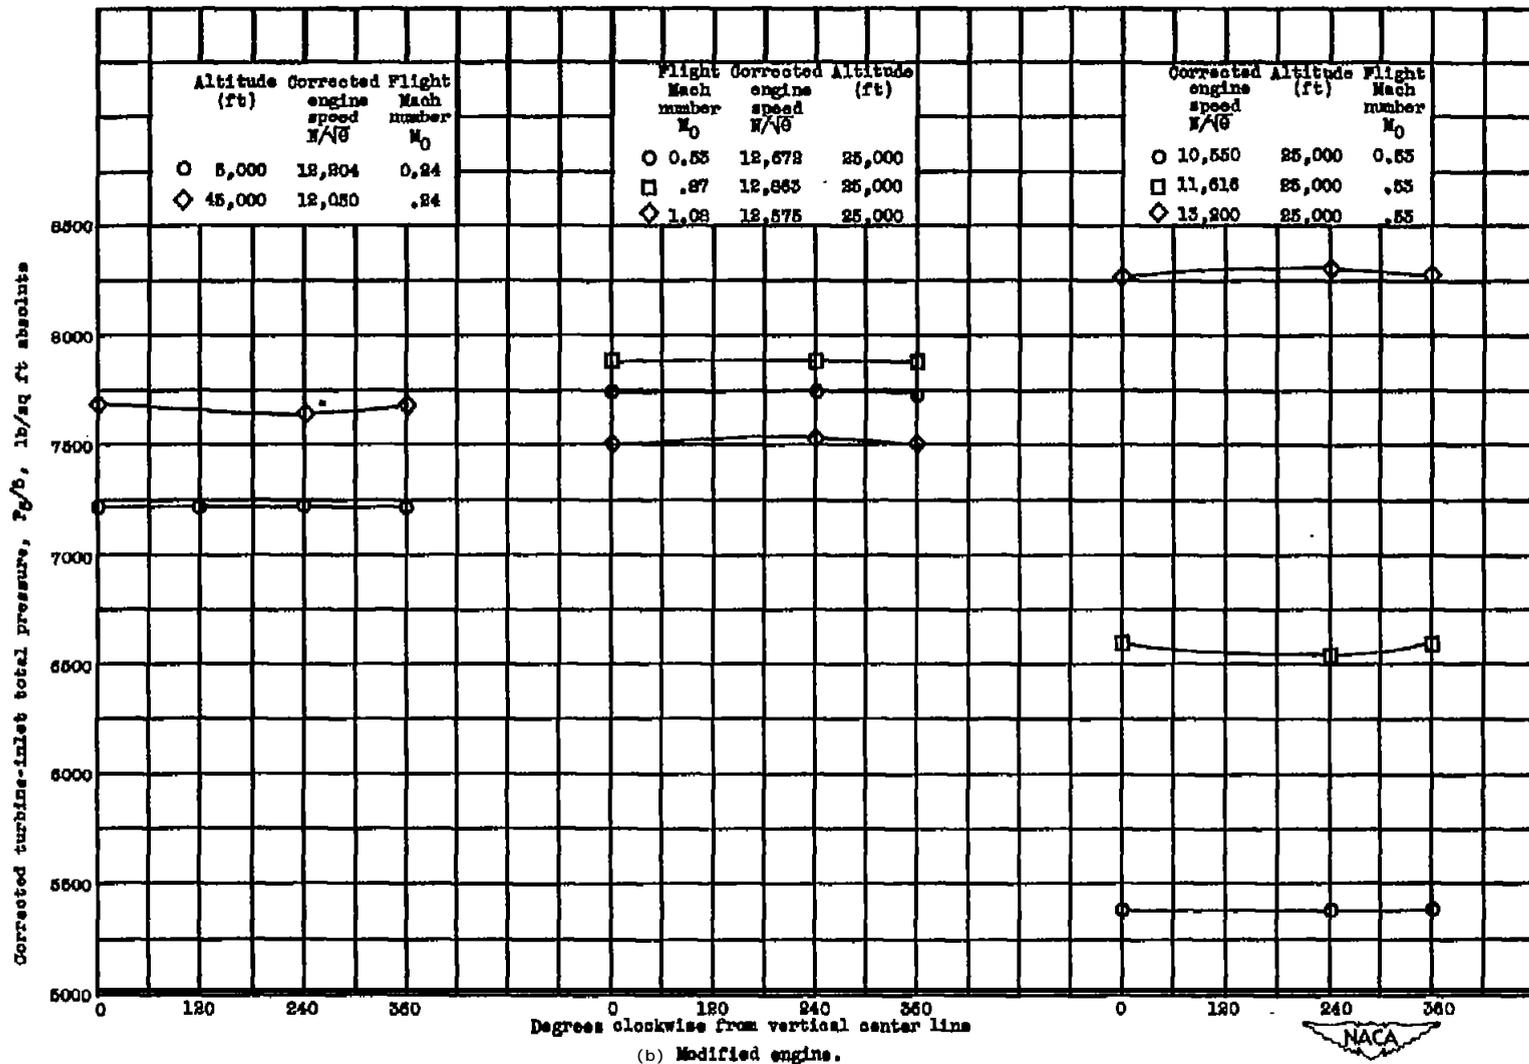
Figure 12. - Effect of altitude, flight Mach number, and engine speed on circumferential distribution of corrected total pressure at turbine inlet, \bullet tations.

Figure 1a. - Concluded. Effect of altitude, flight Mach number, and engine speed on circumferential distribution of corrected total pressure at turbine inlet, station 5.

Circumferential distribution of corrected total pressure- $P_{5/8}$ at the turbine inlet is shown in figure 12 for the original and modified engines. The total-pressure distribution was uniform for both engines at all operating conditions. Changes in altitude, flight Mach number, or engine speed affected only the pressure level.
