NACA RM No. E8C17

ALTITUDE-WIND-TUNNEL INVESTIGATION OF A 3000-POUND-THRUST
AXIAL-FLOW TURBOJET ENGINE

VII - PRESSURE AND TEMPERATURE DISTRIBUTIONS

By Martin J. Saari and William R. Prince

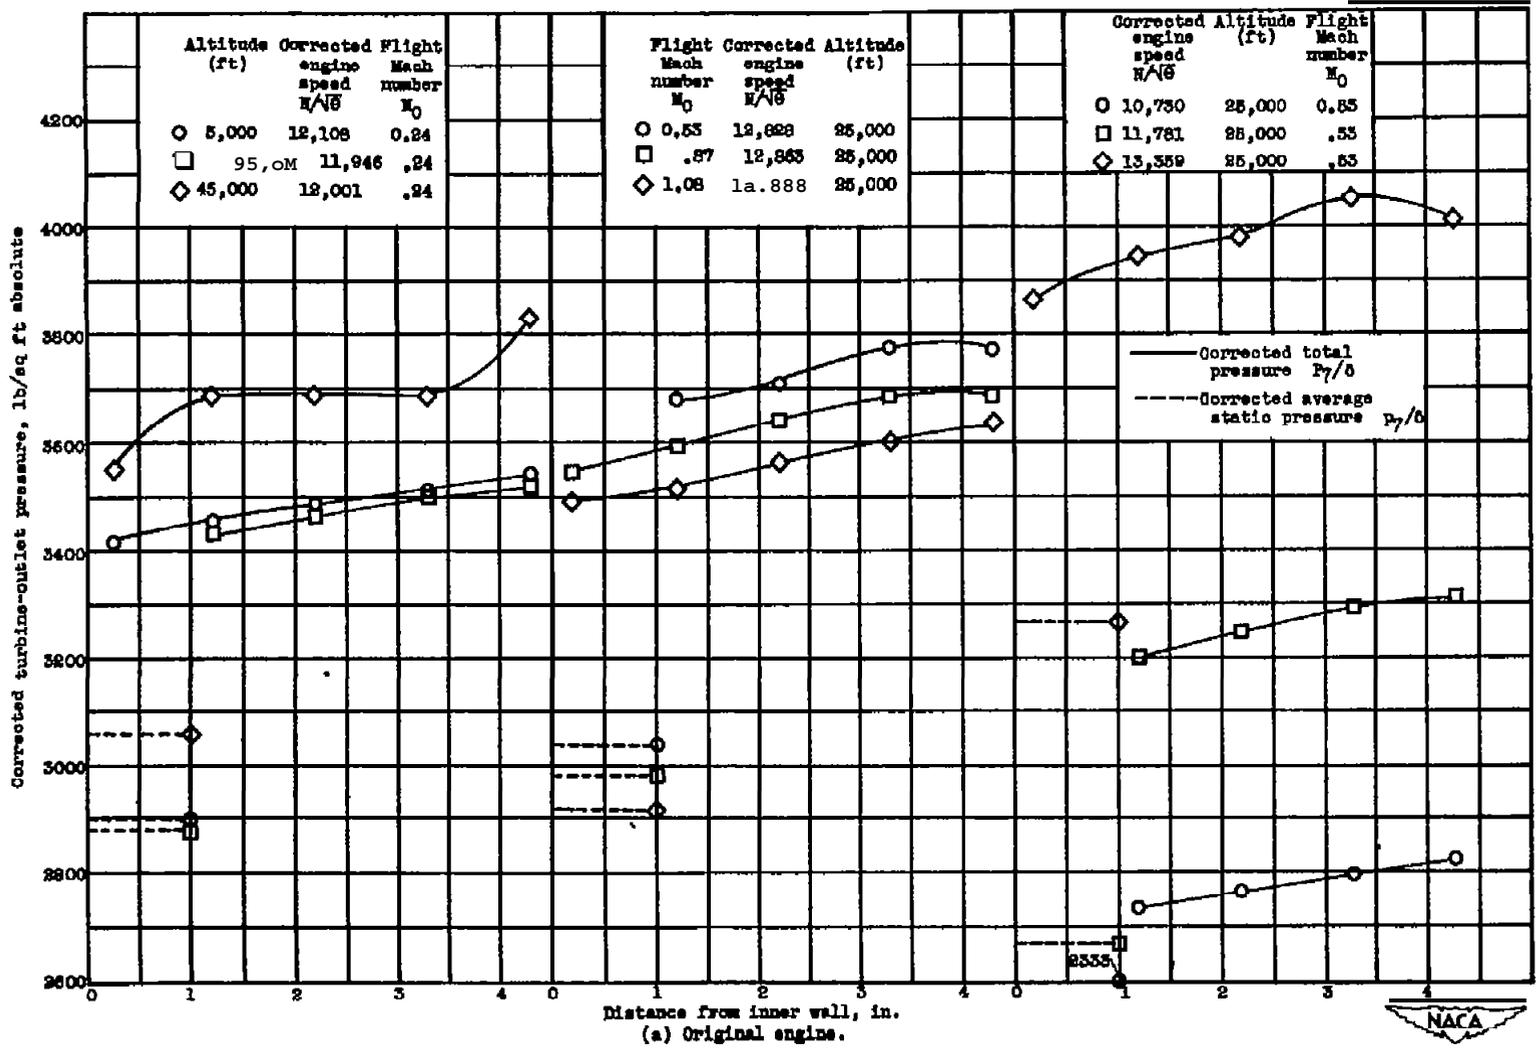
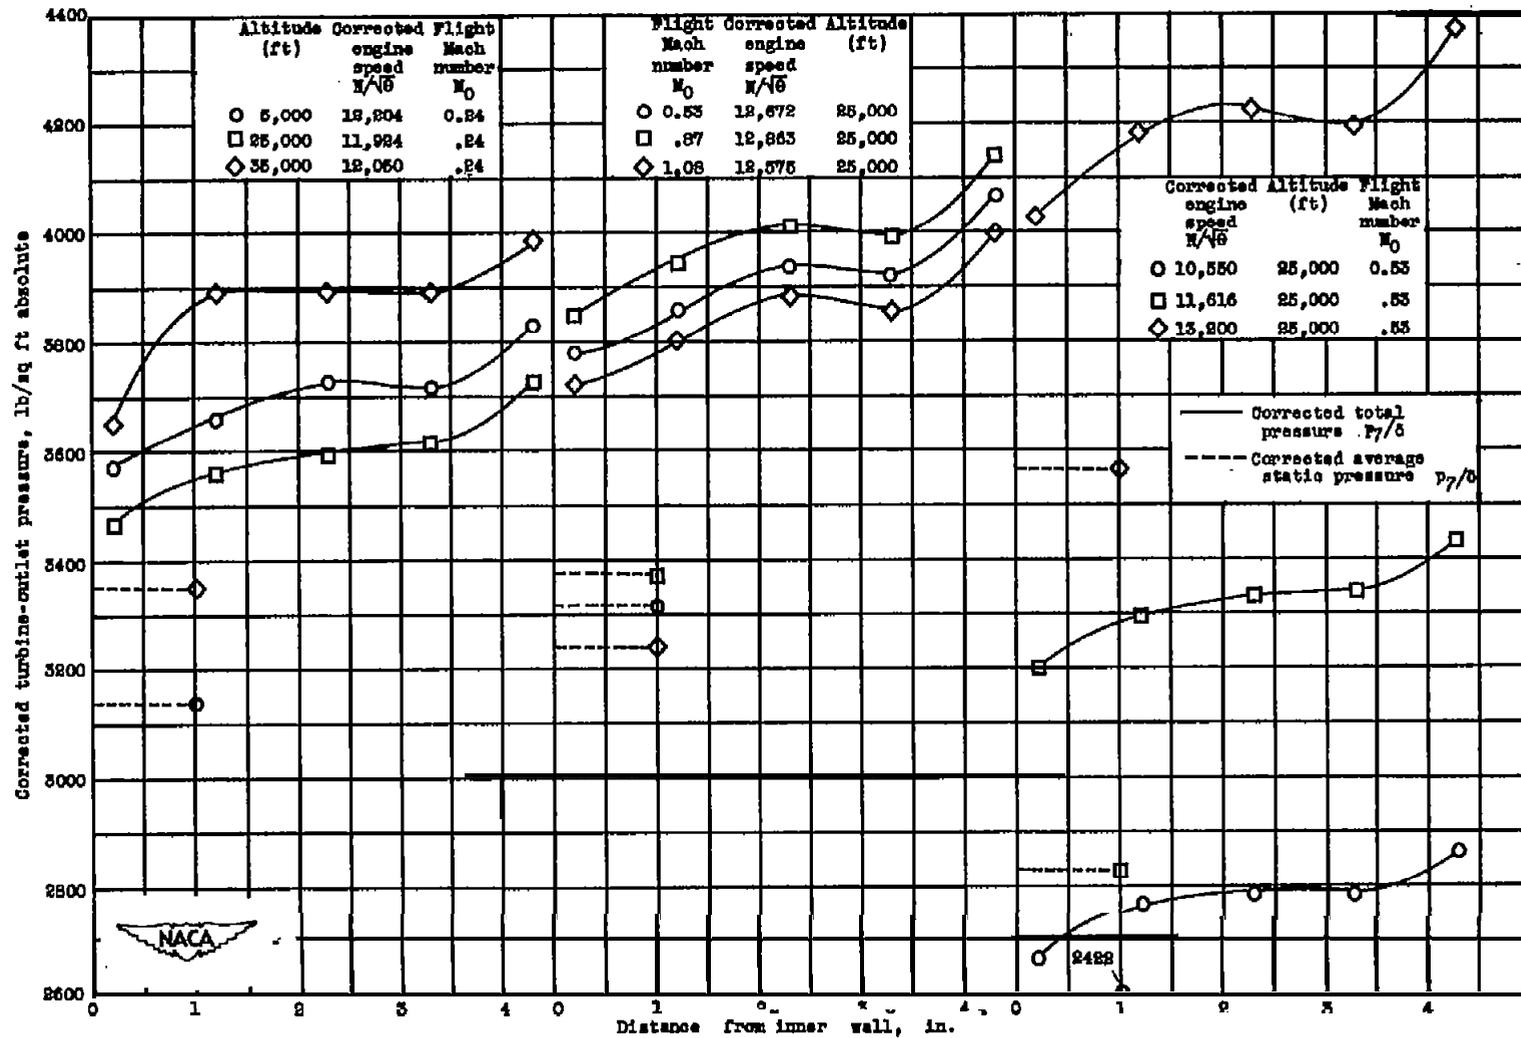
Figure 15. - Effect of altitude, flight Mach number, and engine speed on radial distribution of corrected total pressure at turbine outlet, station 7.

Figure 15. - Concluded. Effect of altitude, flight Mach number, and engine speed on radial distribution of corrected total pressure at turbine outlet, station 7.

Total-pressure distributions at the turbine outlet are presented in figure 13 for both engines. The static pressure shown for each operating condition is an average of three static-wall-orificemeasurements. In general, the corrected total pressure $P_{7/8}$ increased across the passage from the inner wall to the outer wall. For the modified engine (fig. 13(b)), the rapid increase in total pressure near the outer wall is attributed to the reduced blocking area of the screen at the inlet of the Outer annulus of the combustion chamber. The distribution for both engines was not greatly affected by changes in operating conditions.

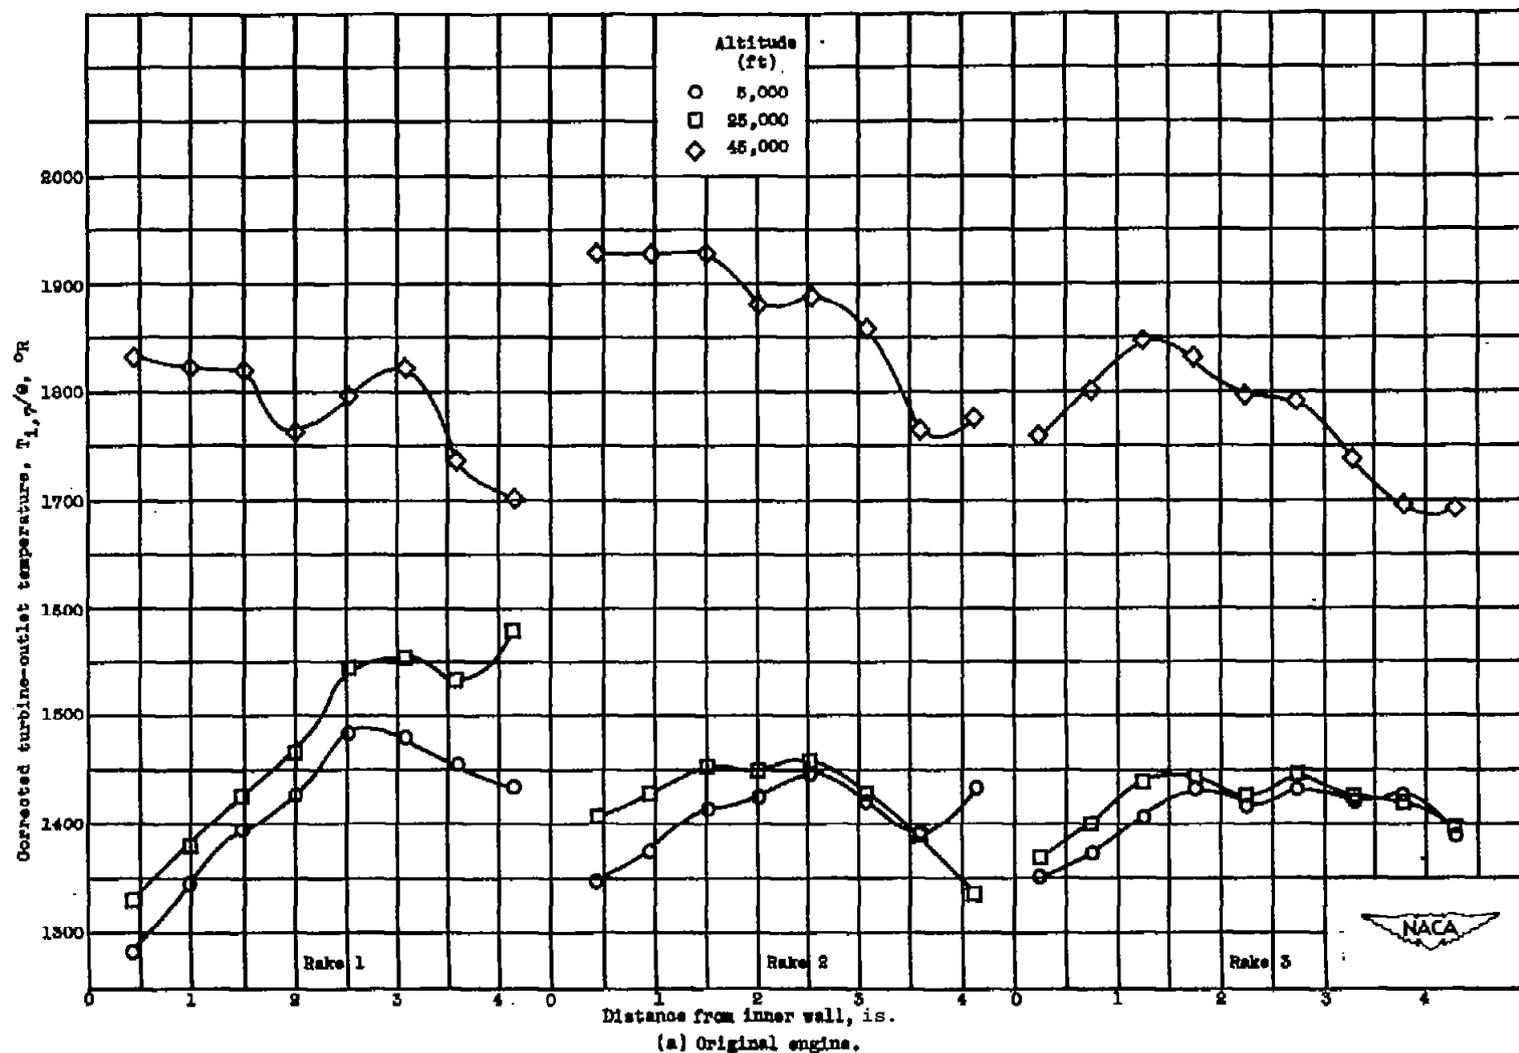
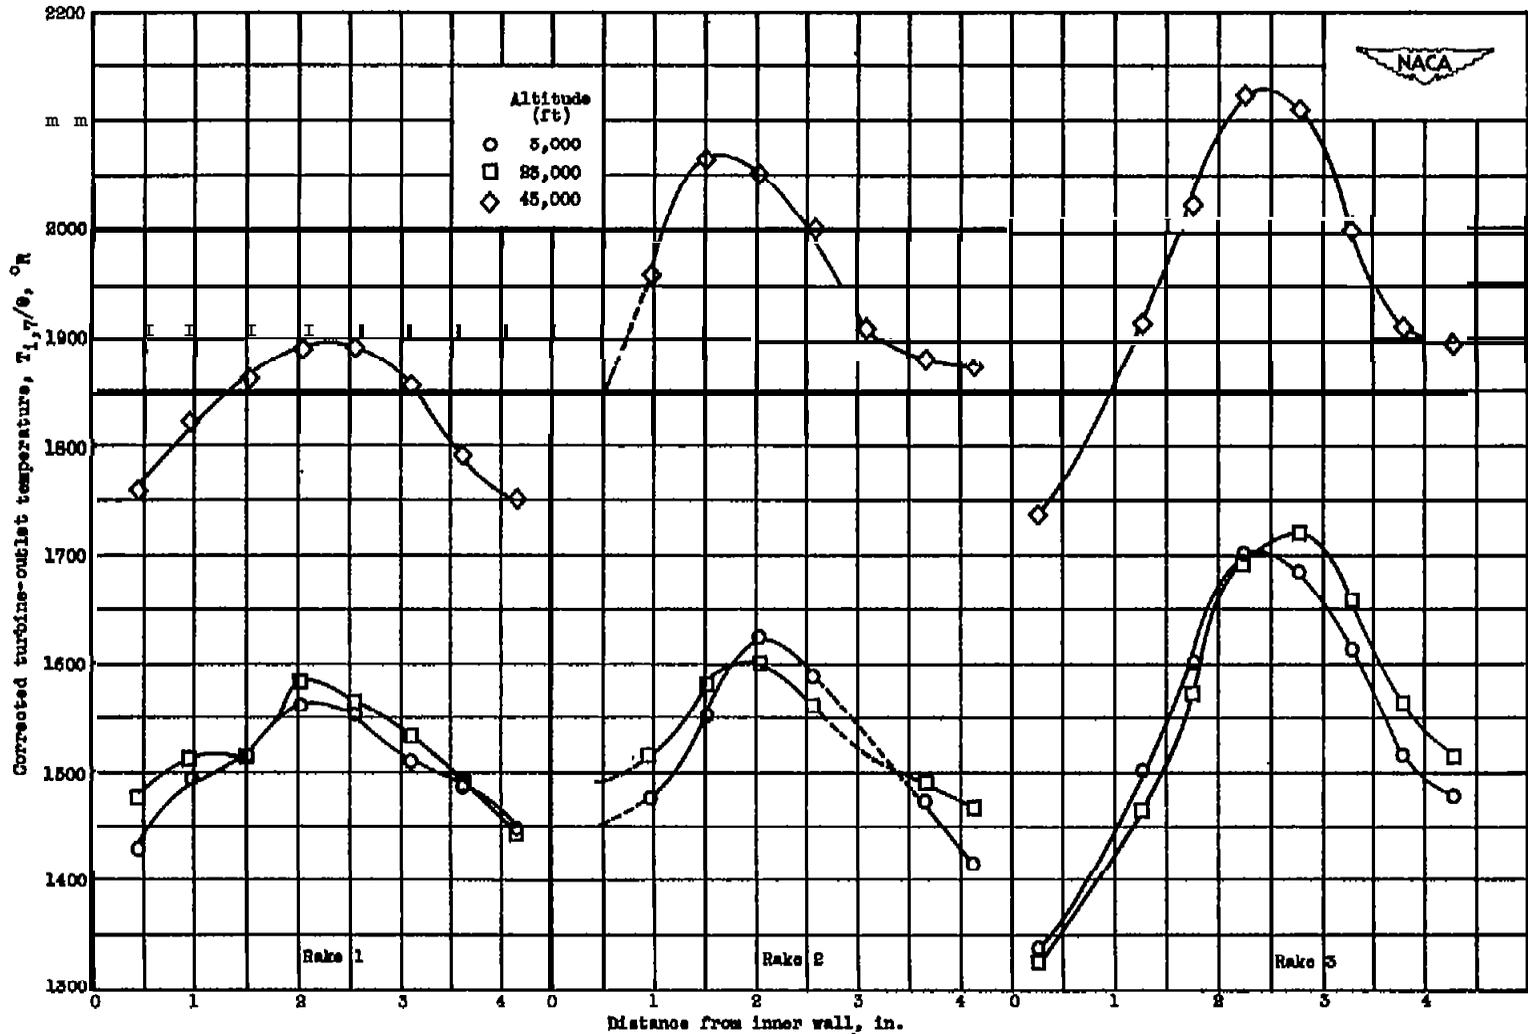
Figure 14. - Effect of altitude on radial distribution of corrected indicated temperature at turbine outlet, station 7. Flight Mach number, 0.84; corrected engine speed, approximately 12,000 rpm.

Figure 14. - Concluded. Effect of altitude on radial distribution of corrected indicated temperature at turbine outlet, station 7. Flight Mach number, 0.84; corrected engine speed, approximately 12,000 rpm.

from 5000 to 45,000 feet is presented in figure 14 for the original and modified engines at a flight Mach number of 0.24 and a corrected engine speed of about 12,000 rpm. The turbine-outlet temperature distribution for the original engine (fig. 14(a)) was not affected, except near the outer wall, when the altitude was increased from 5000 to 25,000 feet. At an altitude of 45,000 feet, the temperature at the inner wall increased with respect to the temperature at the outer wall to such an extent that the highest temperatures occurred in the vicinity of the turbine-blade roots. For the modified engine (fig. 14(b)), the temperature distributions measured by each rake were similar for the range of altitudes investigated. For both engines, an increase in altitude from 5000 to 25,000 feet generally resulted in a small increase in the corrected temperature level. Increasing the altitude beyond 25,000 feet, however, considerably increased the temperature level.

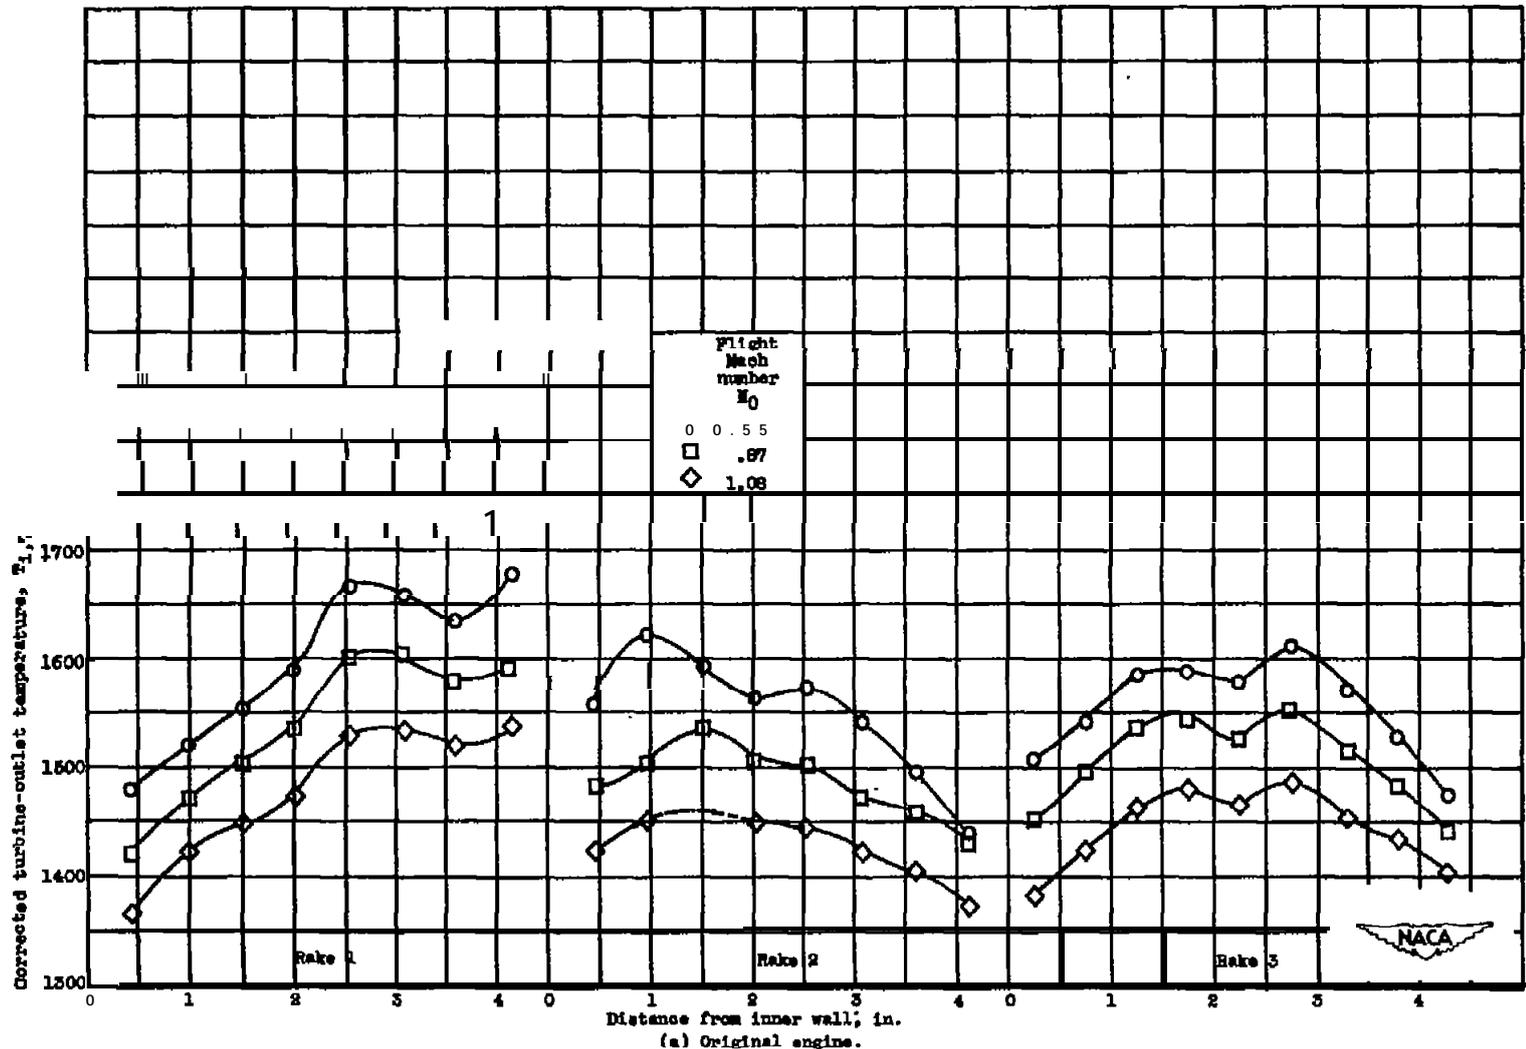
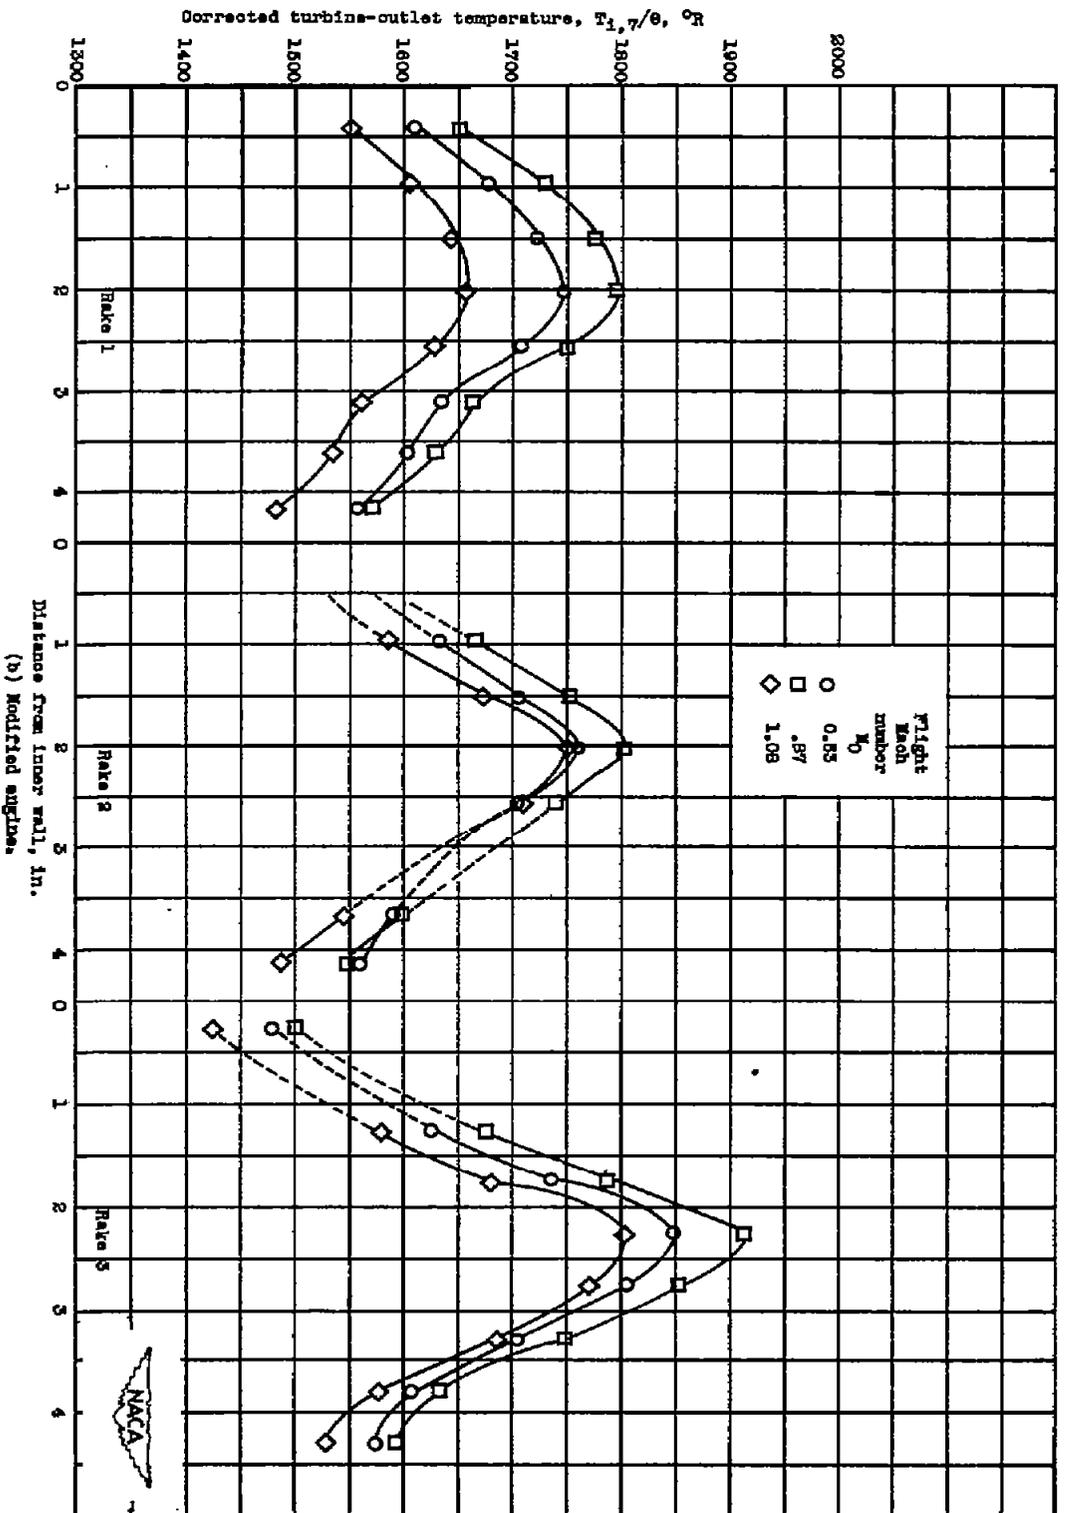
Figure 15. - Effect of flight Mach number on radial distribution of corrected indicated temperature at turbine outlet, station 7. Altitude, 25,000 feet; corrected engine speed, approximately 12,700 rpm.

Figure 15. - Concluded. Effect of flight Mach number on radial distribution of corrected indicated temperature at turbine outlet, station 7. Altitude, 20,000 feet; corrected engine speed, approximately 12,700 rpm.

The radial distribution of corrected temperature at the turbine outlet for flight Mach numbers from 0.53 to 1.06 is presented in figure 15 for both engines at an altitude of 25,000 feet and a corrected engine speed of about 12,700 rpm. For both engines, changes in flight Mach number did not affect the temperature distribution. An increase in flight Mach number decreased the corrected temperature level except at a flight Mach number of 0.87 for the modified engine. The corrected engine speeds at flight Mach numbers of 0.53 and 1.06 for the modified engine were somewhat lower than at the comparable conditions for the original engine and, consequently, the temperature levels are not in the same sequence with increasing flight Mach number as shown for the original engine.

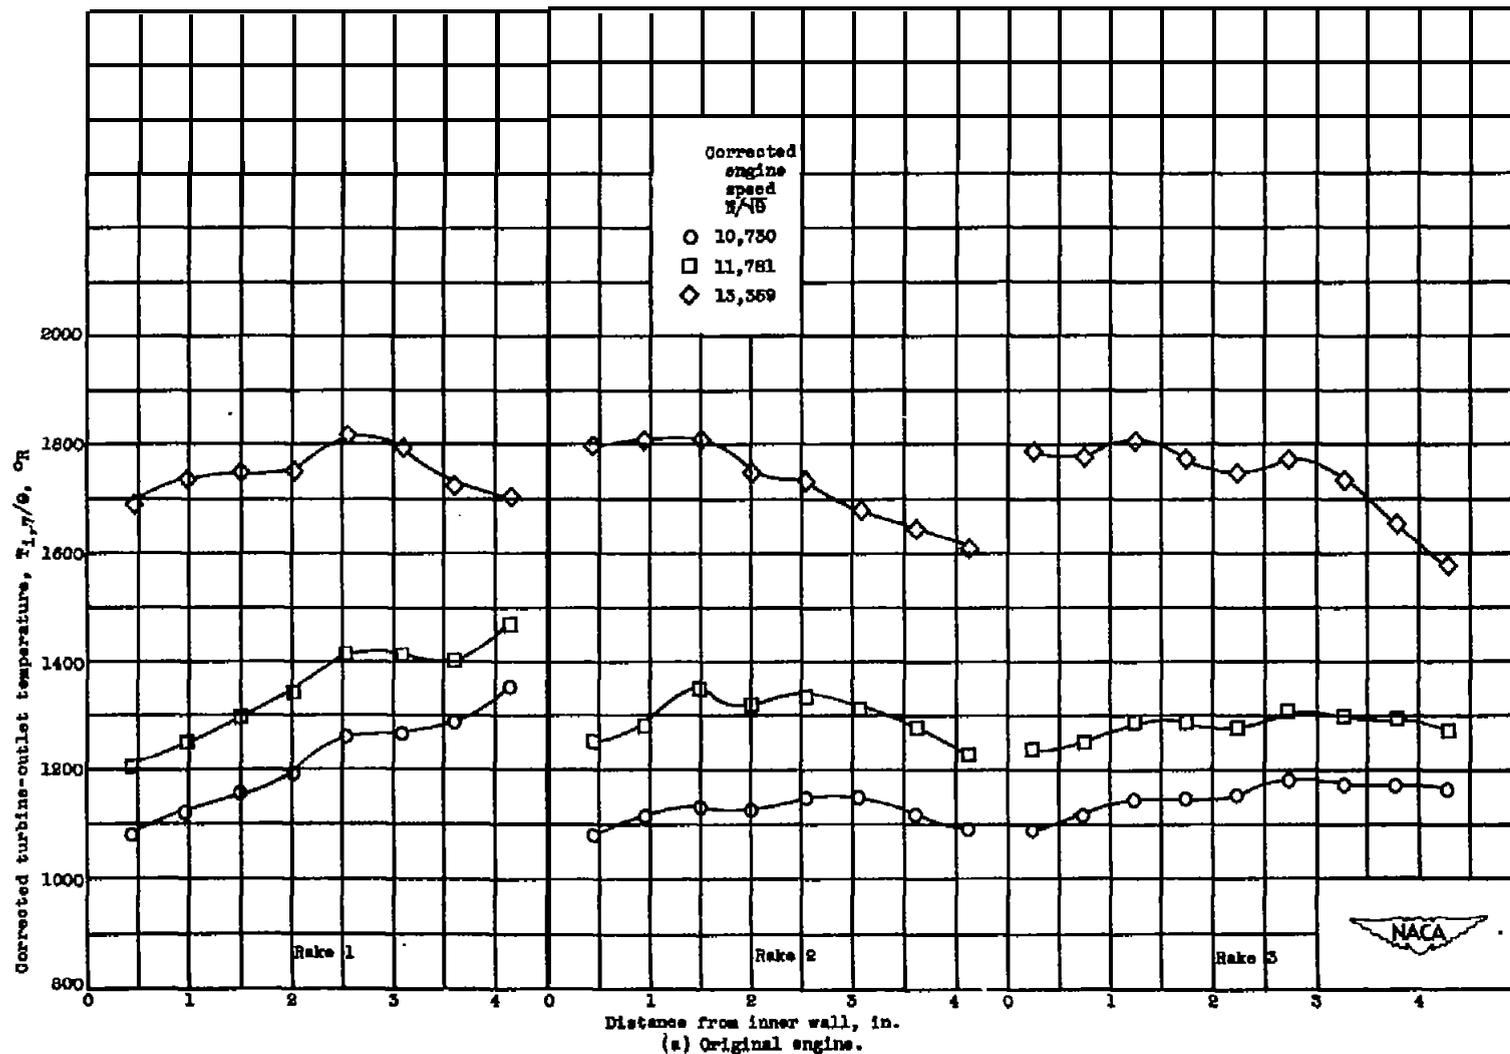
Figure 16. - Effect of engine speed on radial distribution of corrected indicated temperature at turbine outlet, station 7. Altitude, 25,000 feet; flight Mach number, 0.55.

The effect of corrected engine speed on the radial distribution of corrected indicated temperature at the turbine outlet is shown in figure 16 for both engines at an altitude of 25,000 feet and a flight Mach number of 0.53. Increasing the corrected engine speed moved the temperature peak toward the root sections of the turbine blades. However, this effect was more pronounced for the original engine than for the modified engine. At the highest engine speed for the modified engine (fig. 16(b)), the maximum temperature at each rake position occurred in the central part of the passage.

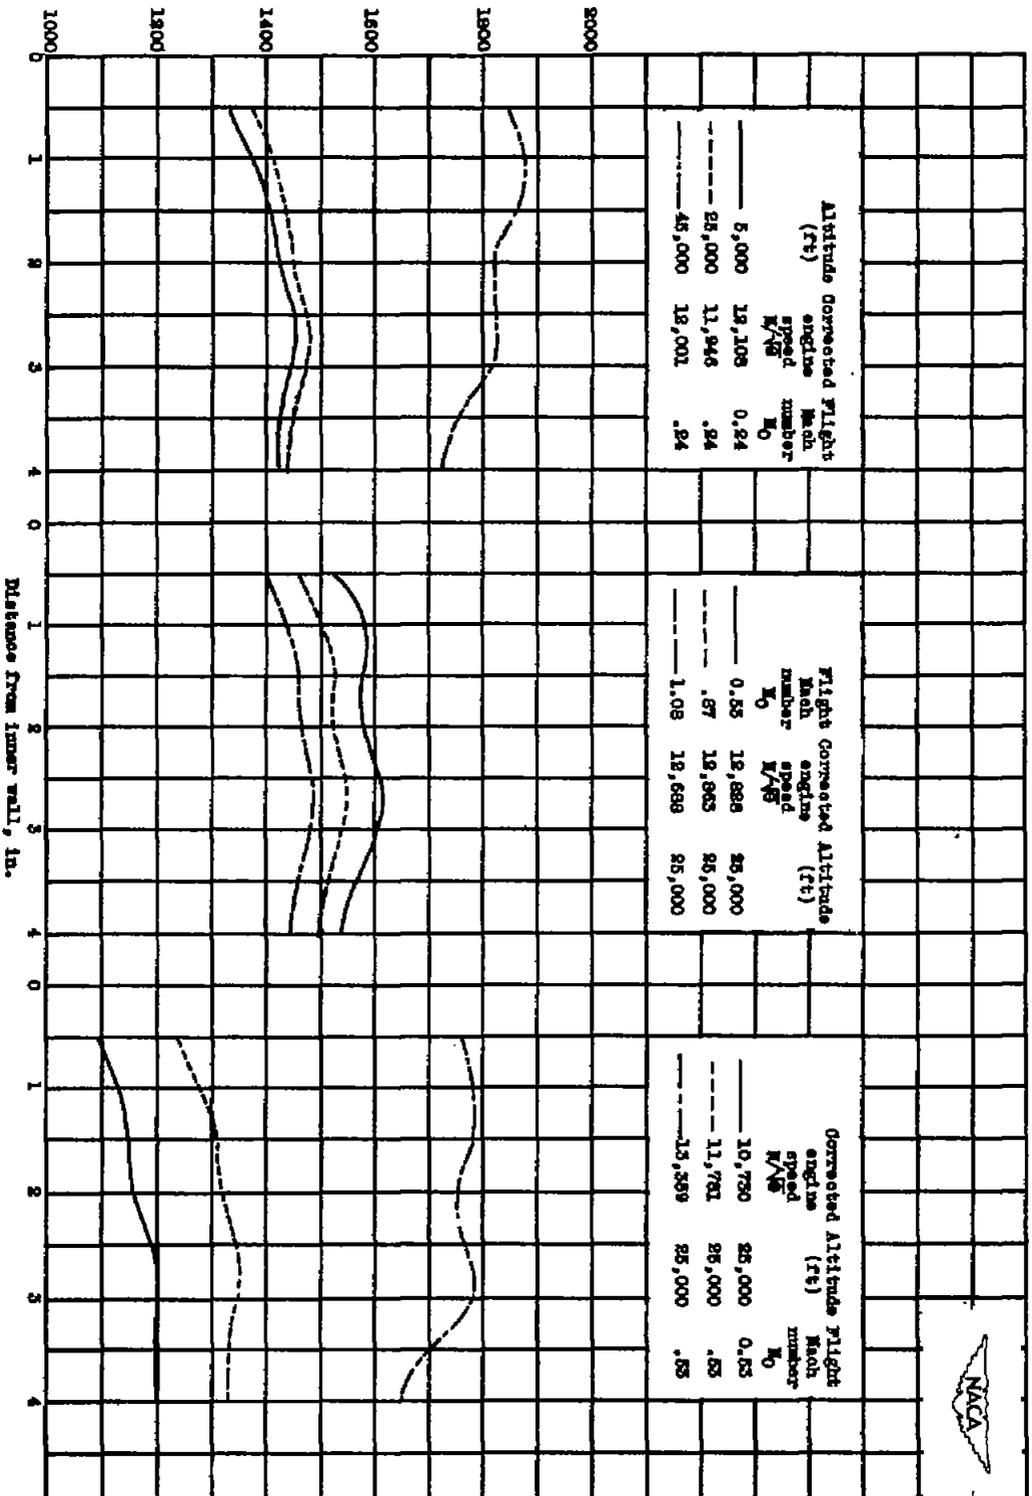
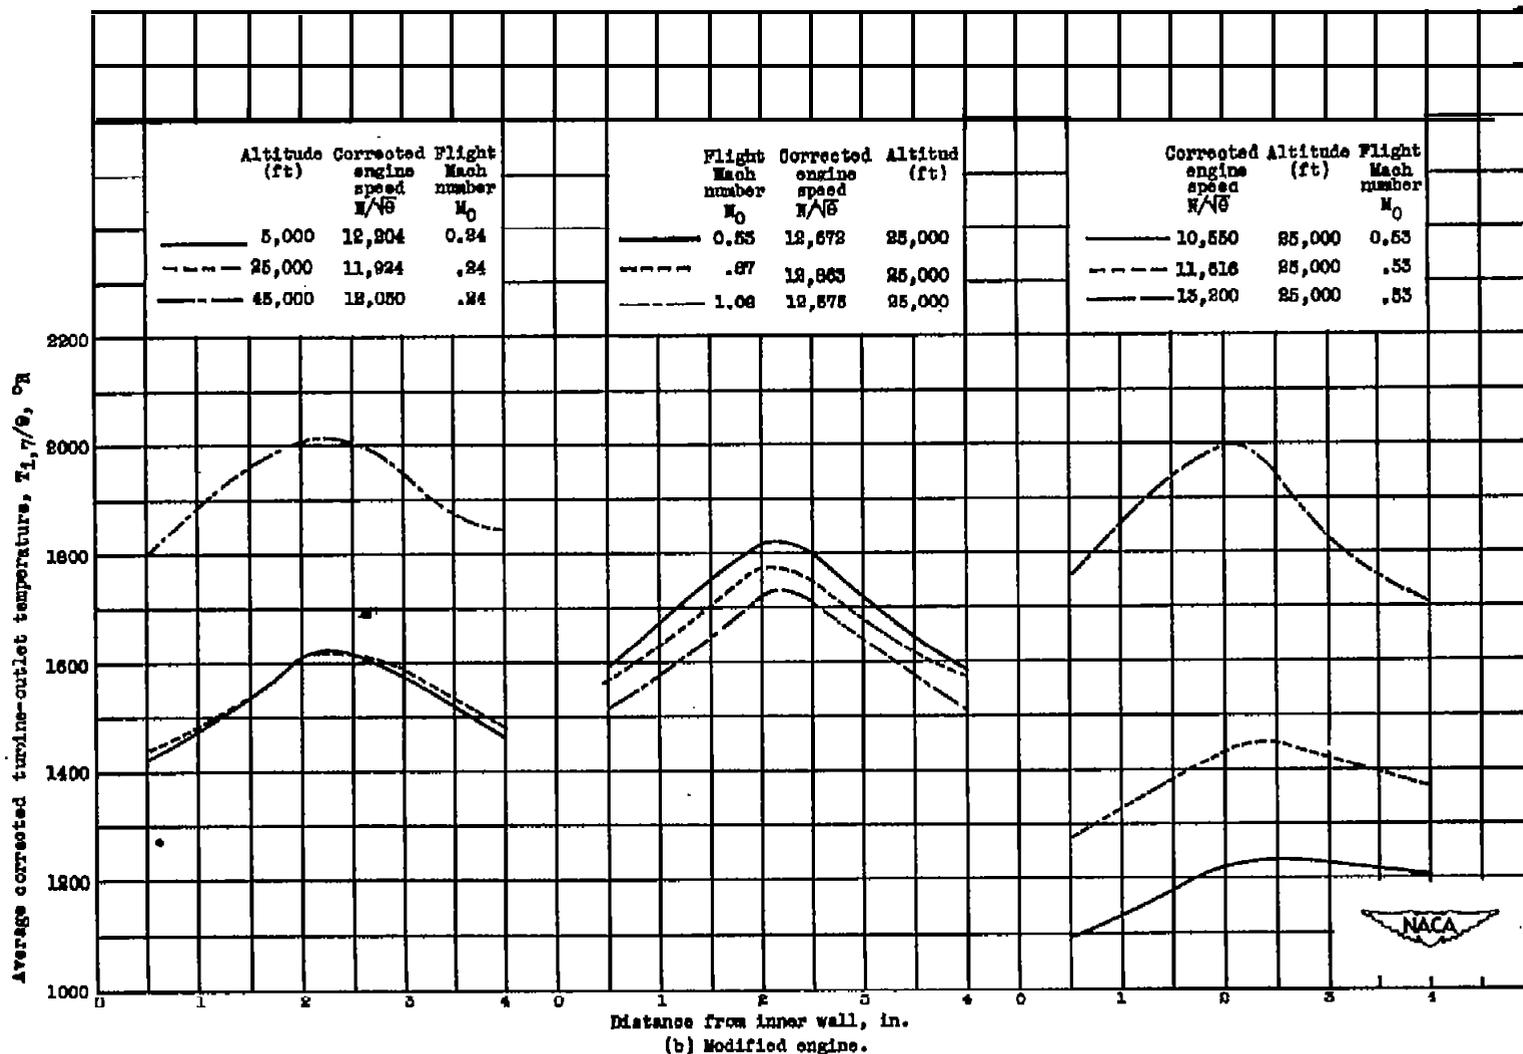
Figure 17. - Effect of altitude, flight Mach number, and engine speed on radial distribution of average corrected indicated temperature at turbine outlet, station 7.

Figure 17. - Concluded. Effect of altitude, flight Mach number, and engine speed on radial distribution of average corrected indicated temperature at turbine outlet, station 7.

The effects of altitude, flight Mach number, and corrected engine speed on the average radial turbine-outlet temperature distribution are shown in figure 17 for both engines. The maximum variation of average temperature across the turbine-outlet passage at any flight condition for the original engine was about 160° F. The high temperatures that occurred near the inner wall at high

altitude and high engine speed for the original engine were undesirable from turbine-blade stress considerations. With regard to blade stress, it is desirable to have the lowest temperatures near the blade roots and the peak temperature near the blade tips. For the modified engine (fig. 17(b)), a temperature peak existed in the central part of the passage for all operating conditions. The temperature distribution for the modified engine corresponded more closely to the aforementioned design temperature distribution.

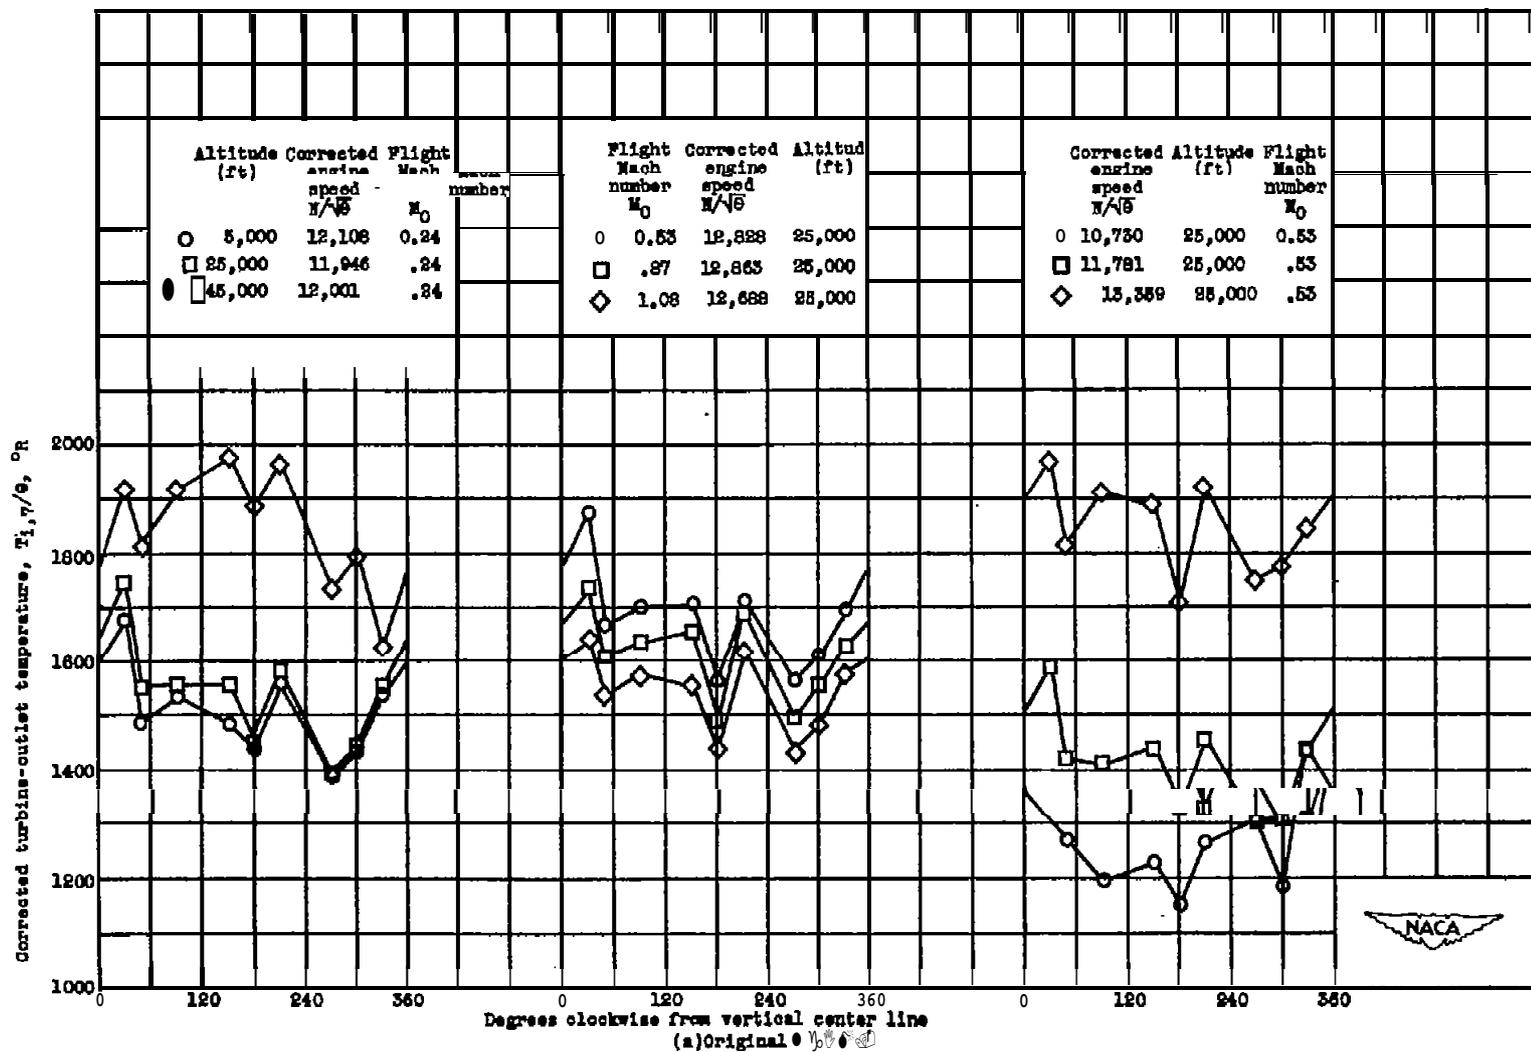
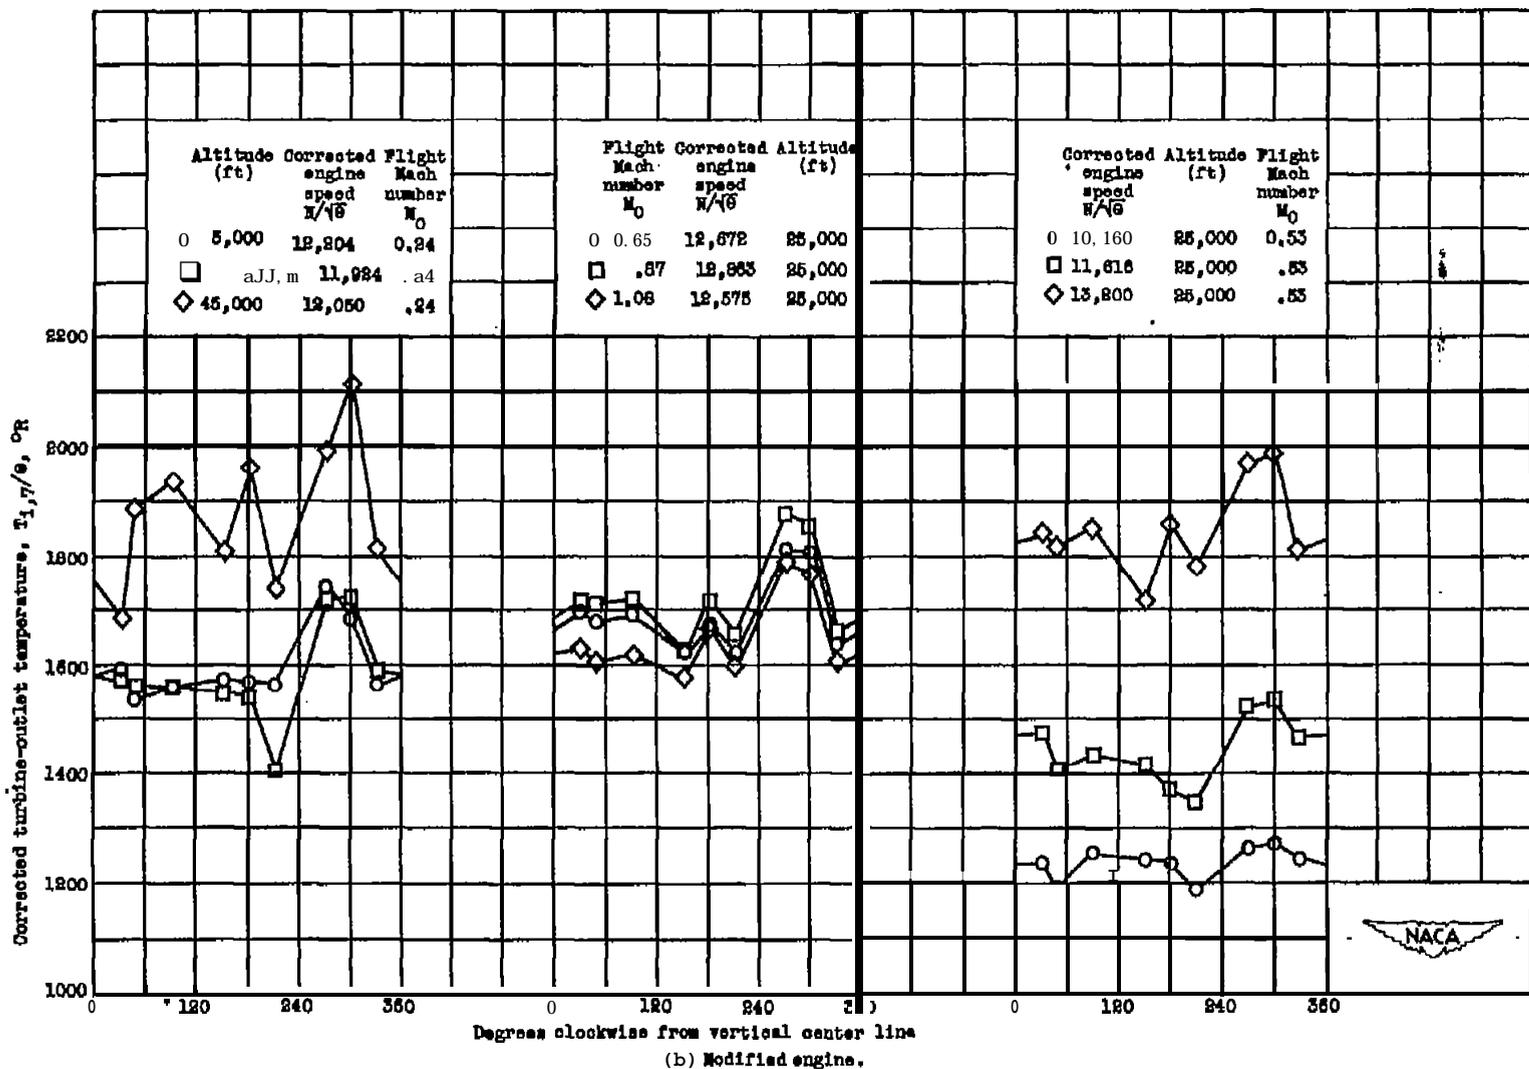
Figure 18. - Effect of altitude, flight Mach number, and engine speed on circumferential distribution of corrected indicated temperature at turbine outlet, station 7, 4 inches from outer wall.

Figure 1a. - Concluded. Effect of altitude, flight Mach number, and engine speed on circumferential distribution of corrected indicated temperature at turbine outlet, station 7, $1\frac{1}{2}$ inches from outer wall.

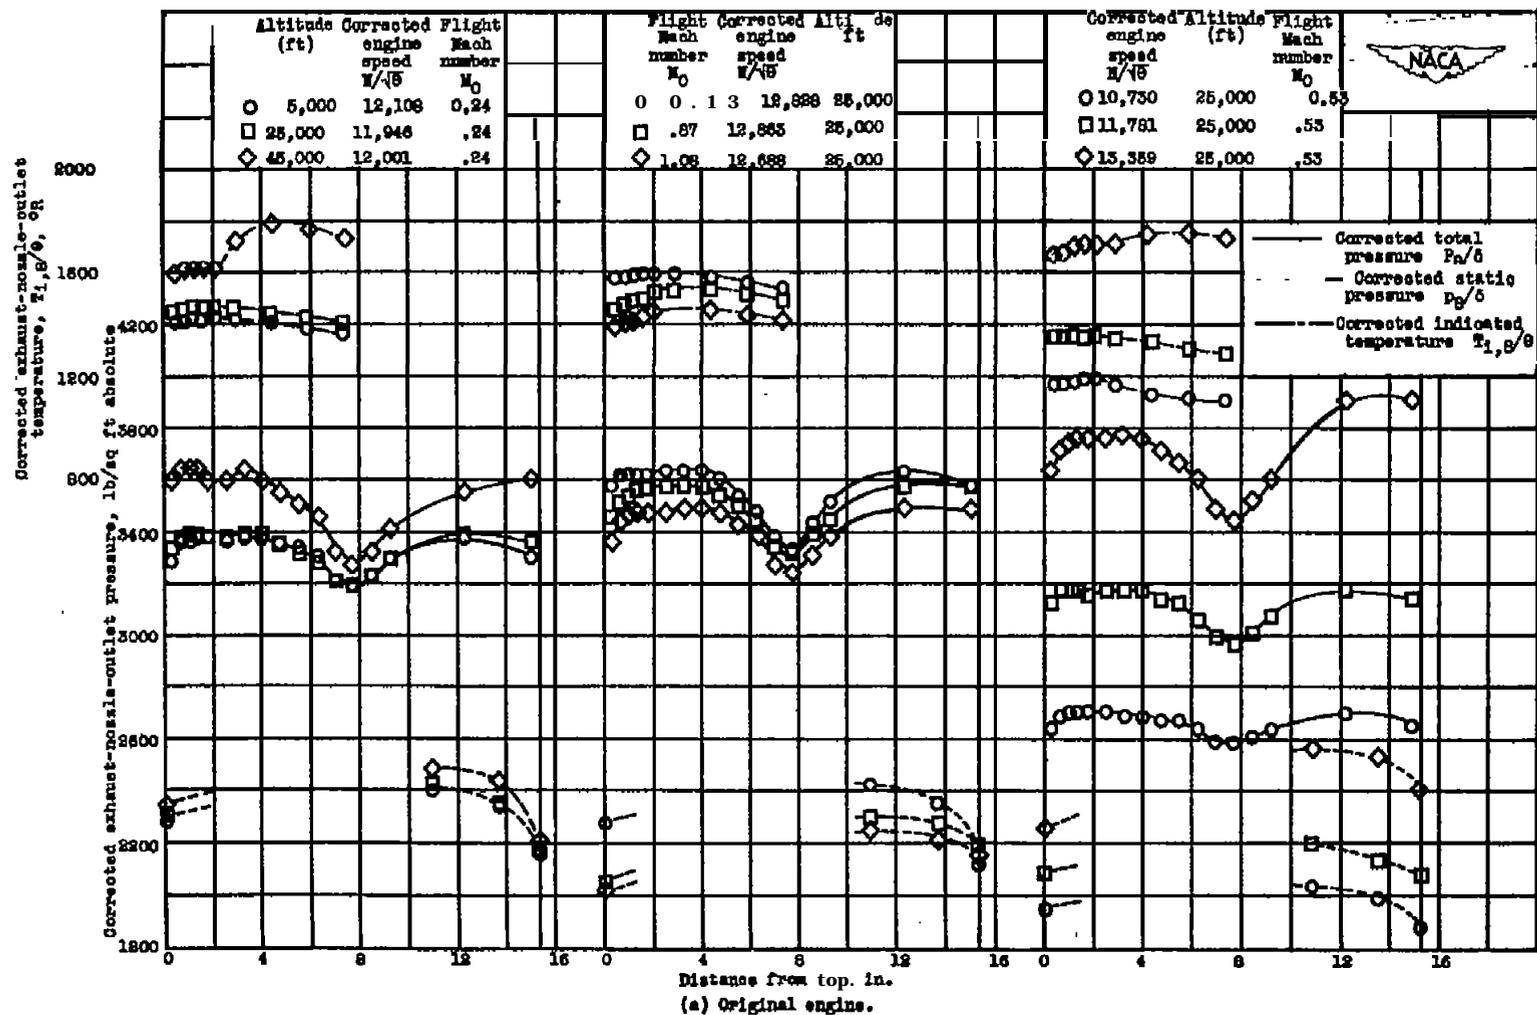
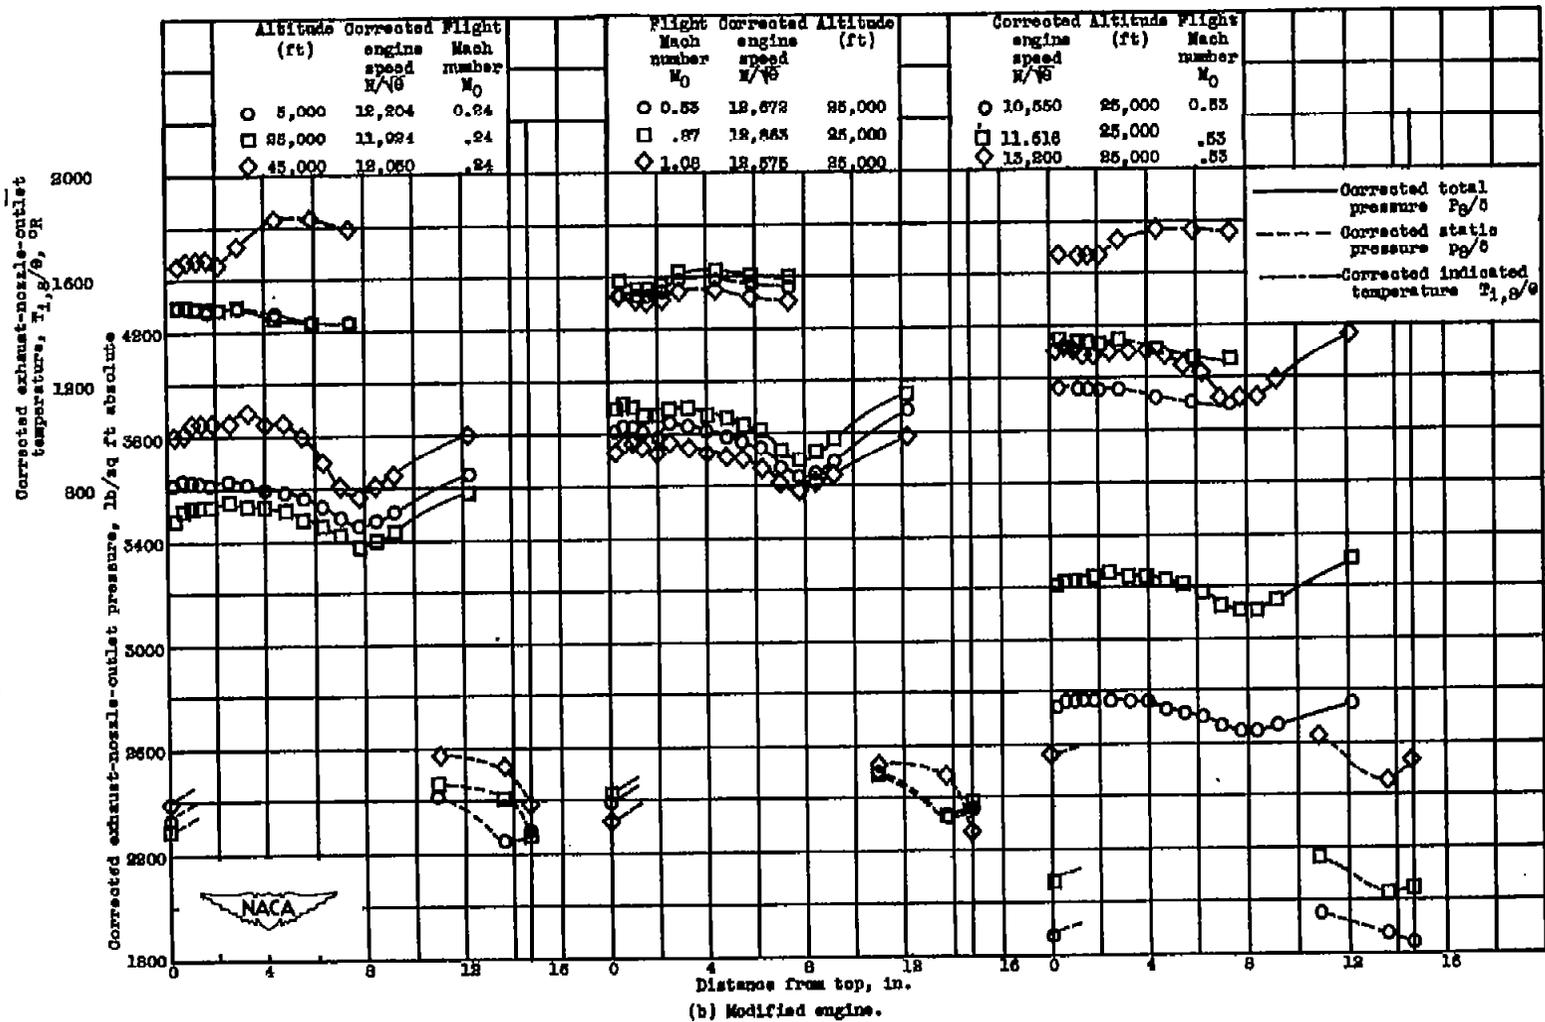
Figure 19. - Effect of altitude, flight Mach number, and speed on distribution of corrected total pressure, static pressure, and indicated temperature at exhaust-nozzle-outlet, station 8.

Figure 19. - Concluded. Effect of altitude, flight Mach number, and engine speed on distribution of corrected total pressure, static pressure, and indicated temperature at exhaust-nozzle-outlet. ●◆◇□○ a.
