NACA RM No. E8C17

ALTITUDE-WIND-TUNNEL INVESTIGATION OF A 3000-POUND-THRUST
AXIAL-FLOW TURBOJET ENGINE

VII - PRESSURE AND TEMPERATURE DISTRIBUTIONS

By Martin J. Saari and William R. Prince

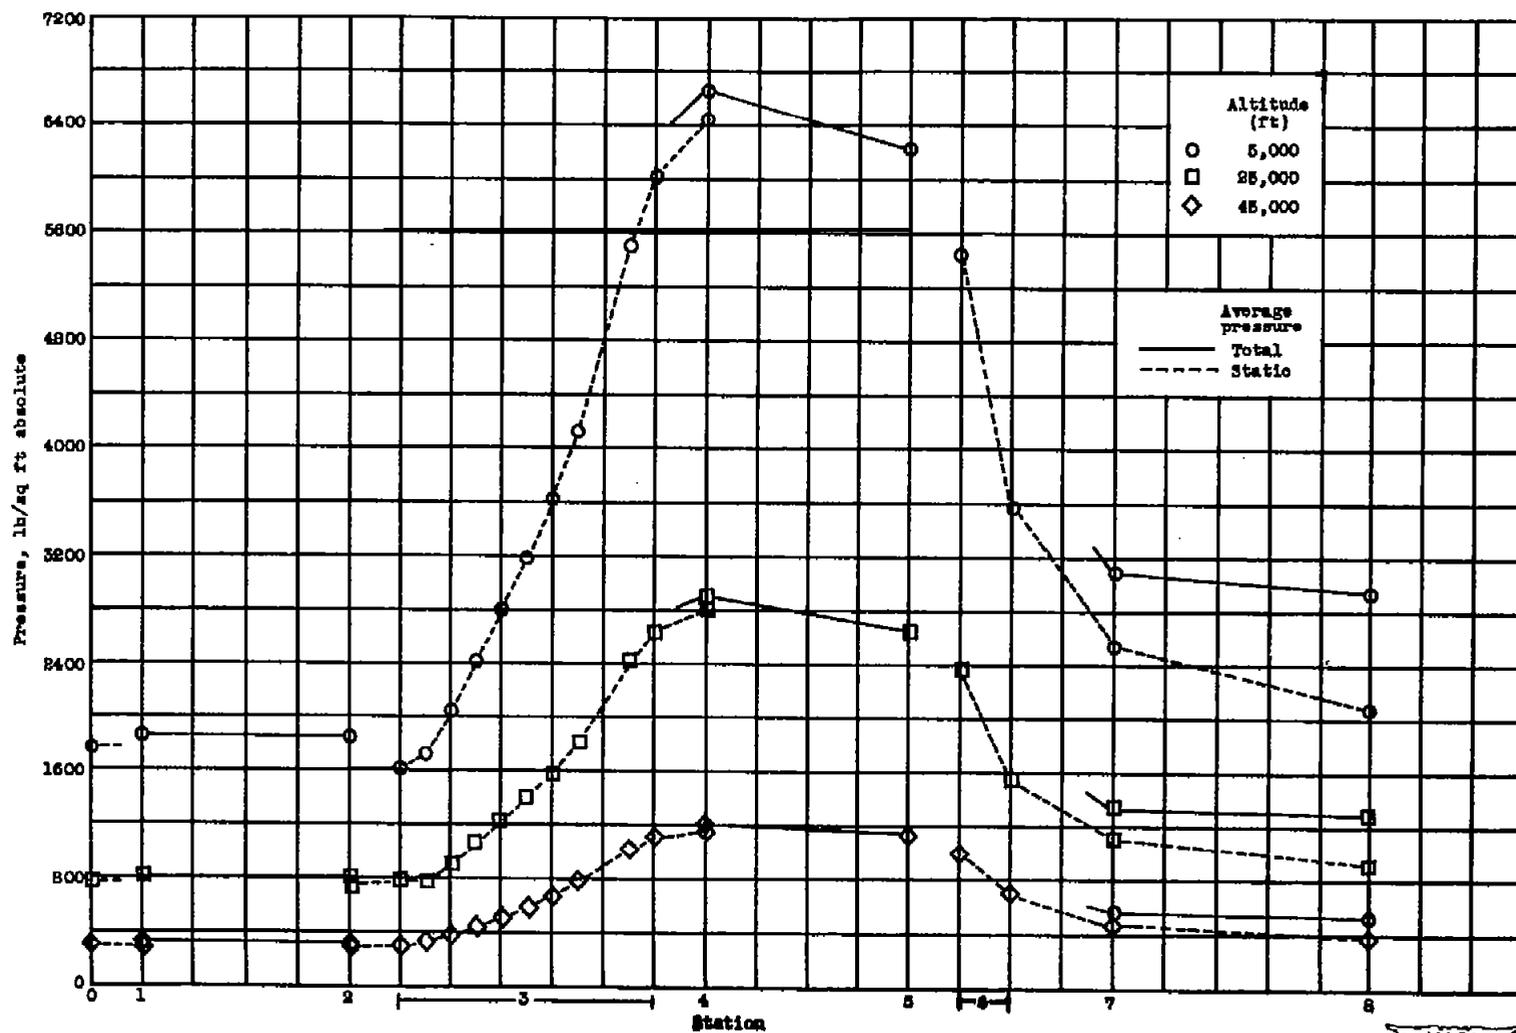
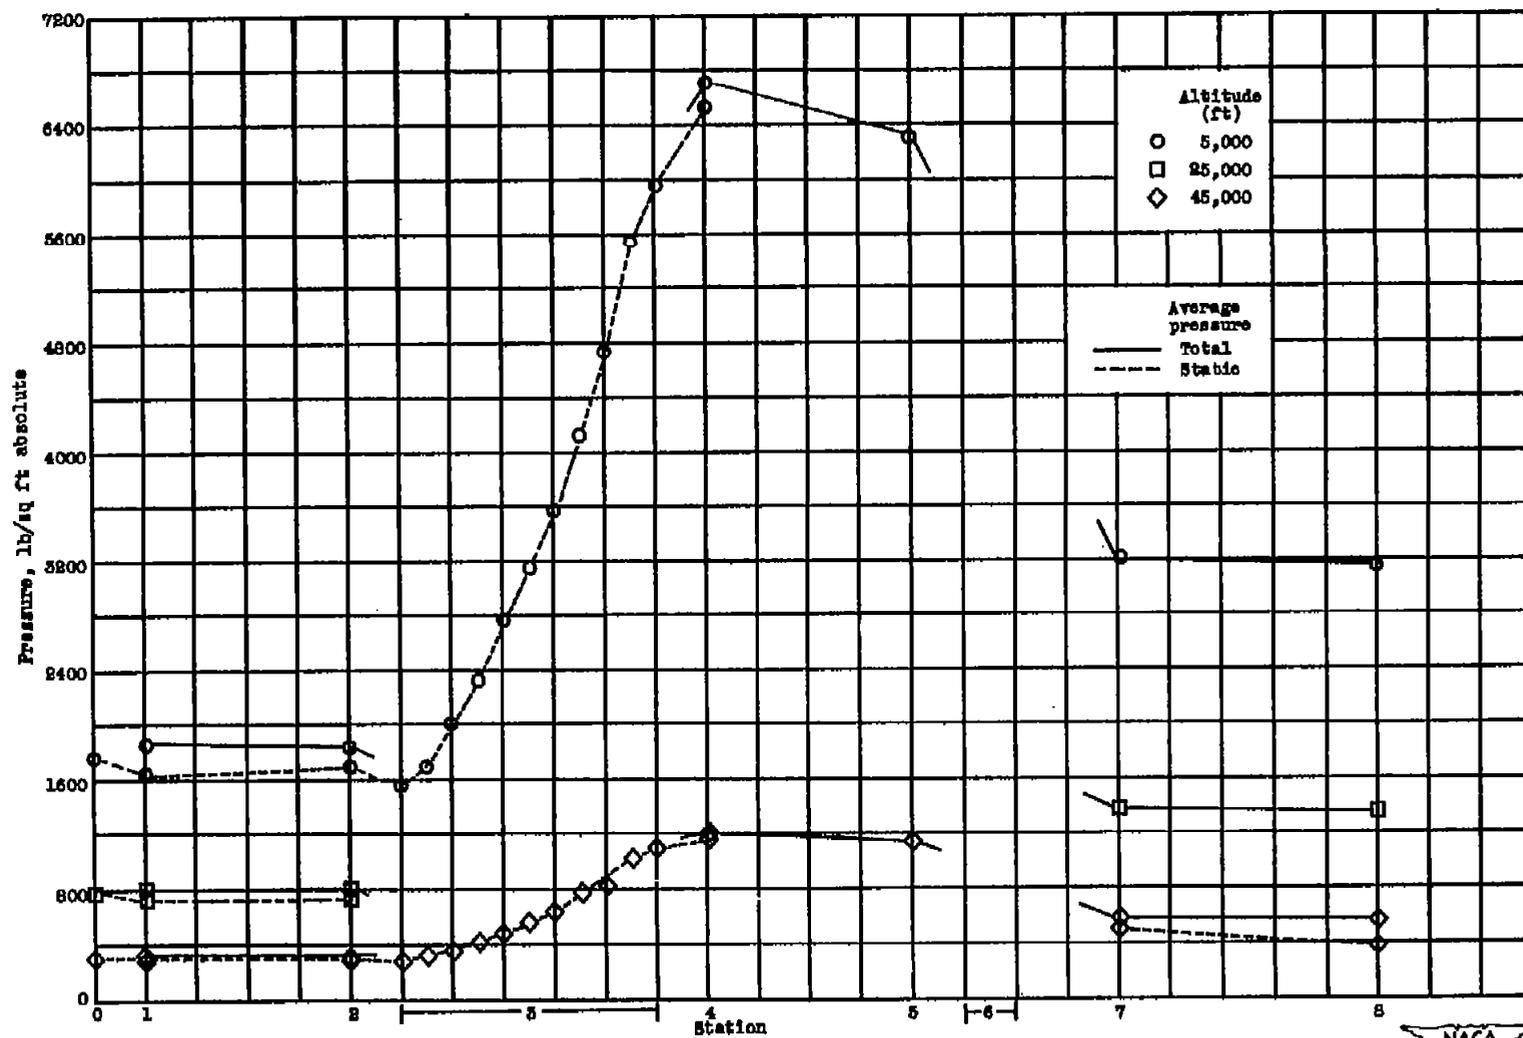
Figure 80. - Variation of average total and static pressures through engine for several altitudes. Flight Mach number, 0.26; corrected engine speed, approximately 15,000 rpm.

Figure P0. - Concluded. Variation of average total and static pressure through engine for several altitudes. Flight Mach number, 0.84; corrected engine speed, approximately 18,000 rpm.

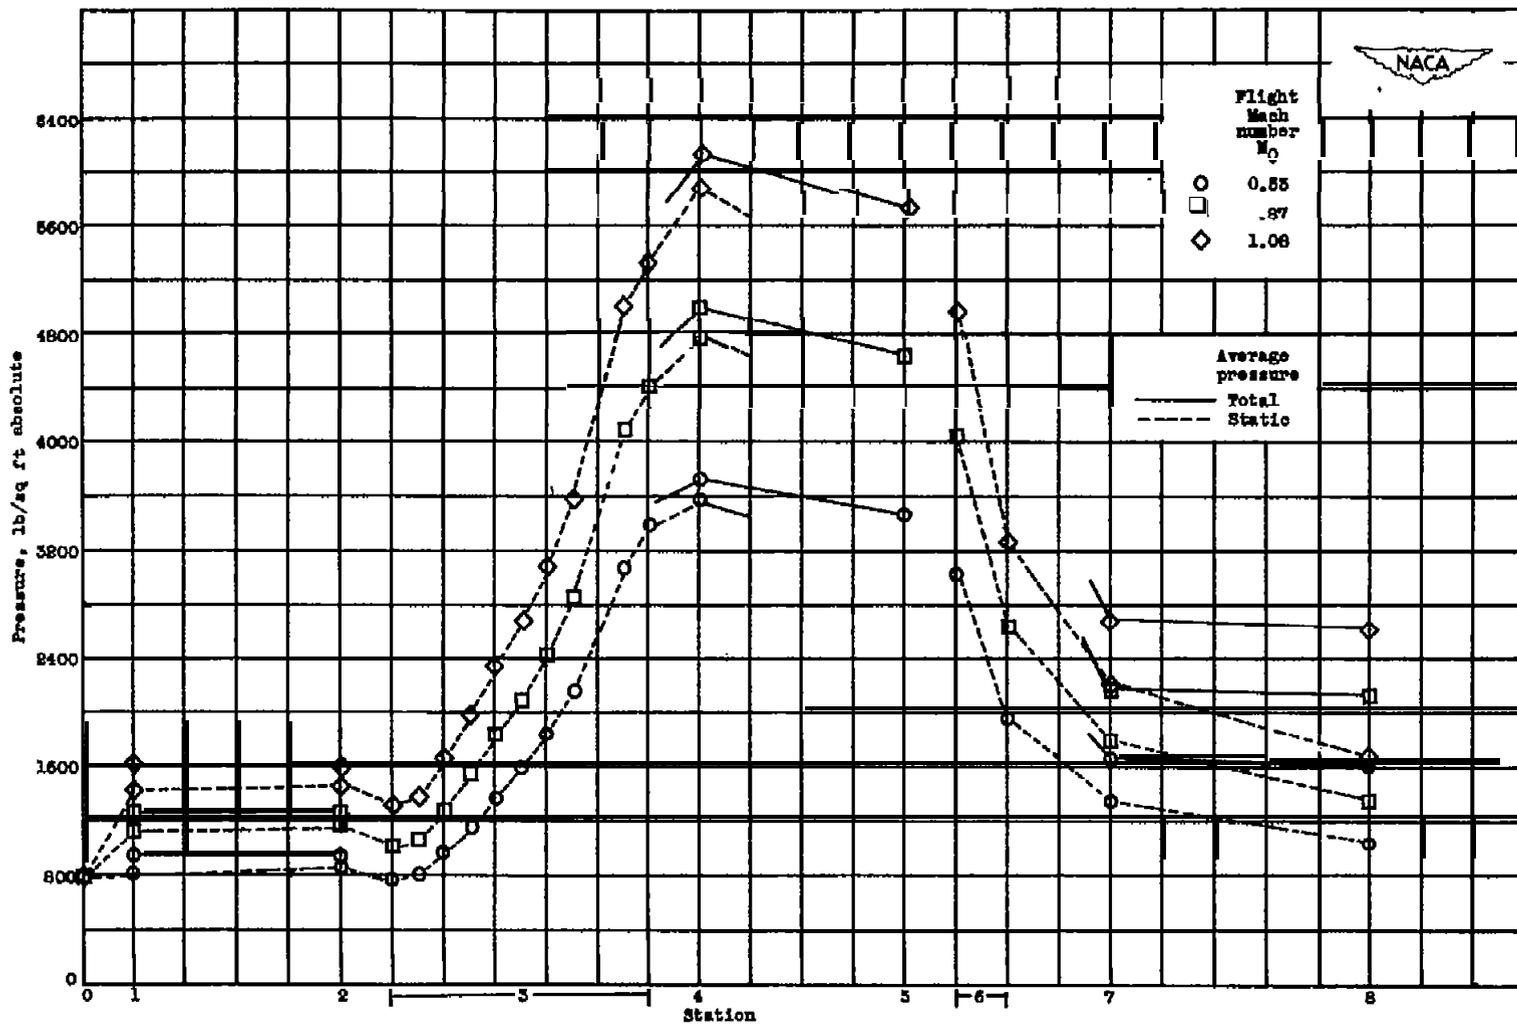
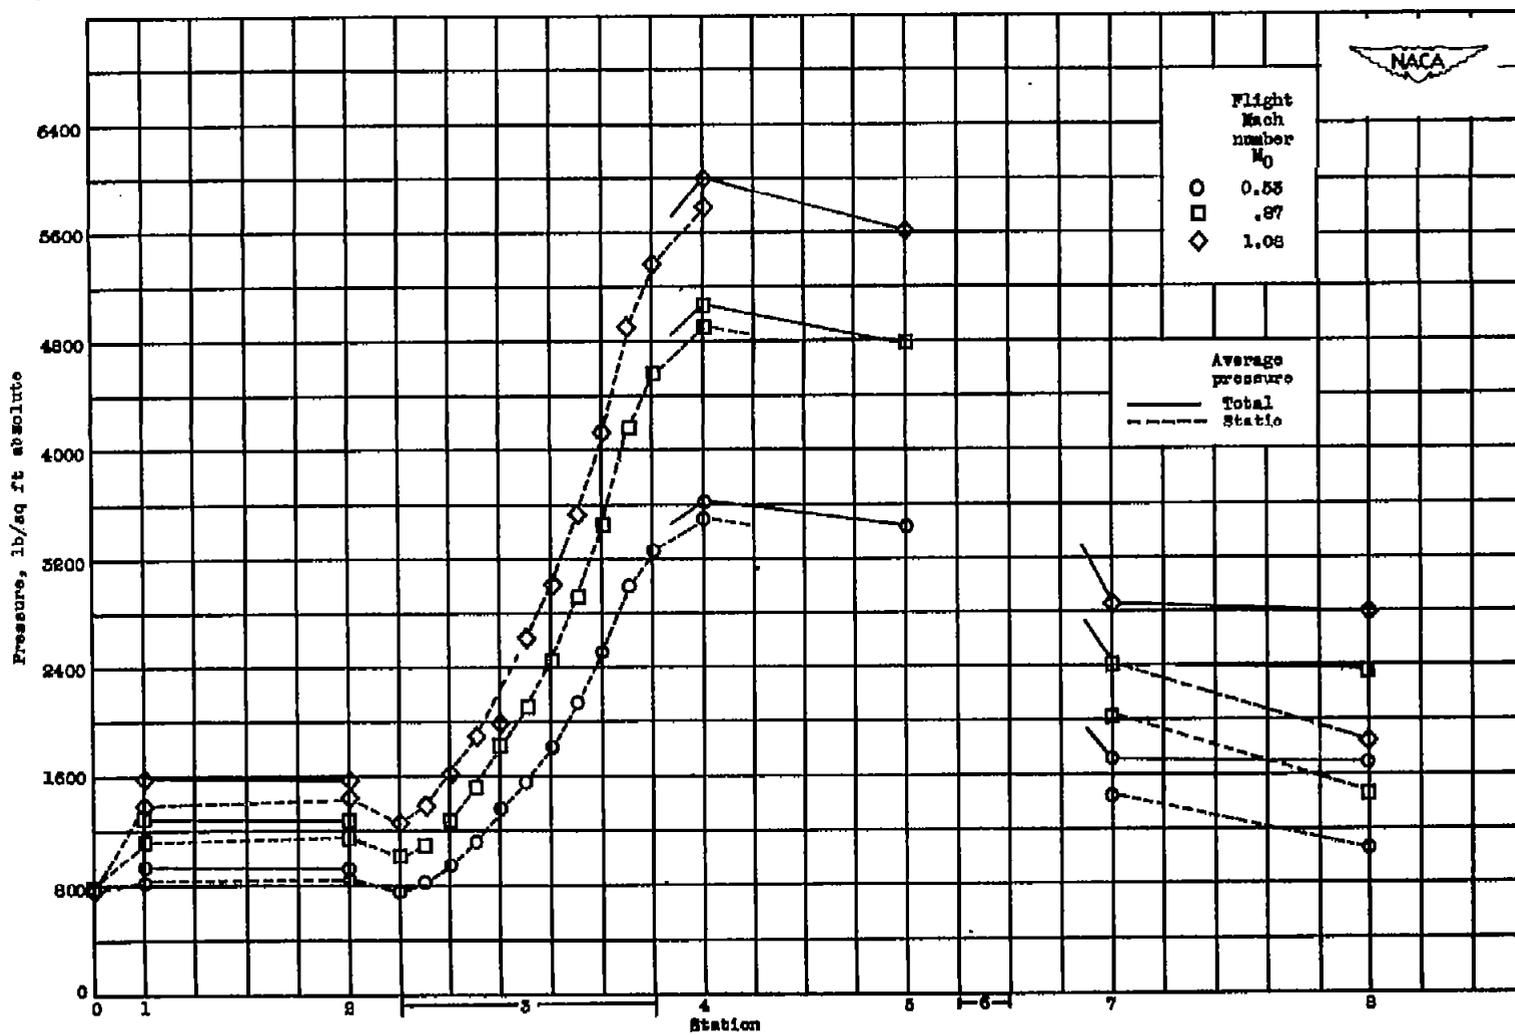
Figure 21. - Variation of average total and static pressures through engine for several flight Mach numbers. Altitude, 85,000 feet; corrected engine speed, approximately 12,700 rpm.

Figure 21. - Concluded. Variation of average total and static pressures through engine for several flight Mach numbers. Altitude, 25,000 feet; corrected engine speed, approximately 18,700 rpm.

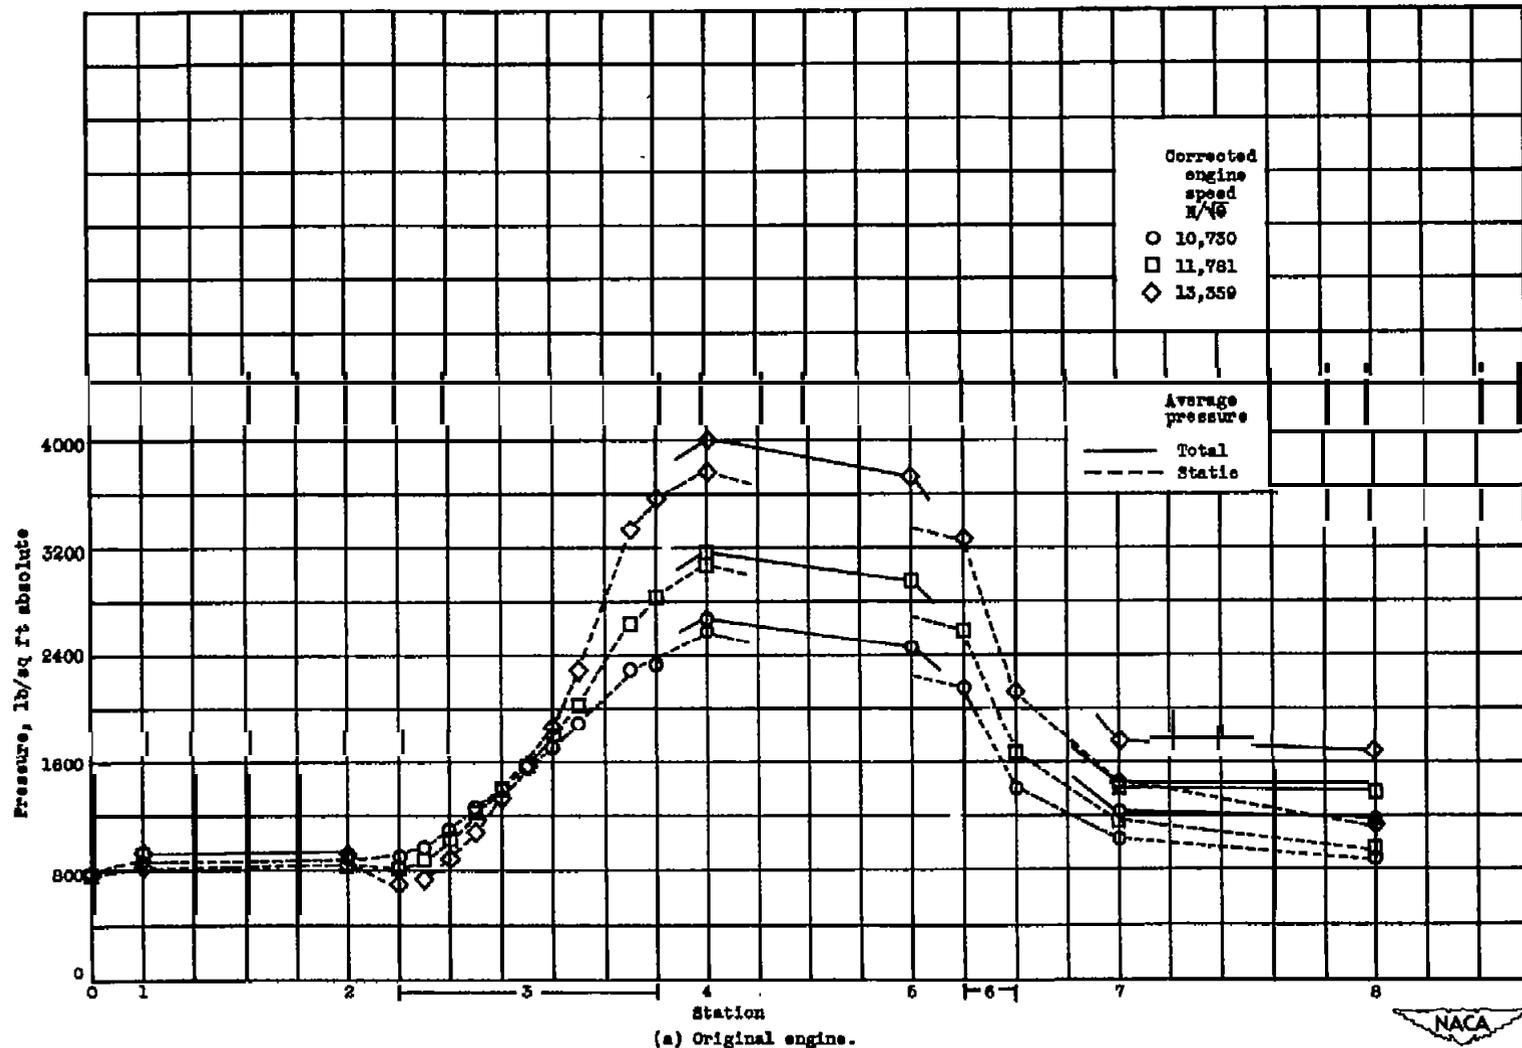
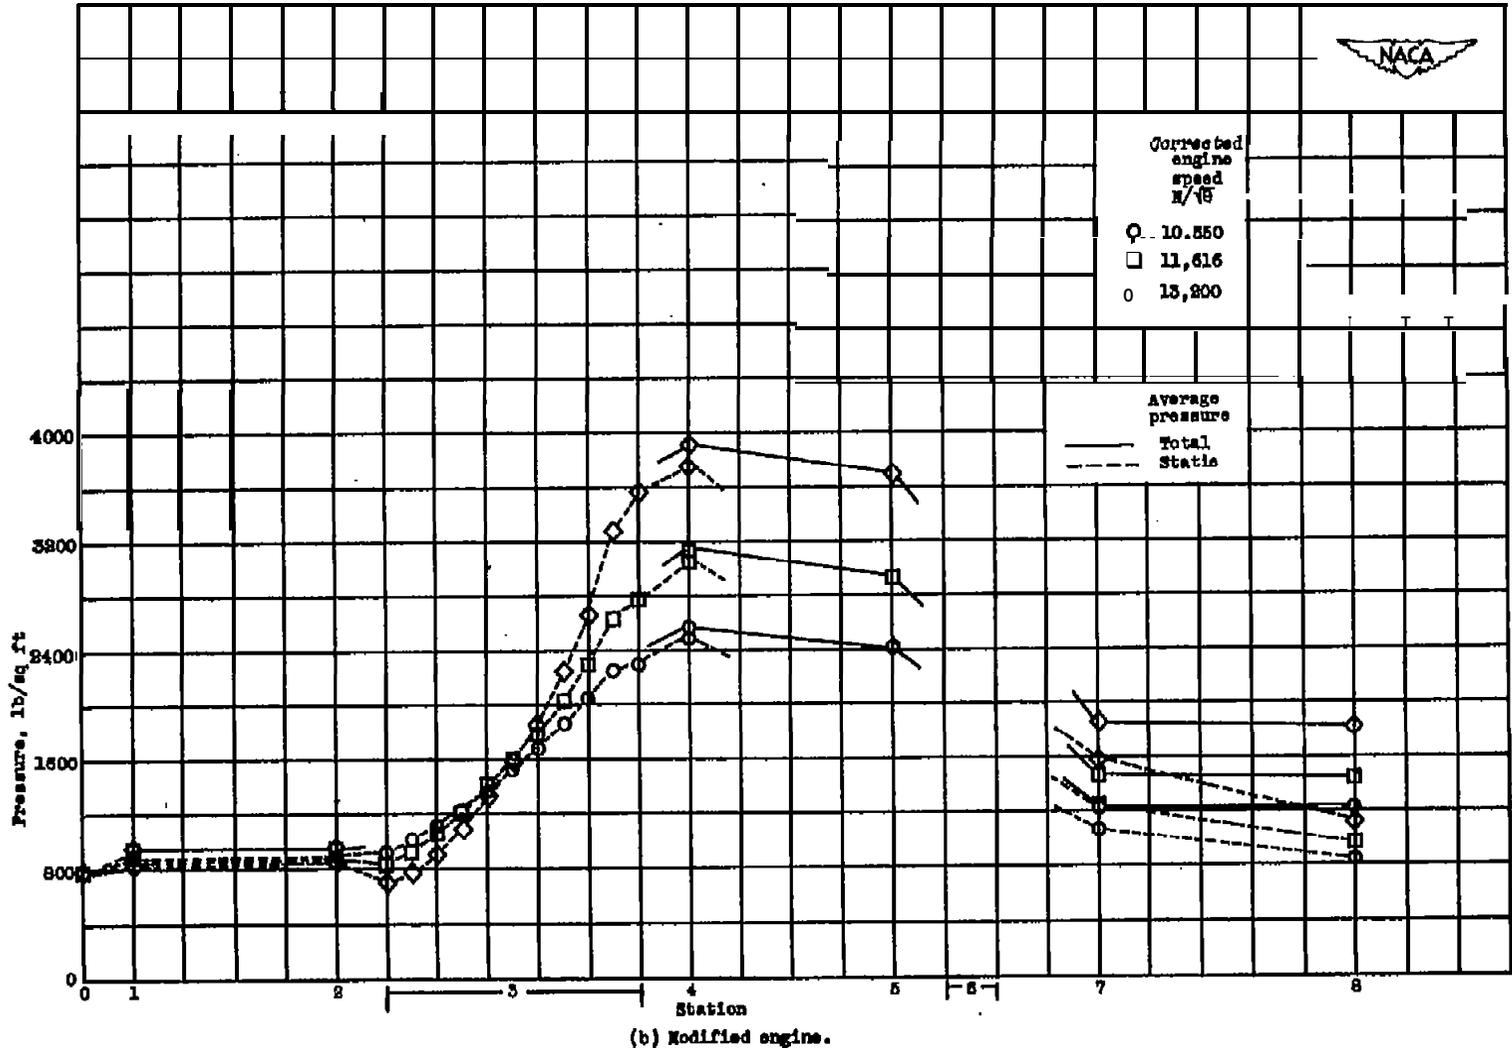
Figure 22. - Variation of average total and static pressures through engine for several engine speeds. Altitude, 25,000 feet; flight Mach number, 0.82.

Figure 28. - Concluded. Variation of average total and static pressures through engine for several $\circ \square \diamond$ speeds. Altitude, 85,000 feet; flight Mach number, 0.55.
