NACA RM E53101

EXPERIMENTAL INVESTIGATION OF SCREECHING COMBUSTION  
IN FULL-SCALE AFTERBURNER

By Karl H. Usow, Carl L. Meyer, and Frederick W. Schulze

Lewis Flight Propulsion Laboratory  
Cleveland, Ohio

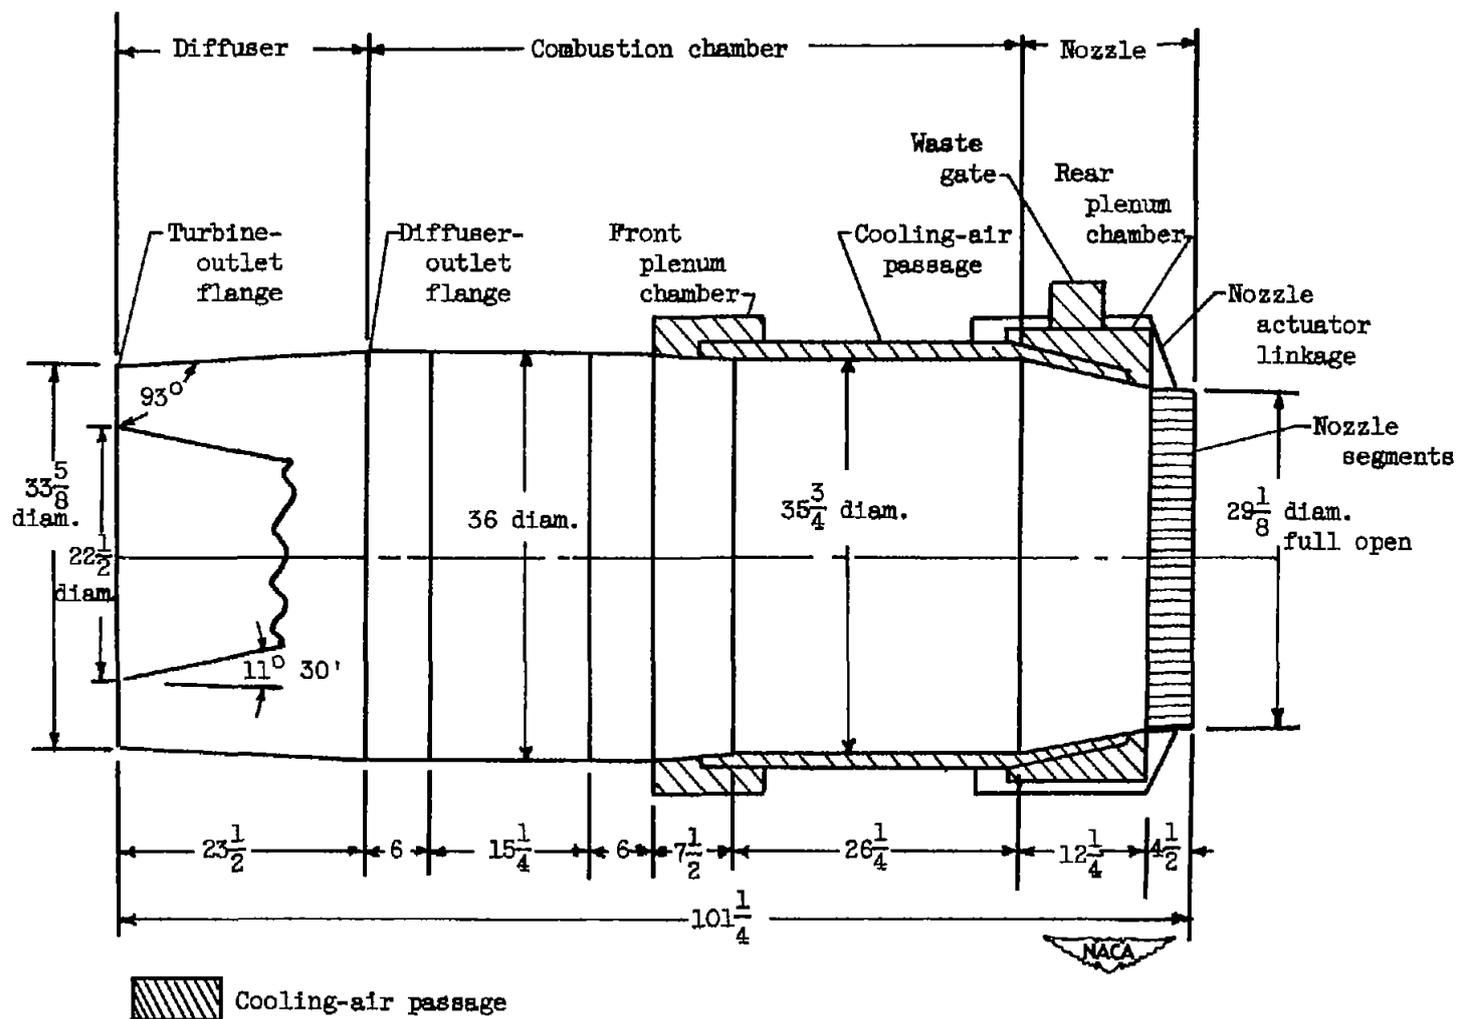
Figure 1. - Details of afterburner shell and diffuser section. (All dimensions in inches.)

The over-all length of the afterburner (fig. 1), including diffuser, combustion chamber, and exhaust nozzle, is  $101\frac{1}{4}$  inches; the maximum diameter of the afterburner combustion chamber is 36 inches. A cooling-air passage, designed at the NACA for the present investigation, surrounded the rear portion of the afterburner (fig. 1).

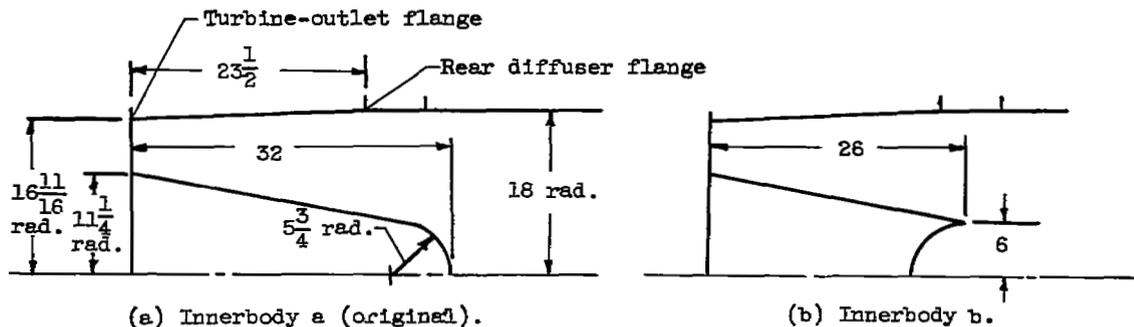
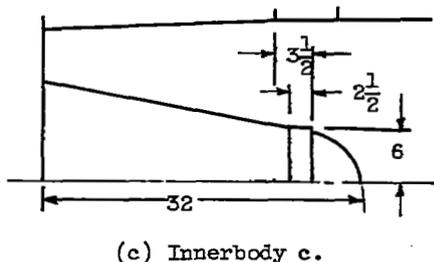
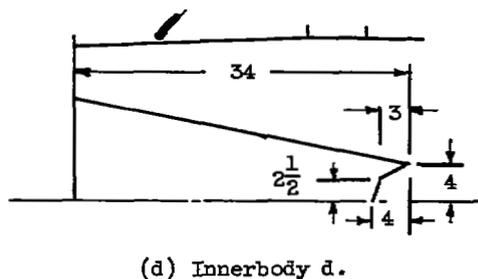
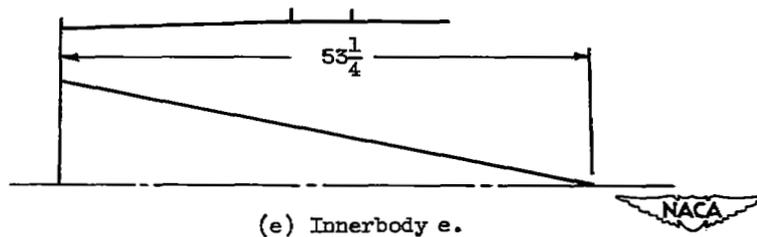
Figure 2. - Details of diffuser innerbodies investigated. (All dimensions in inches.)

Diffuser. - Five diffuser innerbodies were used, the details of which are shown in figure 2. These innerbodies include the original configuration (a), three modifications of the original (b, c, and d) designed to form a pilot or flame-holding surface at the downstream end of the innerbody as a possible means of improving burner stability at low burner pressures, and one modification (e) designed to eliminate (or keep to a minimum) air-flow separation from the innerbody. Antiswirl vanes attached to the skin of the innerbody were installed at the diffuser inlet on 29 of the configurations to reduce turbine-outlet swirl and thereby alter the radial mass, or velocity, distribution. Thirteen configurations had sets of 33 short antiswirl vanes (fig. 3(a)), while 16 configurations had sets of 48 full-passage vanes (fig. 3(b) and (c)). A boundary-layer tripper (fig. 4) was installed on the innerbody of configuration 43 to alter the mass and velocity distributions.

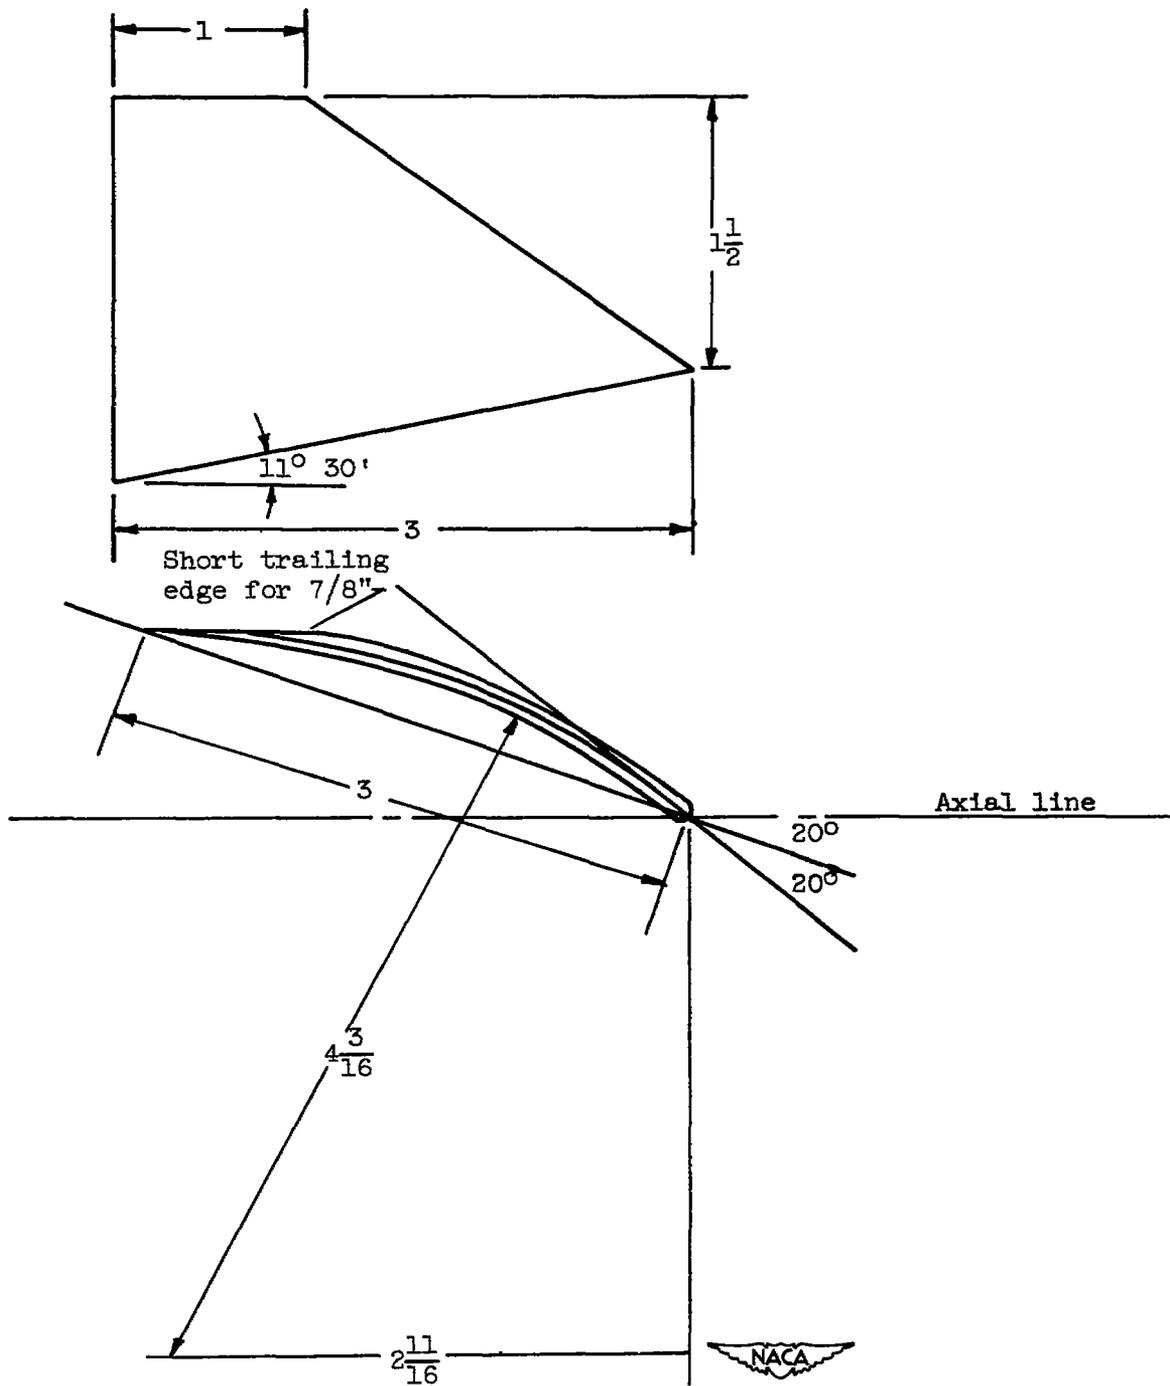
(a) Details of 33 short antiswirl vanes. (All dimensions in inches.)

Figure 3. - Turbine-outlet straightening vanes.

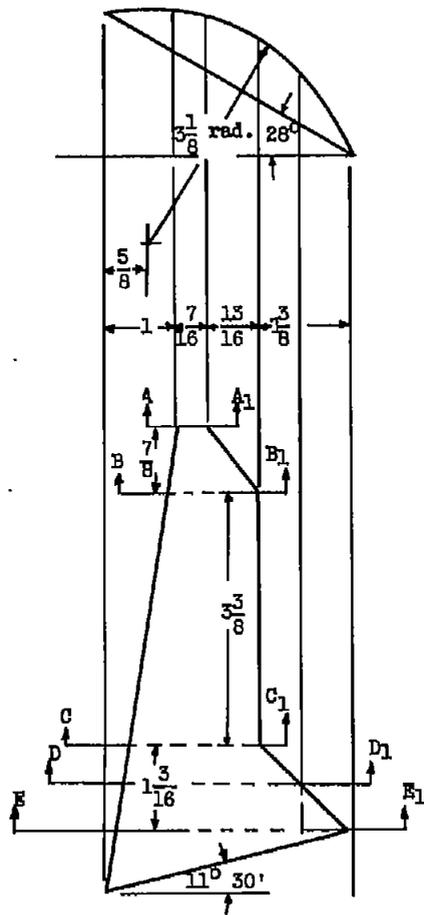
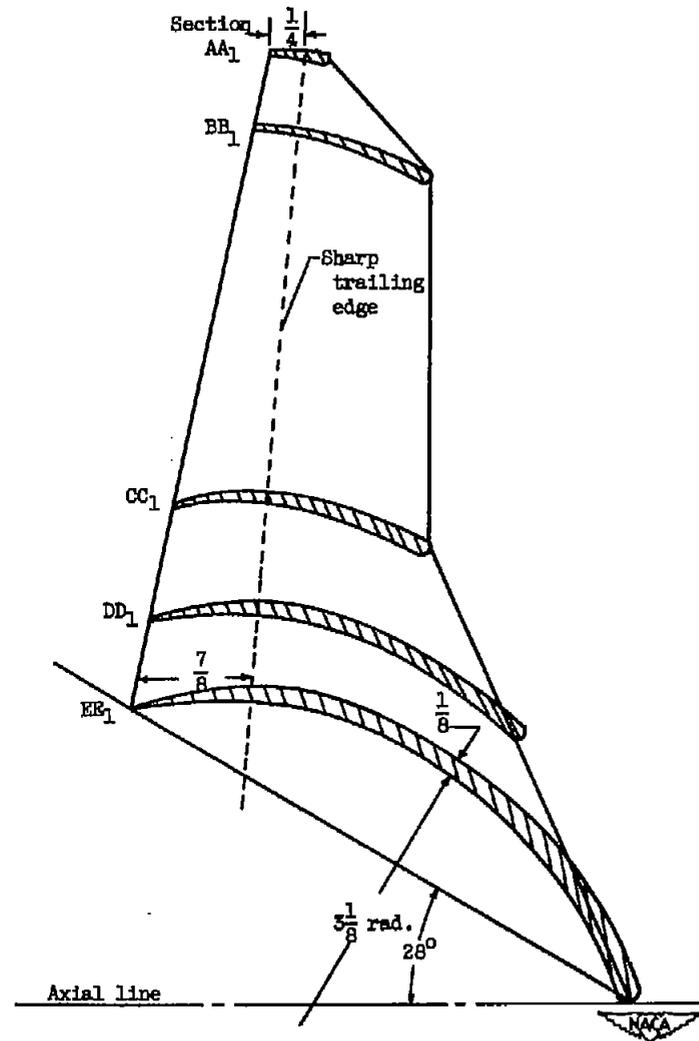
(b) Details of 48 long antiswirl vanes. (All dimensions in inches.)

Figure 3. - Continued. Turbine-outlet straightening vanes.

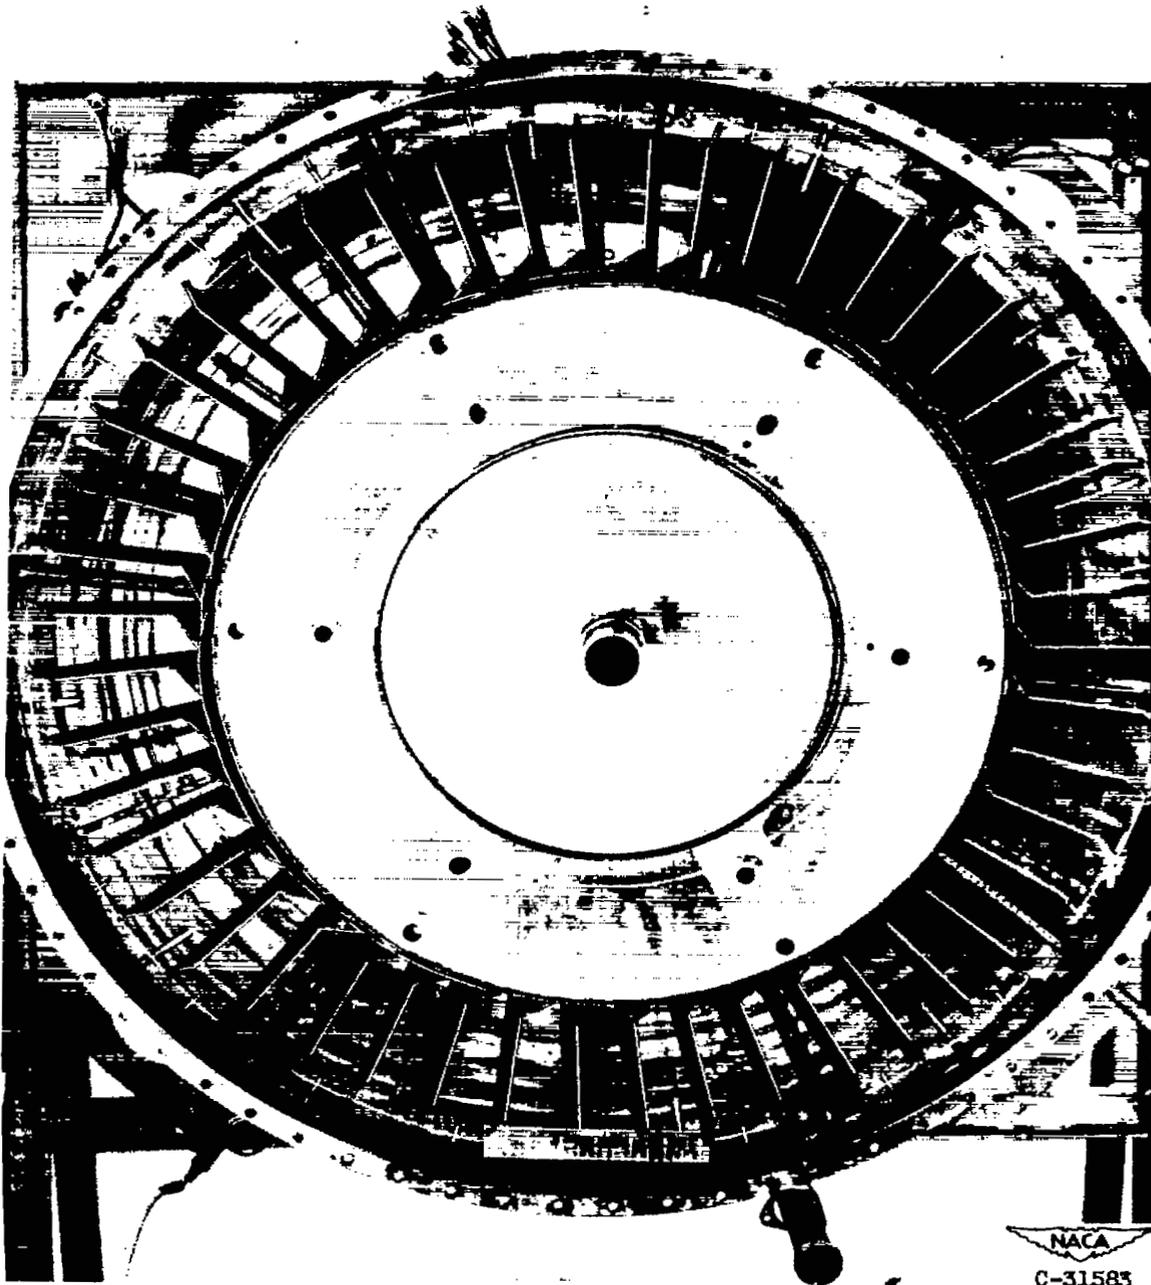
(c) View of 48 long vanes installed in diffuser section.

Figure 3 - Concluded: Turbine-outlet straightening vanes.

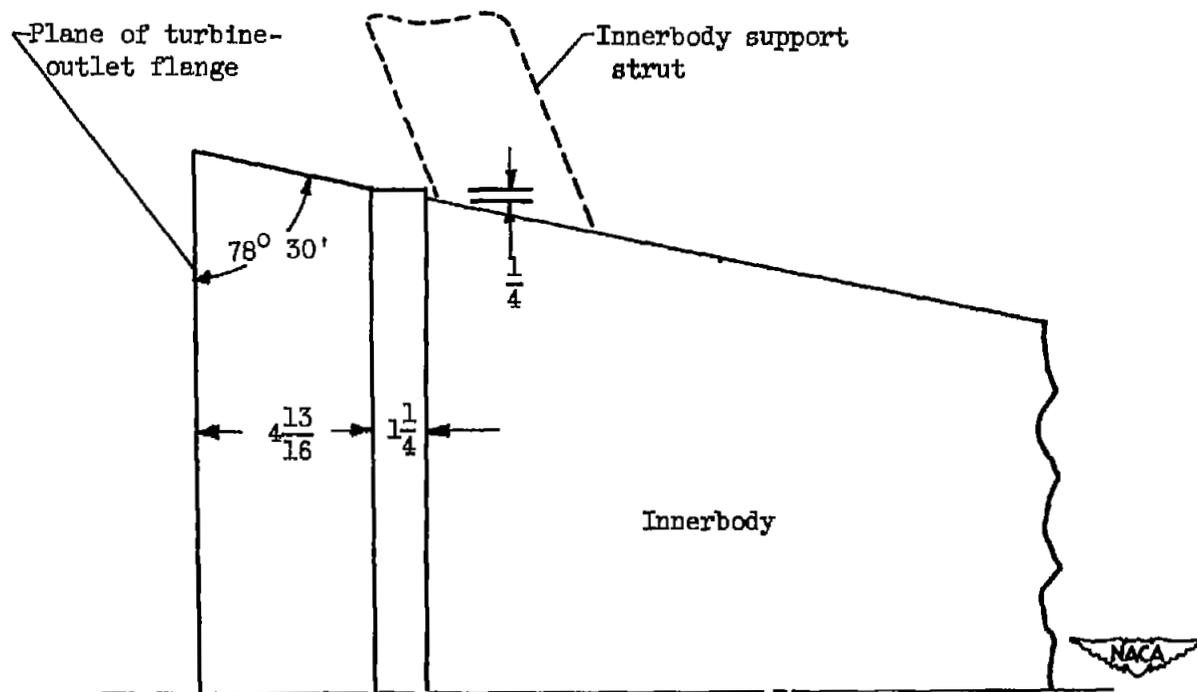
Figure 4. - Details of boundary-layer tripper incorporated with configuration 43. (All dimensions in inches.)

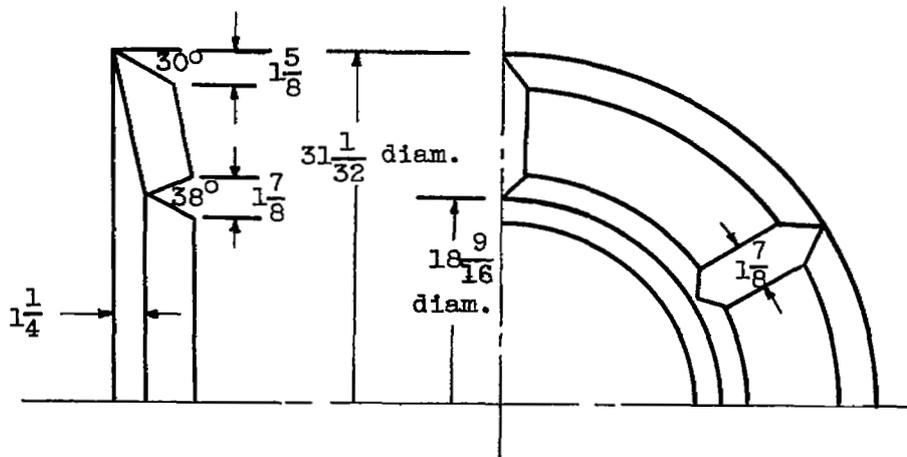
(a) Flame holder (A). Blocked area, 300 square inches.

Figure 5. - Details of flame holders investigated. (All dimensions in inches.)

Flame holders. - The 13 flame holders used in the investigation are illustrated in figure 5. All but three of these were conventional V-gutter flame holders having projected areas that blocked from 29 to 46.8 percent of the flow area at the flame-holder position. The gutter widths of these flame holders ranged from  $1\frac{1}{4}$  to  $5\frac{3}{4}$  inches, and the number of annular gutter elements varied from one to four. The three exceptions to this general arrangement were flame holders (I), (K), and (L). Flame holder (I) (fig. 5(i)) had two U-shaped circular gutter elements; flame holder (K) (fig. 5(k)) comprised U- and V-shaped elements combined to form a star design; and flame holder (L) was a conventional V-gutter incorporating a long water-cooled annular splitter. The significance of these three designs will be discussed in a later section of this report. The flame holders were installed in several longitudinal positions along the afterburner, as indicated in figure 6 and table I.

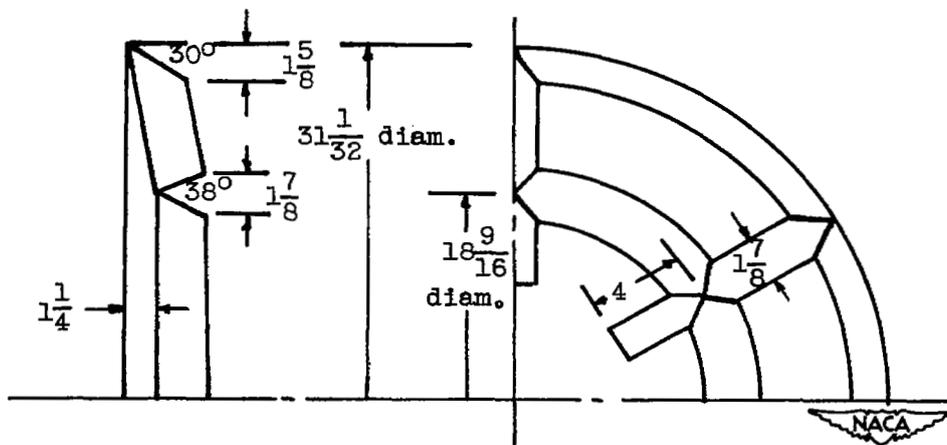
(b) Flame holder (B). Blocked area, 334.2 square inches.

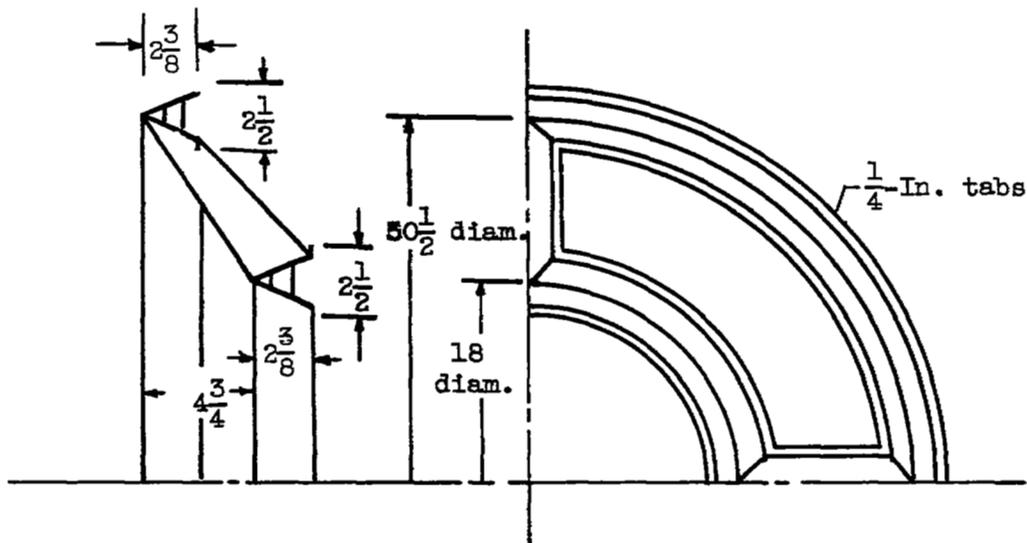
(c) Flame holder (C). Blocked area, 418.4 square inches.

Screech occurred, for example, at a pressure level of 4220 pounds per square foot absolute in configuration 12, where the distance between flame holder (C) and the burner wall was  $1\frac{1}{2}$  inches. Configuration 11, in which the distance was  $2\frac{1}{2}$  inches, did not screech at this level. However, in configurations 21, 22, and 23, where the flame holders were  $5\frac{3}{4}$  to 4 inches from the burner wall, only the one with the greatest distance did not screech. Because variables such as blockage were not controlled in these configurations, the degree to which the distance factor influences screeching combustion is inconclusive.

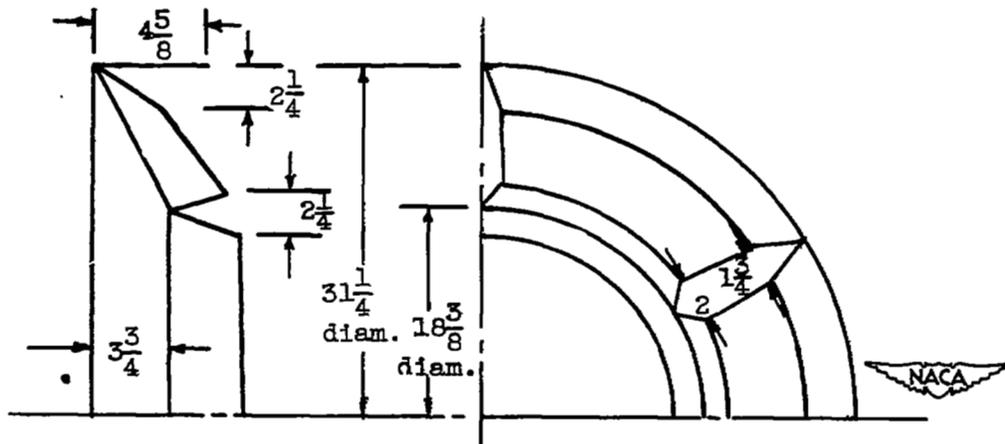
(d) Flame holder (D). Blocked area, 376 square inches.

Figure 5. - Continued. Details of flame holders investigated.  
(All dimensions in inches.)

Another factor considered of possible importance in influencing screeching combustion was the vortex systems formed by the flame-holder gutters. In an effort to alter the vortex systems, flame holders such as (D) and (H) were investigated. These flame holders had conventional 2-V-gutters, except that the inner and outer trailing edges of each gutter were in different planes. Screeching combustion was observed for both flame holders.

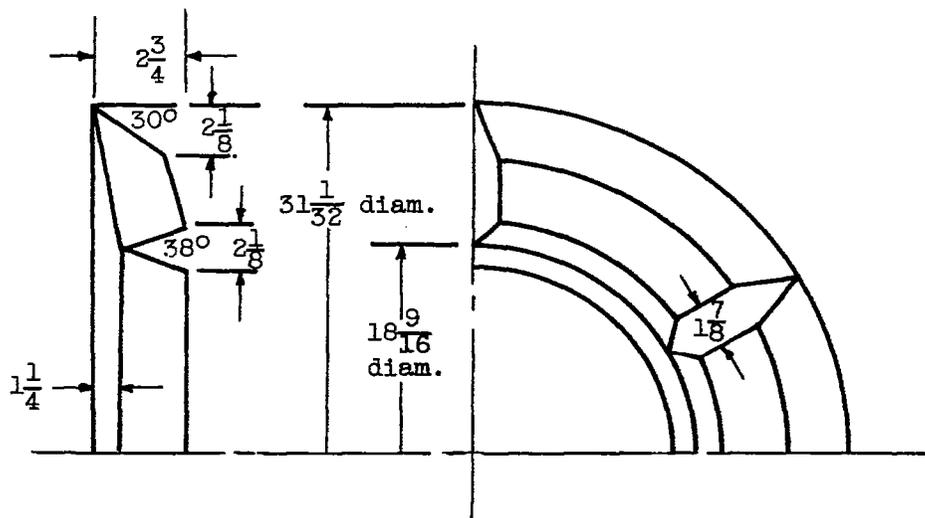
(e) Flame holder (E). Blocked area, 357.5 square inches.

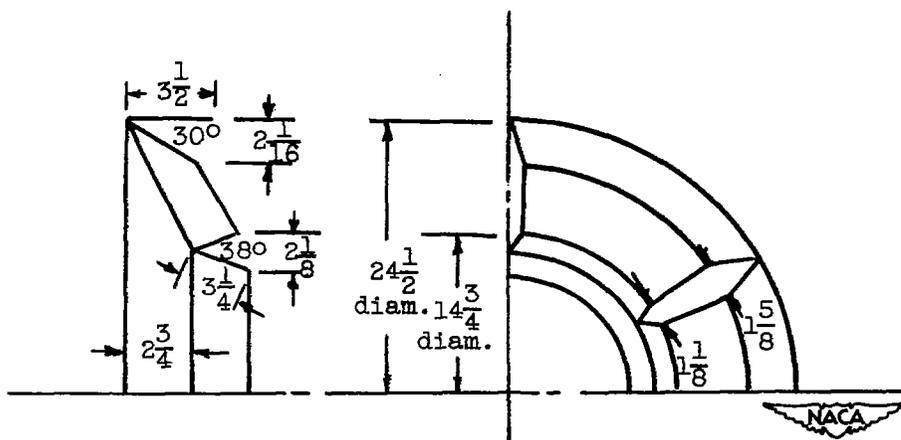
(f) Flame holder (F). Blocked area, 254.2 square inches.

Figure 5. - Continued. Details of flame holders investigated.  
(All dimensions in inches.)

Further comparison of configurations 21, 22, and 23 led to the belief that flame-holder gutter width could have been the influencing factor instead of distance from the outer gutter to the burner wall. Figure 22(c) presents an evaluation of these three flame holders. One of these was a flame holder having a single V-gutter with a gutter width of  $5\frac{3}{4}$  inches and an outer diameter of 28 inches (flame holder (G), configuration 22). Screeching combustion was encountered with this configuration over the entire operable range of fuel-air ratio at a burner-inlet total pressure of 2240 pounds per square foot absolute (fig. 22(c)); in fact, the observation of an audible sound with the afterburner inoperative suggested that this flame holder was inducing a flow instability even in the absence of combustion. The flame holder with gutter widths of  $2\frac{1}{8}$  and  $2\frac{1}{16}$  inches (flame holder (F), configuration 21) did not screech

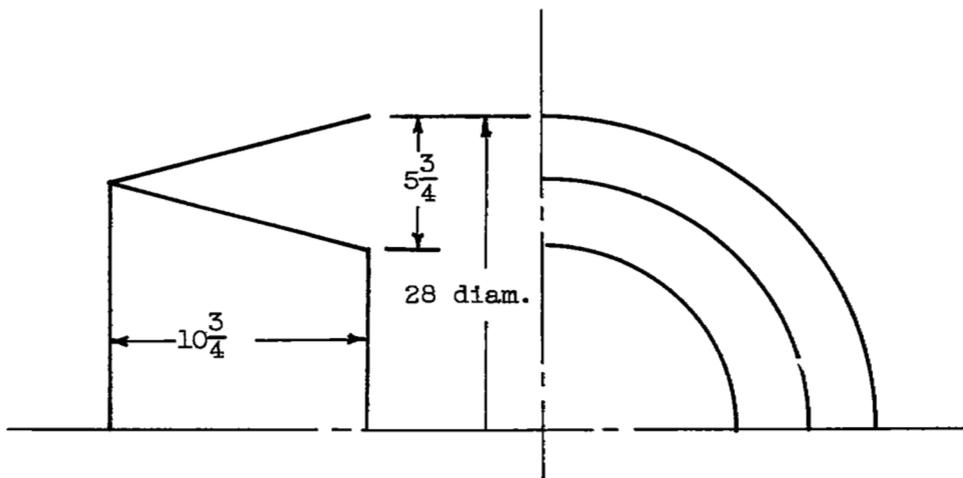
(g) Flame holder (G). Blocked area, 402 square inches.

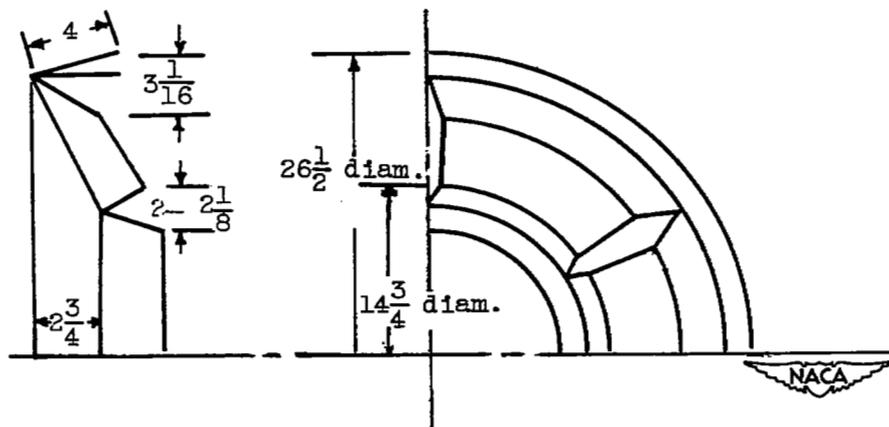
(h) Flame holder (H). Blocked area, 334.2 square inches.

Figure 5. - Continued. Details of flame holders investigated.  
(All dimensions in inches.)

at burner-inlet total pressures as high as 4070 pounds per square foot absolute; while the flame holder with an outer-gutter width of  $3\frac{1}{16}$  inches (flame holder (H), configuration 23) screeched at a burner-inlet total pressure of 2240 pounds per square foot absolute (fig. 22(c)). The observations made with these three flame holders strongly suggested that flame-holder gutter width was an important factor.

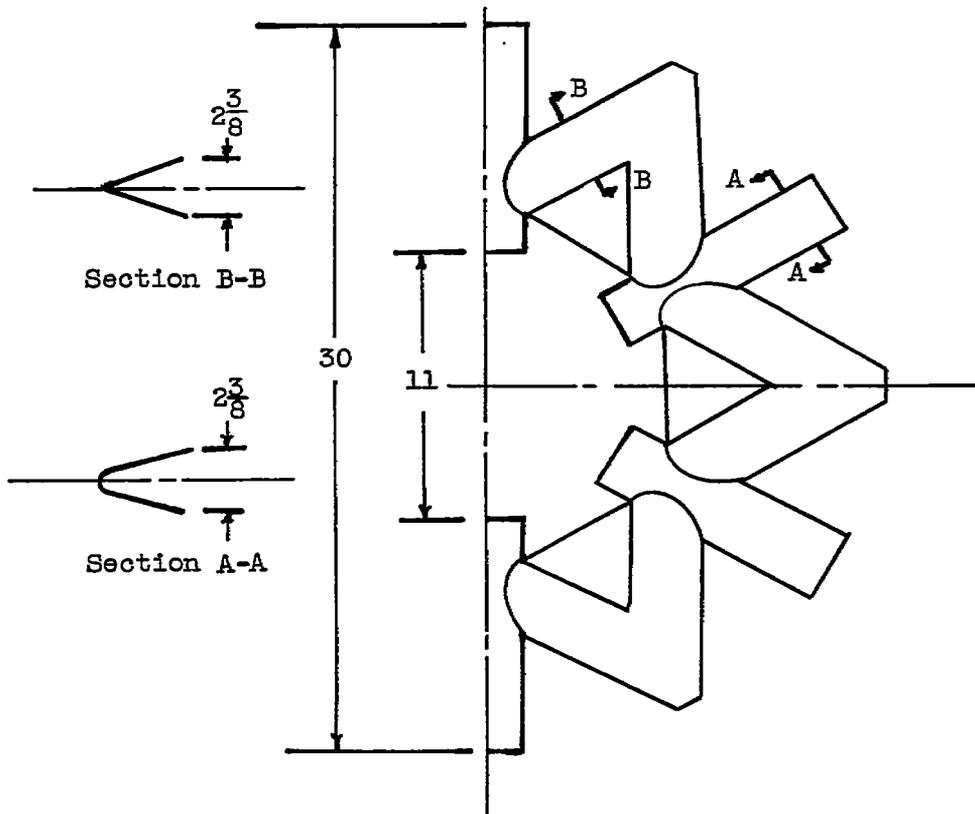
(k) Flame holder (K). Blocked area, 341 square inches.

Figure 5. - Continued. Details of flame holders investigated. (All dimensions in inches.)

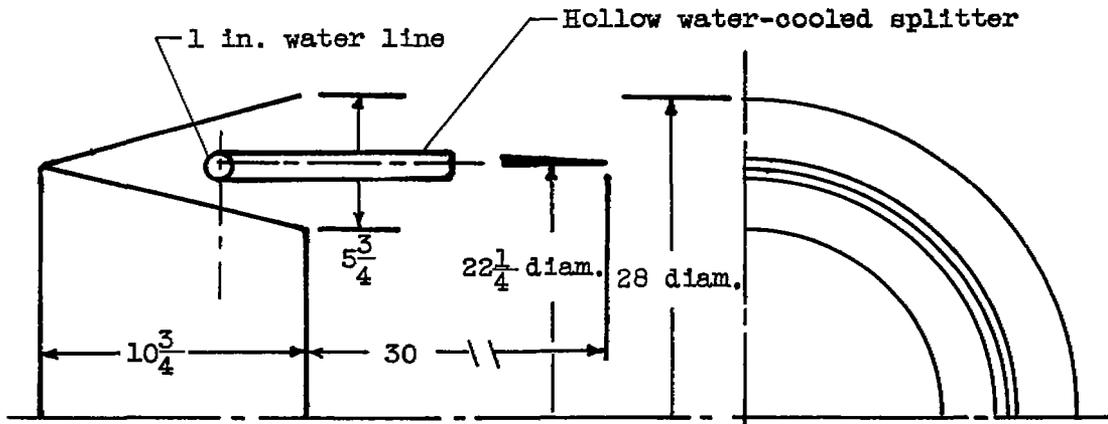
(1) Flame holder (L). Blocked area, 402 square inches.  
Figure 5. - Continued. Details of flame holders investigated. (All dimensions in inches.)

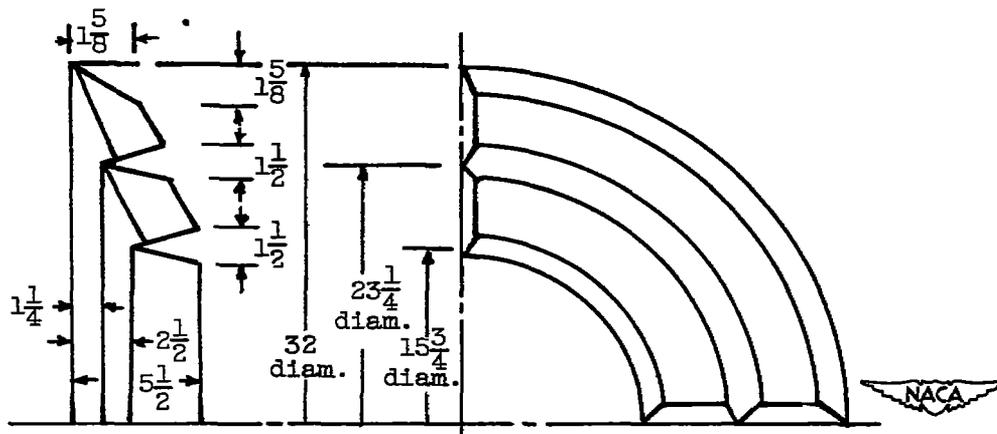
(m) Flame holder (M). Blocked area, 362 square inches.

Figure 5. - Concluded. Details of flame holders investigated.  
(All dimensions in inches.)

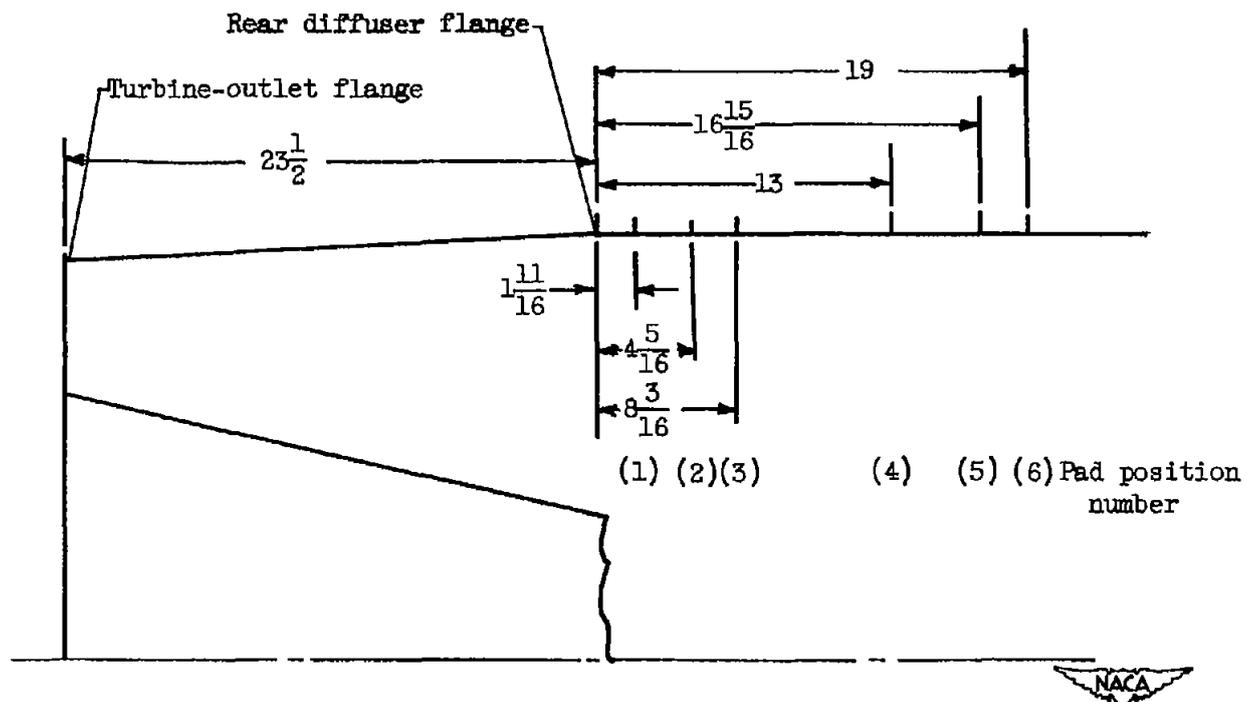
Figure 6. - Sketch of diffuser and afterburner section, indicating positions of flame holders. (All dimensions in inches.)

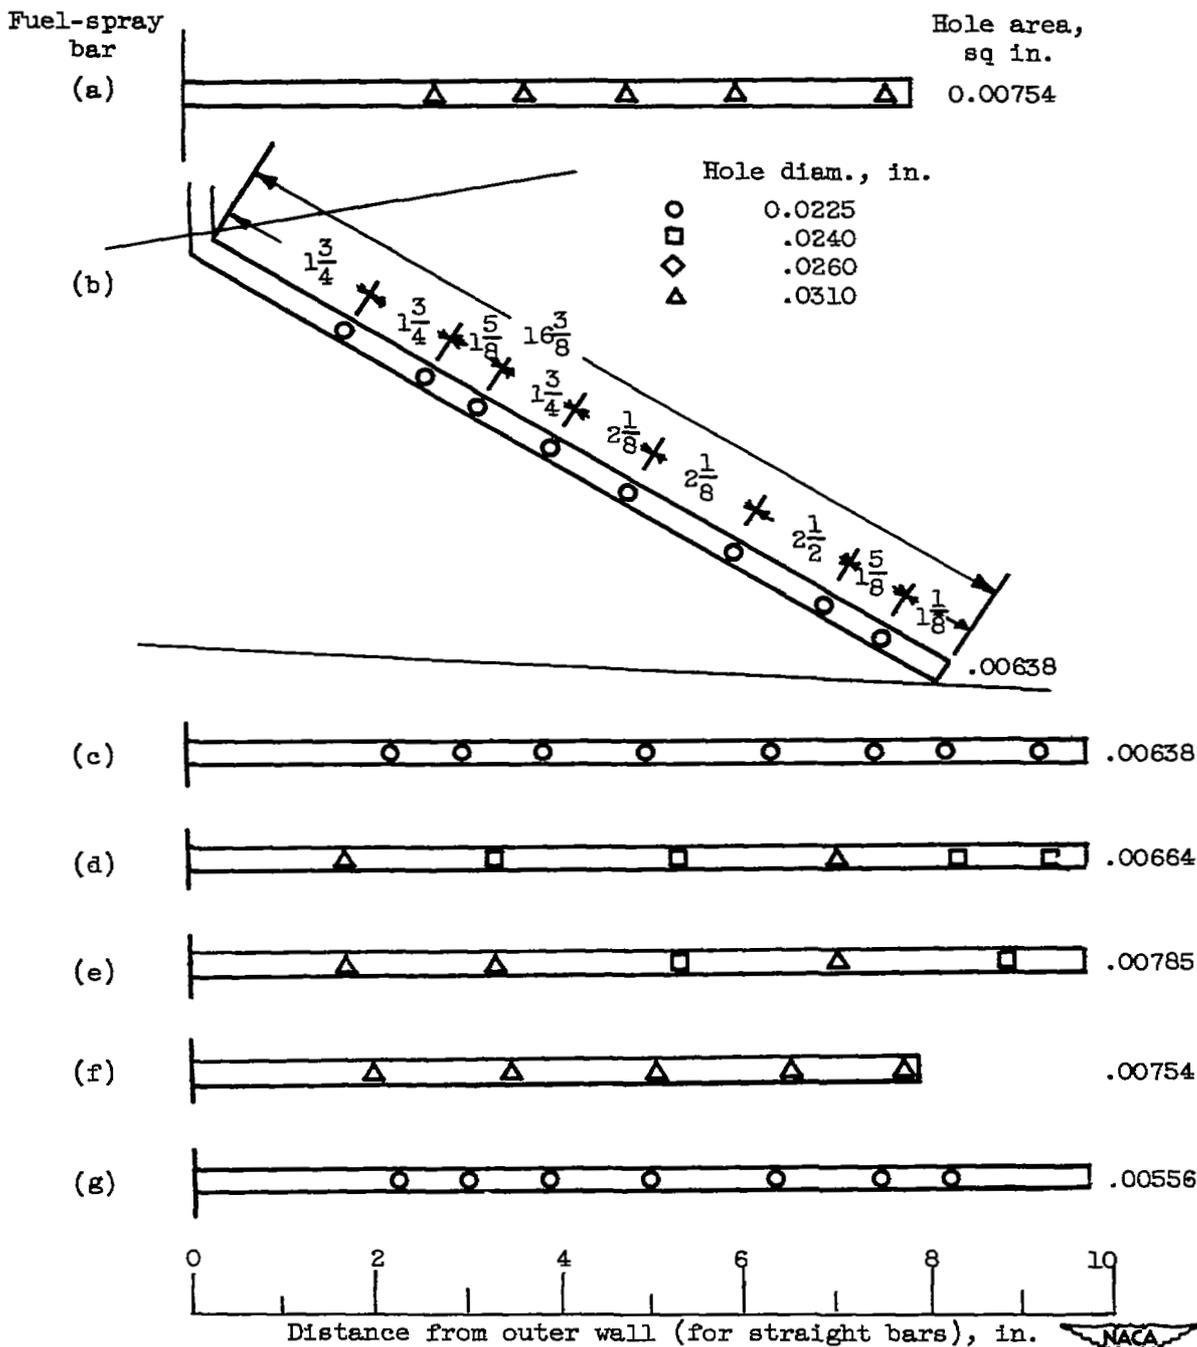
Figure 7. - Details of fuel-spray bars investigated.

shown in figure 7. The number of spray bars installed in the afterburner for each of the several designs investigated varied from 13 to 20. All but two of the 13 types of spray bars were inserted radially into the afterburner. The exceptions, spray bars (b) and (h), were installed so as to slant downstream.

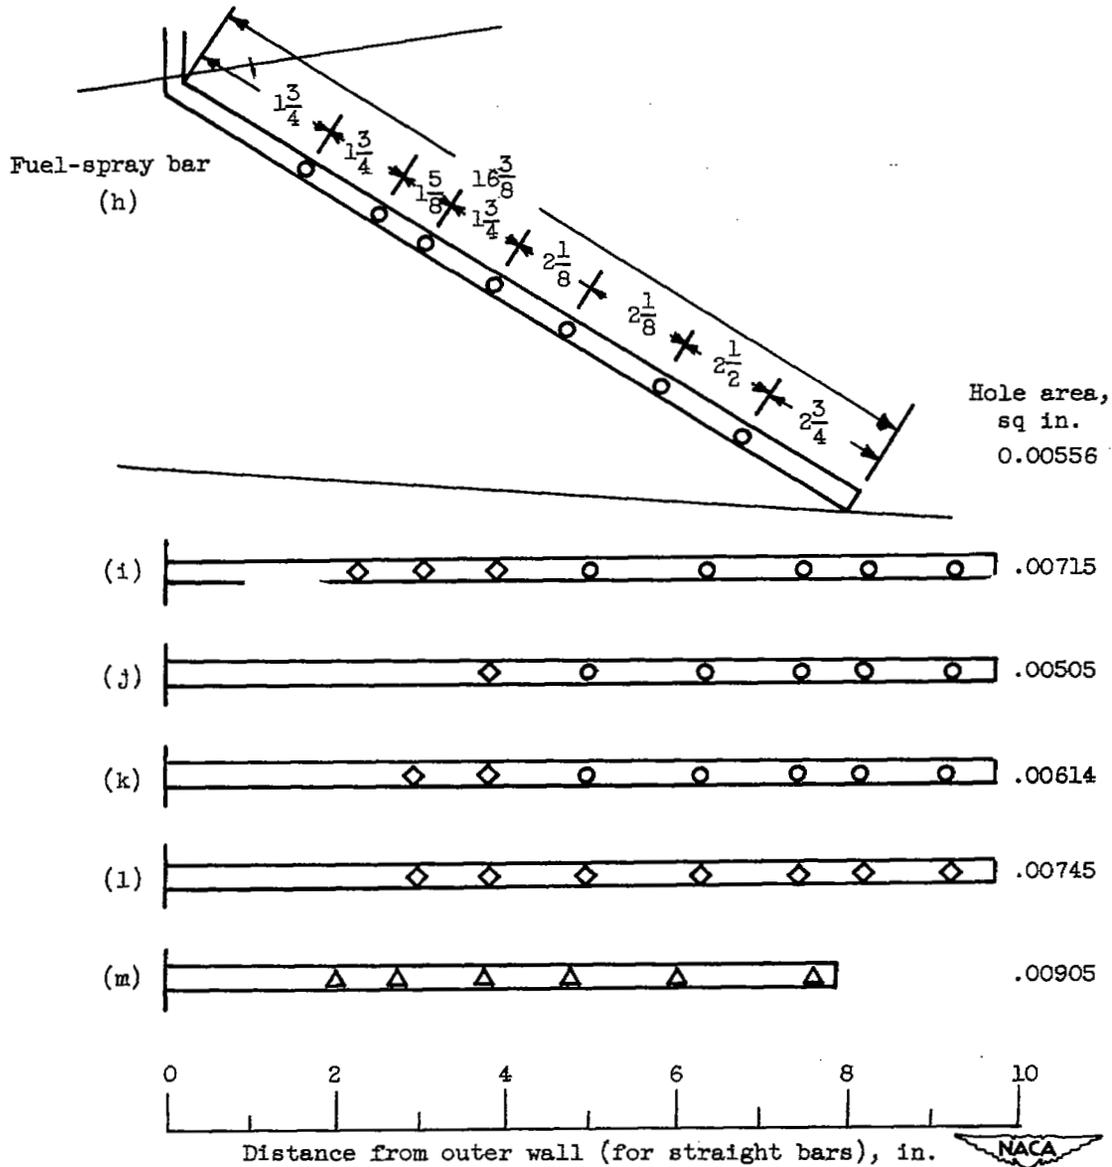
Figure 7. - Concluded. Details of fuel-spray bars investigated.

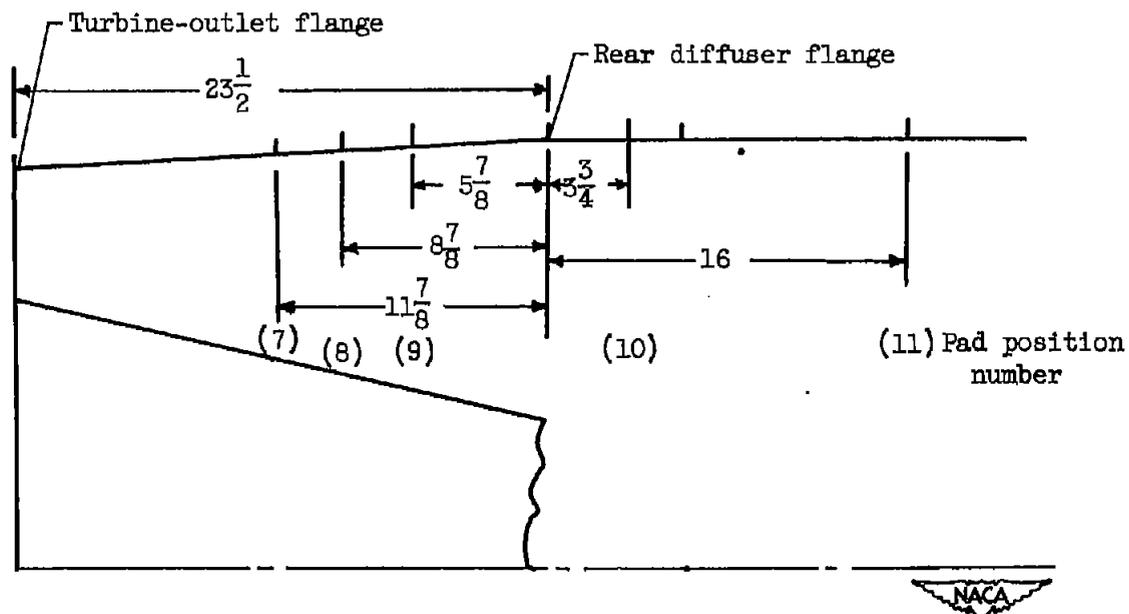
Figure 8. - Sketch of diffuser and afterburner section, indicating positions of fuel-spray bars. (All dimensions in inches.)

The fuel-spray bars were located at several longitudinal positions in the diffuser and combustion chamber, as indicated in figure 8 and table I. For configurations 28 to 43, fuel-spray bars were located at two longitudinal positions; separate fuel manifolds and regulating systems were used for each set of spray bars. It was thus possible to operate with two separate fuel systems, either independently or combined, without shutting down the engine and facility to make the change.

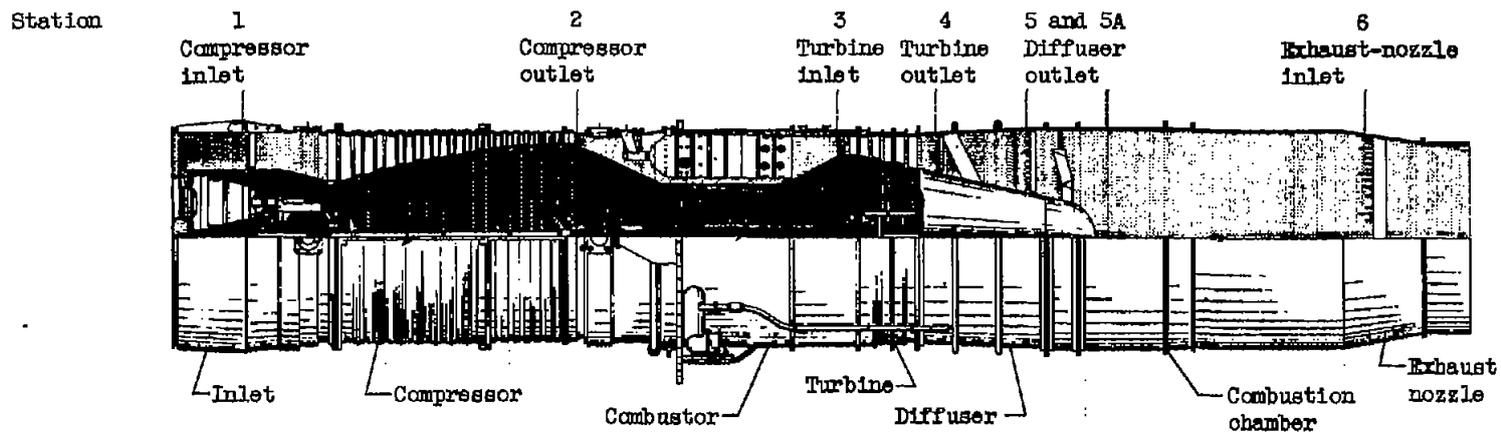
Figure 9. - Cross-sectional view of engine and afterburner indicating instrumentation stations.

Instrumentation for the measurement of pressures and temperatures was installed in various stations in the engine and afterburner, as indicated in figure 9. Total pressures and temperatures at the turbine outlet were obtained 3 inches downstream of the rear turbine flange from three rakes having seven total-pressure tubes, two wall static-pressure taps (inner and outer wall), and six thermocouples each. The 12 control thermocouples connected in parallel were equally spaced around the burner  $1\frac{1}{2}$  inches from the outer wall 5 inches downstream of the rear turbine flange. Pressures at the diffuser outlet were taken from a rake containing 12 total-pressure tubes and an inner and outer wall static-pressure tap located  $3\frac{1}{2}$  inches ahead of the rear diffuser flange. When the configuration permitted, flame-holder inlet pressures were measured with a rake containing 12 total-pressure tubes and inner and outer wall static taps located  $9\frac{3}{8}$  inches downstream of the rear diffuser flange. At a location  $1\frac{13}{16}$  inches downstream of the exhaust-nozzle inlet, pressures were measured by 20 total-pressure tubes, four stream static tubes, and two wall static-pressure taps mounted in a vertical water-cooled rake. The afterburner cooling-air passages were instrumented with total-pressure tubes, stream static tubes, wall static taps, and thermocouples located at strategic points so that cooling-air flow could be calculated.

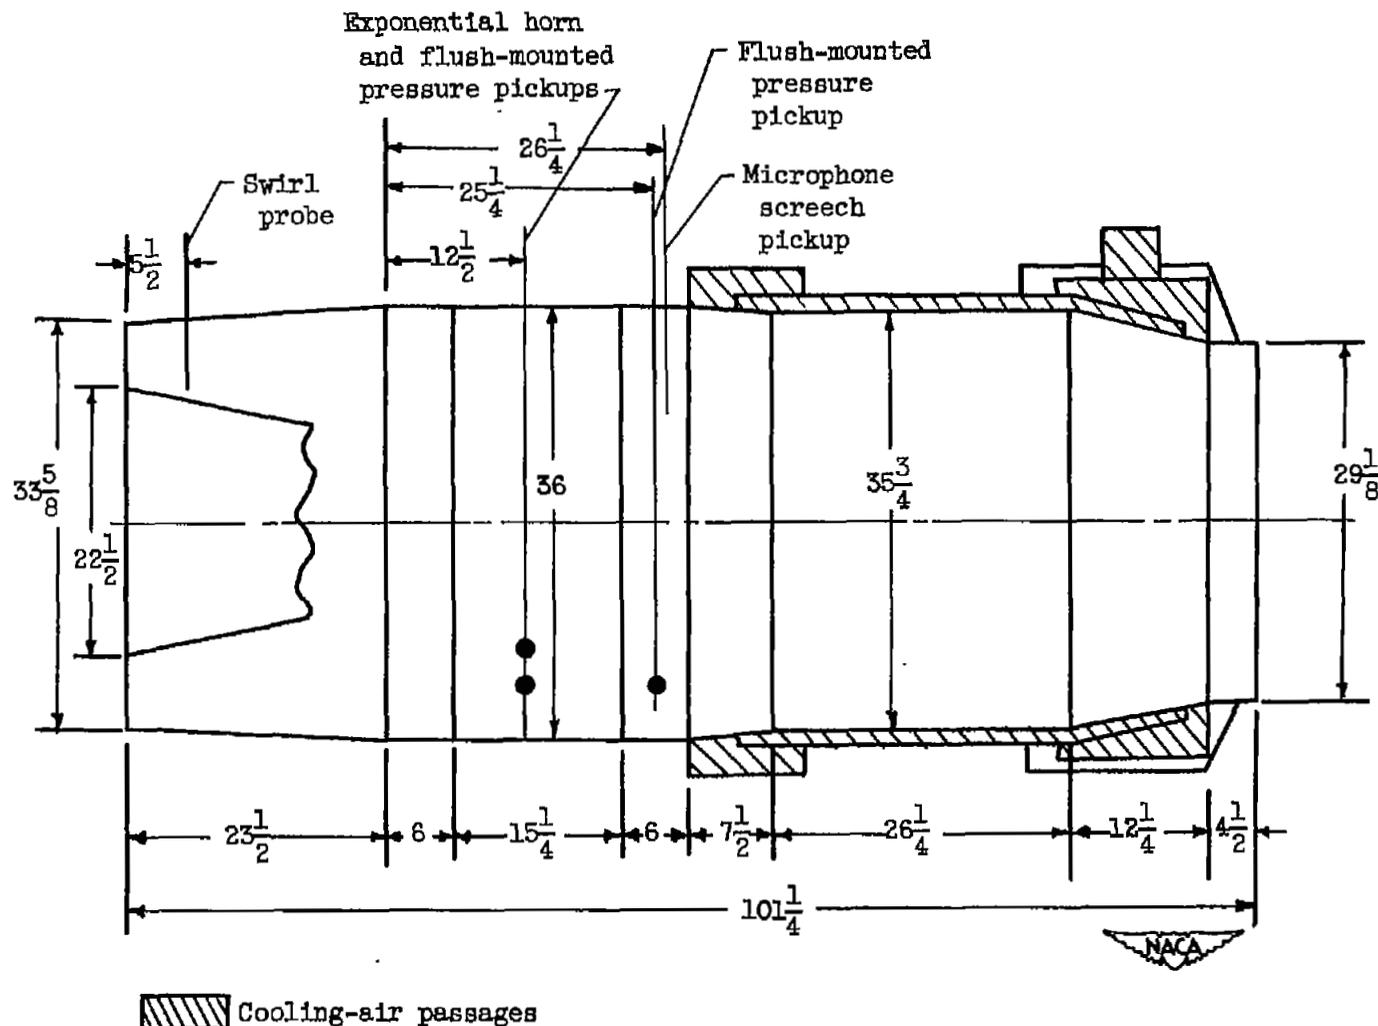
Figure 10. - Sketch of afterburner indicating positions of screech pickups and swirl surveys.  
(All dimensions in inches.)

The location of special instrumentation, which included an adjustable swirl-angle probe (ref. 4) and screech-detecting devices, is shown in figure 10. The probe from which swirl angle at the turbine outlet was determined consisted of two total-pressure-indicating tubes facing  $\pm 40^\circ$  from a true upstream direction. At each of several radial positions the probe was rotated until the two tubes indicated no difference in pressure as measured by a mercury U-tube. The angle of flow or swirl was then taken to be the angle of the probe.
