NACA RM E53101

EXPERIMENTAL INVESTIGATION OF SCREECHING COMBUSTION  
IN FULL-SCALE AFTERBURNER

By Karl H. Usow, Carl L. Meyer, and Frederick W. Schulze

Lewis Flight Propulsion Laboratory  
Cleveland, Ohio

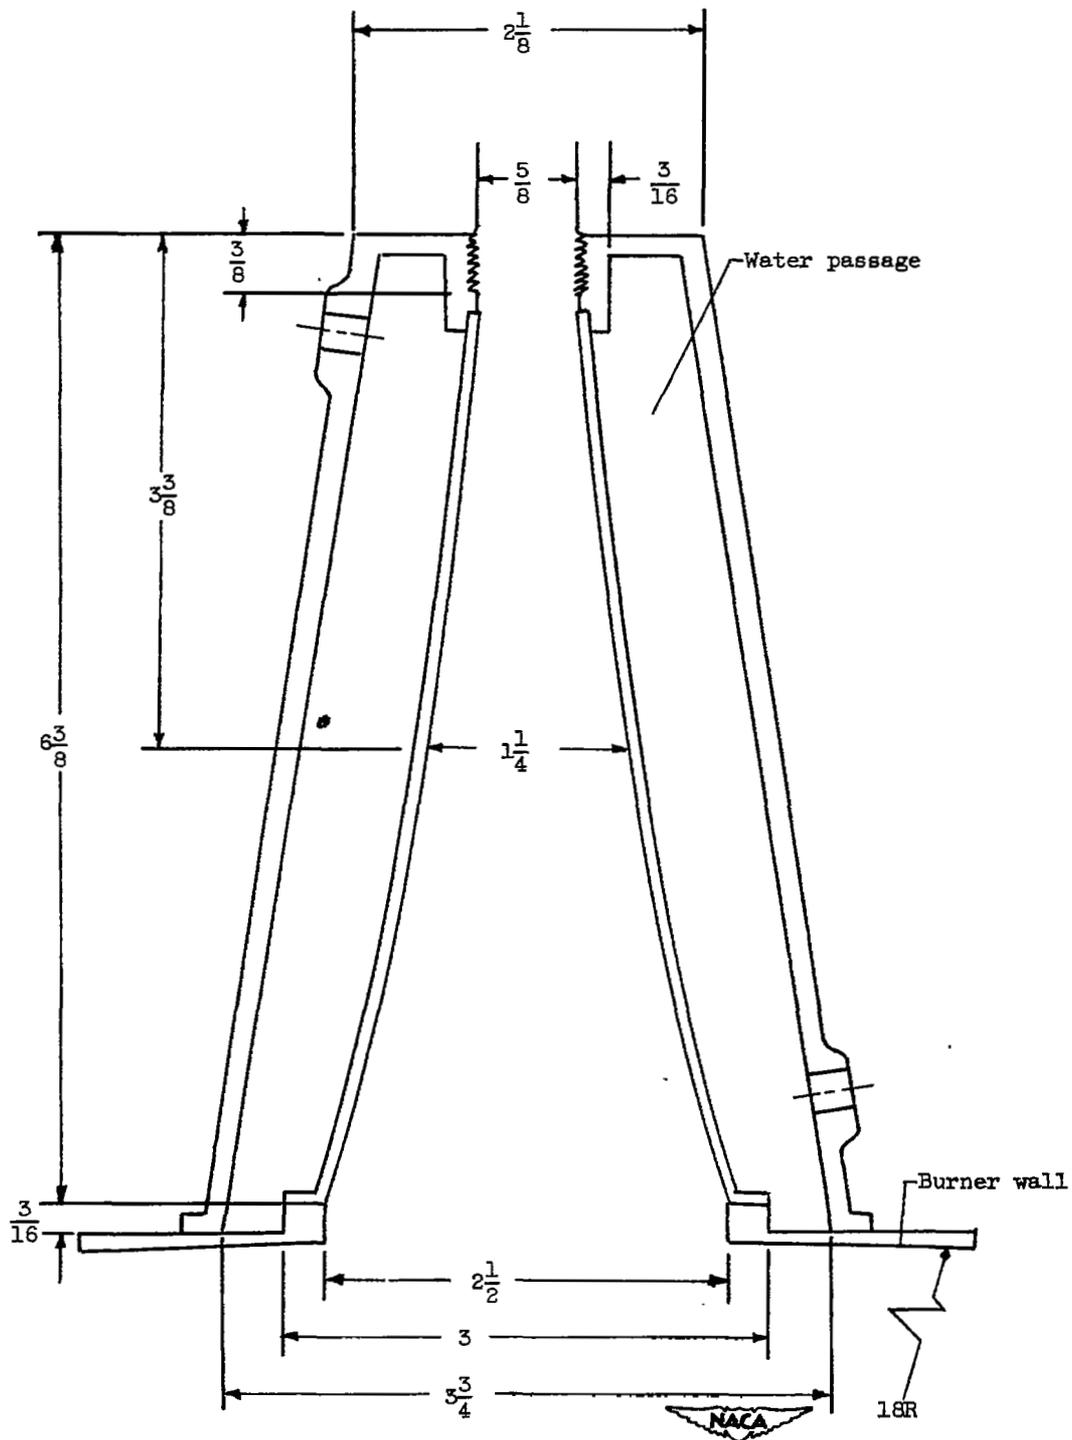
Figure 11. - Details of exponential horn for mounting strain-gage pressure pickup. (All dimensions in inches.)

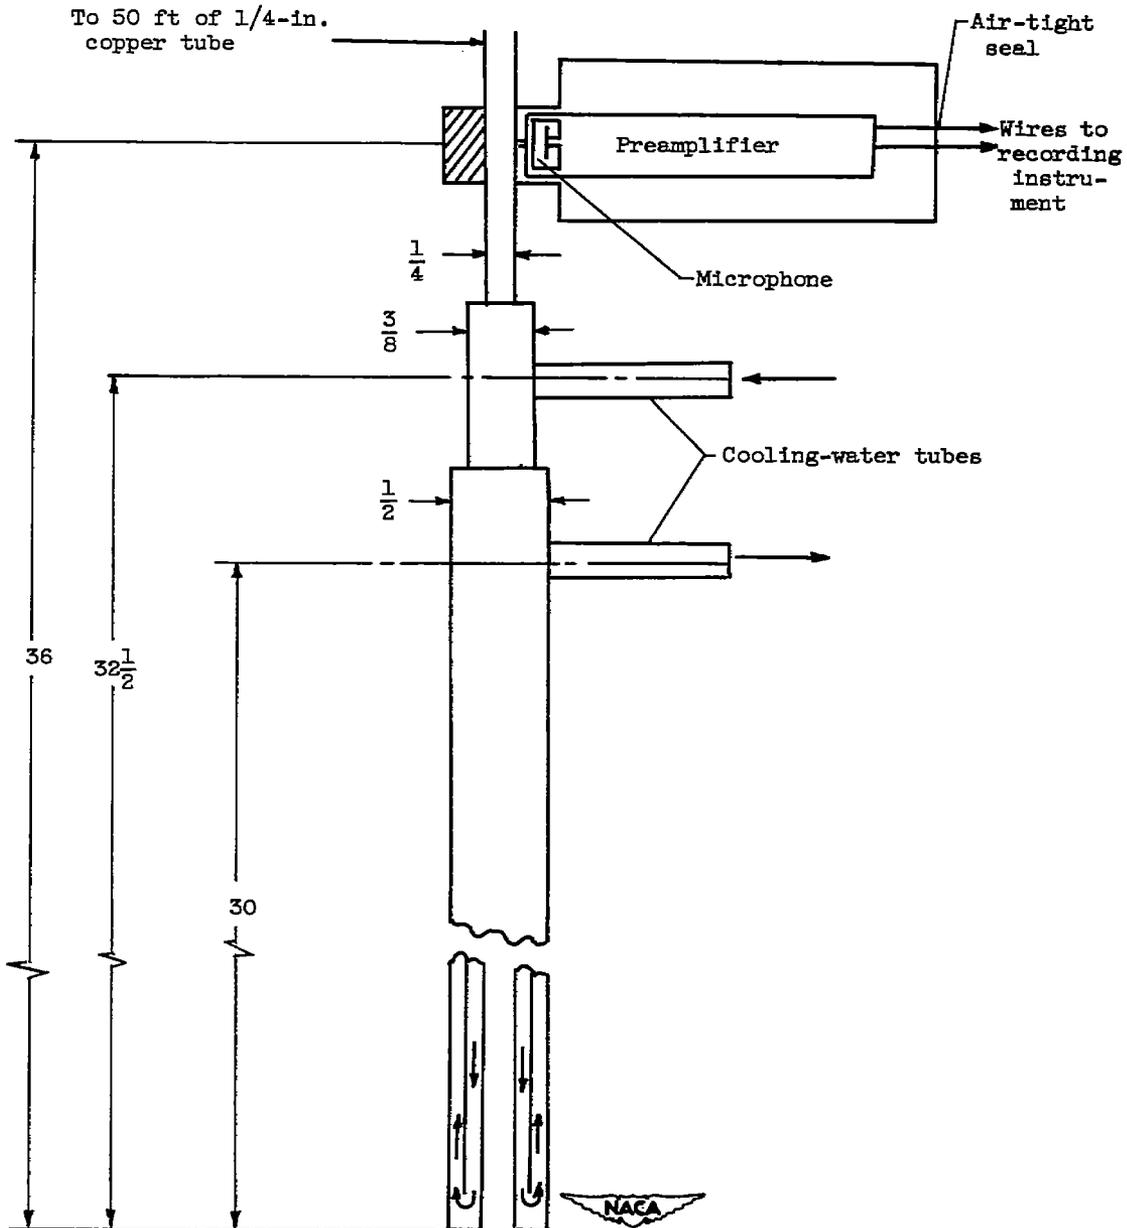
Figure 12. - Details of acoustic probe and microphone mounting. (All dimensions in inches.)

A second type of screech pickup (fig. 12), which employed a condenser microphone tied to an adjustable water-cooled probe, is referred to as an acoustic probe. The microphone was located as near the probe sensing end as possible so as to reduce attenuation of the signal; also 50 feet of copper tubing was added after the microphone to simulate an infinite tube and thus repress any signal reflection. The unit was mounted downstream of the flame holder and was able to traverse radially across the burner for a distance of 9 inches from the burner skin.

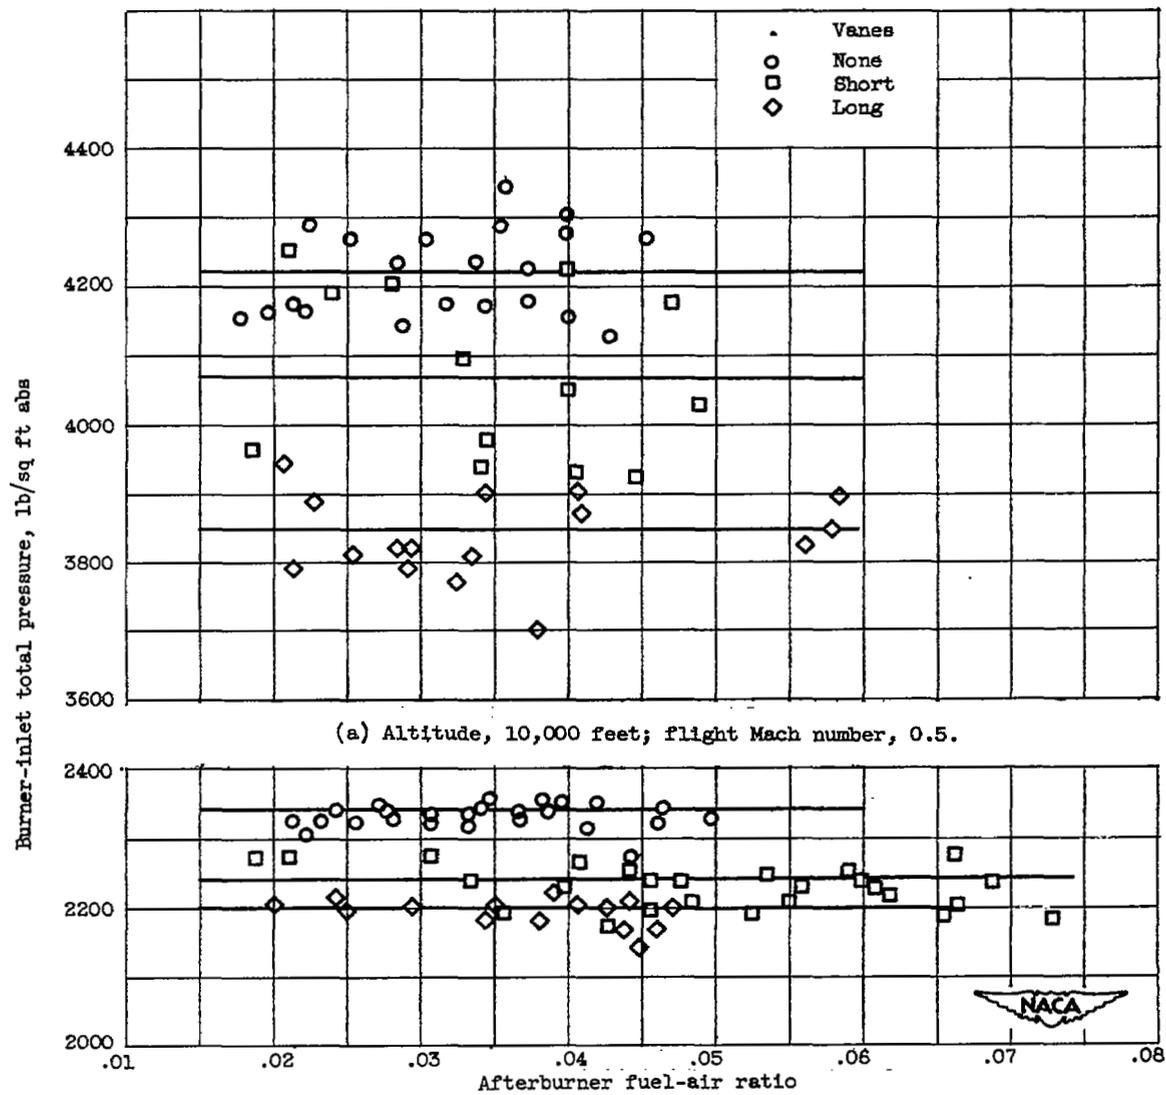
(a) Altitude, 10,000 feet; flight Mach number, 0.5.

(b) Altitude, 35,000 feet; flight Mach number, 1.0.

Figure 13. - Average burner-inlet total pressures.

The resulting afterburner-inlet conditions obtained at the two simulated flight conditions are shown in figures 13 and 14. Total pressures at the afterburner inlet (fig. 13) ranged from about 2200 to 2340 pounds per square foot absolute at the 35,000-foot altitude to 3850 to 4220 pounds per square foot absolute at the 10,000-foot altitude. Variations in pressure at a given altitude resulted from differences in diffuser performance when antiswirl vanes were installed. Since a total of eight engines was used during the investigation, variations in pressure and temperature could have resulted from slight differences in performance from engine to engine.

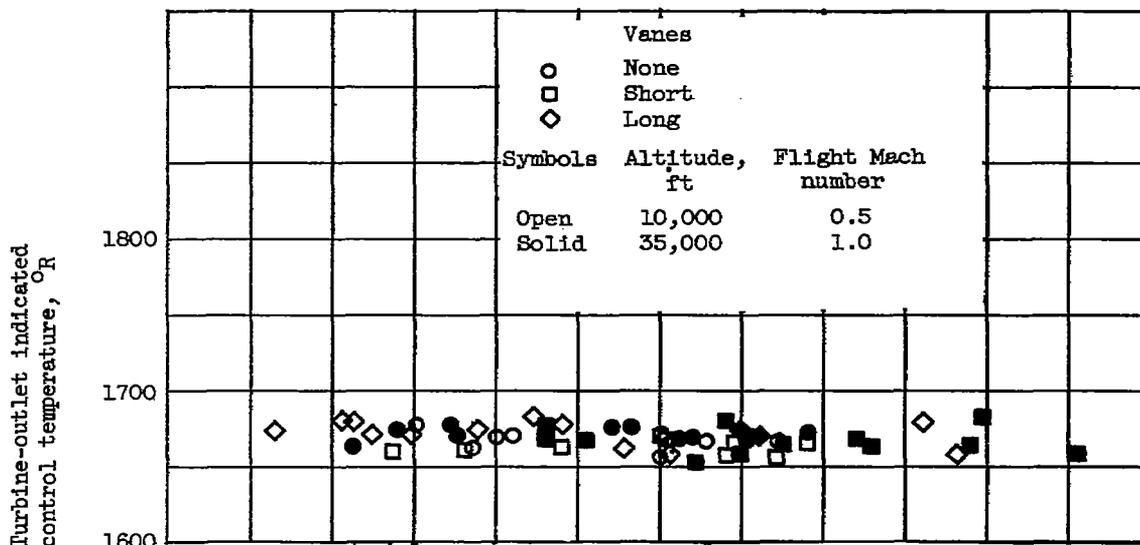
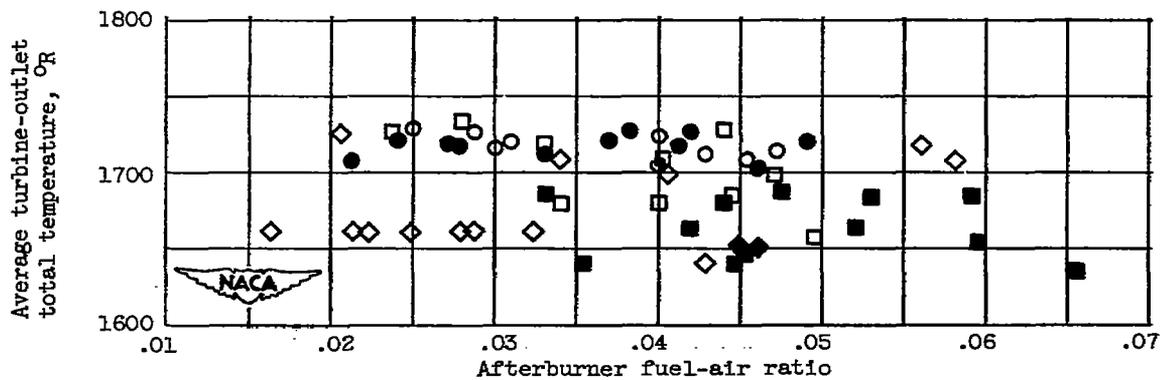
(a) Turbine-outlet indicated control temperature.

(b) Average turbine-outlet total temperature.

Figure 14. - Typical turbine-outlet temperatures.

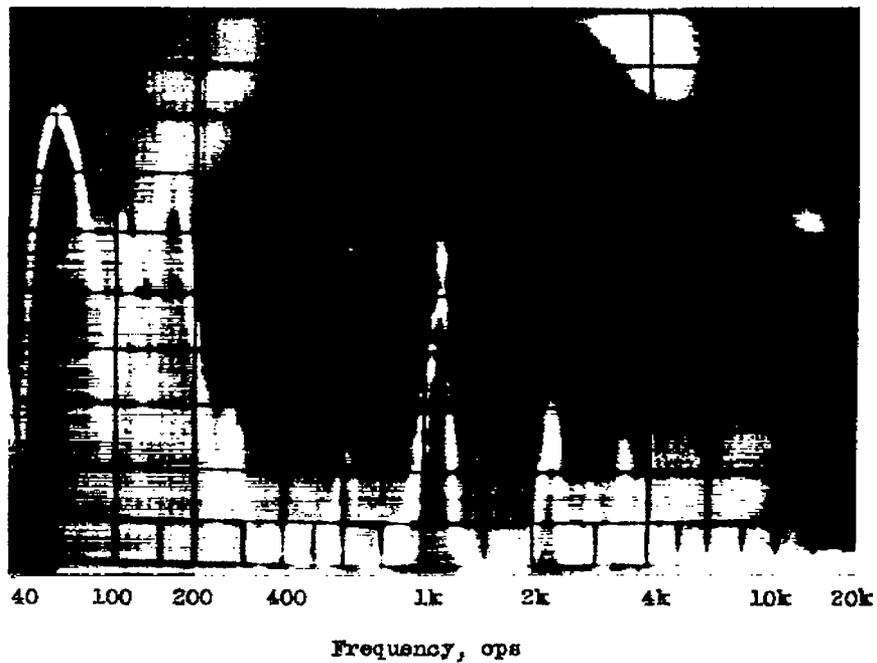
(a) Flush-mounted strain-gage pressure pickup; afterburning but no screech.

(b) Flush-mounted strain-gage pressure pickup; screeching combustion.

Figure 15. - Typical examples of panoramic traces sensed by various transducers.

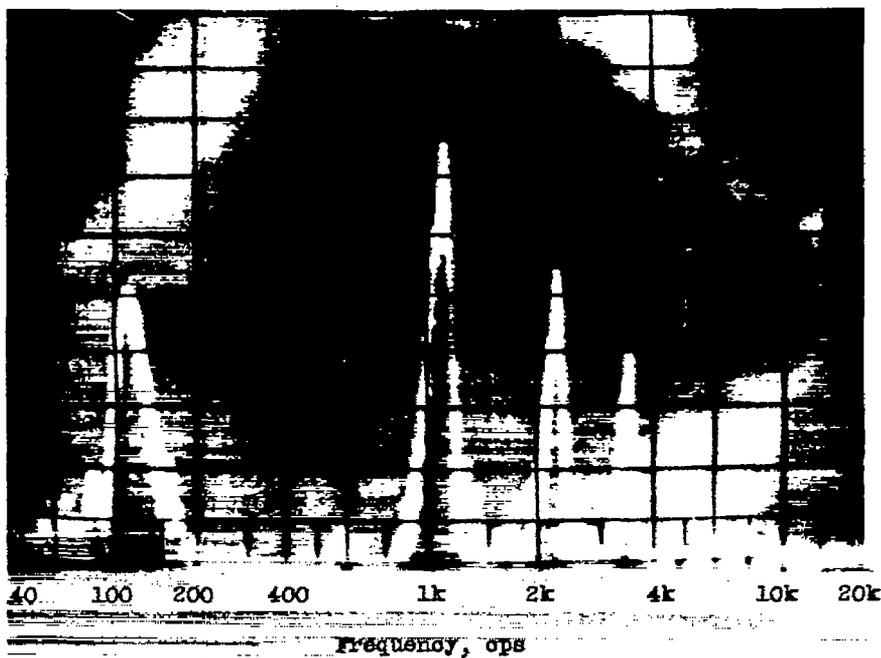
(c) Exponential-horn mounted strain-gage pressure pickup; afterburning but no screech.

(d) Exponential-horn mounted strain-gage pressure pickup; screeching combustion.

Figure 15. - Continued. Typical examples of panoramic traces sensed by various transducers.

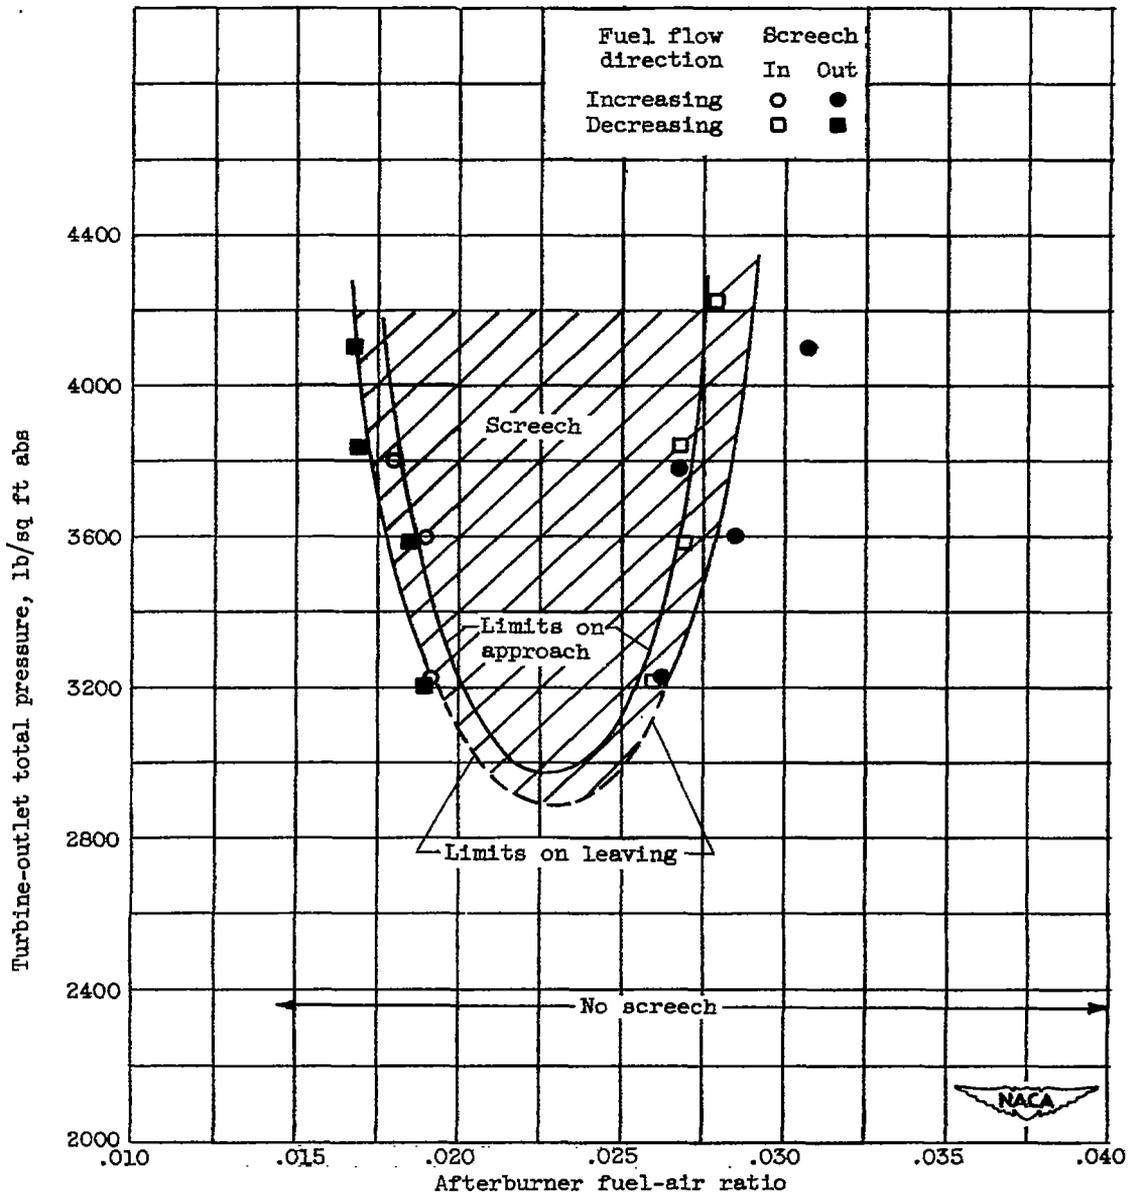
Figure 17. - Variation of screech limits with pressure level of operation for configuration 37.

The range of afterburner fuel-air ratio over which screeching combustion was encountered generally increased as burner-inlet total pressure was raised. This trend is illustrated in figure 17, which also indicates the hysteresis that existed in the screech limits for most configurations. At a given burner-inlet pressure, the range of fuel-air ratio over which screech existed was narrower when approaching the screech zone than when leaving the zone after screech was encountered. (The fuel-air ratio presented in figure 17 and subsequent figures is the ratio of afterburner fuel flow to unburned air entering the afterburner.) Over the limited range of burner-inlet temperatures investigated, there was no consistent effect of inlet temperature on the screech limits. These observations confirm those of reference 3, which shows no effect of inlet temperature on screech limits.

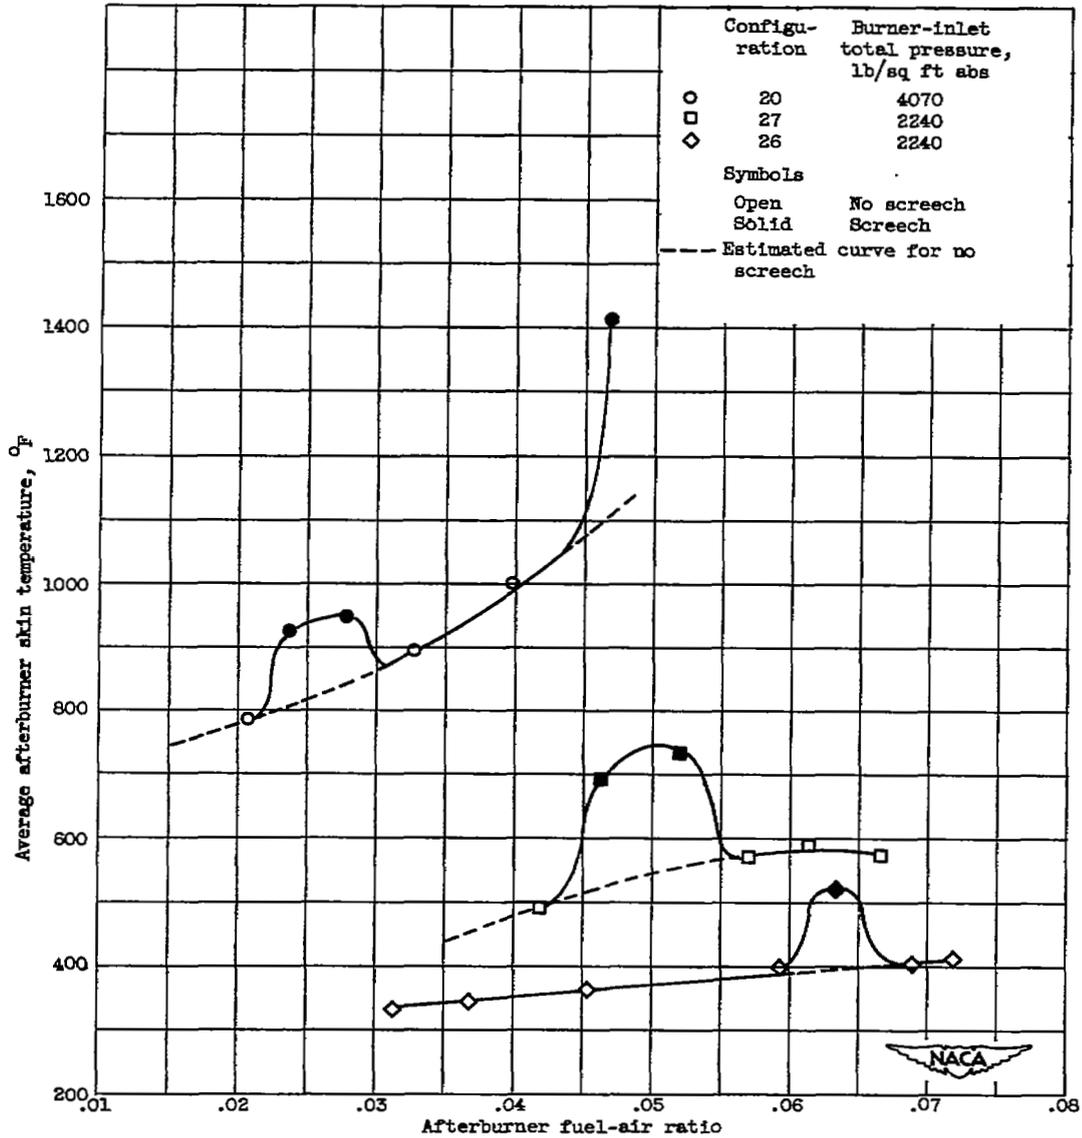
Figure 18. - Effect of screech on afterburner skin temperature.

Another observation was that the afterburner shell and exhaust-nozzle segments overheated in many cases during operation with screeching combustion. It appeared that during such operation the flame became very turbulent and spread rapidly in much the same manner as that reported in reference 5. Based on this observation, it was believed that the distance between the outer gutter of the flame holder and the burner wall might be a factor influencing screeching combustion.

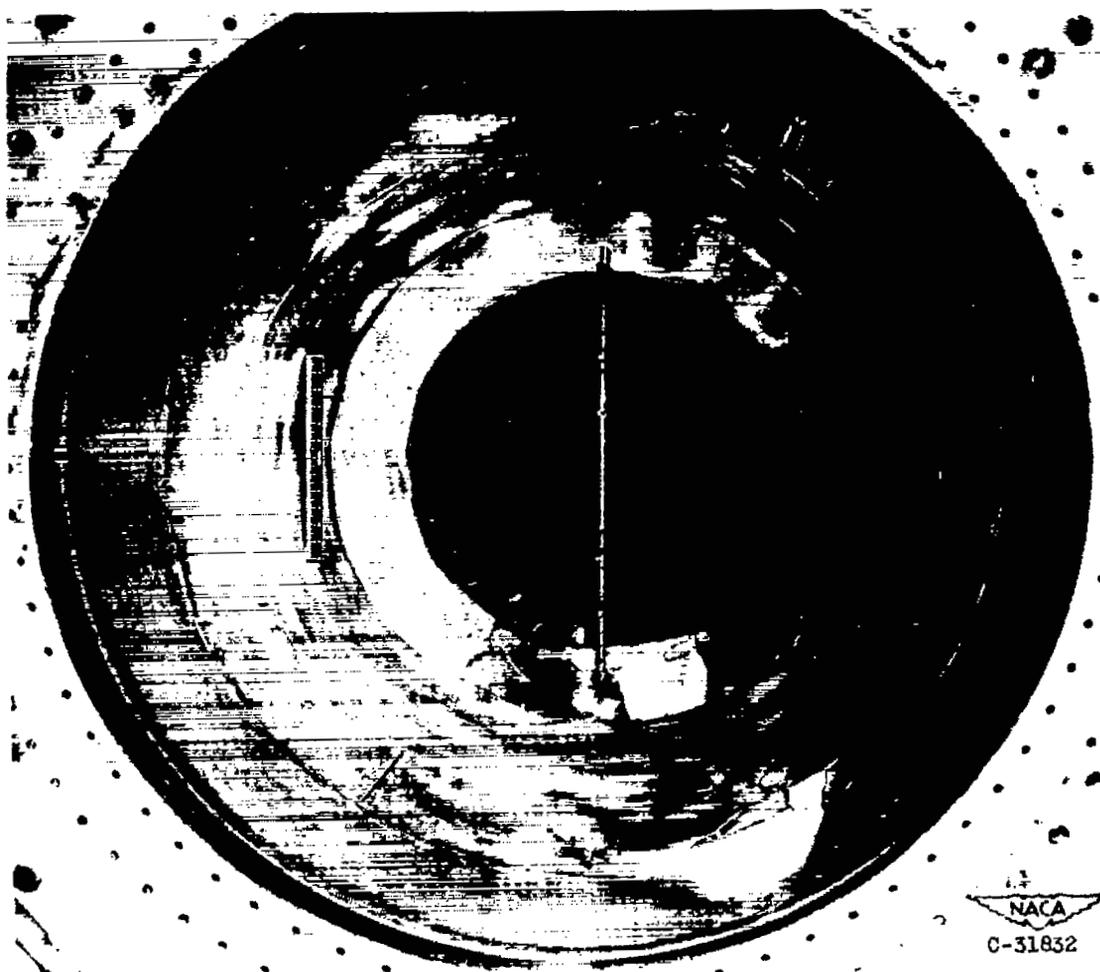
Figure 19. - Destruction of combustion chamber due to screech. Configuration 36.

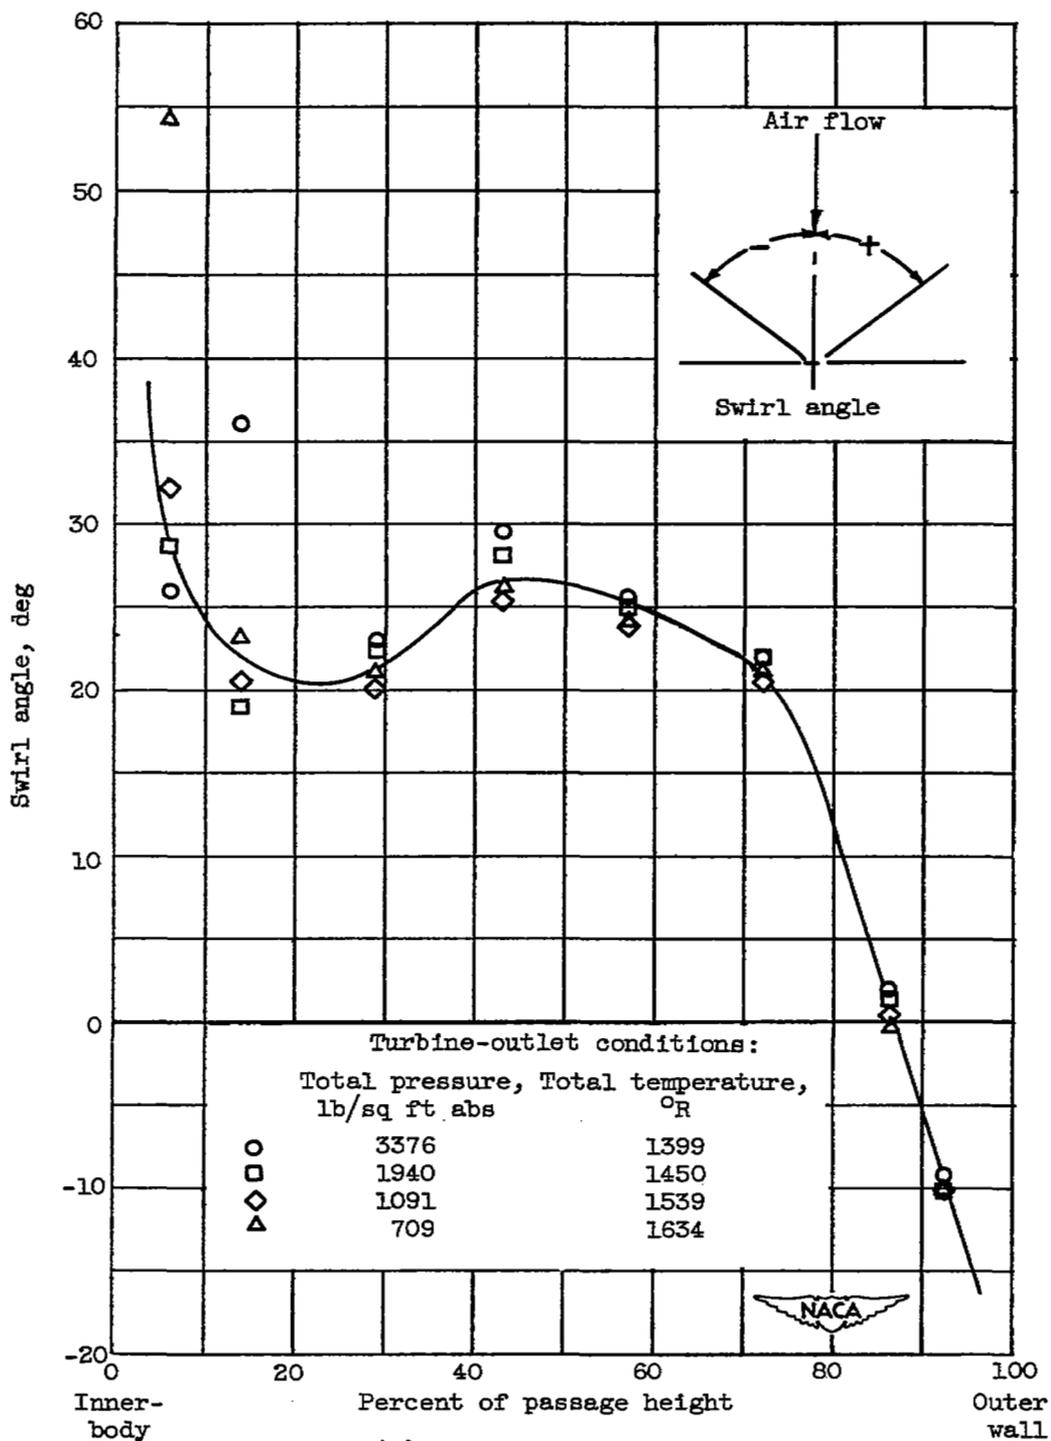
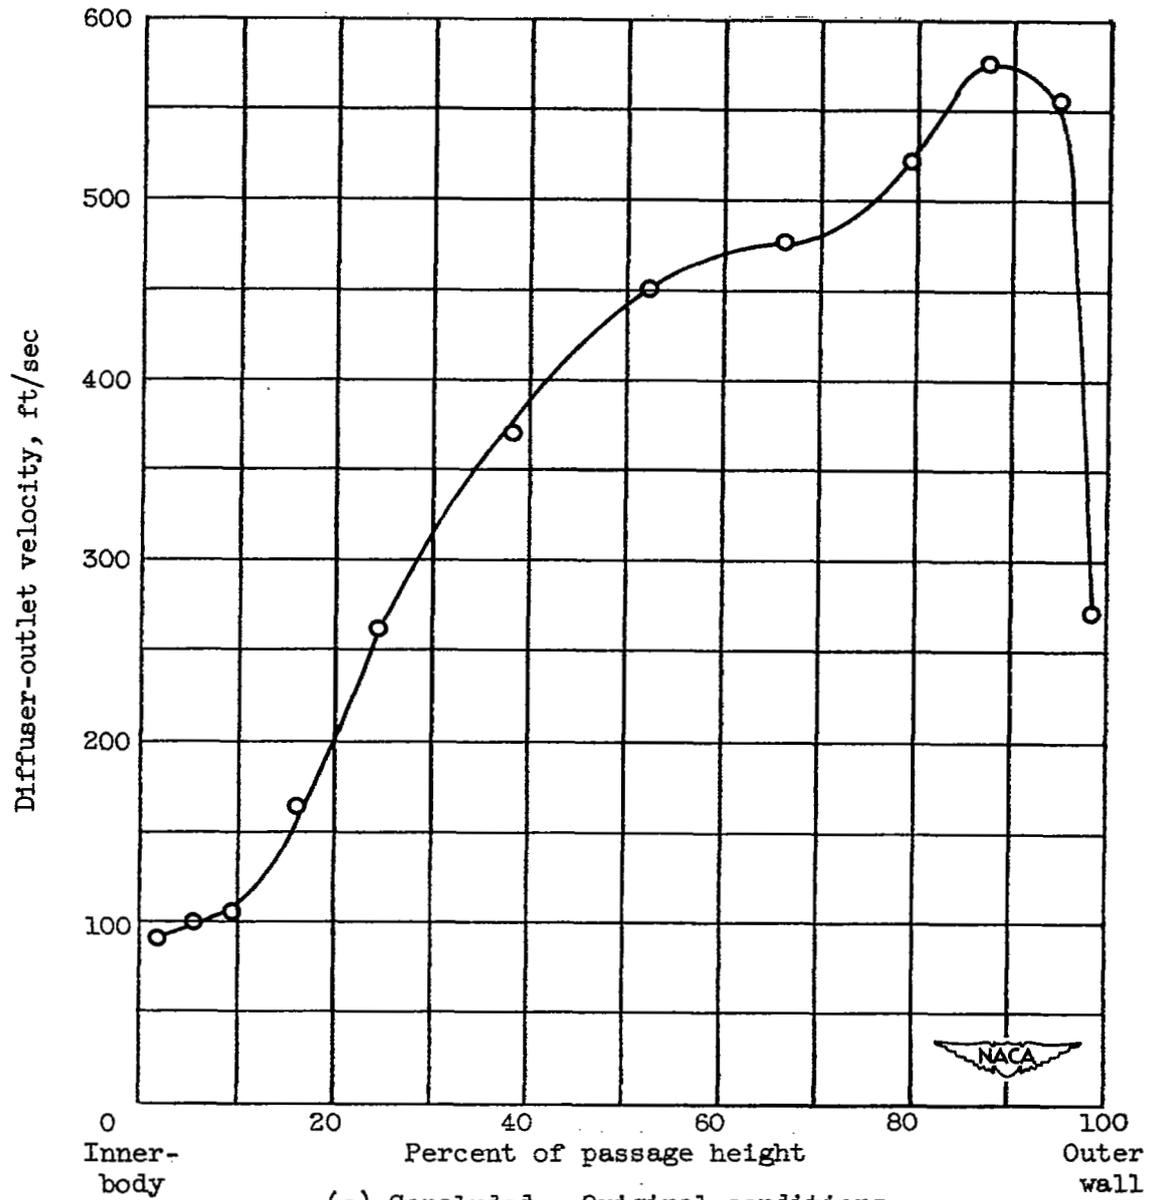
(a) Original conditions.

Figure 20. - Diffuser flow conditions.

In order to determine the flow characteristics entering the burner, measurements of pressure and swirl angle were obtained at the diffuser inlet and outlet. These measurements indicated considerable swirl entering the diffuser and the burner and a large velocity gradient at the diffuser outlet. Some typical examples of the swirl angles and velocity profiles measured near the diffuser outlet are presented in figure 20(a). (Velocities were calculated from the rake total pressures with the assumption of uniform static pressure across the passage.) The velocity was very low near the innerbody and became very high in the outer half of the diffuser annulus. It should be noted that some of the configurations discussed in the subsequent paragraphs for these diffuser-outlet conditions incorporated short antiswirl vanes at the diffuser inlet, as illustrated in figure 3(a). Because these vanes had no appreciable effect on the diffuser-exit conditions, as shown in figure 20(b), data thus obtained are grouped with the other data observed with the same diffuser-outlet conditions.

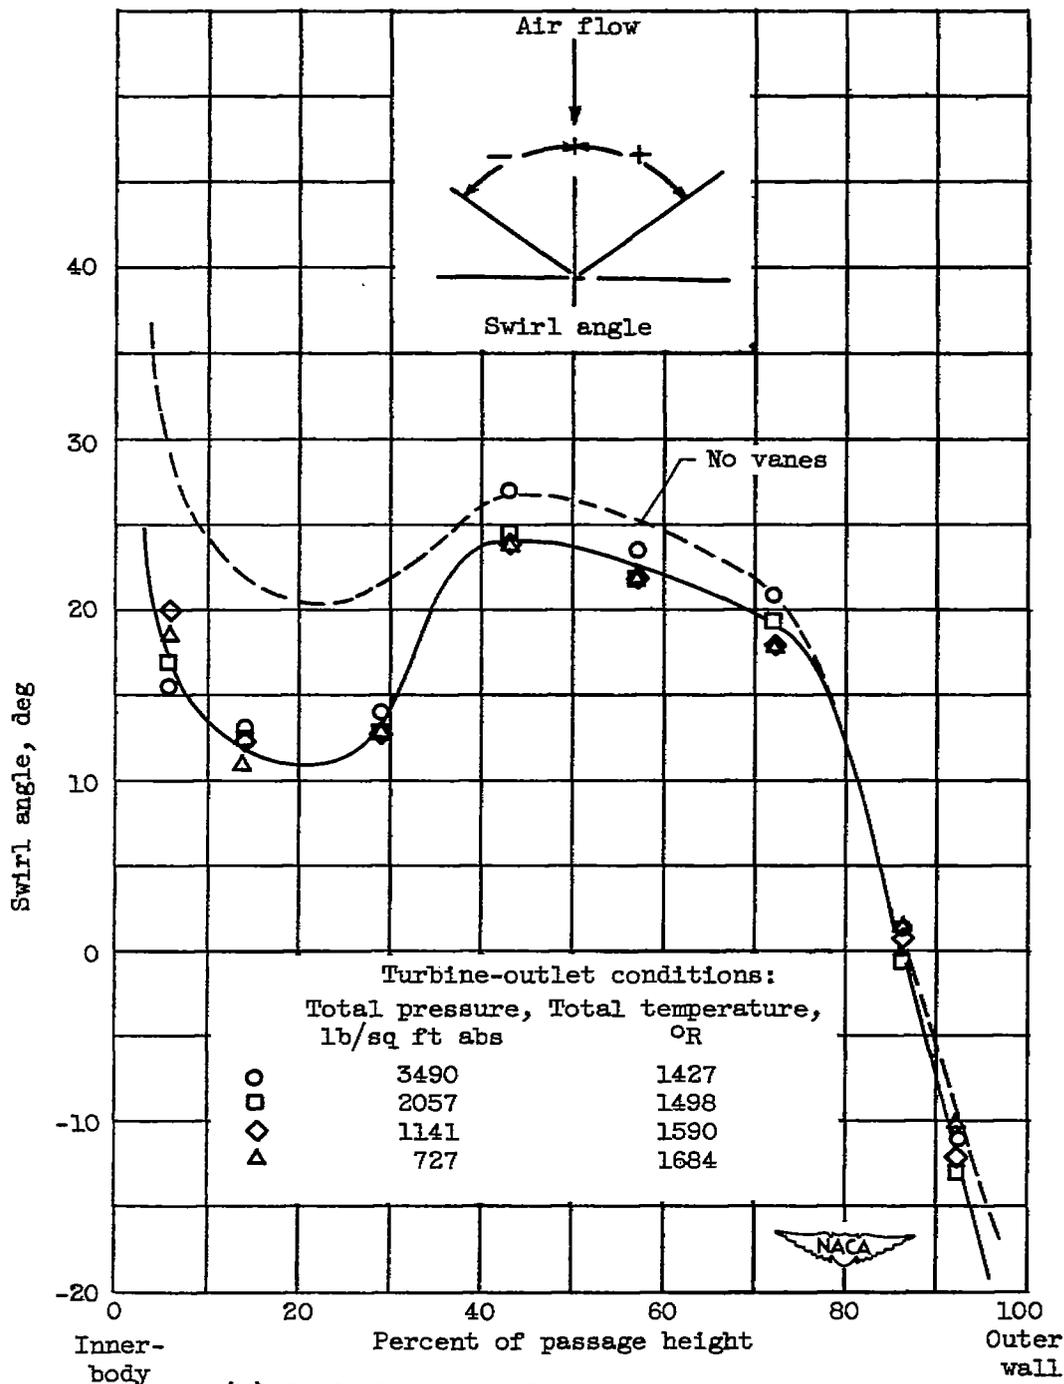
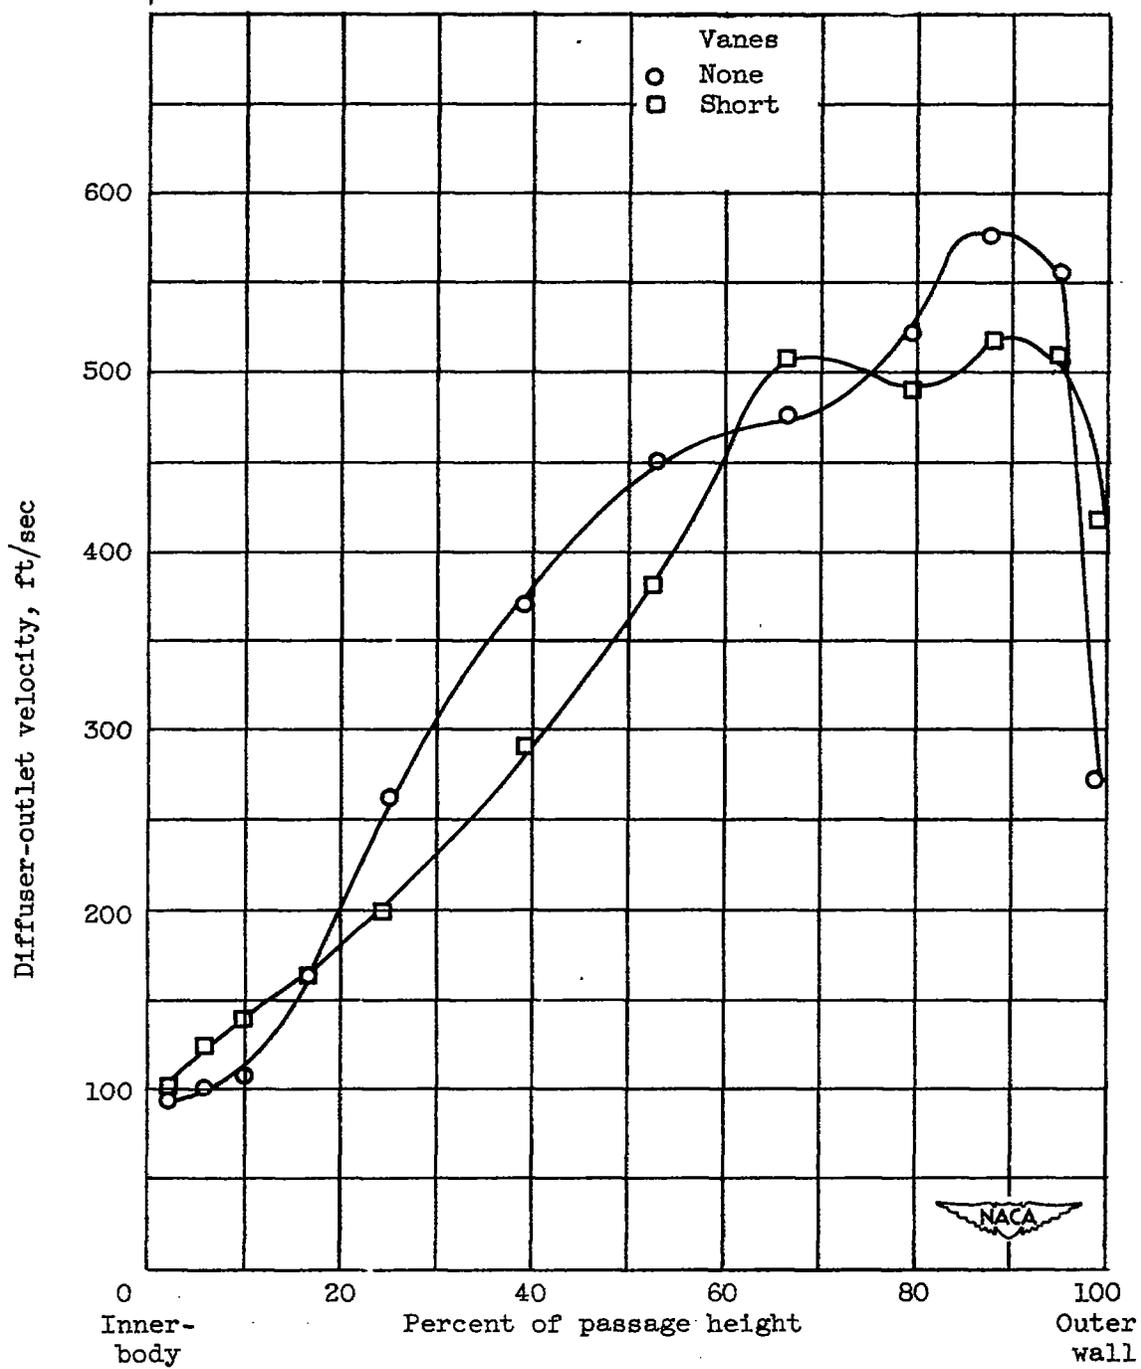
(b) Conditions with 33 short antiswirl vanes.

Figure 20. - Continued. Diffuser flow conditions.

Swirl and velocity profile. - Because screeching combustion had not been eliminated by eliminating burning in the low-velocity region along the diffuser innerbody, it was considered possible that the swirl and attendant severe velocity gradient at the diffuser outlet could be factors influencing screech. As previously mentioned, the short antiswirl vanes had no effect on turbine-outlet swirl; therefore, a set of antiswirl vanes was installed across the full passage at the turbine outlet to reduce the swirl. These vanes reduced the swirl considerably, as shown in figure 20(c). In addition to reducing the swirl, these vanes produced a velocity profile without steep gradients at the diffuser outlet (fig. 20(c)).

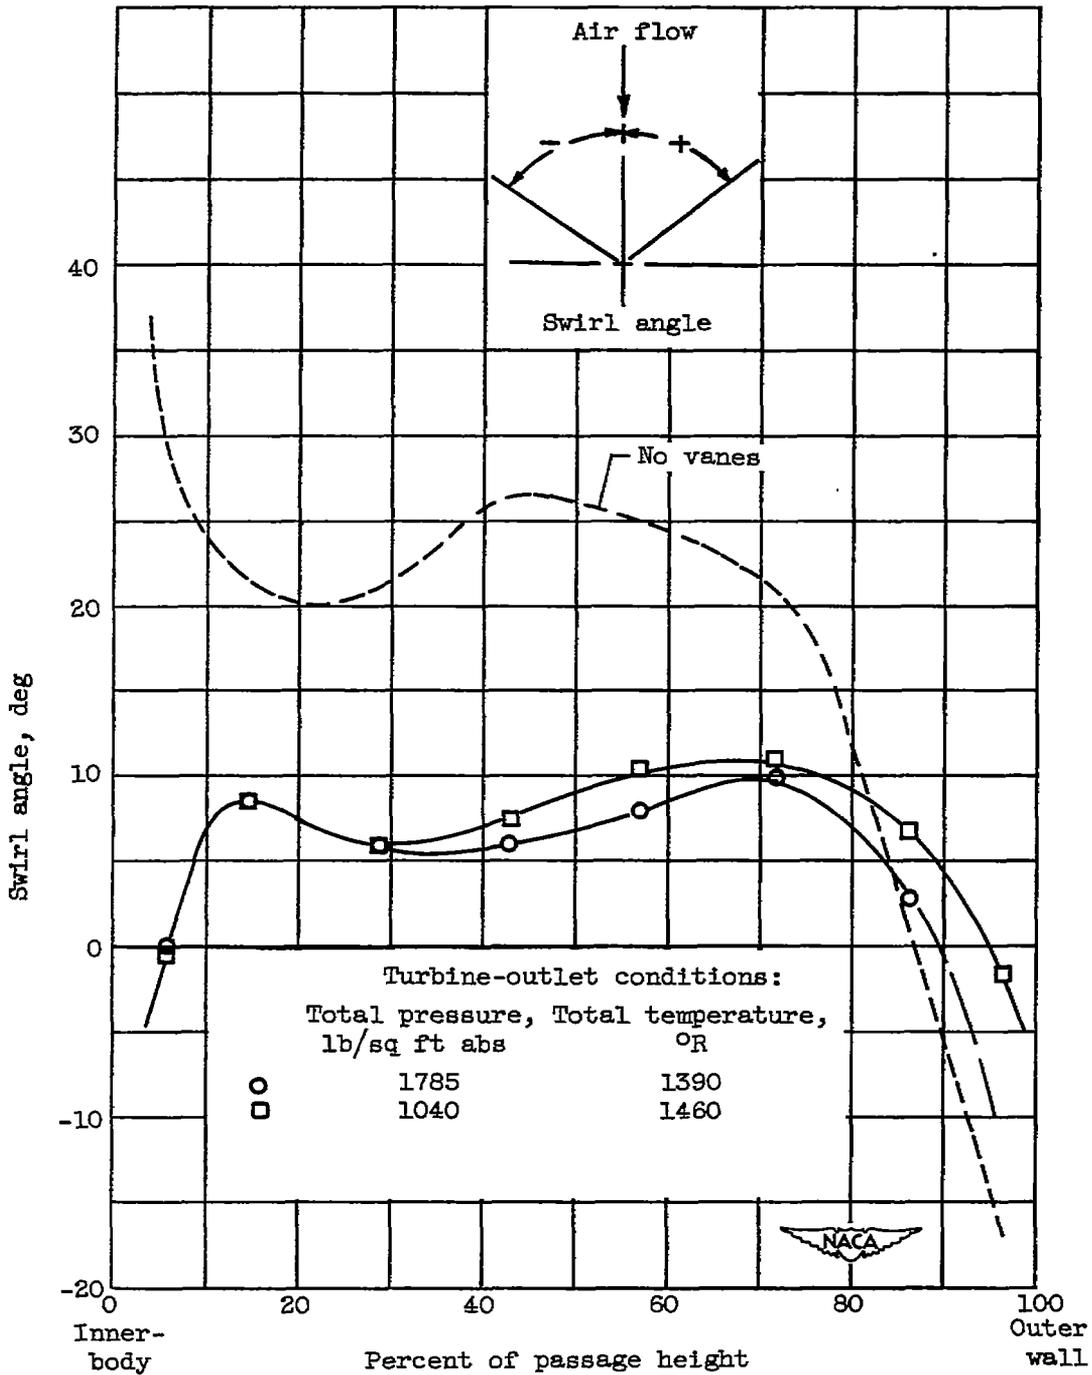
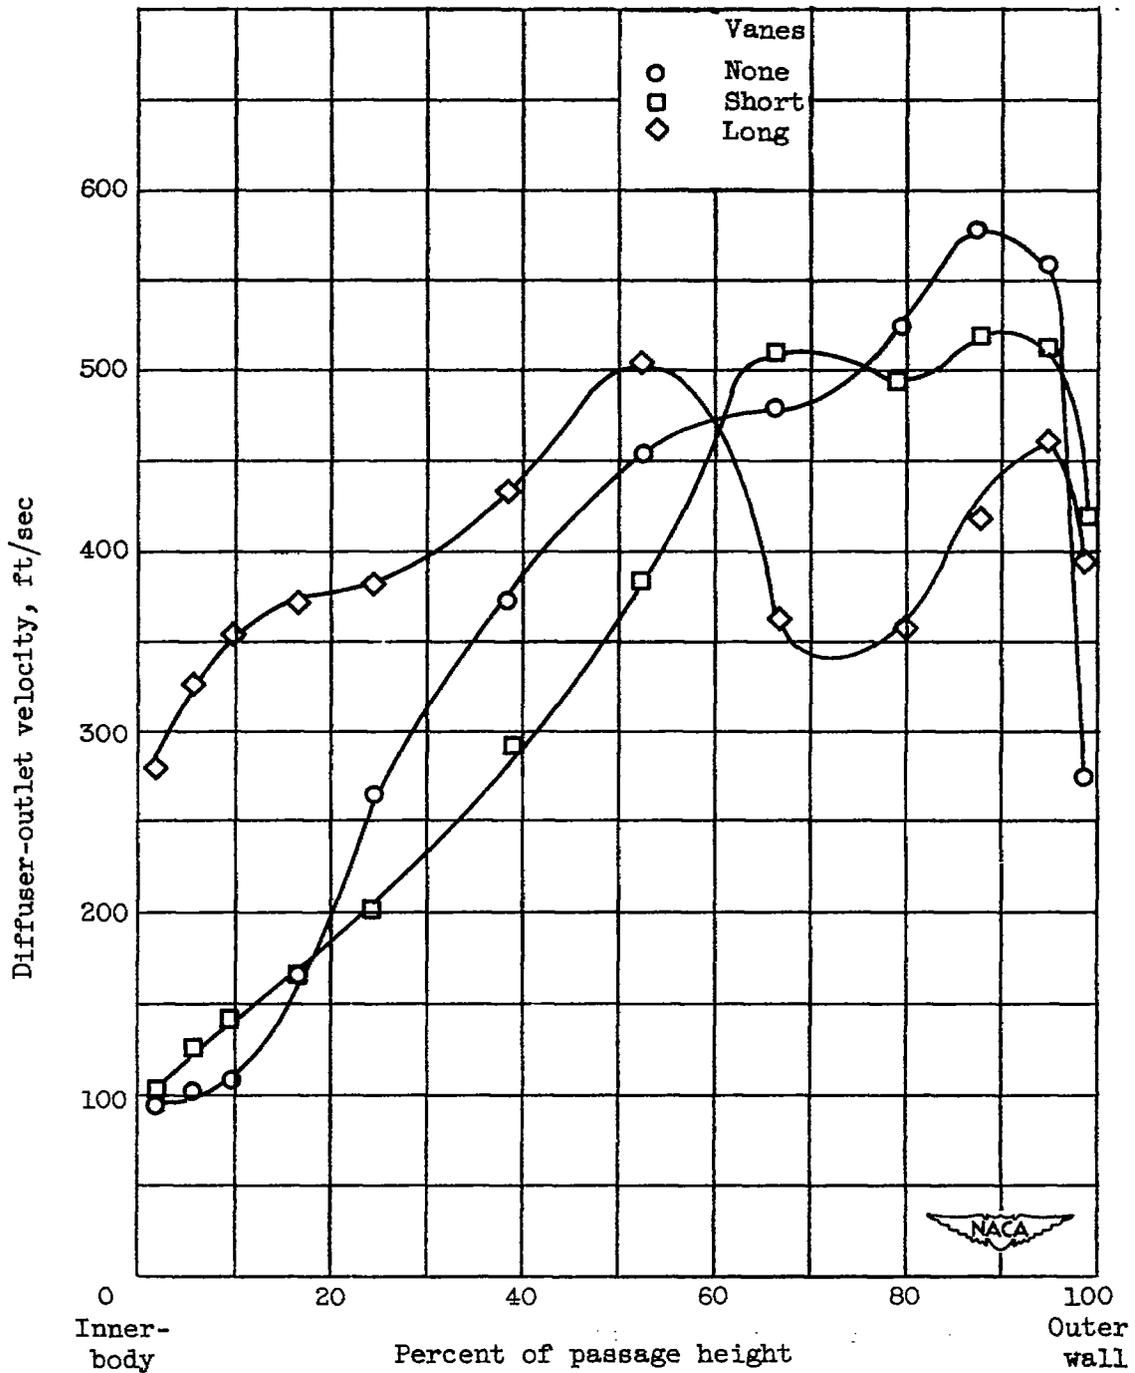
(c) Conditions with full-passage antiswirl vanes.

(c) Concluded. Conditions with full-passage antiswirl vanes.

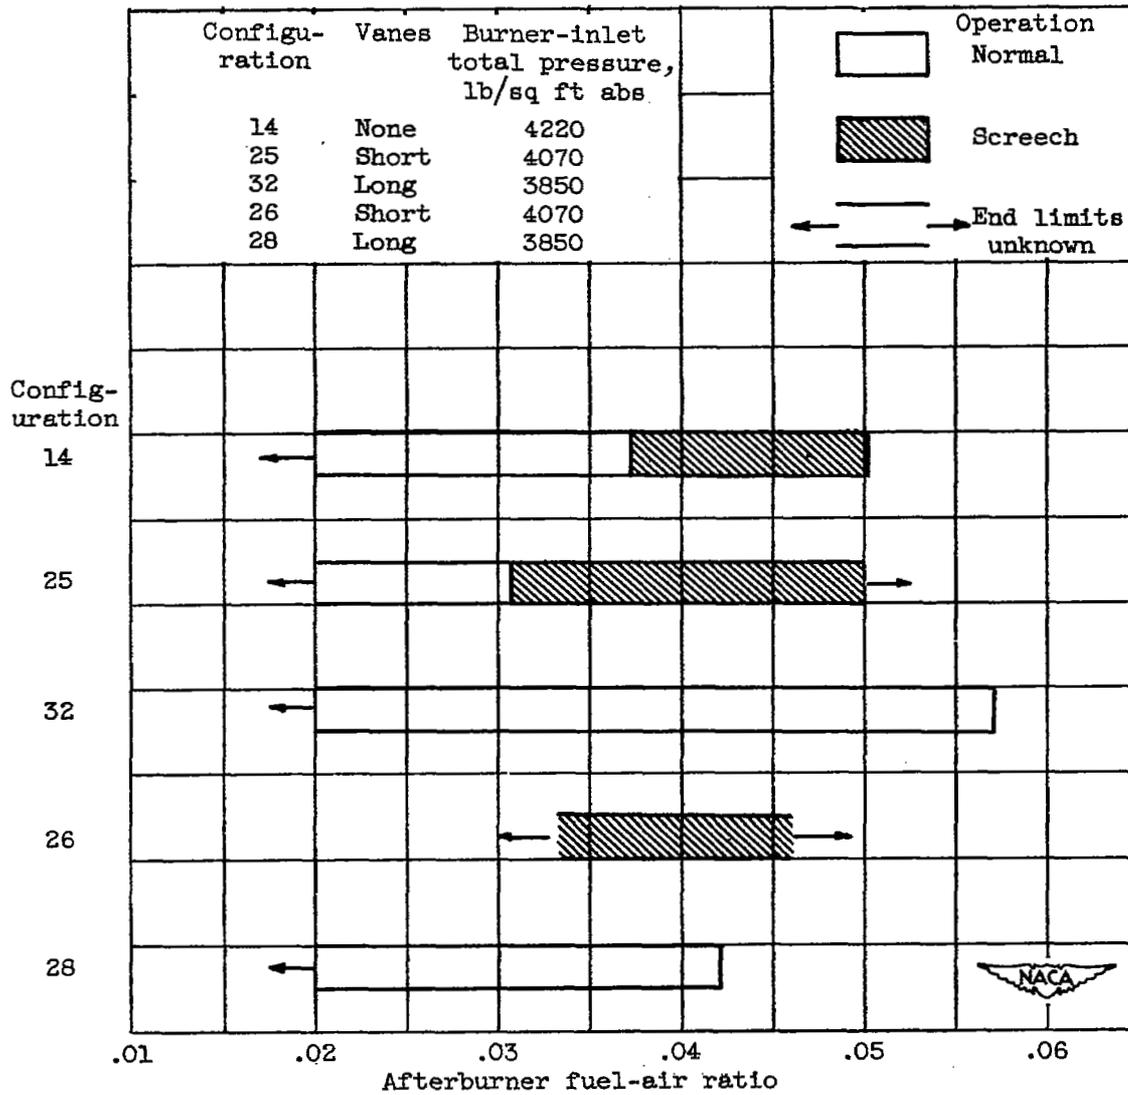
(a) Effect of antiswirl vanes.

Figure 22. - Screech limits.

configuration 28 having long vanes. Screeching combustion was encountered with configuration 26 at burner-inlet total pressures of 2250 and 4070 pounds per square foot. Configuration 28 was free of screech at pressures as high as 3850 pounds per square foot (fig. 22(a)).

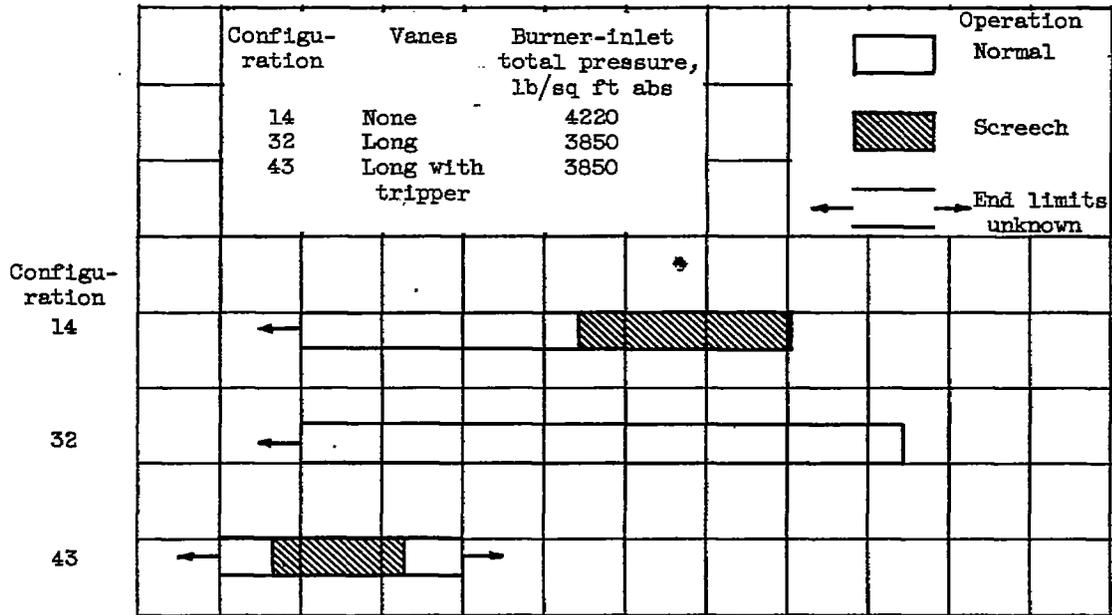
(b) Effect of velocity profile.

The effect of velocity profile on screech is illustrated in figure 22(b), which compares configurations 14, 32, and 43, which were similar except for diffuser flow conditions. Configuration 14 had both swirl and a severe velocity gradient; configuration 32 had both reduced swirl and more uniform velocity profile; and configuration 43 had the reduced swirl with the severe velocity gradient. Both configurations 14 and 43 operated with screeching combustion at burner-inlet total pressures near 4000 pounds per square foot, but configuration 32, as previously mentioned, operated in this pressure range without screech.
