NACA RM E53101

EXPERIMENTAL INVESTIGATION OF SCREECHING COMBUSTION  
IN FULL-SCALE AFTERBURNER

By Karl H. Usow, Carl L. Meyer, and Frederick W. Schulze

Lewis Flight Propulsion Laboratory  
Cleveland, Ohio

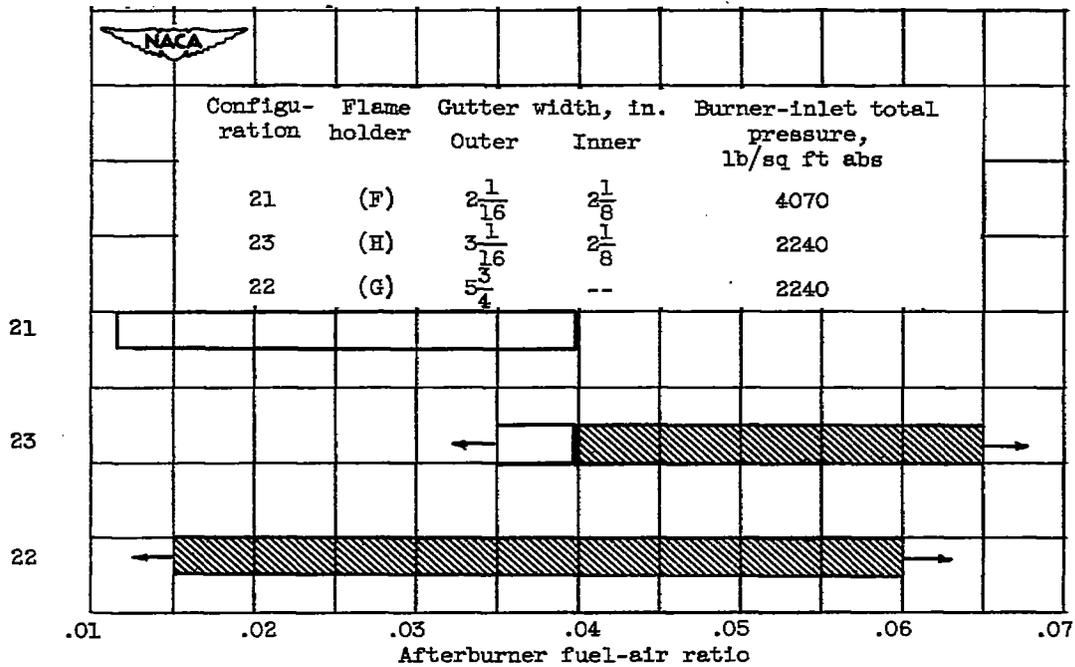
(c) Effect of flame-holder gutter width.

Figure 22. - Continued. Screech limits.

Further comparison of configurations 21, 22, and 23 led to the belief that flame-holder gutter width could have been the influencing factor instead of distance from the outer gutter to the burner wall. Figure 22(c) presents an evaluation of these three flame holders. One of these was a flame holder having a single V-gutter with a gutter width of  $5\frac{3}{4}$  inches and an outer diameter of 28 inches (flame holder (G), configuration 22). Screeching combustion was encountered with this configuration over the entire operable range of fuel-air ratio at a burner-inlet total pressure of 2240 pounds per square foot absolute (fig. 22(c)); in fact, the observation of an audible sound with the afterburner inoperative suggested that this flame holder was inducing a flow instability even in the absence of combustion. The flame holder with gutter widths of  $2\frac{1}{8}$  and  $2\frac{1}{16}$  inches (flame holder (F), configuration 21) did not screech

at burner-inlet total pressures as high as 4070 pounds per square foot absolute; while the flame holder with an outer-gutter width of  $3\frac{1}{16}$  inches (flame holder (H), configuration 23) screeched at a burner-inlet total pressure of 2240 pounds per square foot absolute (fig. 22(c)). The observations made with these three flame holders strongly suggested that flame-holder gutter width was an important factor.

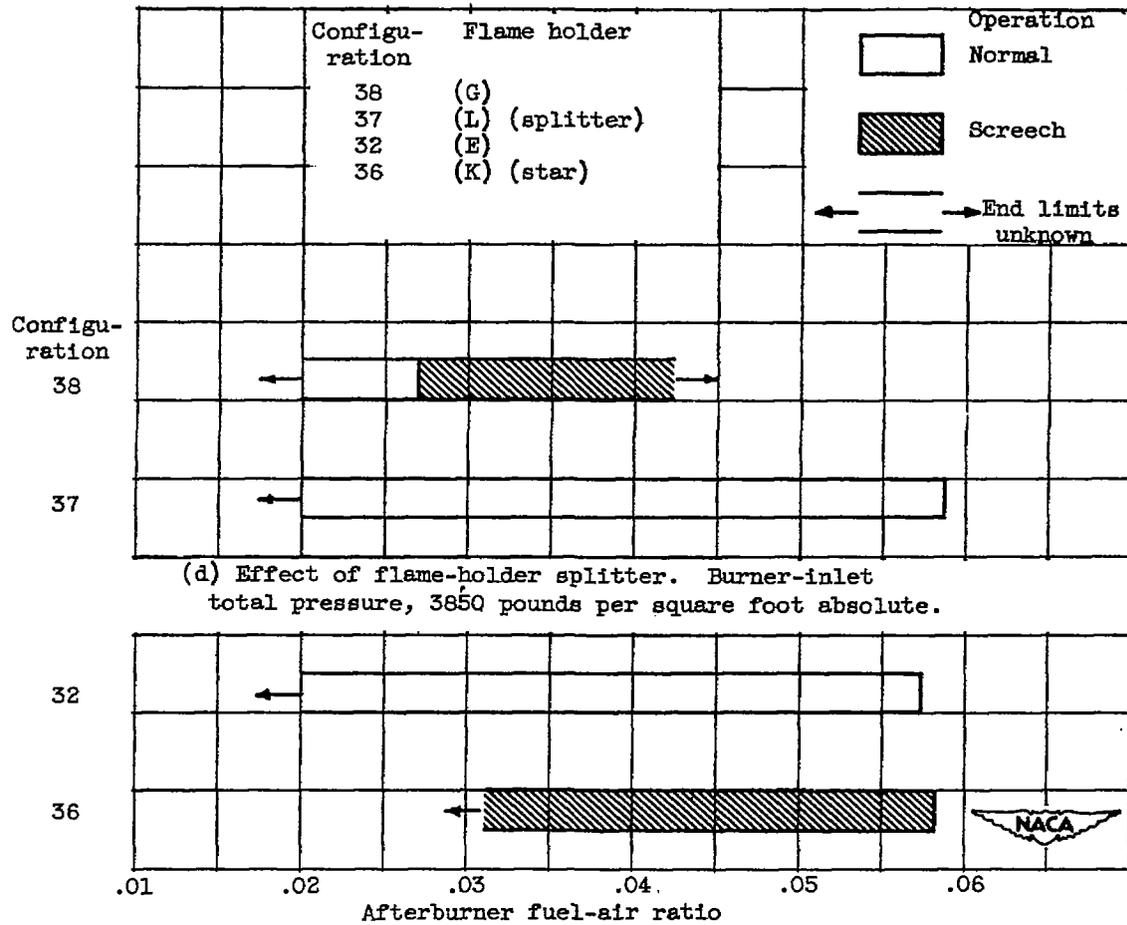
(e) Effect of star-shaped flame holder. Burner-inlet total pressure, 3850 pounds per square foot absolute.

Figure 22. - Concluded. Screech limits.

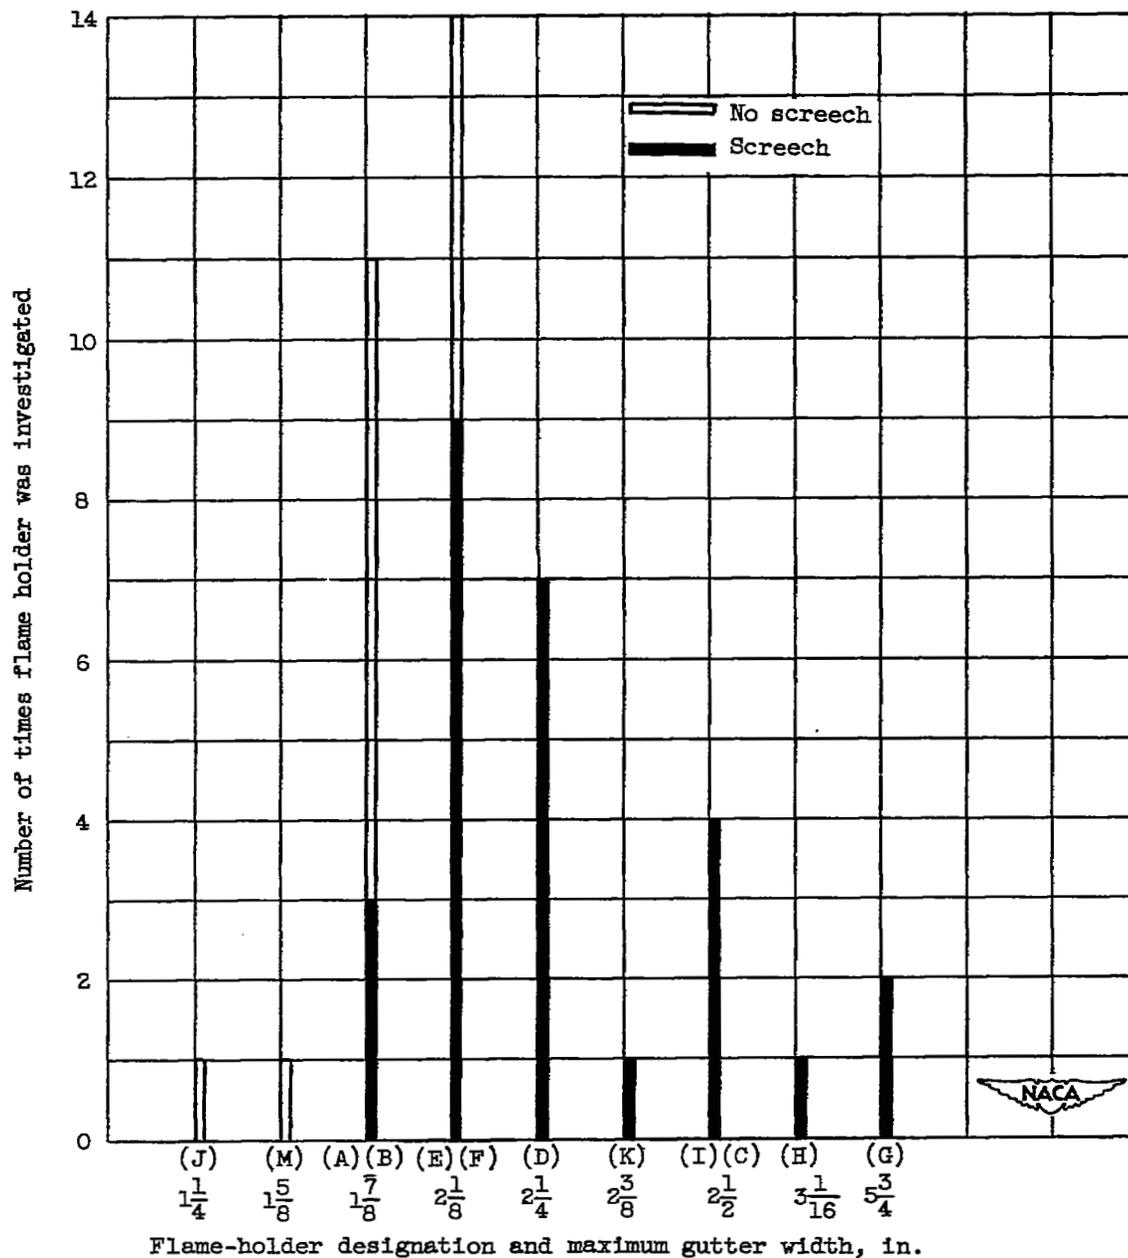
Figure 23. - Variation of flame-holder proneness to screech with gutter width at burner-inlet total pressures from 3850 to 4220 pounds per square foot absolute.

The most pronounced effect of flame-holder geometry on screeching combustion was found to be that of varying gutter width. Reducing gutter width reduced the tendency of the burner to screech, the flame holders with the smallest gutters being screech-free. Screeching combustion was also eliminated by installing a long water-cooled cylindrical splitter on a large single-V-gutter flame holder. The function of this splitter was believed to be either that of preventing interaction between the vortices from opposite edges of the gutter and the resultant shedding of vortices, or damping of the acoustical oscillations believed by some experimenters to be the cause of screech.

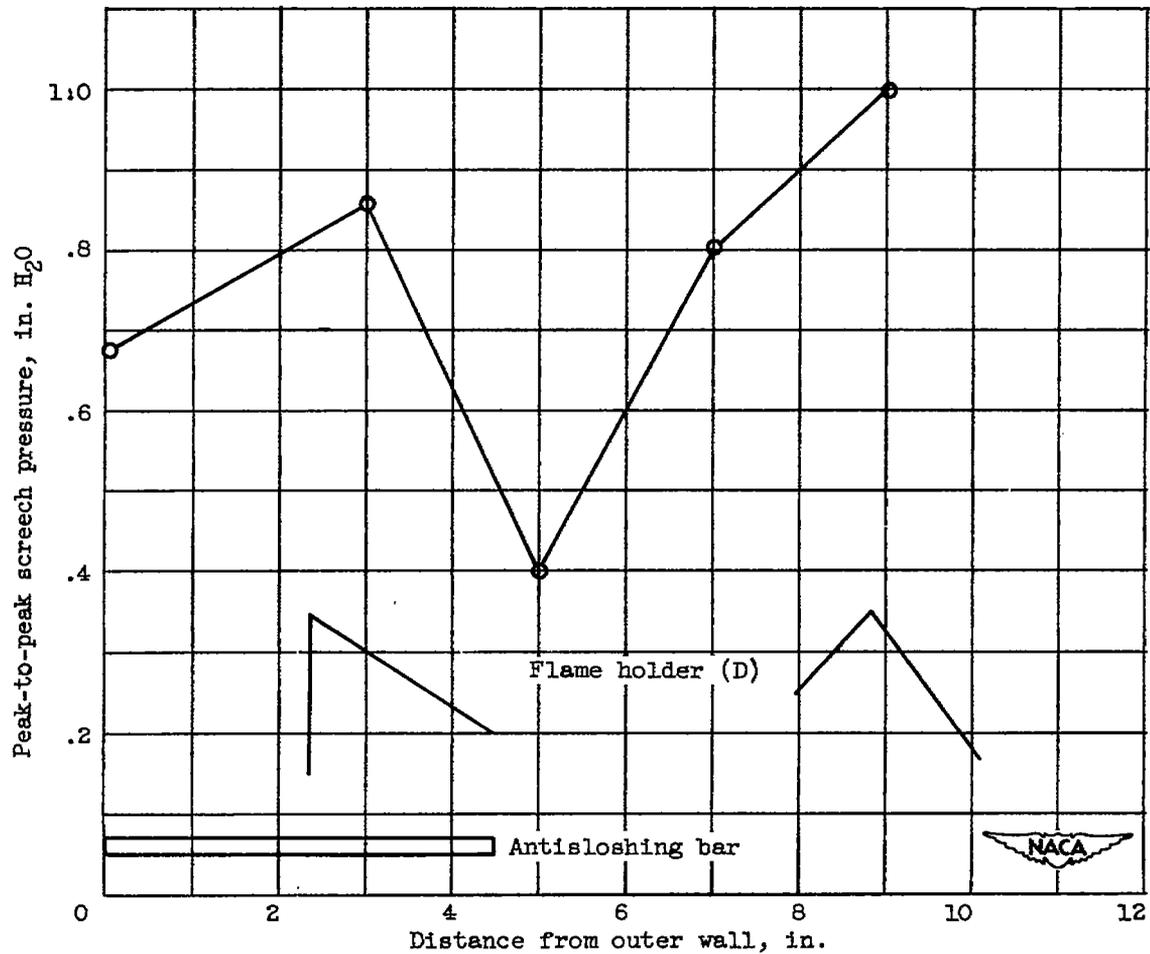
Figure 24. - Variation of screech pressure amplitude downstream of flame holder. Configuration 39.

During operation with configuration 39, an acoustic probe, located a few inches downstream of the flame holder, was traversed radially inward from the afterburner shell during a mild screech condition. From observation of the panoramic sonic analyzer, there was no change in the frequency of screech across the burner. There was a slight variation in the amplitude of pressure pulsations, as shown in figure 24; but no particular significance has been attached to these measurements, since it has not been possible to correlate them with any acoustical oscillation that might exist in the burner. It should be noted that this configuration included a set of small antisloshing vanes inserted in an attempt to disrupt an acoustical oscillation of this type. It is now believed that these vanes were too small to have any measurable effect on screeching combustion.
