# RESEARCH MEMORANDUM

DYNAMIC CORROSION OF A STAINLESS-STEEL SPECIMEN BY WATER

AT 500° F USING A TOROID CIRCULATING APPARATUS

**NATIONAL ADVISORY COMMITTEE  
FOR AERONAUTICS**

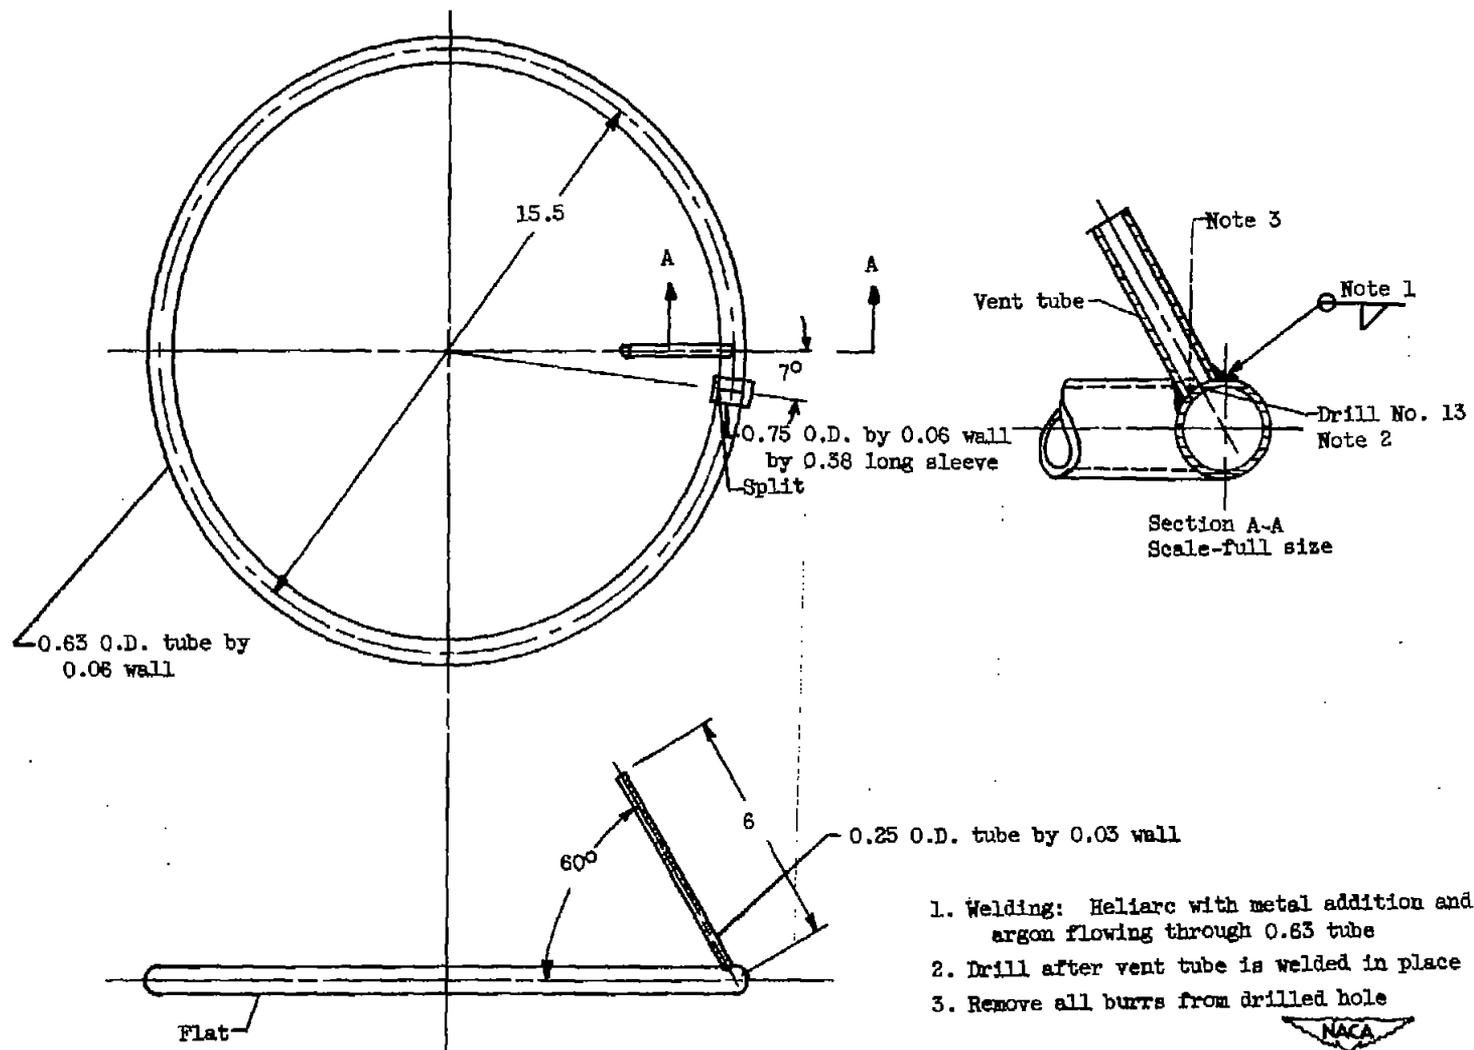
Figure 1. - Fabrication drawing of specimen.

Fabrication of specimen. - The circulating apparatus is described in reference 1. The specimen was a length of 0.63-inch outside diameter by 0.06-inch wall AISI 347 stainless-steel tubing bent into a toroid with a mean diameter of 15.5 inches (fig. 1). A small bore vent tube was heliarc welded to the toroid near one of its ends. The sleeve over the juncture of the butted ends was fusion welded to the tubing with an inert atmosphere flowing over the weld area and into the vent tube.

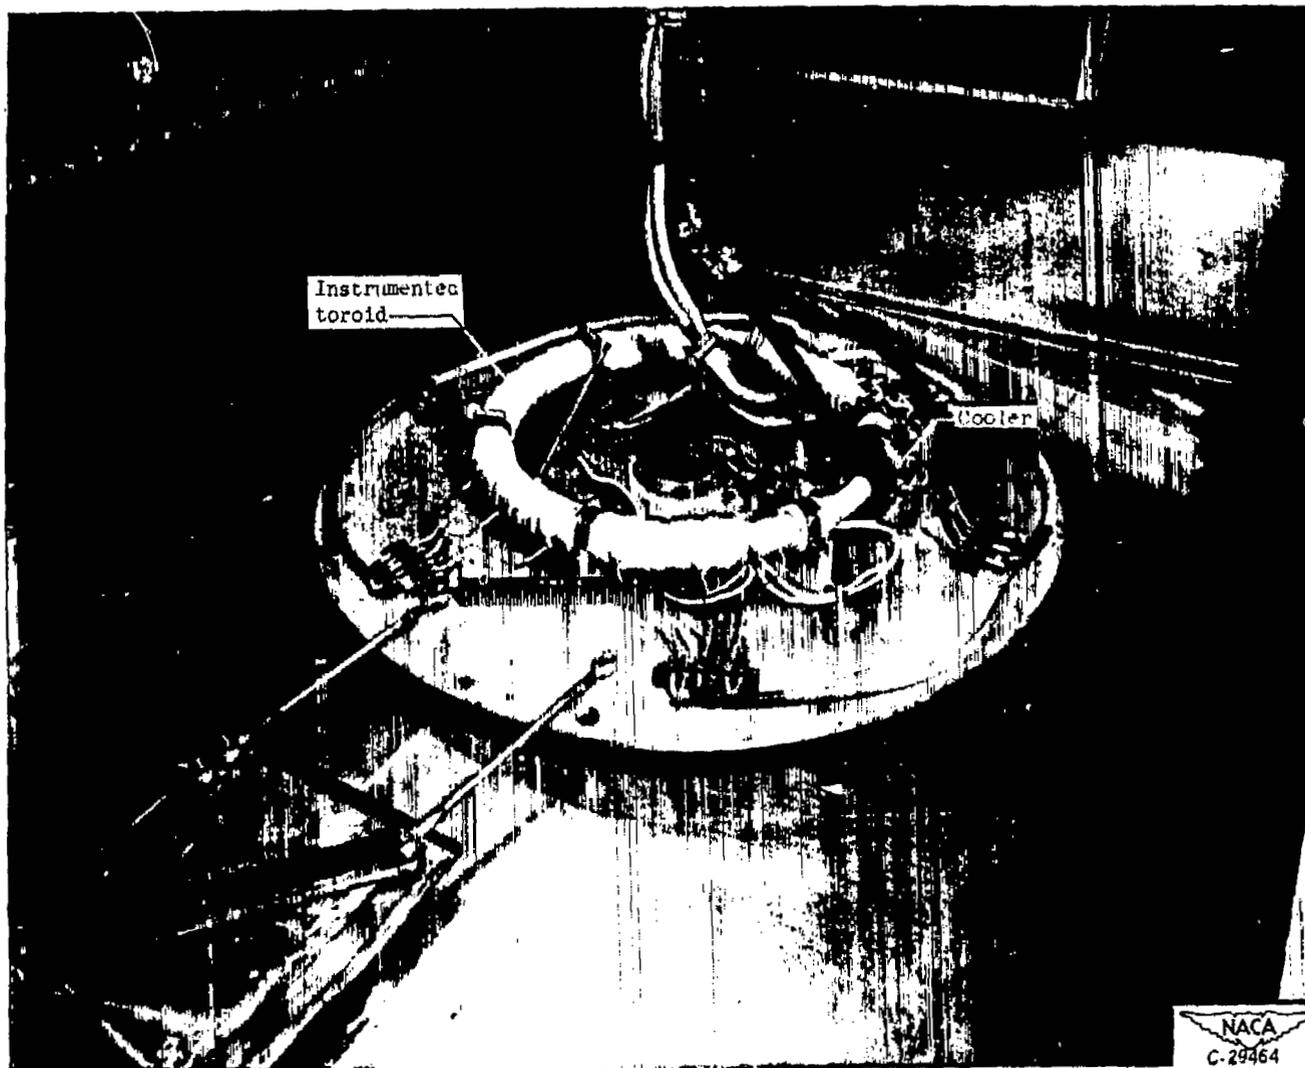
Figure 2. - Circulating apparatus with specimen in place.

Installation. - The specimen was mounted on the table of the circulating apparatus by six clamps, as shown in figure 2, and the thermocouples and heaters were connected. The cooler, an annular chamber arranged to discharge compressed air through holes drilled in the inner shell was placed to direct air at the cold section.
