NACA RM L56G10

MODEL DITCHING INVESTIGATION OF A JET TRANSPORT
AIRPLANE WITH VARIOUS ENGINE INSTALLATIONS

By William C. Thompson

Langley Aeronautical Laboratory
Langley Field, Va.

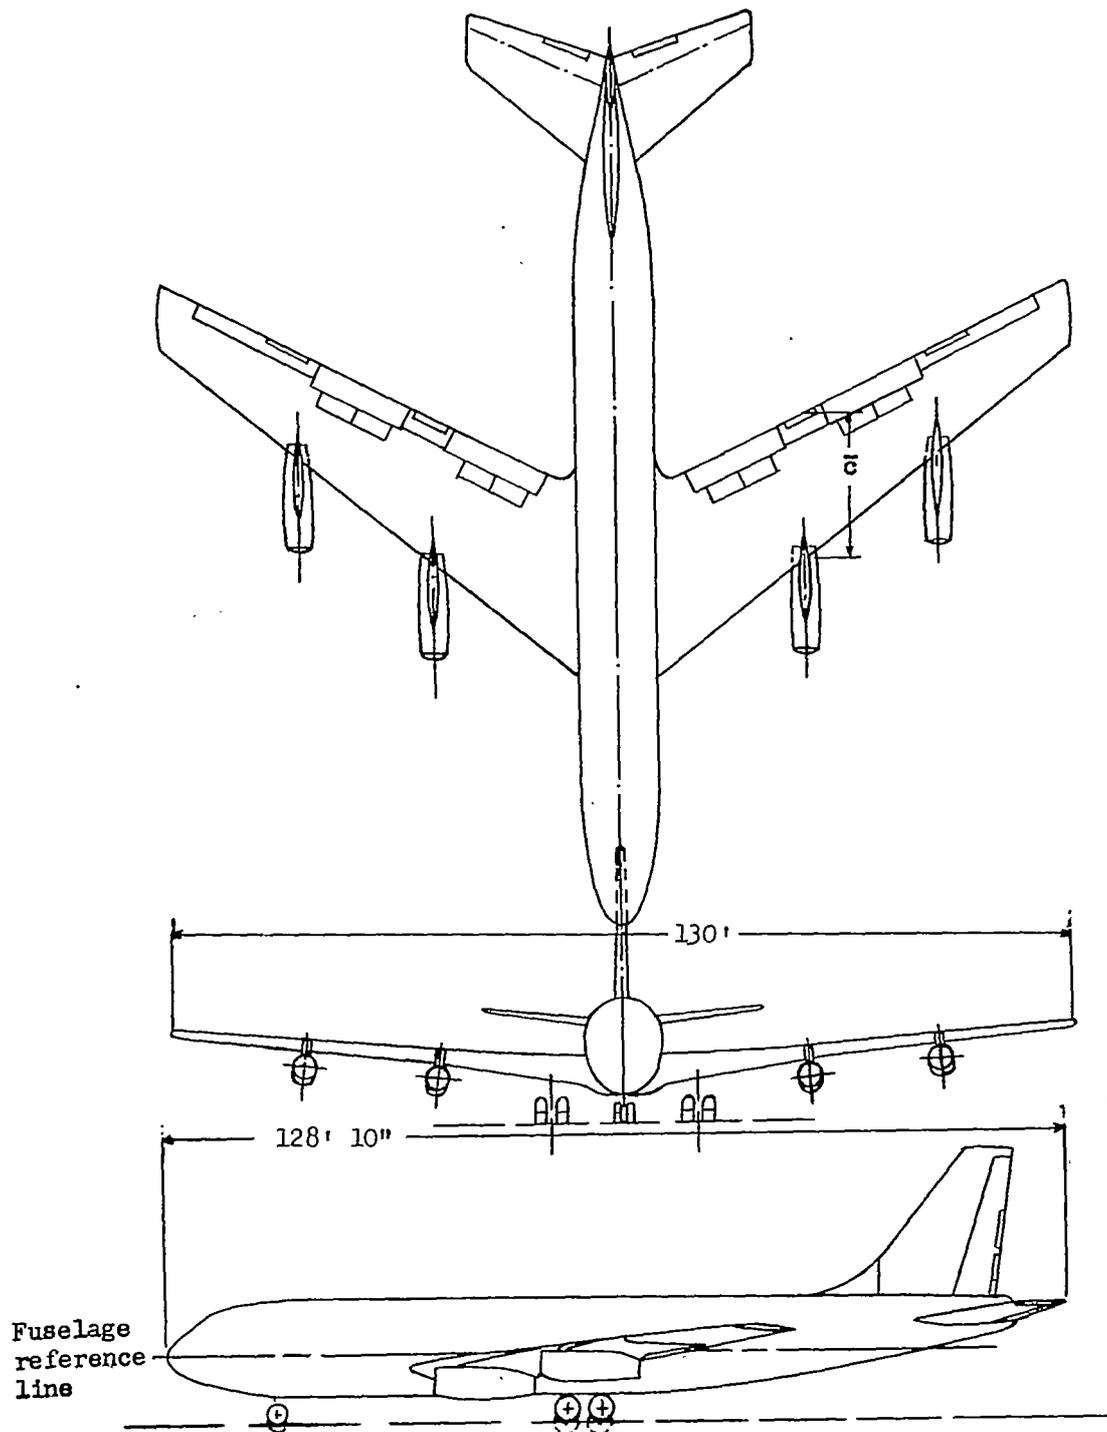
Figure 1.- Three-view drawing of a jet transport airplane with strut-pod engine installation.

An investigation of a model of a typical jet transport airplane with various engine configurations was made to observe the ditching behavior and to determine the safest procedure for making an emergency water landing. The ditching characteristics of these configurations were of general interest inasmuch as there is a current trend toward the use of large swept-wing multiengine airplanes. Four different engine installations were investigated with the model. Three arrangements were investigated only briefly, but a more detailed investigation was made with the strut-pod installation. (A three-view drawing of an airplane with a strut-pod engine installation is shown in fig. 1.) The investigation was made in calm water at the Langley tank no. 2 monorail.

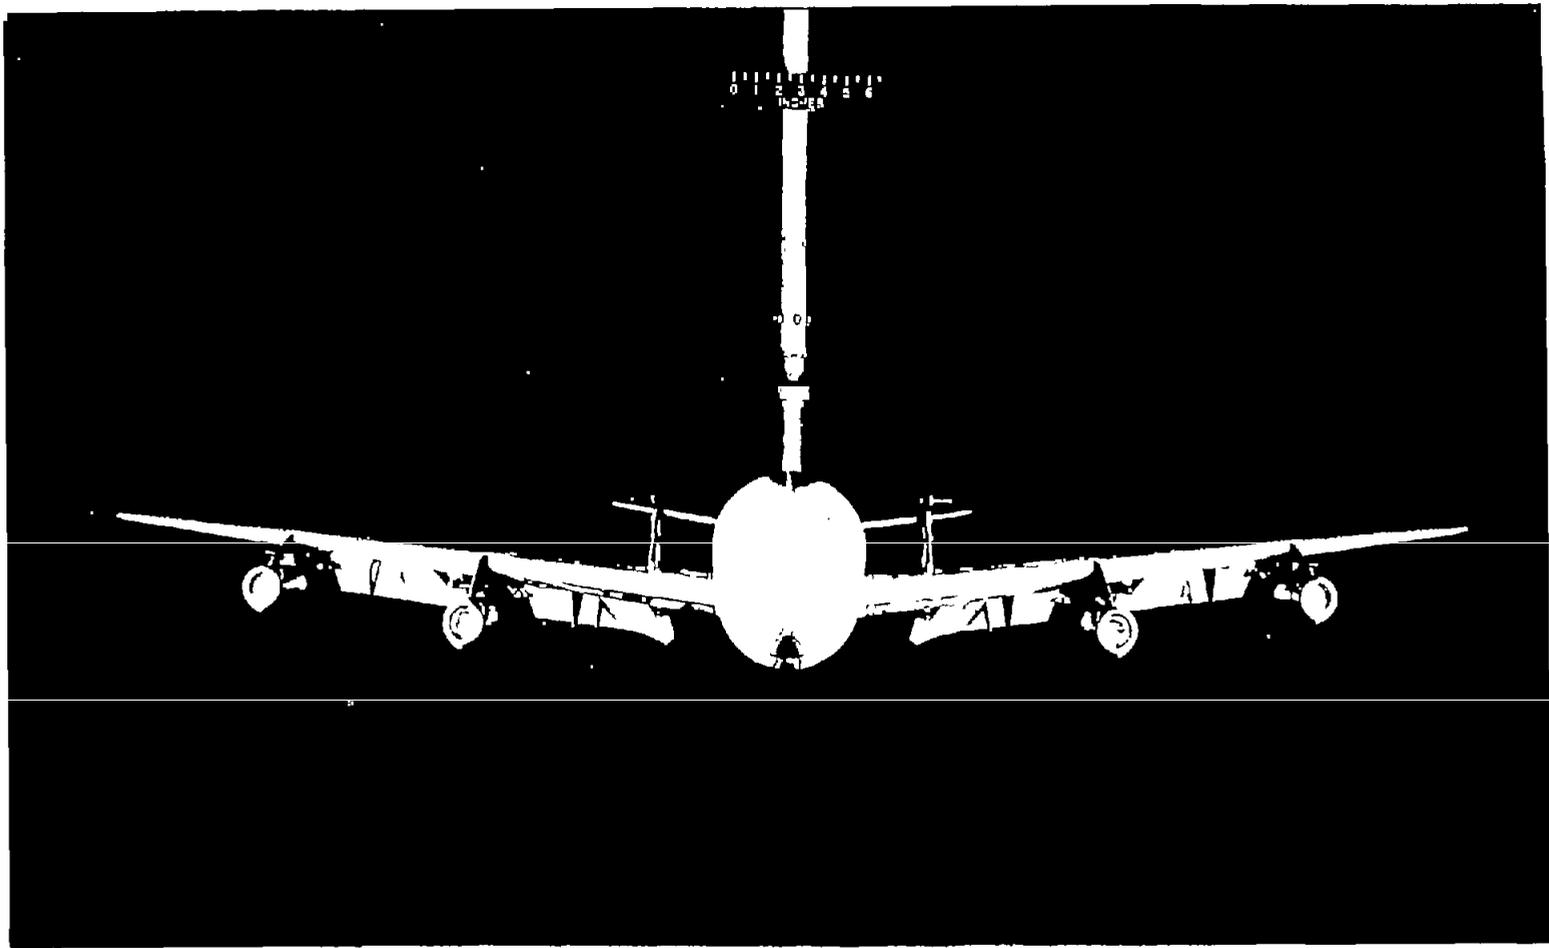
(a) Strut-pod engine installation, front view. L-85060

Figure 2.- Ditching model of jet transport airplane with various engine installations.

The 0.043-scale model of a jet transport airplane with various engine arrangements shown in figure 2 was used in the investigation. The model was constructed of balsa wood and spruce, and was covered with silk to provide a durable water-resistant finish. Internal ballast was used to obtain scale weight and moments of inertia. The model had a wing span of 5.59 feet and an overall length of 5.50 feet.

- (a) Strut-pod engines, figures 2(a), (b), and (c)
- (b) Wing-root engines, figure 2(d)
- (c) Under-fuselage engines, figure 2(e)
- (d) Side-fuselage engines, figure 2(f)

Simulated damage.- Further investigation made with the various nacelle installations and simulated damage to the aft fuselage shown in figure 4 resulted in considerable differences in behavior. The model with the strut-pod engine installation shown in figure 2(a) trimmed down, trimmed up, and ran smoothly when ditched with the flaps up or down. With flaps up, the maximum longitudinal deceleration was about $4g$ and the maximum normal acceleration was about $3g$ in landing runs of about 845 feet. Ditchings with the flaps down resulted in landing runs of about 610 feet, a maximum longitudinal deceleration of about $3\frac{1}{2}g$, and a maximum normal acceleration of about $3g$.

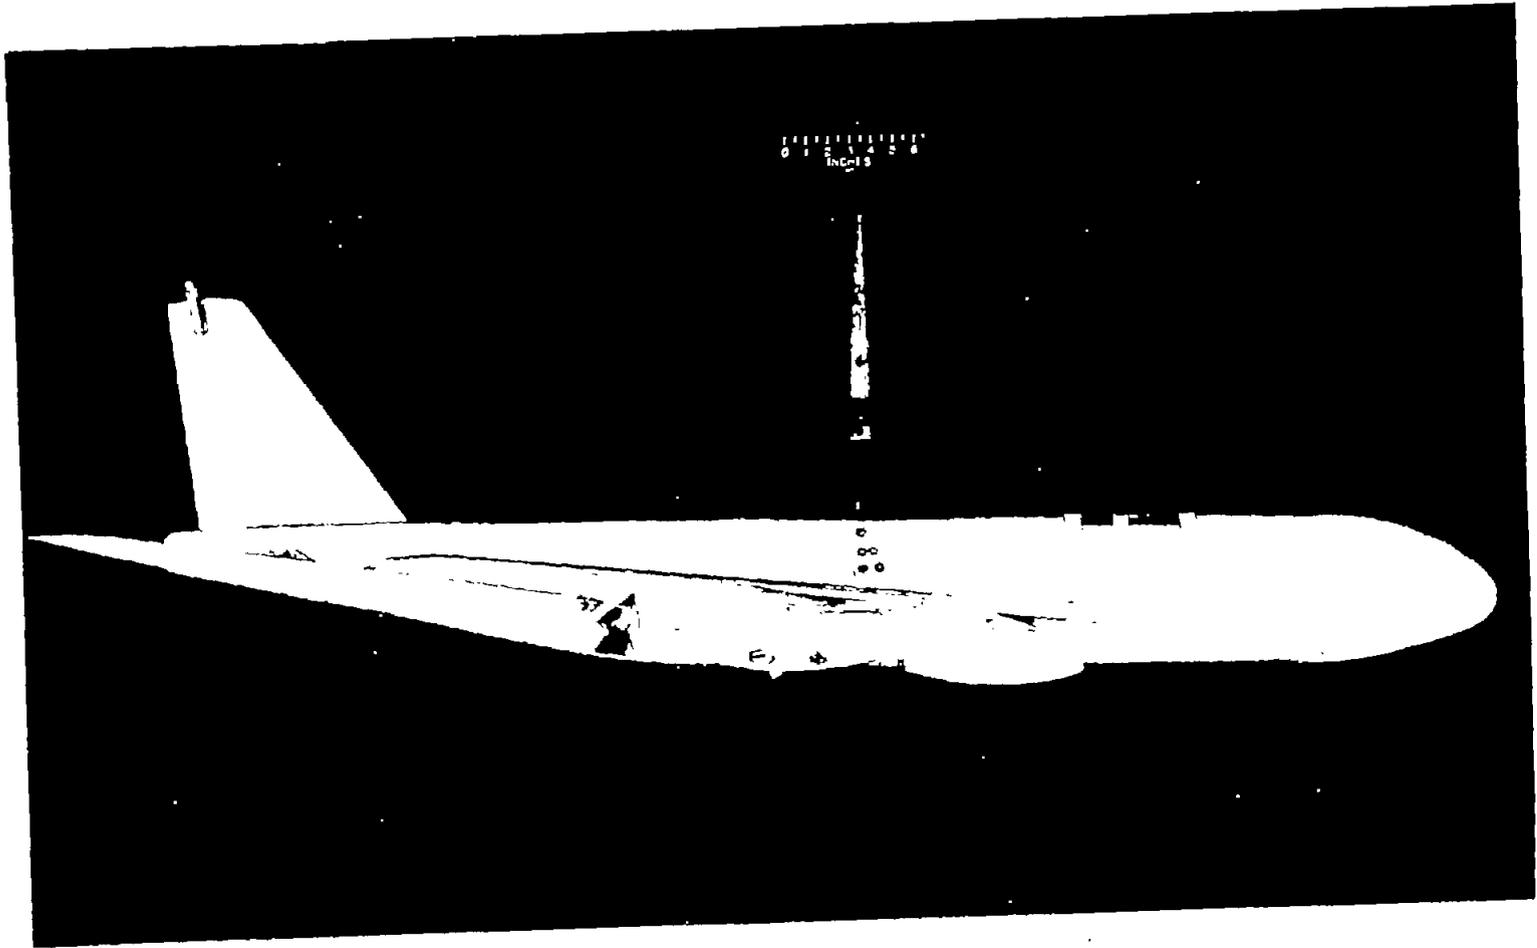
(b) Strut-pod engine installation, side view. L-85059

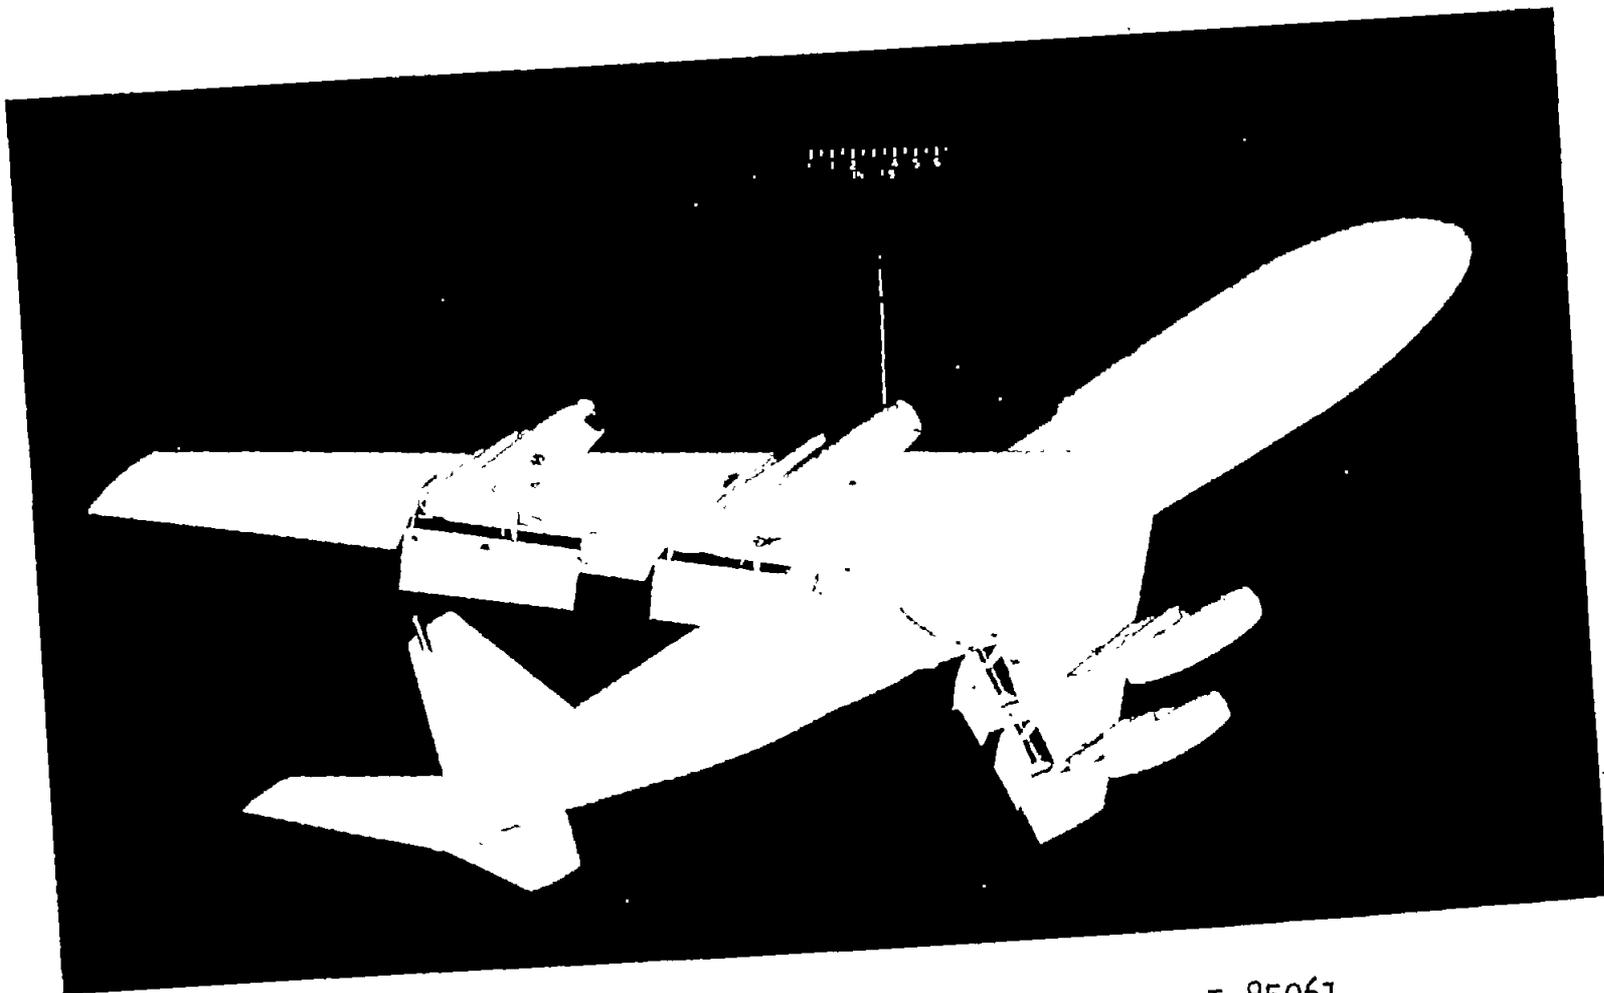
L-85061
(c) Strut-pod engine installation, three-quarter bottom view.

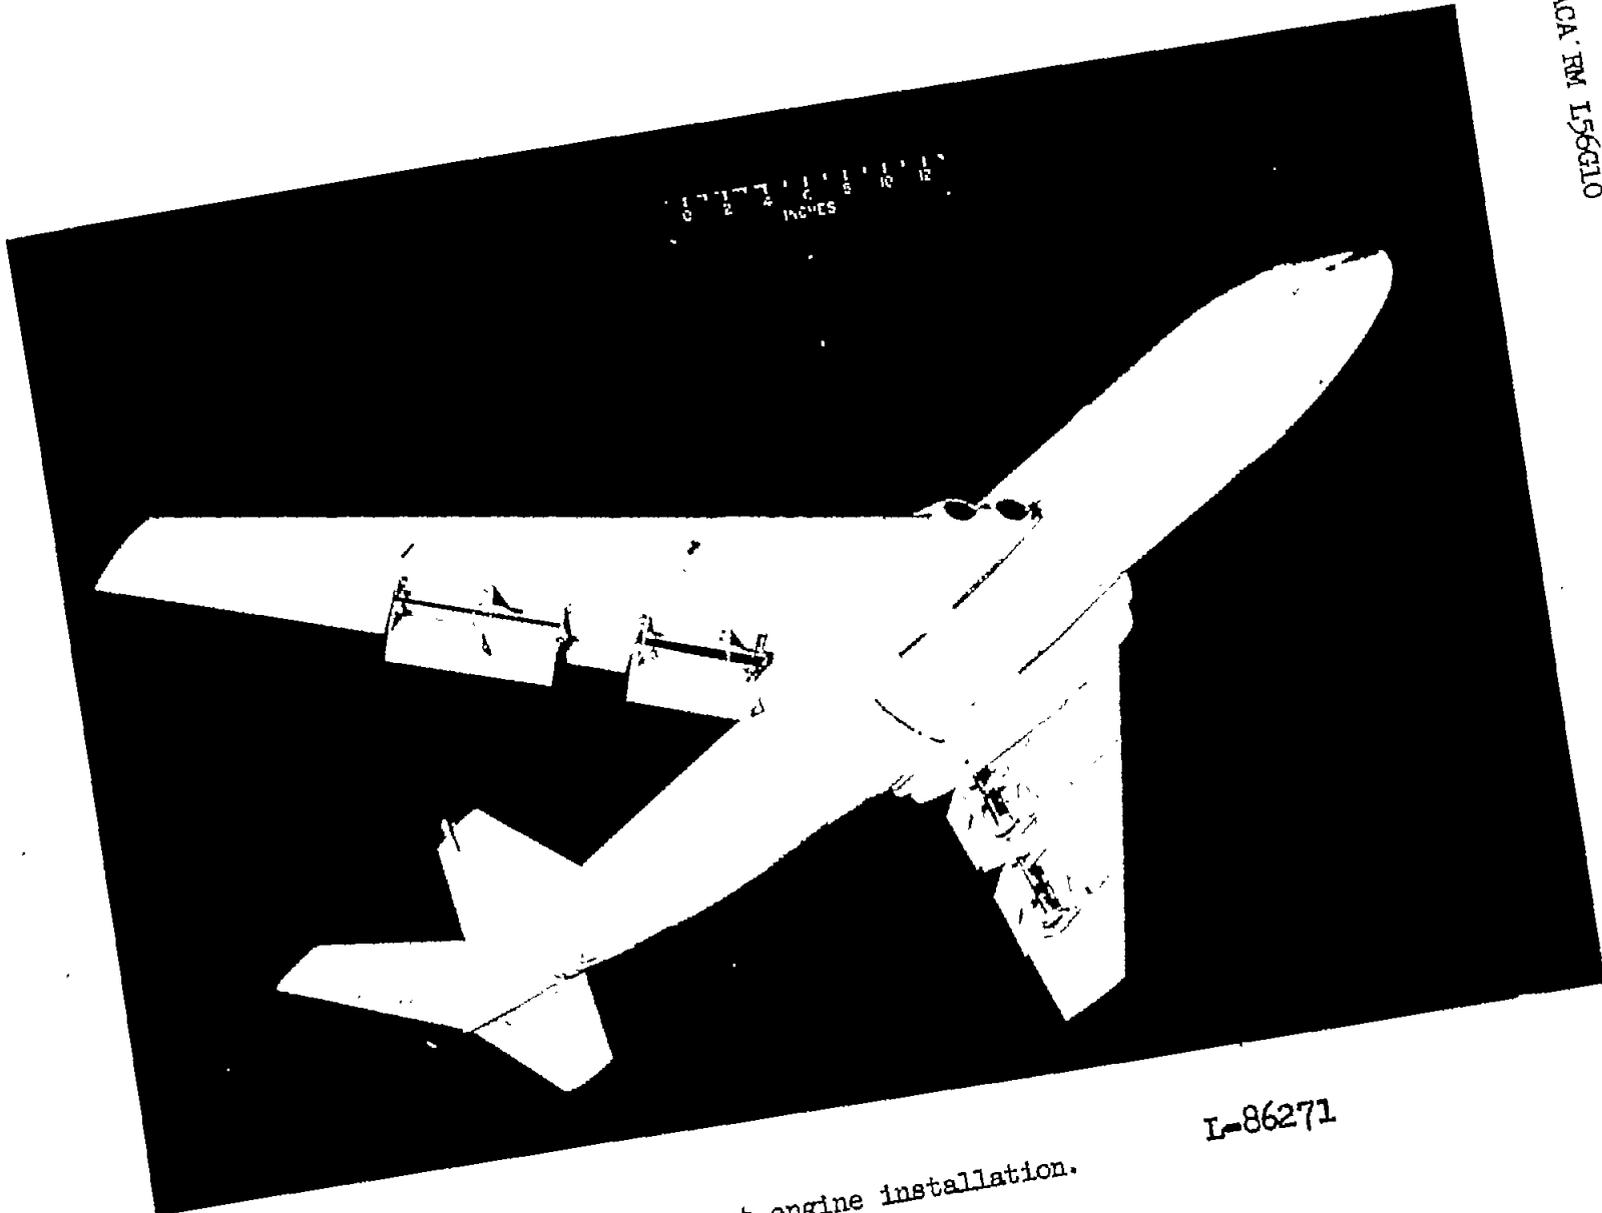
(d) Wing-root engine installation.
Figure 2.- Continued.

The model with the wing-root engine installation shown in figure 2(d) porpoised and ran smoothly with the flaps up; the maximum longitudinal deceleration was about $4g$ and the maximum normal acceleration was about $3\frac{1}{2}g$ in landing runs of about 930 feet. Ditchings with the flaps down resulted in landing runs of about 535 feet, a maximum longitudinal deceleration of about $3\frac{1}{2}g$, and a maximum normal acceleration of about $2\frac{1}{2}g$.

The wing-root engine installation affected the ditching behavior only when the conditions were such that the model settled deeply into the water. The additional bottom area furnished by the nacelle bottoms produced more lift causing the model to trim up, thus resulting in a porpoising motion. As the forward speed decreased the porpoising ceased and the model ran smoothly.

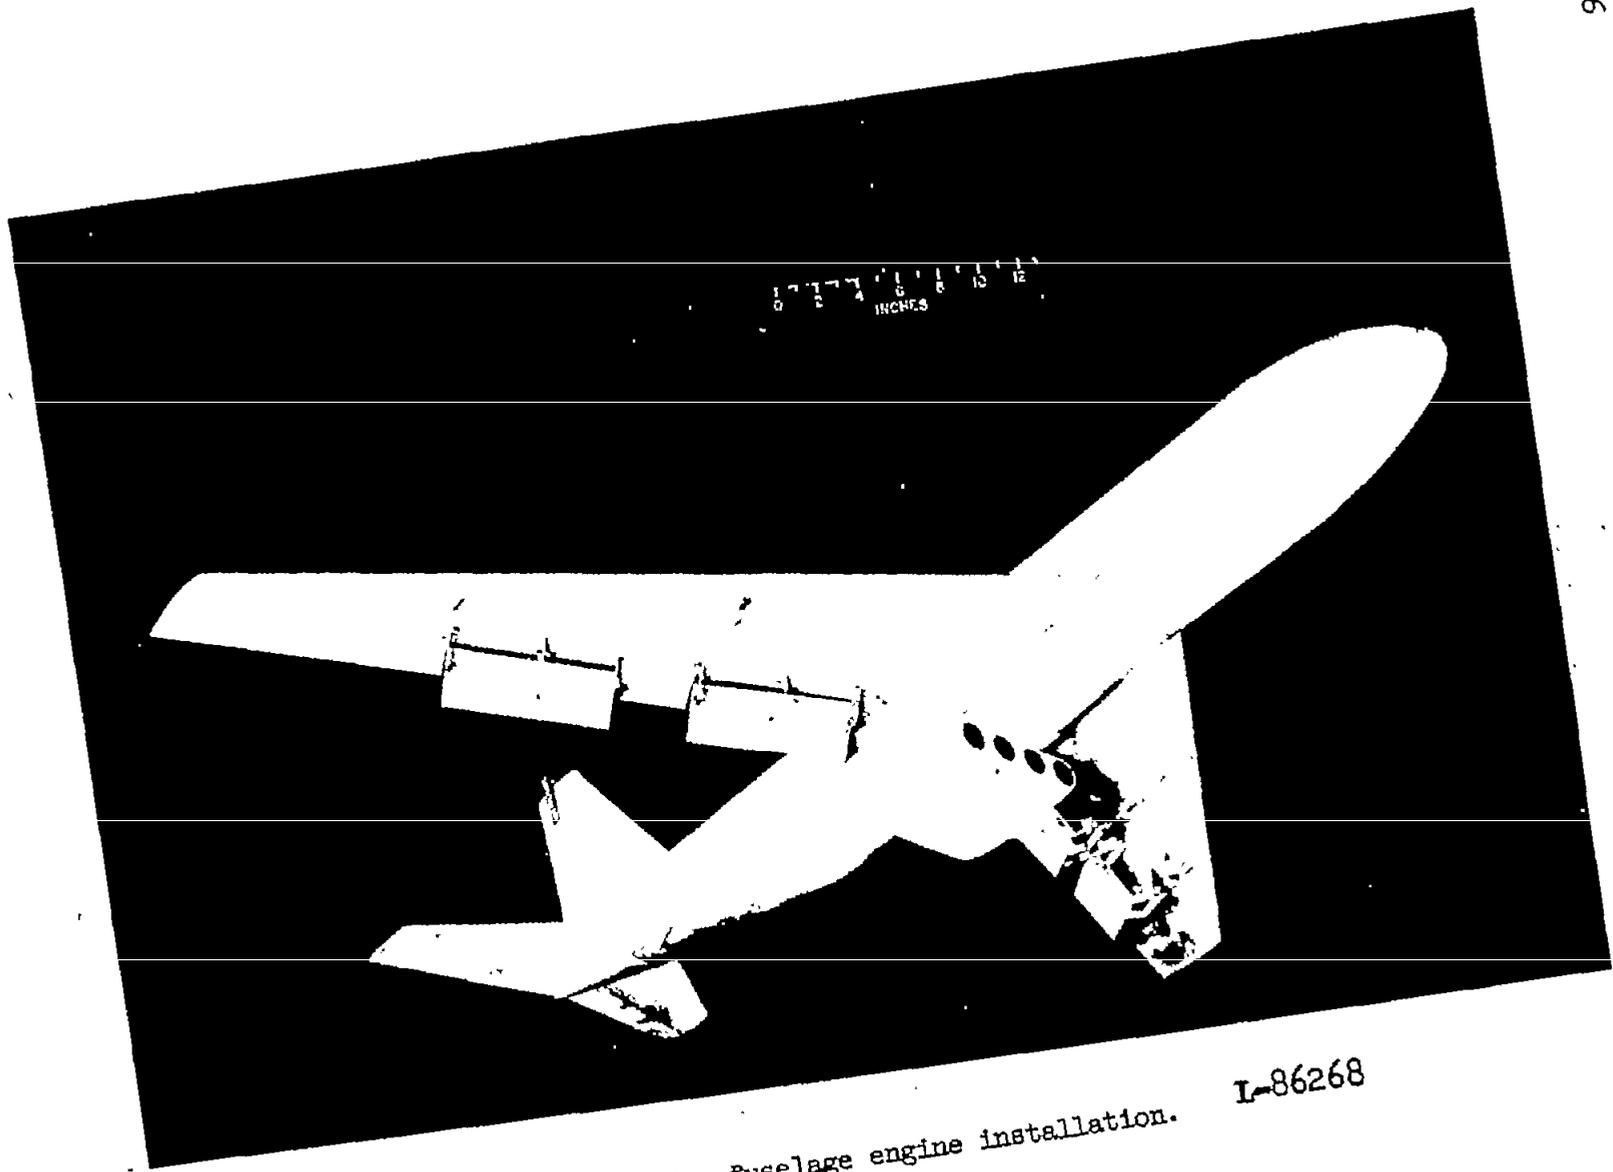
(e) Under-fuselage engine installation. L-86268

The model with the under-fuselage engine installation shown in figure 2(e) skipped and ran deeply with the flaps up. The maximum longitudinal deceleration was about $5\frac{1}{2}g$ and the maximum normal acceleration was about $4\frac{1}{2}g$ in landing runs of about 630 feet. The model ran smoothly and ran deeply in ditchings with the flaps down and showed a maximum longitudinal deceleration of about $3\frac{1}{2}g$ and a maximum normal acceleration of $2\frac{1}{2}g$ in landing runs of about 465 feet.

When the model was ditched with the under-fuselage engine installation, the engine cluster contacted the water first. During the first portion of the ditching run the engine cluster served as a planing surface. Near the end of the run the model settled in rather deeply and came to an abrupt stop. The model had a slight skipping or bouncing tendency but in general ran fairly smoothly for the greater portion of the run.

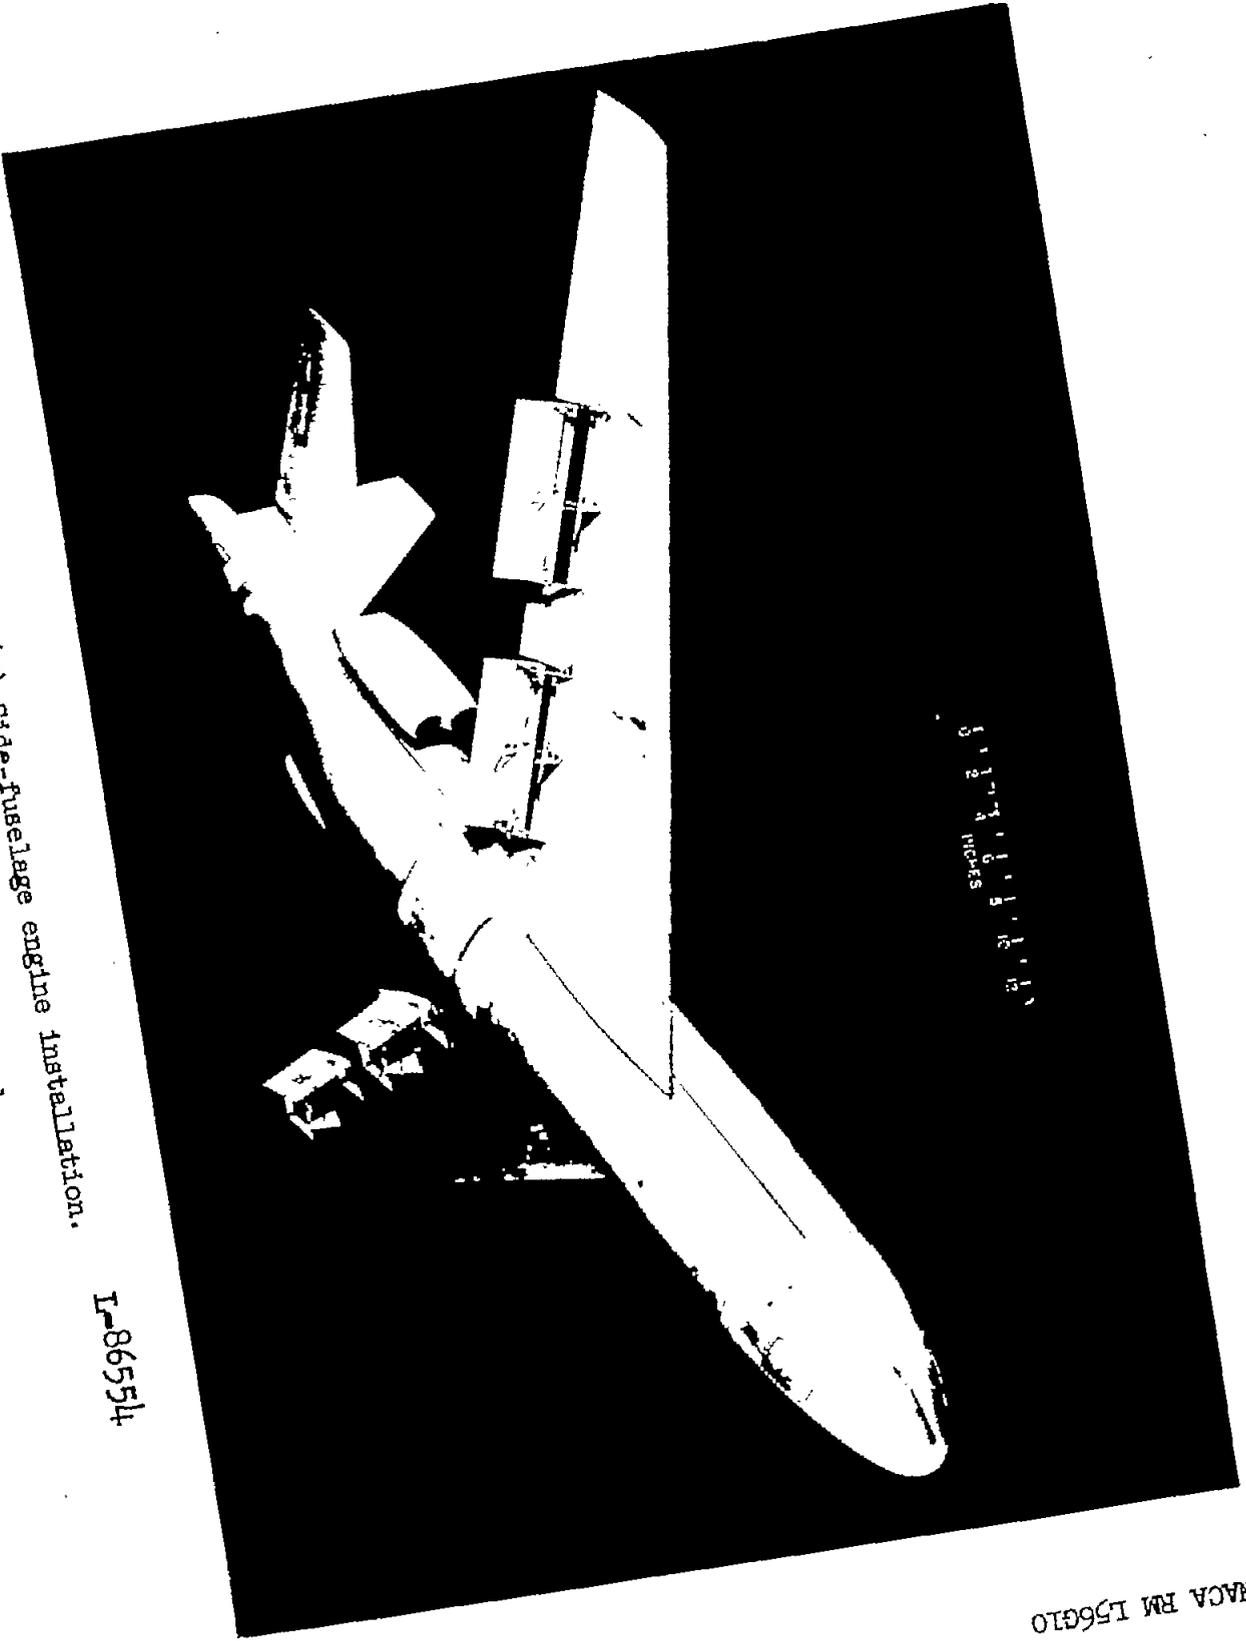
(F) Side-fuselage engine installation.
Figure 2.- Concluded.

The model with the side-fuselage engine installation shown in figure 2(f) trimmed down, trimmed up, and ran smoothly when ditched with the flaps up or down. With flaps up, the maximum longitudinal deceleration was about $3\frac{1}{2}g$ and the maximum normal acceleration was about $4\frac{1}{2}g$ in landing runs of about 675 feet. Flaps-down ditchings had a maximum longitudinal deceleration of about $3g$ and a maximum normal acceleration of about $5\frac{1}{2}g$ in landing runs of about 600 feet.

During a ditching with the side-fuselage engine installation the nacelle pods caused considerable spray as they entered the water. This configuration tended to have the highest normal accelerations of those tested; however, the longitudinal decelerations were about the same as for the other configurations.

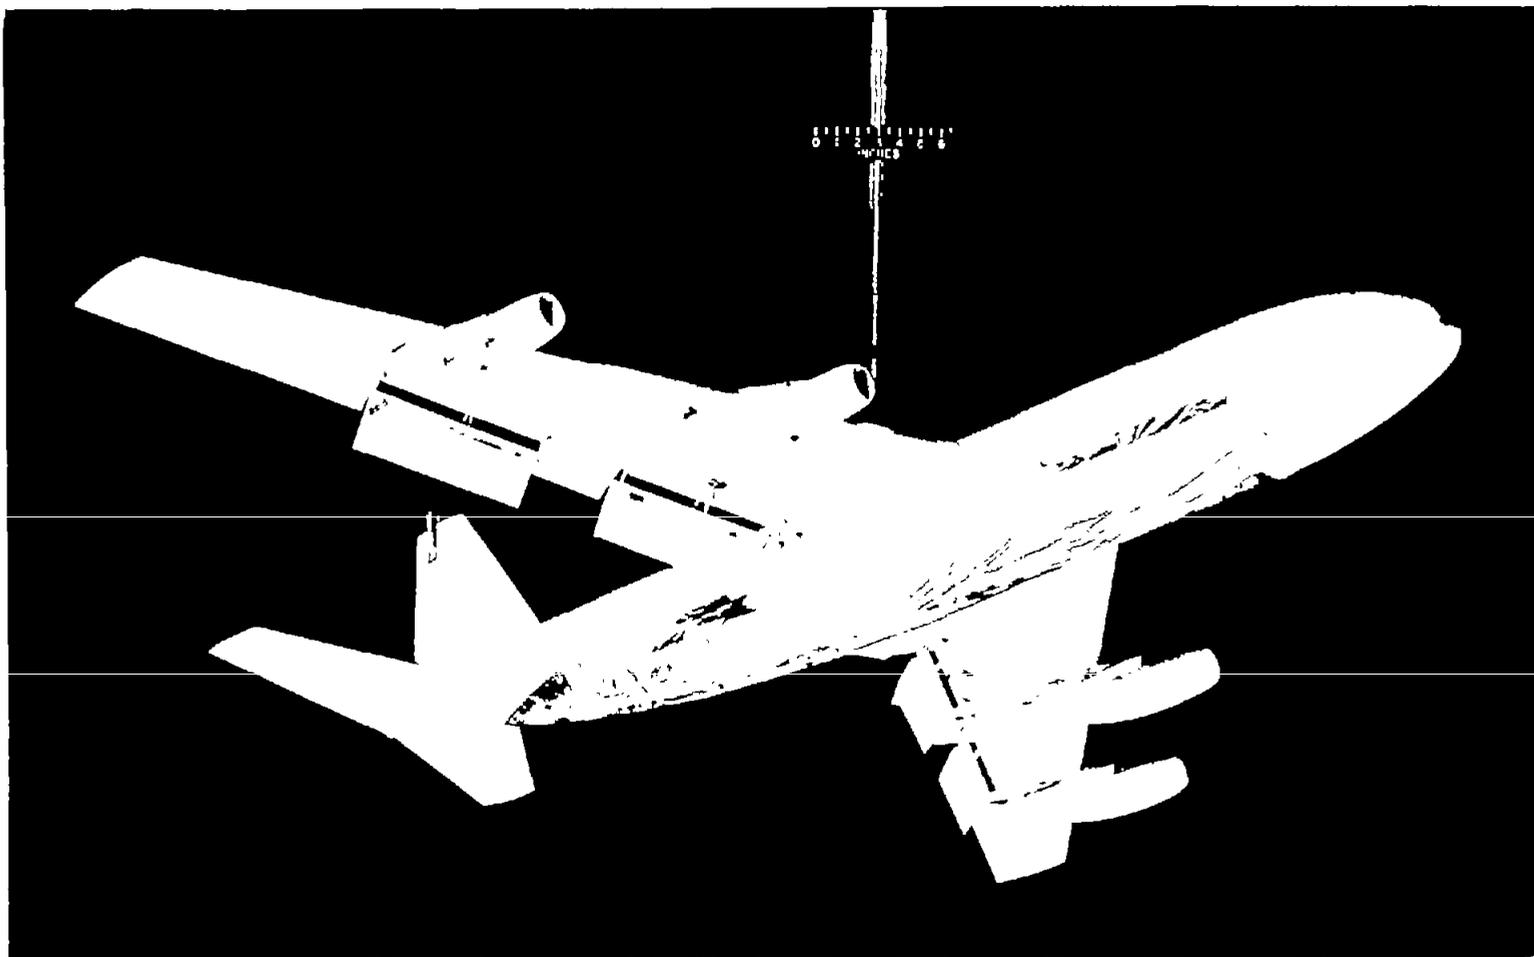
Figure 3.- Model with scale-strength fuselage bottom section. L-85062

The model was constructed so that a portion of the fuselage bottom could be replaced with an approximately scale-strength section. The assumed full-scale ultimate strength of the fuselage bottom surface was approximately 10 pounds per square inch. The scale-strength bottoms were constructed of cardboard bulkheads and balsa-wood stringers and were covered with aluminum foil. A bottom is shown installed on the model in figure 3. Scale-strength bottoms were used to indicate the location and extent of damage that might occur in a ditching. The scale-strength fuselage bottoms were applied only with the strut-pod engine installation, but all engine installations were tested with the model having a simulated damage bottom as shown in figure 4. The simulated damage bottom was used to expedite the test program because the use of the scale-strength bottoms indicated the portion of the fuselage bottom that would be damaged and the behavior resulting with the simulated damage bottom was not appreciably different from that with the scale-strength bottom.

- (a) No damage simulated, figure 2
- (b) Scale-strength fuselage bottom installed, figure 3 (strut-pod installation only)
- (c) Simulated damage to the aft fuselage bottom, figure 4

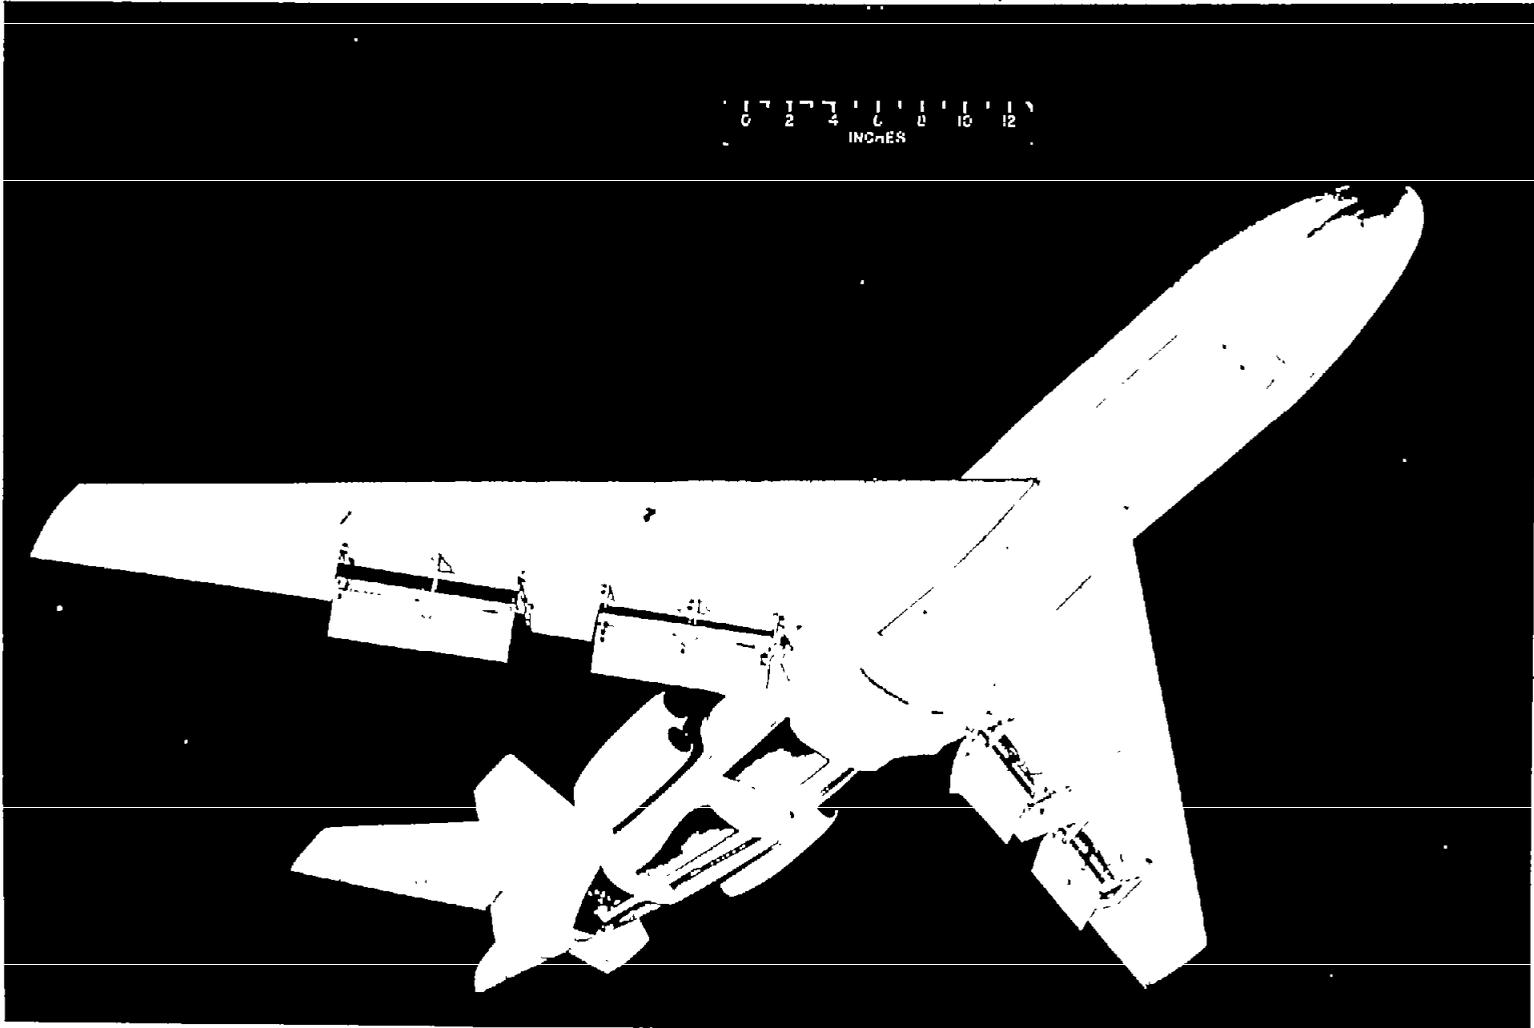
Figure 4.- Model with simulated damage to aft fuselage.

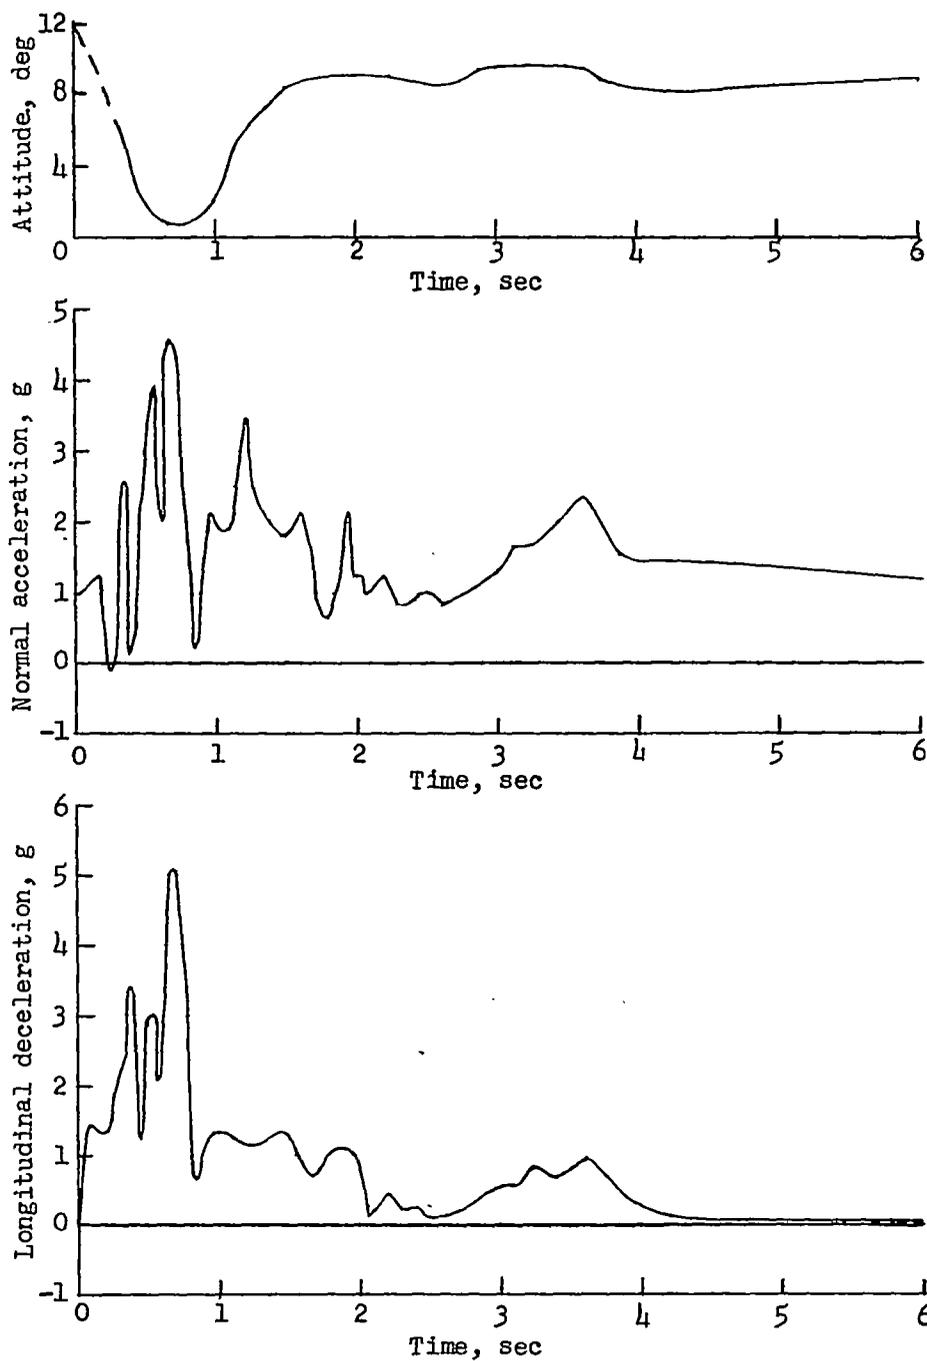
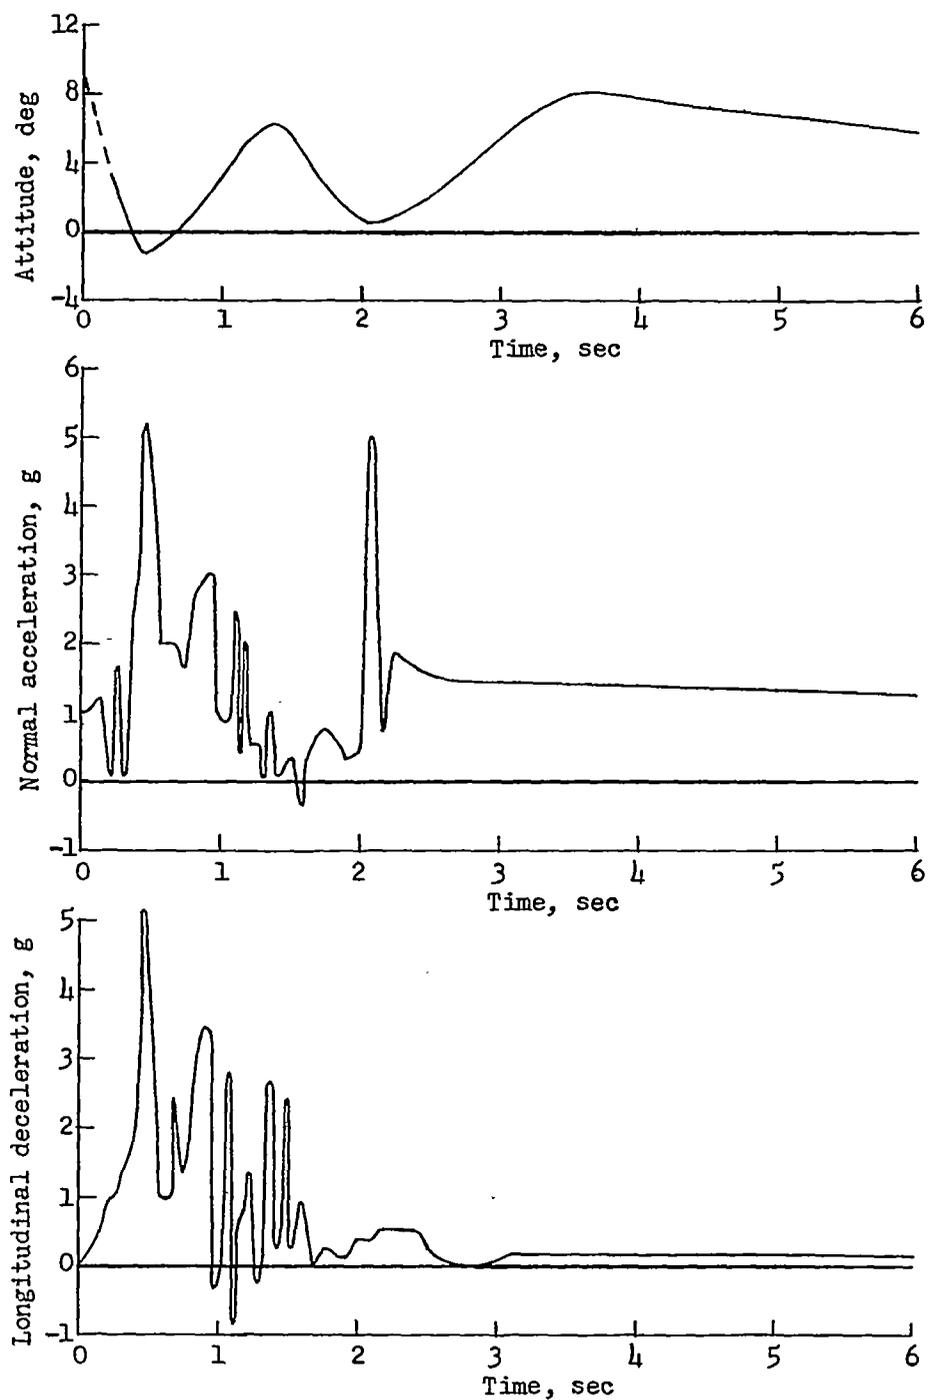
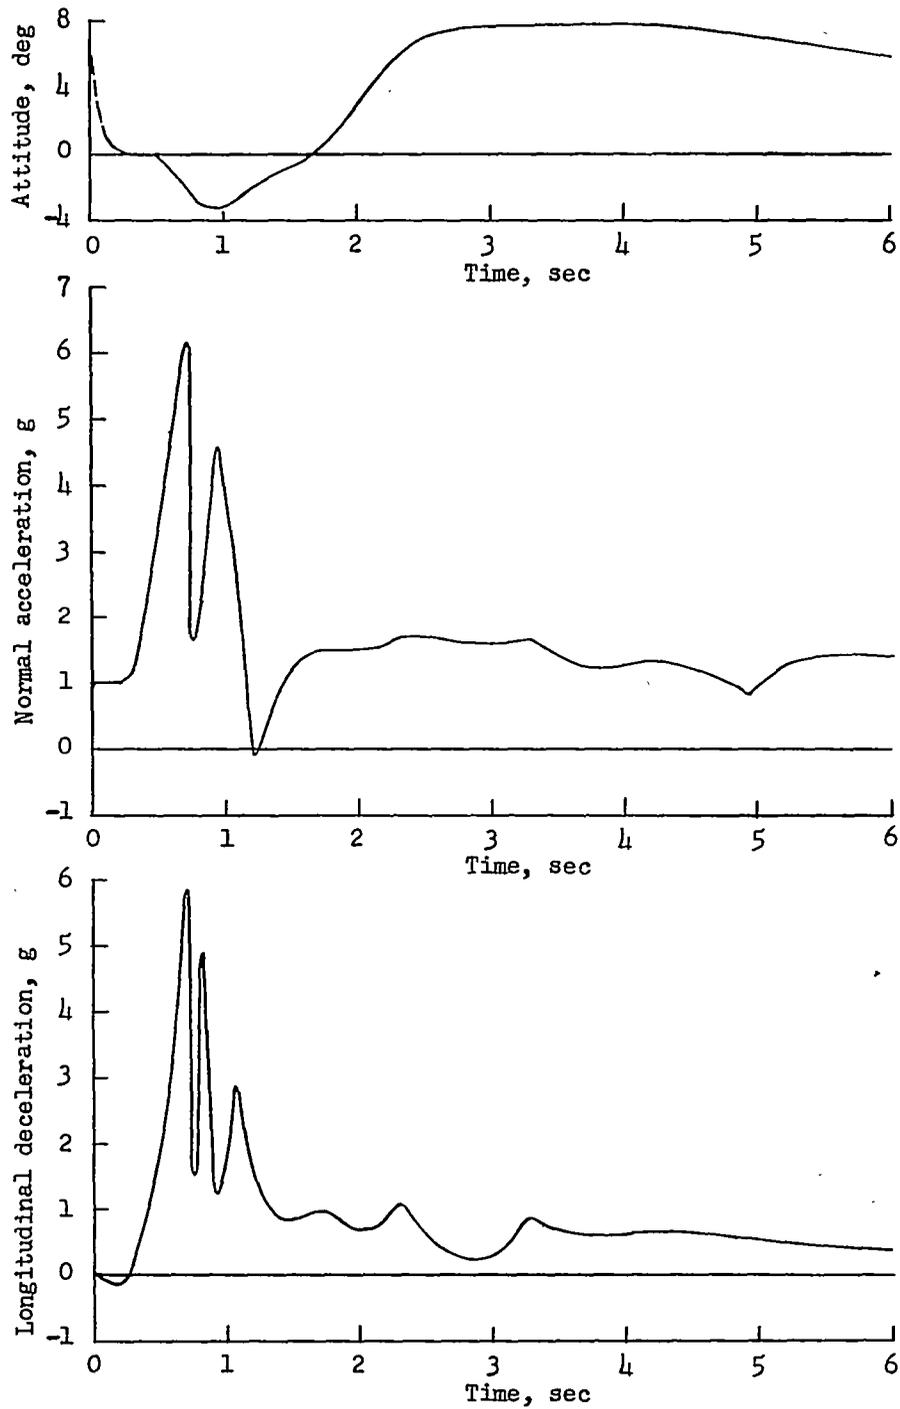
(a) Landing attitude, 12° ; landing speed, 100 knots.

Figure 6.- Time history plots with scale-strength fuselage bottom and scale-strength struts on the strut-pod engine installation. Flaps down; values are full scale.

(b) Landing attitude, 9° ; landing speed, 104 knots.

(c) Landing attitude, 6° ; landing speed, 113 knots.

Scale-strength fuselage bottom.- When the model with the strut-pod engine configuration was ditched with scale-strength fuselage bottom installed, it trimmed down immediately after contact with the water, then trimmed up and ran smoothly for the remainder of the run. This behavior was characteristic for ditchings at all three landing attitudes tested with the flaps either up or down. The changes in attitude during typical ditchings with the flaps down are shown in figure 6. Also shown in figure 6 are typical time-history plots of normal acceleration and longitudinal deceleration. Figure 7 shows sequence photographs of a typical ditching run at the 12° landing attitude.

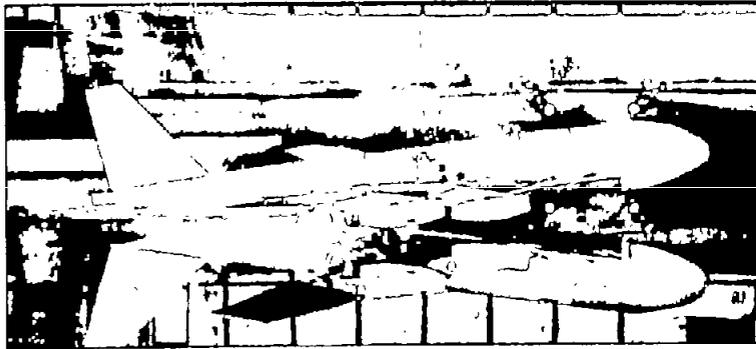
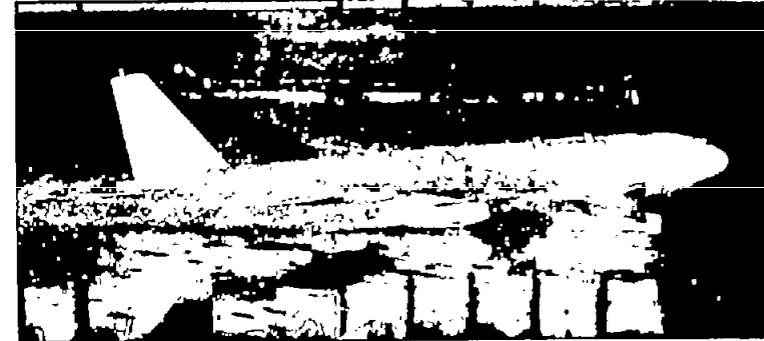
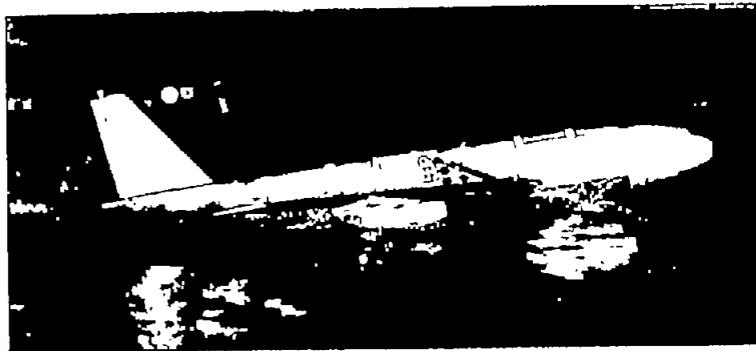
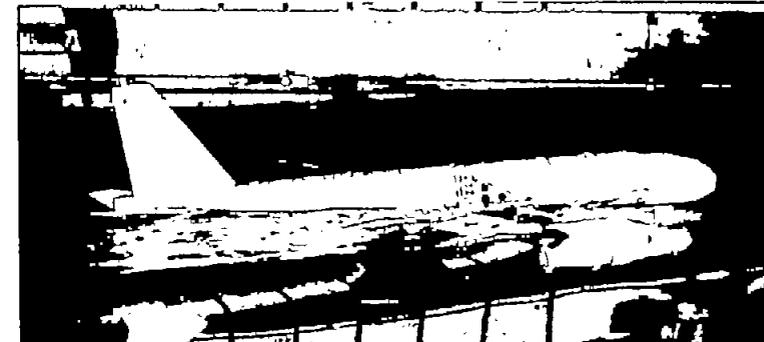
Figure 7.- Sequence photographs of a typical landing run with scale-strength fuselage bottom and scale-strength struts on the strut-pod engine installation. Flaps down: landing attitude, 12° ; landing speed, 100 knots. Distance after contact is indicated in feet. All values are full scale.
