NACA RM L56G10

MODEL DITCHING INVESTIGATION OF A JET TRANSPORT
AIRPLANE WITH VARIOUS ENGINE INSTALLATIONS

By William C. Thompson

Langley Aeronautical Laboratory
Langley Field, Va.

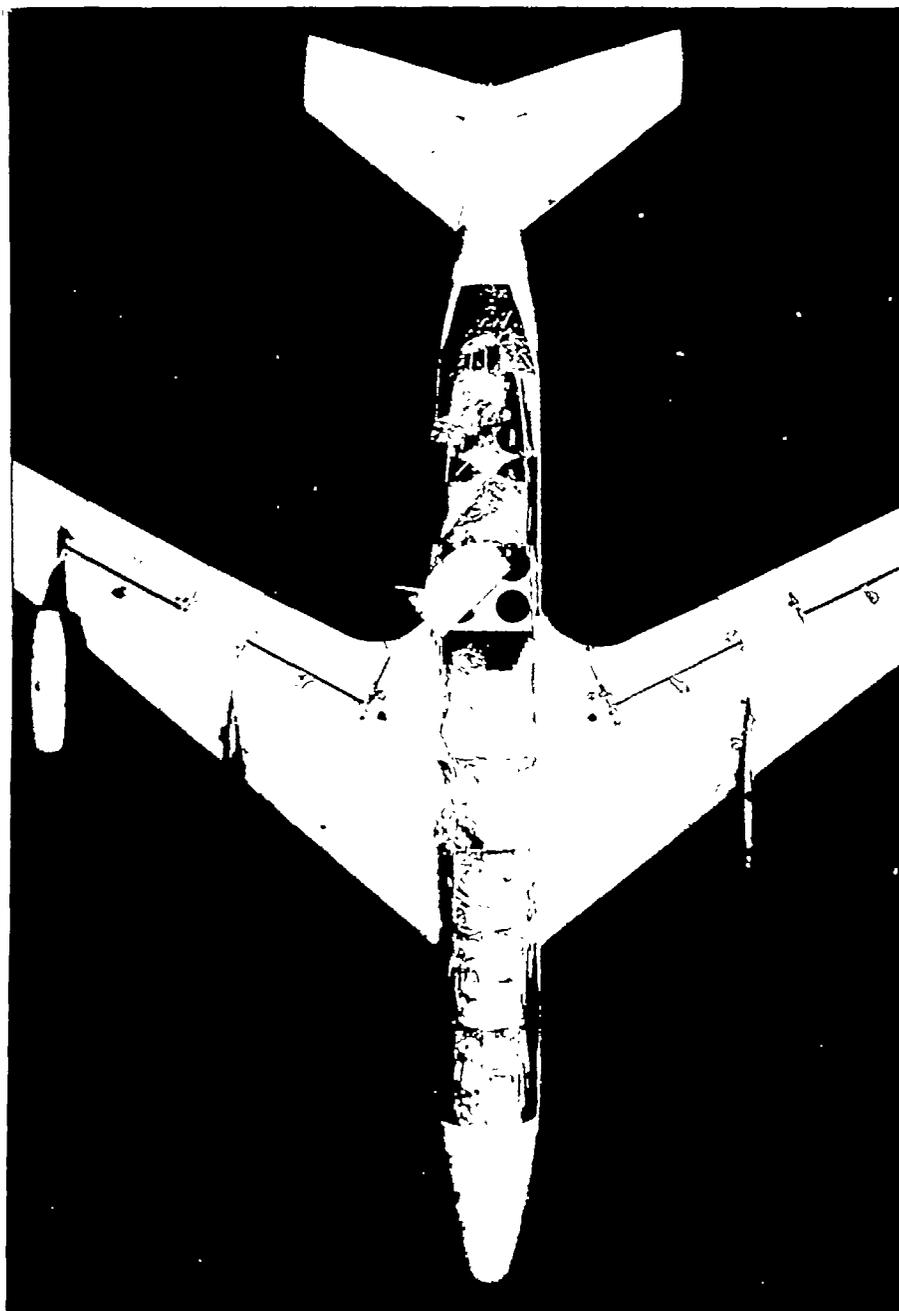
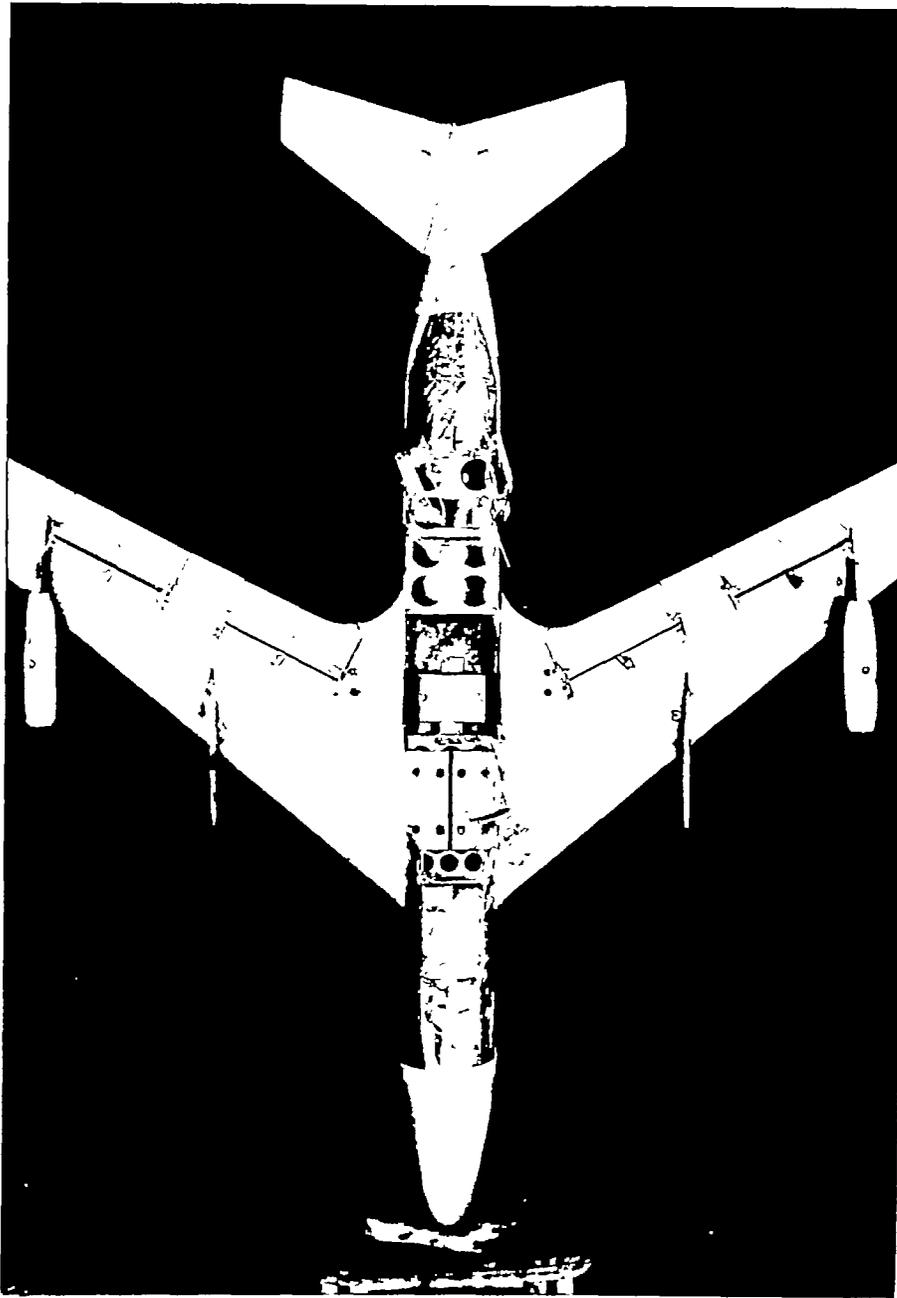
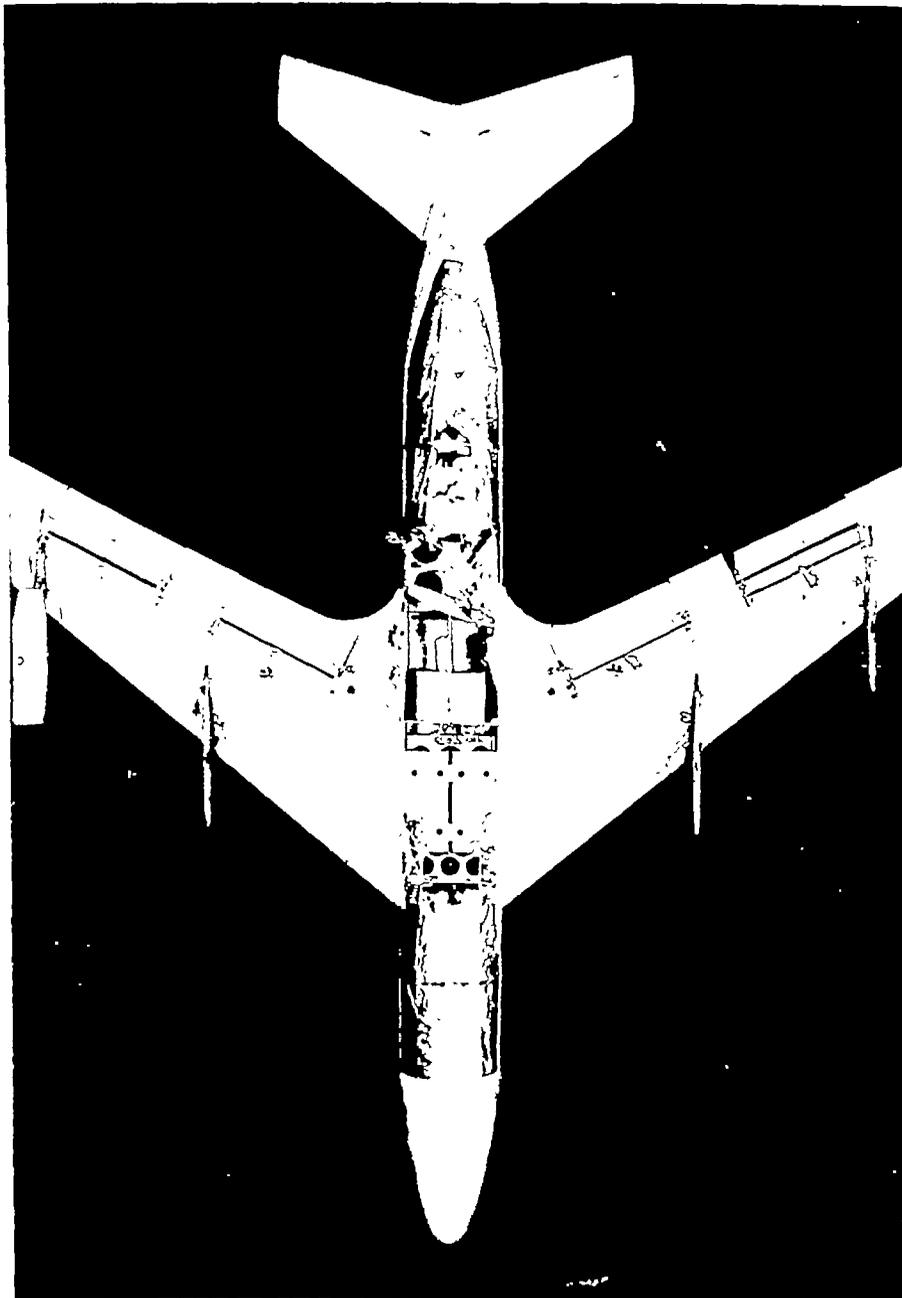
(a) Landing attitude, 12° ; landing speed, 100 knots. L-90559

Figure 8.- Typical damage to the scale-strength bottoms. Flaps down.

(b) Landing attitude, 9° ; landing speed, 104 knots. L-90560

(c) Landing attitude, 6° ; landing speed, 113 knots. L-90561

trim down shortly after contact, and the landing runs were shorter and the decelerations higher than when no damage was present. Typical damage to the scale-strength portion of the fuselage bottom is shown in figure 8. Ditchings at the 12° landing attitude for the condition with the flaps down resulted in less damage than for the other conditions tested. The simulated damage condition (fig. 4) resulted in the same general type of behavior as that resulting from the scale-strength bottom even though the decelerations were somewhat lower and the landing runs slightly longer.
