# RESEARCH MEMORANDUM

FLIGHT MEASUREMENT OF THE STABILITY CHARACTERISTICS  
OF THE DOUGLAS D-558-1 AIRPLANE  
(BUAERO NO. 37971) IN SIDESLIPS

Walter C. Williams

April 18, 1949

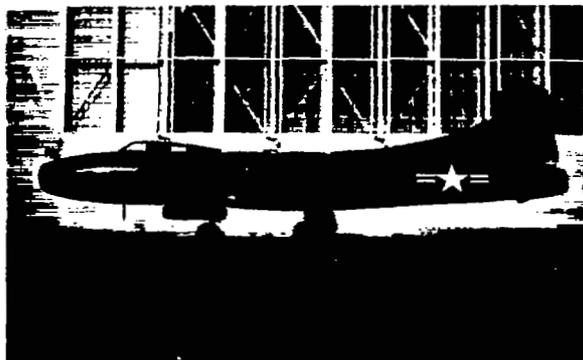
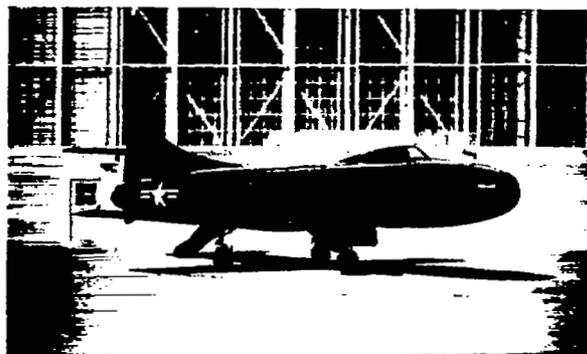
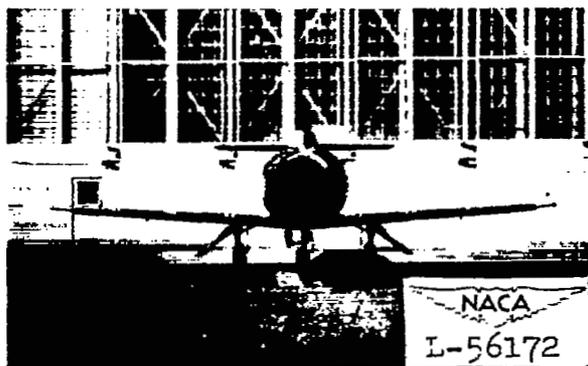
(a) Side view.

(b) Three-quarter front view.

(c) Front view.

Figure 1.- Photographs of D-558-1 airplane.

The Douglas D-558-1 airplane is a single-place low-wing monoplane powered by a single General Electric TG-180 turbojet engine. General views of the airplane are given in figures 1(a), (b), and (c). A three-view layout of the airplane is given in figure 2. Detailed specifications of the airplane are given in reference 1.

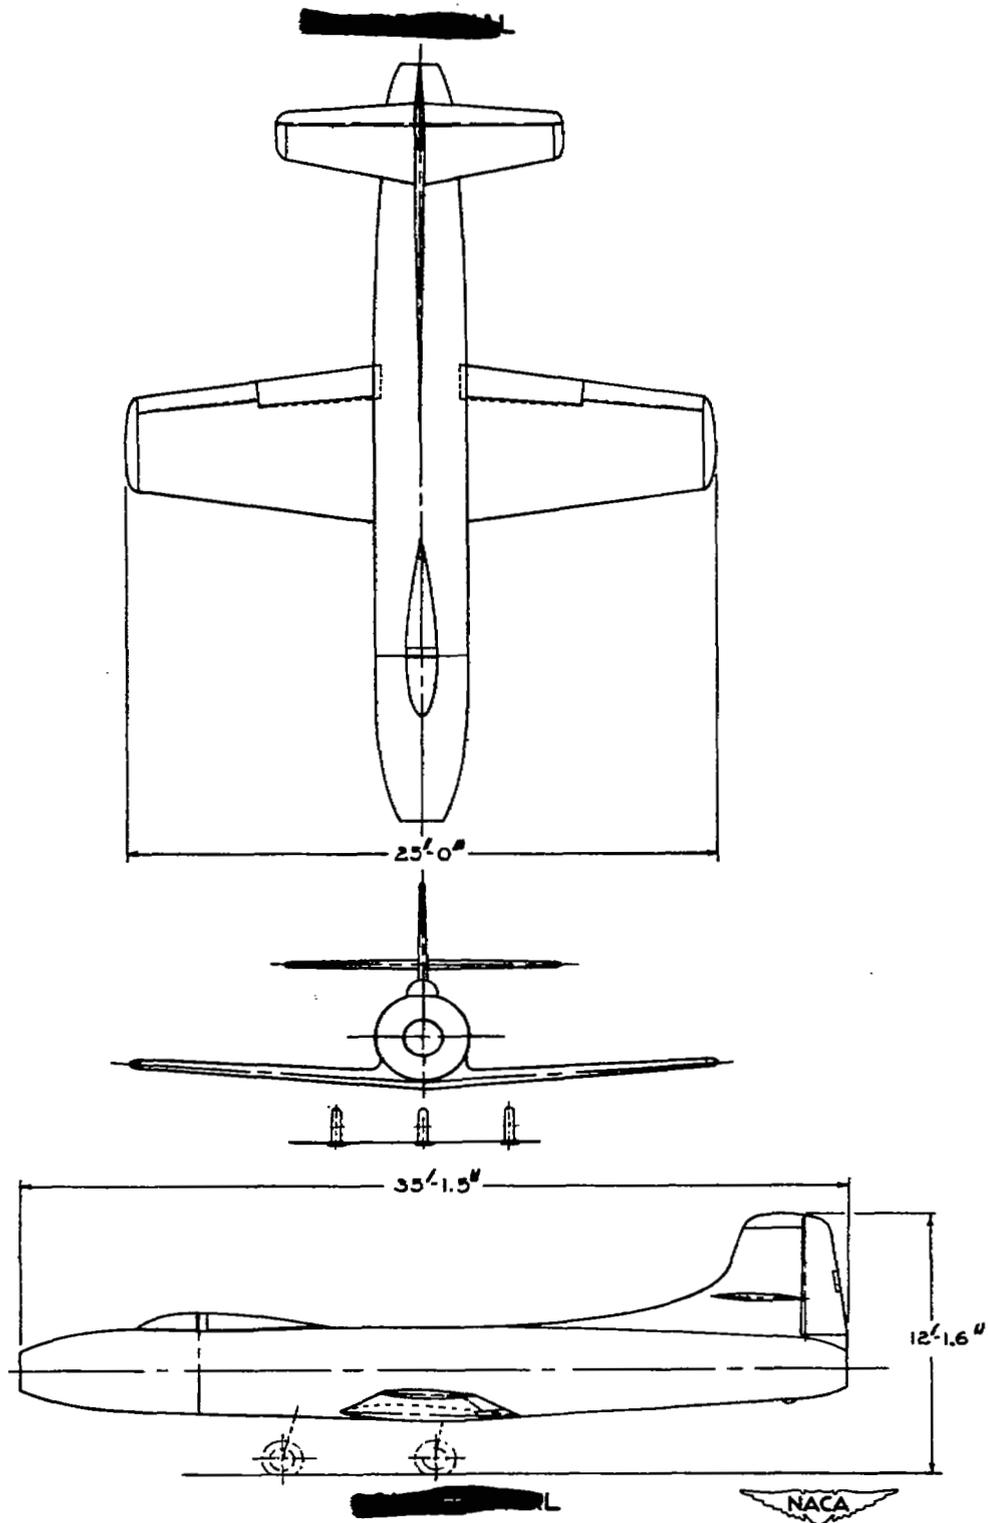
Figure 2.- Three-view drawing of D-558-1 airplane.

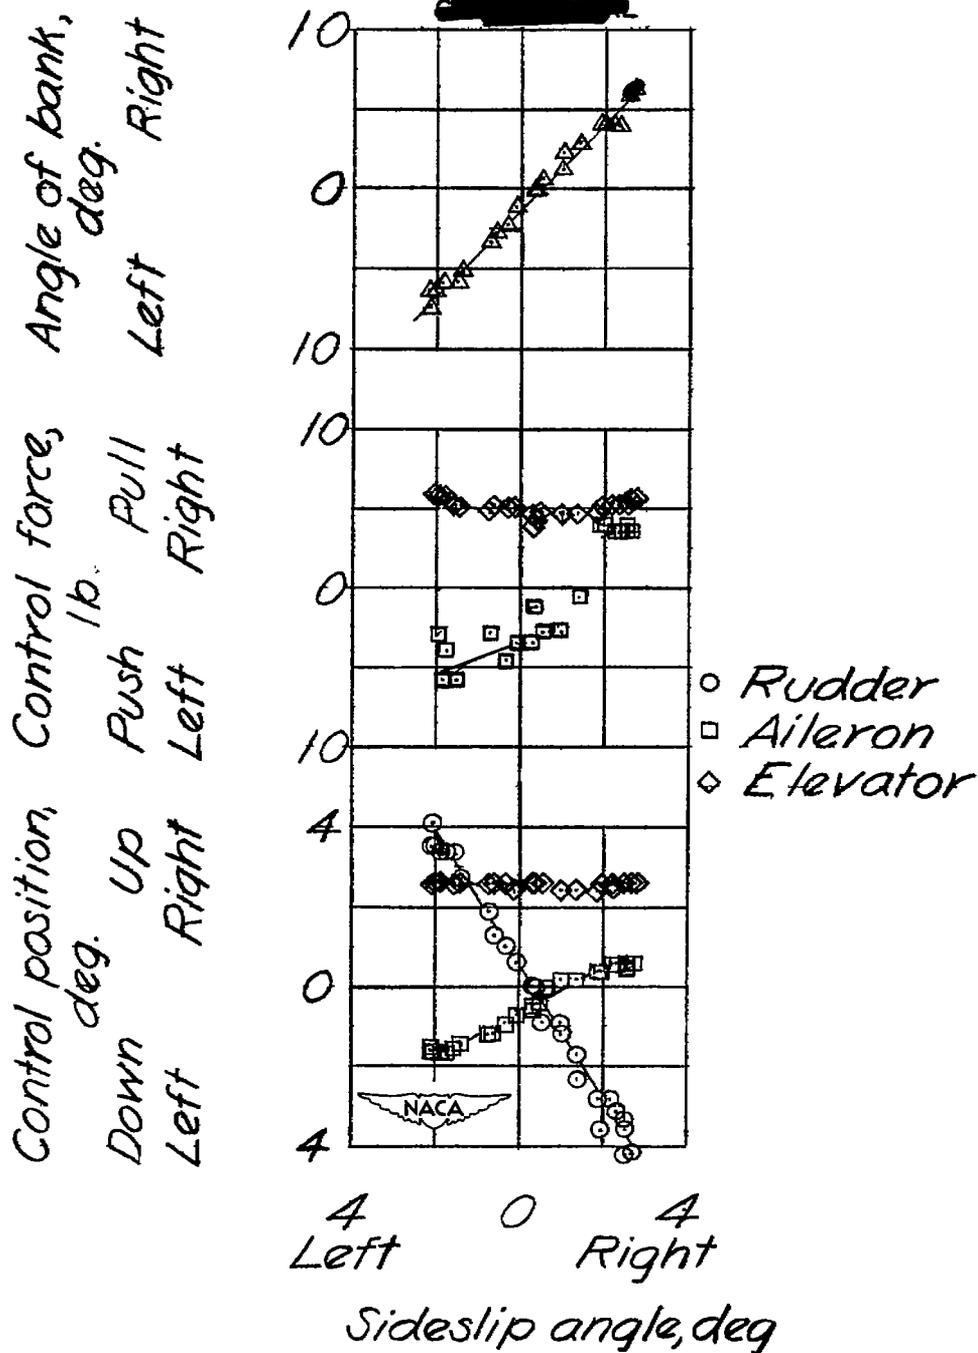
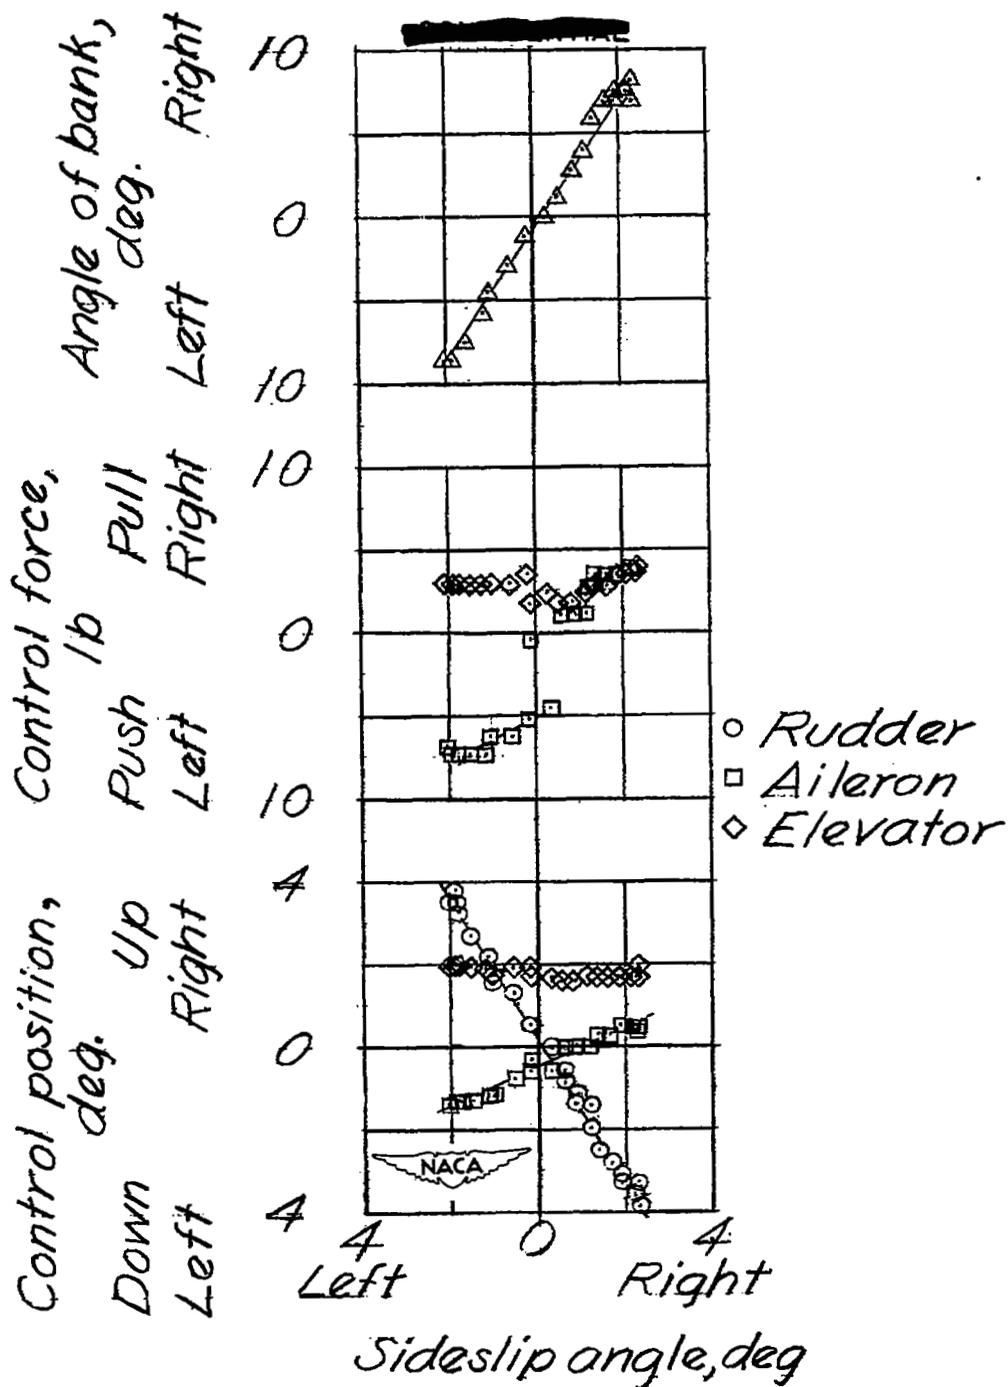
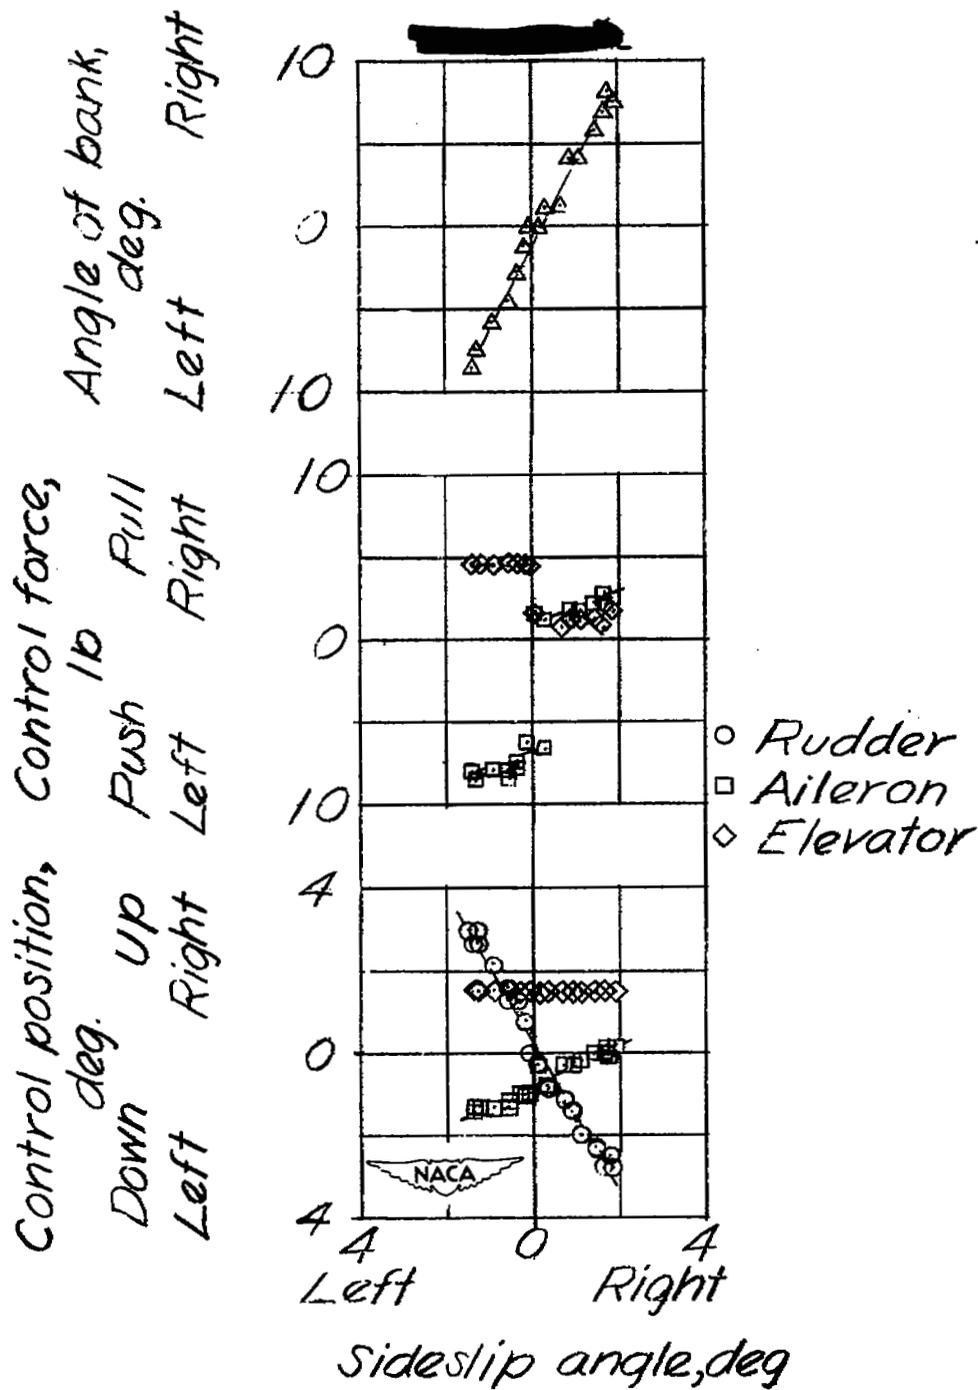
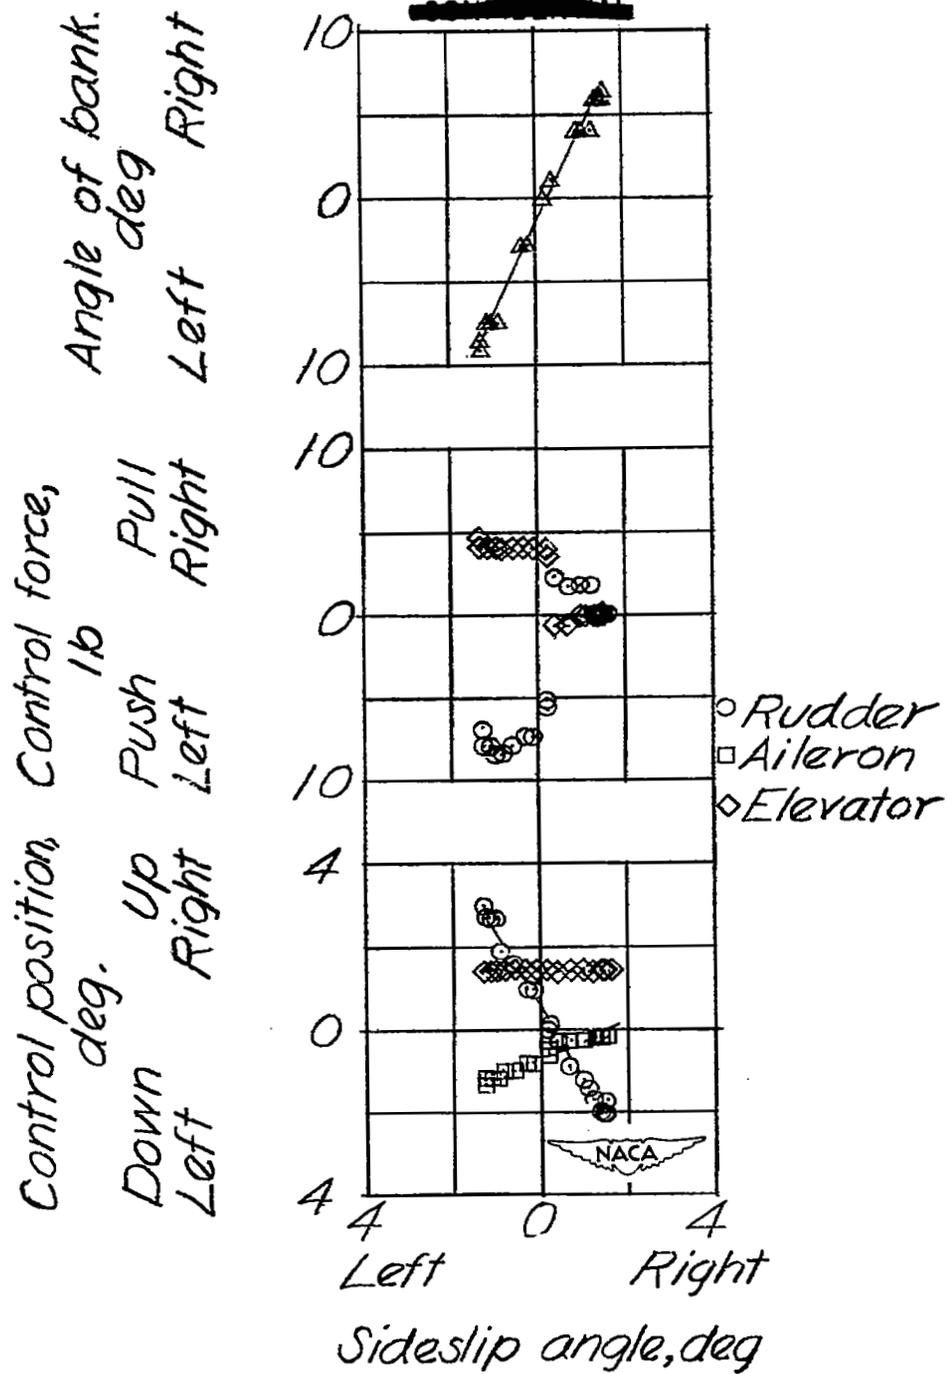
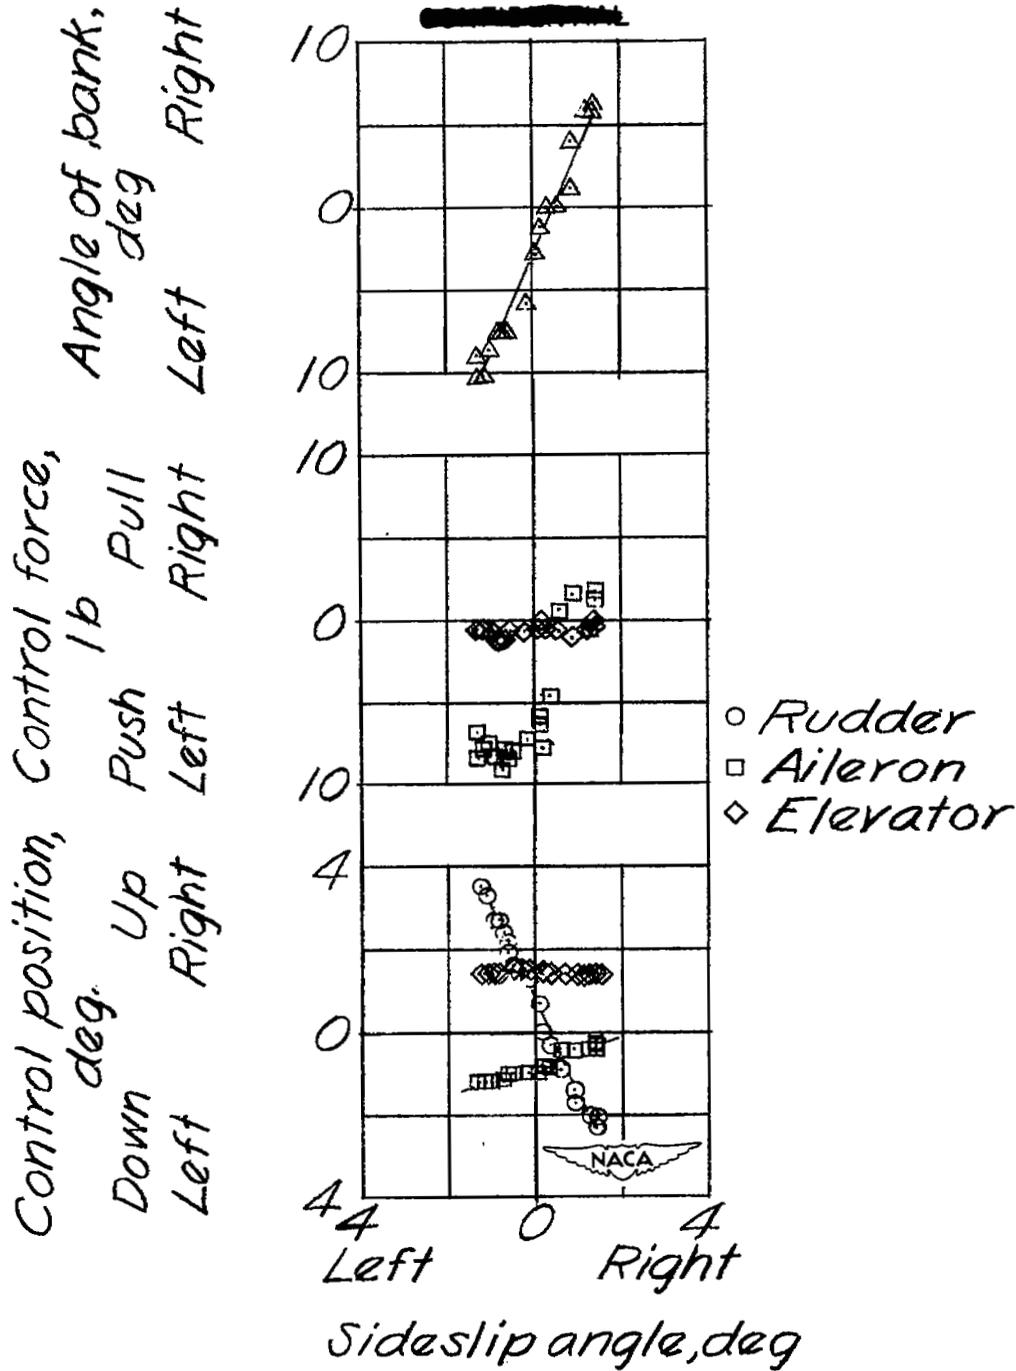
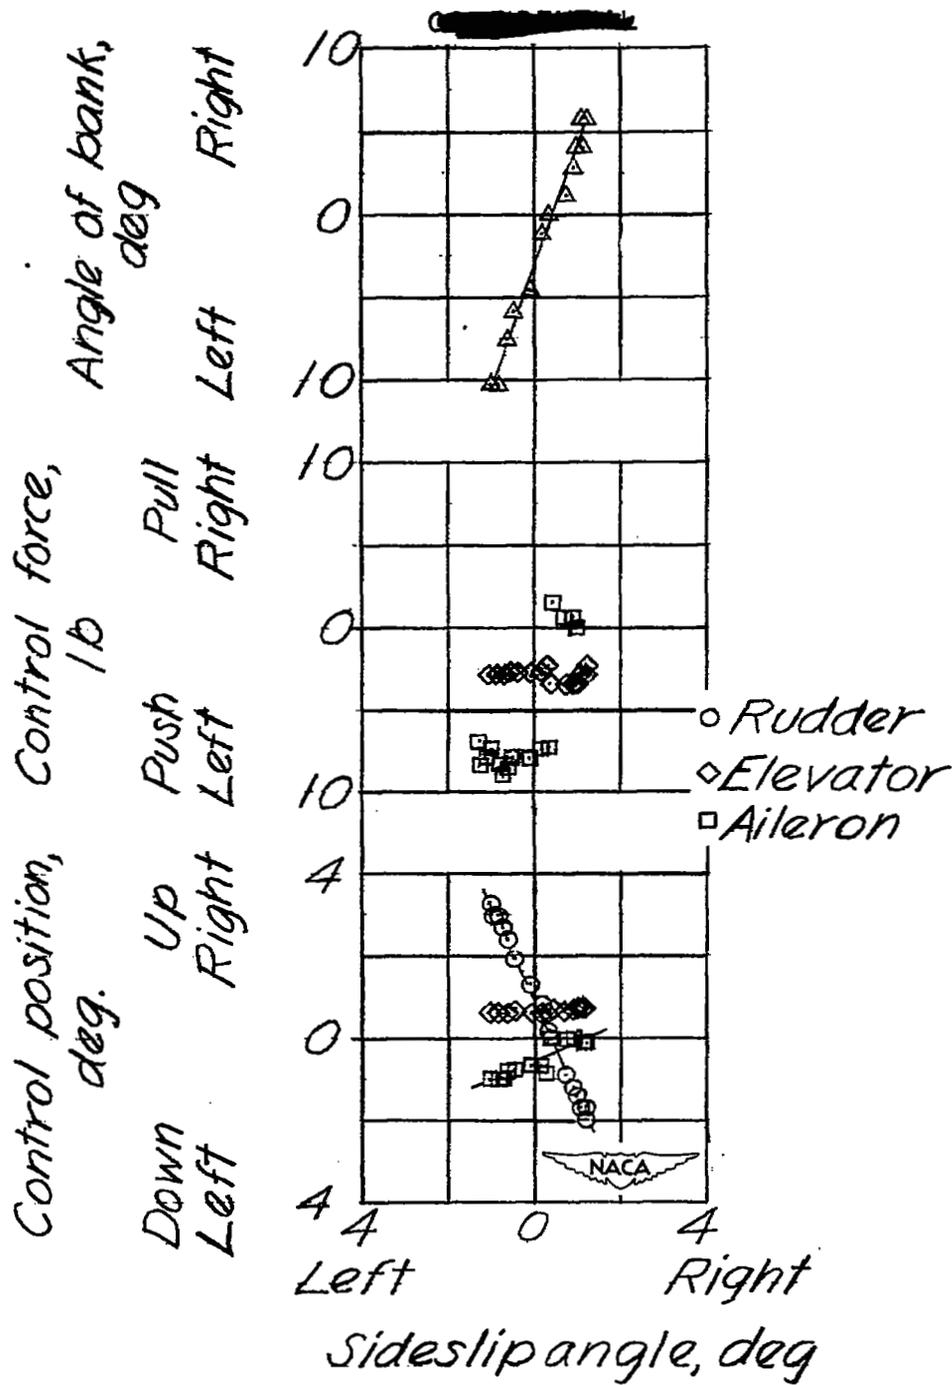
Figure 3.- Steady sideslip characteristics at 10,000 feet altitude.  
D-558-1 airplane.

The results of the tests made at 10,000 feet are given in figures 3(a) to 3(f) whereas results obtained at 30,000 feet are in figures 4(a) to 4(g). In these figures, rudder, aileron, and elevator position and force and angle of bank are plotted as functions of sideslip angle. The values of bank angle were obtained from measurements of the transverse acceleration. No measurements of rudder force were obtained, however, at 10,000 feet altitude. The variation of rudder position and force with sideslip angle gives a measure of the static directional stability, control fixed and free. A measure of the dihedral effect, control fixed and control free, is afforded by the variation of aileron position and force with sideslip angle. The pitching moment due to sideslip is illustrated by the variation of elevator position and force with sideslip angle and the variation of angle of bank with sideslip angle gives a measure of the cross-wind-force characteristics.

The data given in figures 3 and 4 show that the directional stability of the D-558-1 is high throughout the speed range tested. The dihedral effect of the airplane is positive, although low, throughout the speed range. There are some discontinuities in the variation of aileron force and position with sideslip angle near zero sideslip. It is believed that these discontinuities are caused by the friction in the control system in the case of the force measurements and caused by some play in the aileron linkage between the aileron and the point of measurement in the case of position measurements. The slopes of these curves, however, should afford a good measure of the dihedral effect. There appears to

be little or no change in pitching moment with sideslip angle for all sideslips presented. The cross-wind force was positive; that is, right bank accompanied right sideslip.

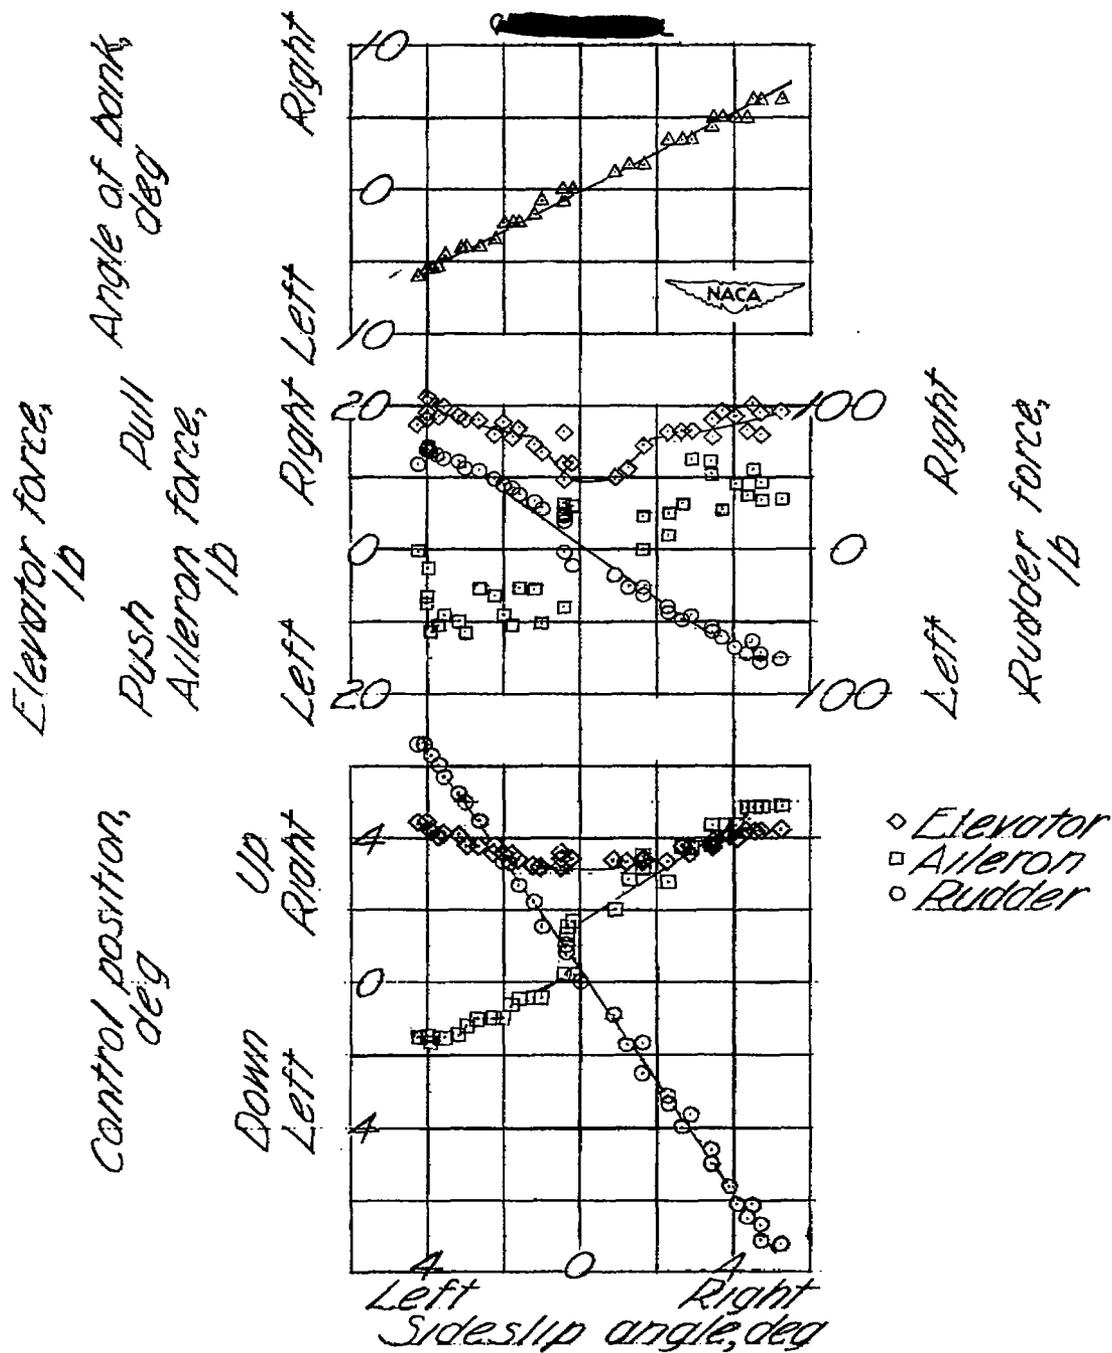
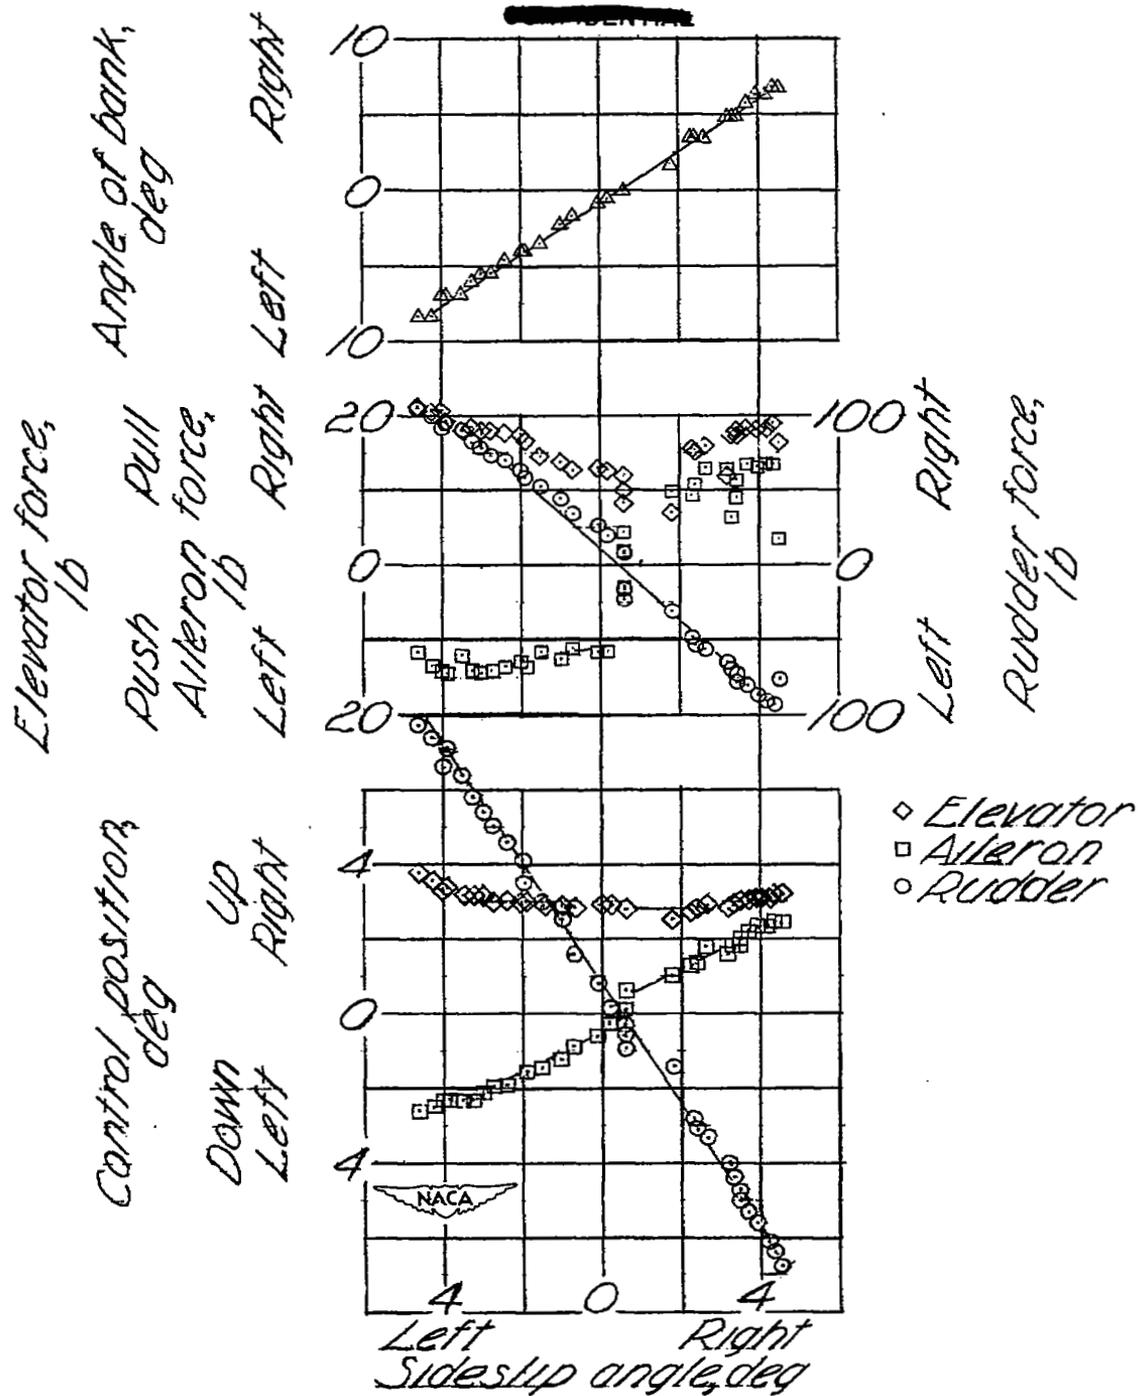
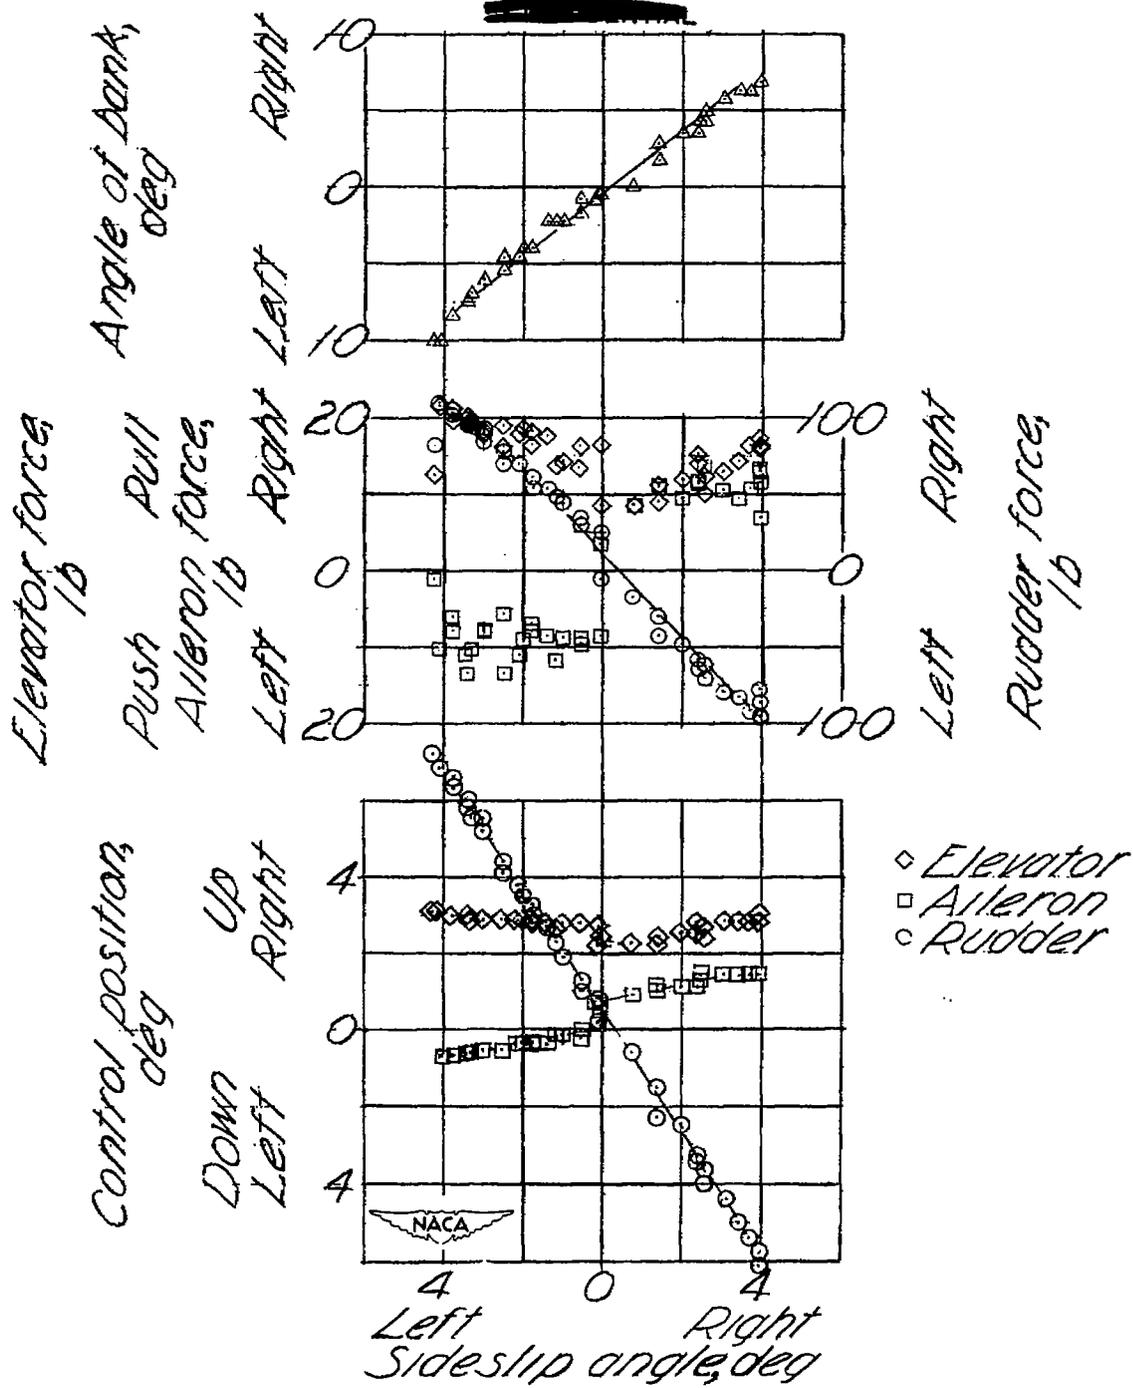
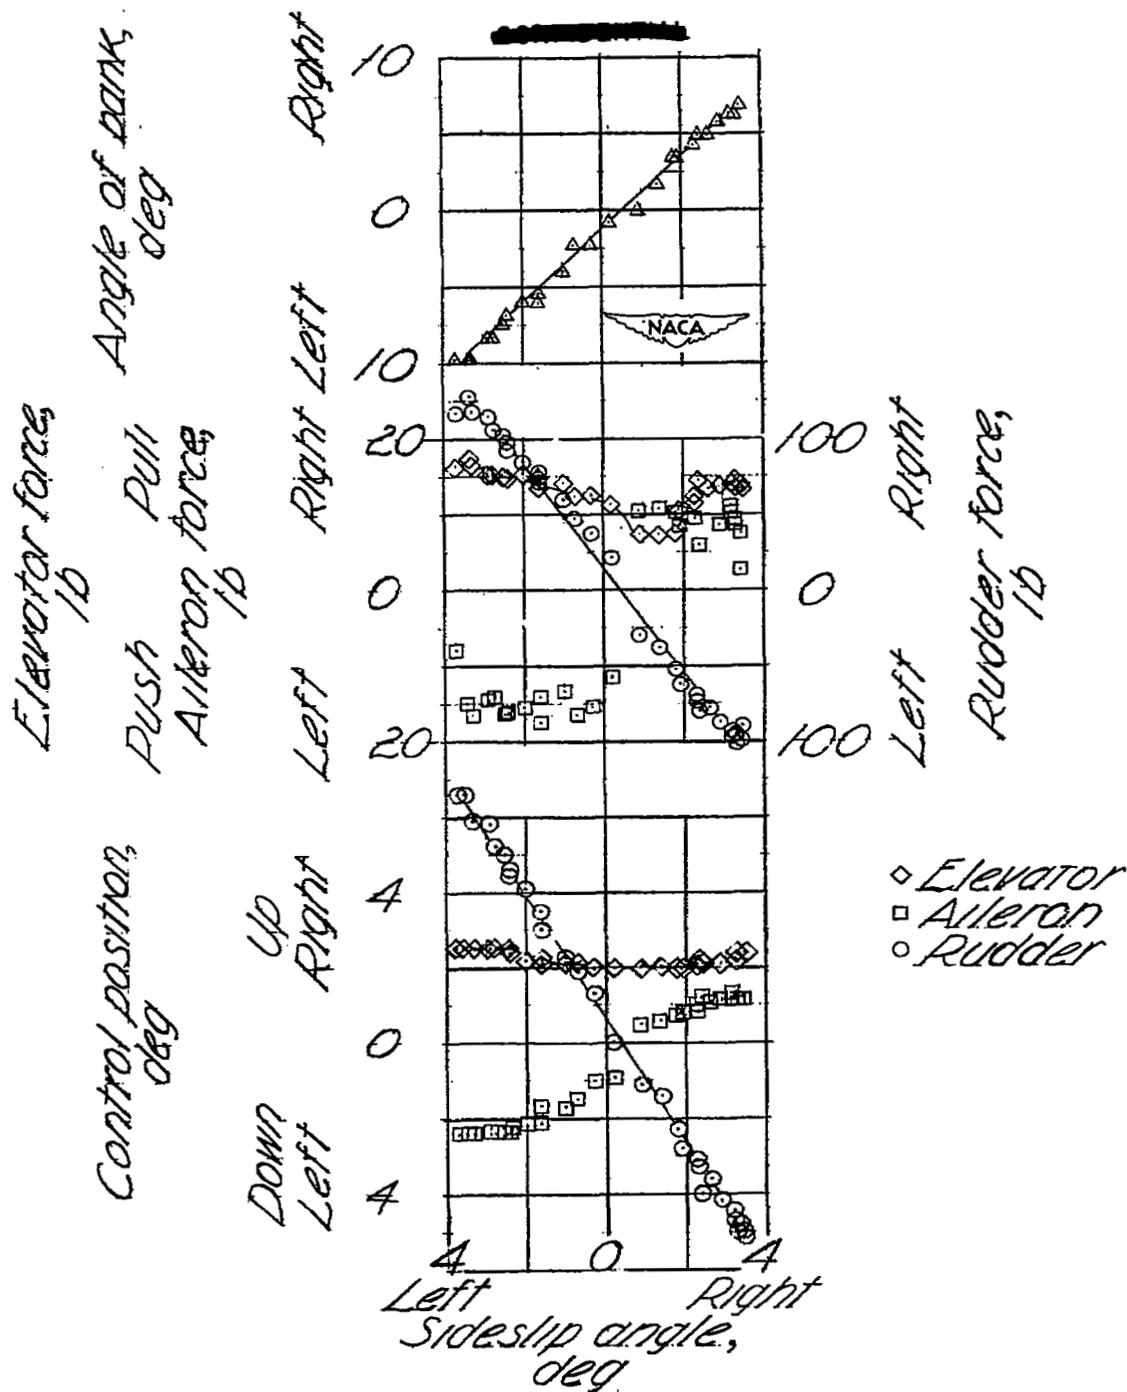
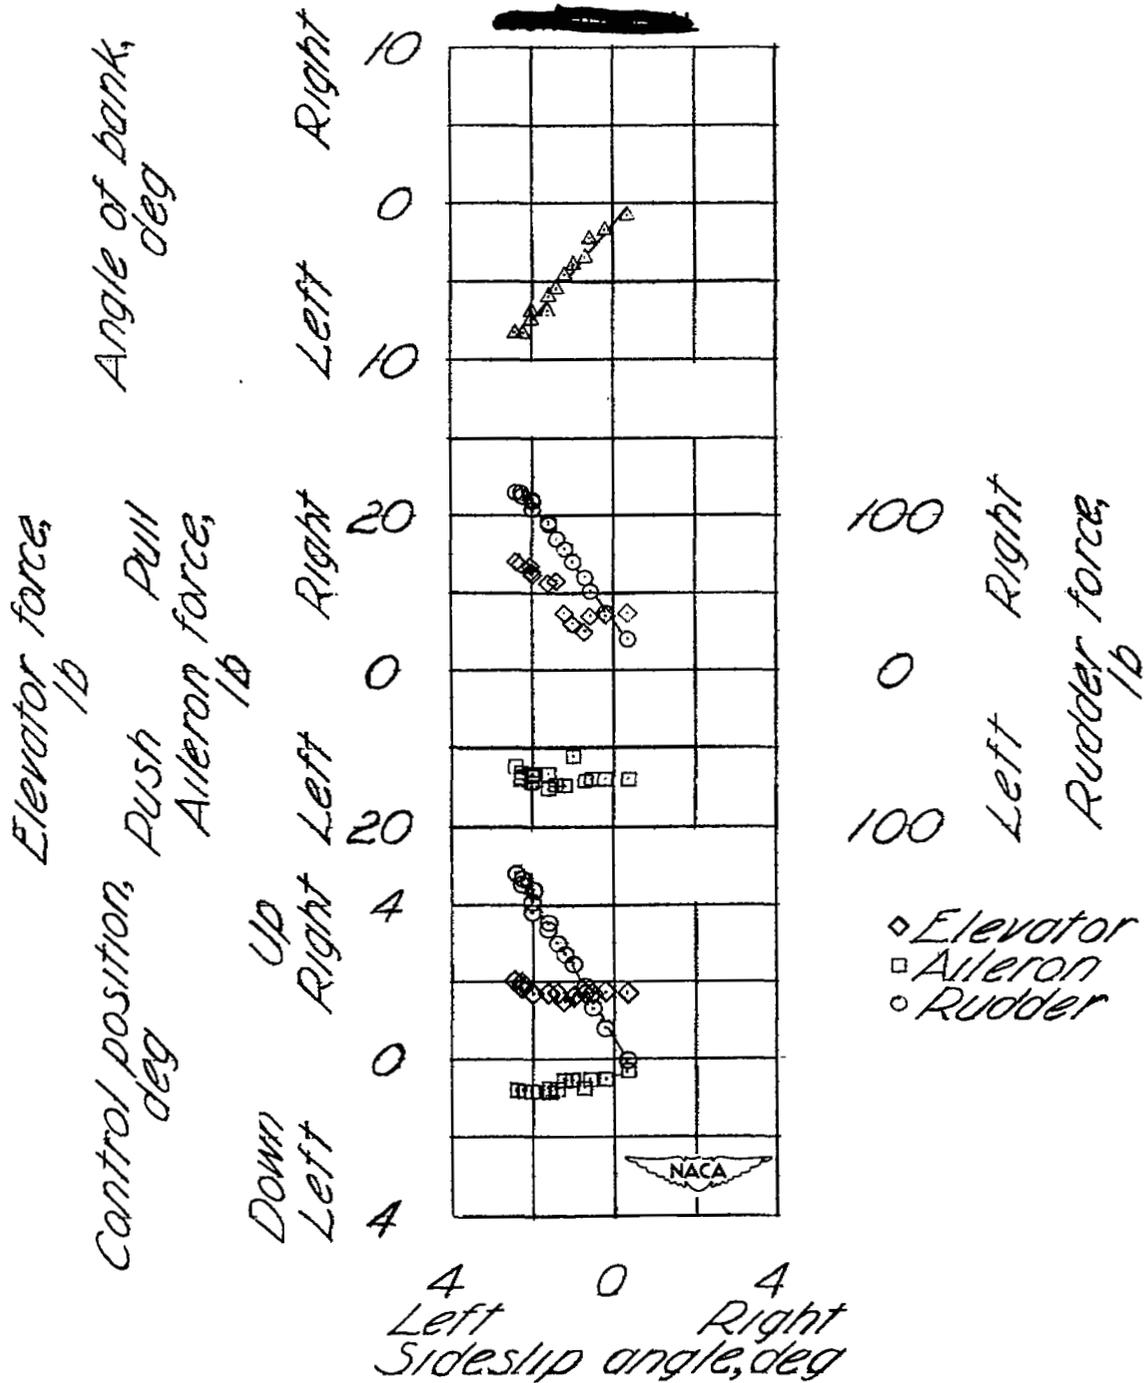
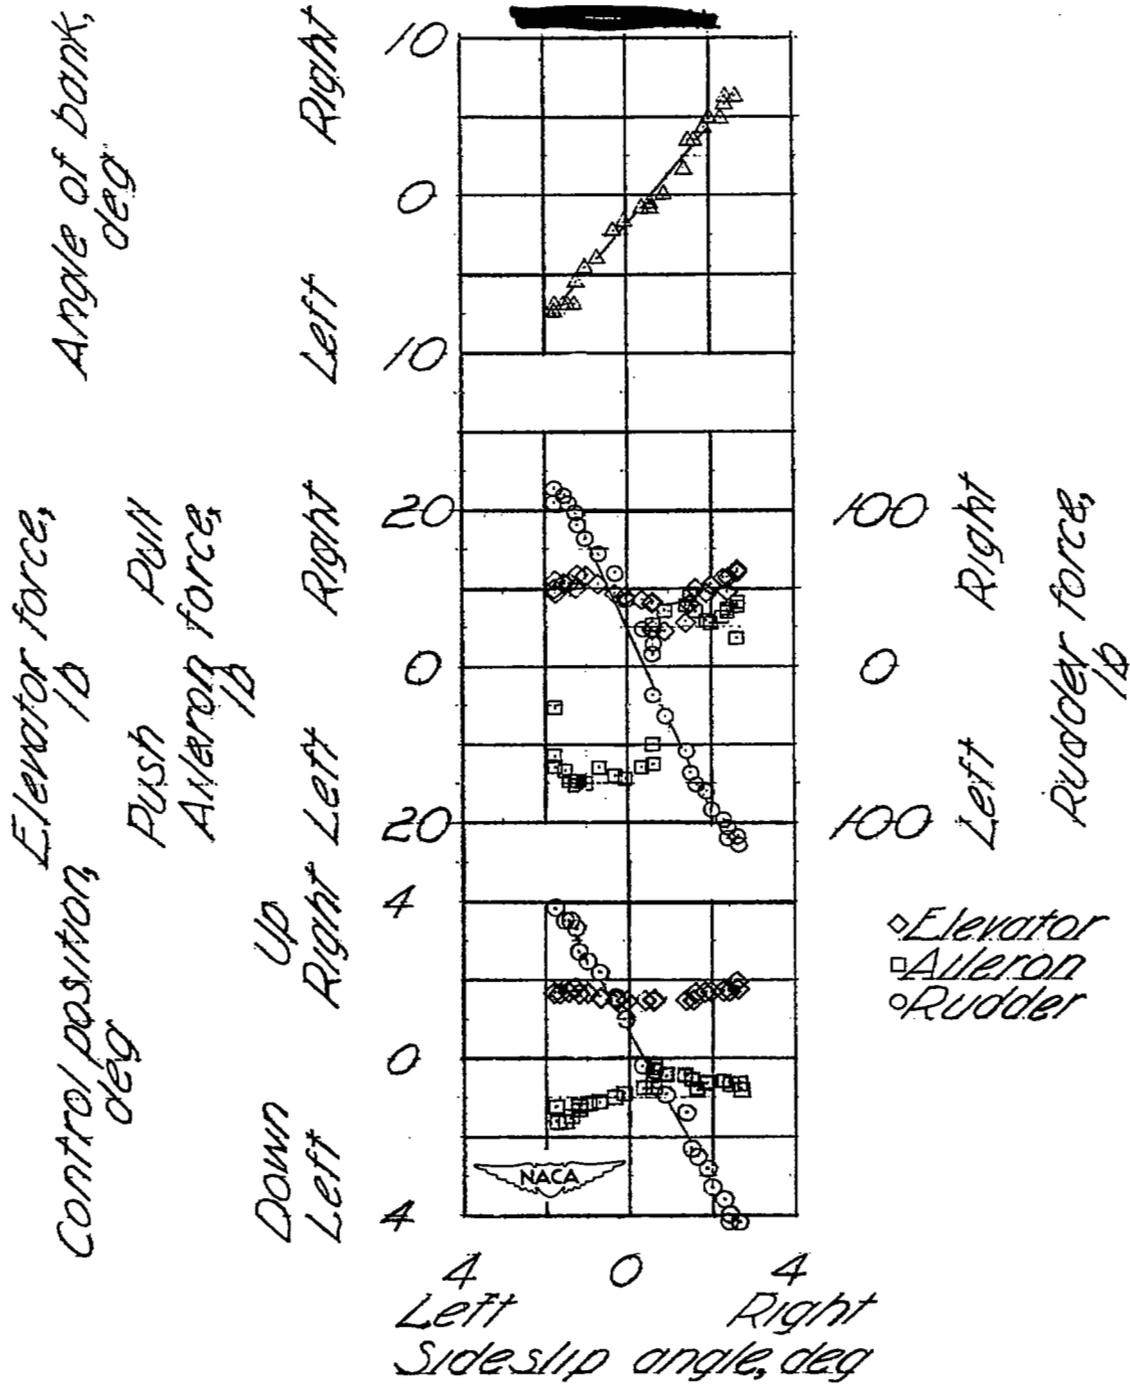
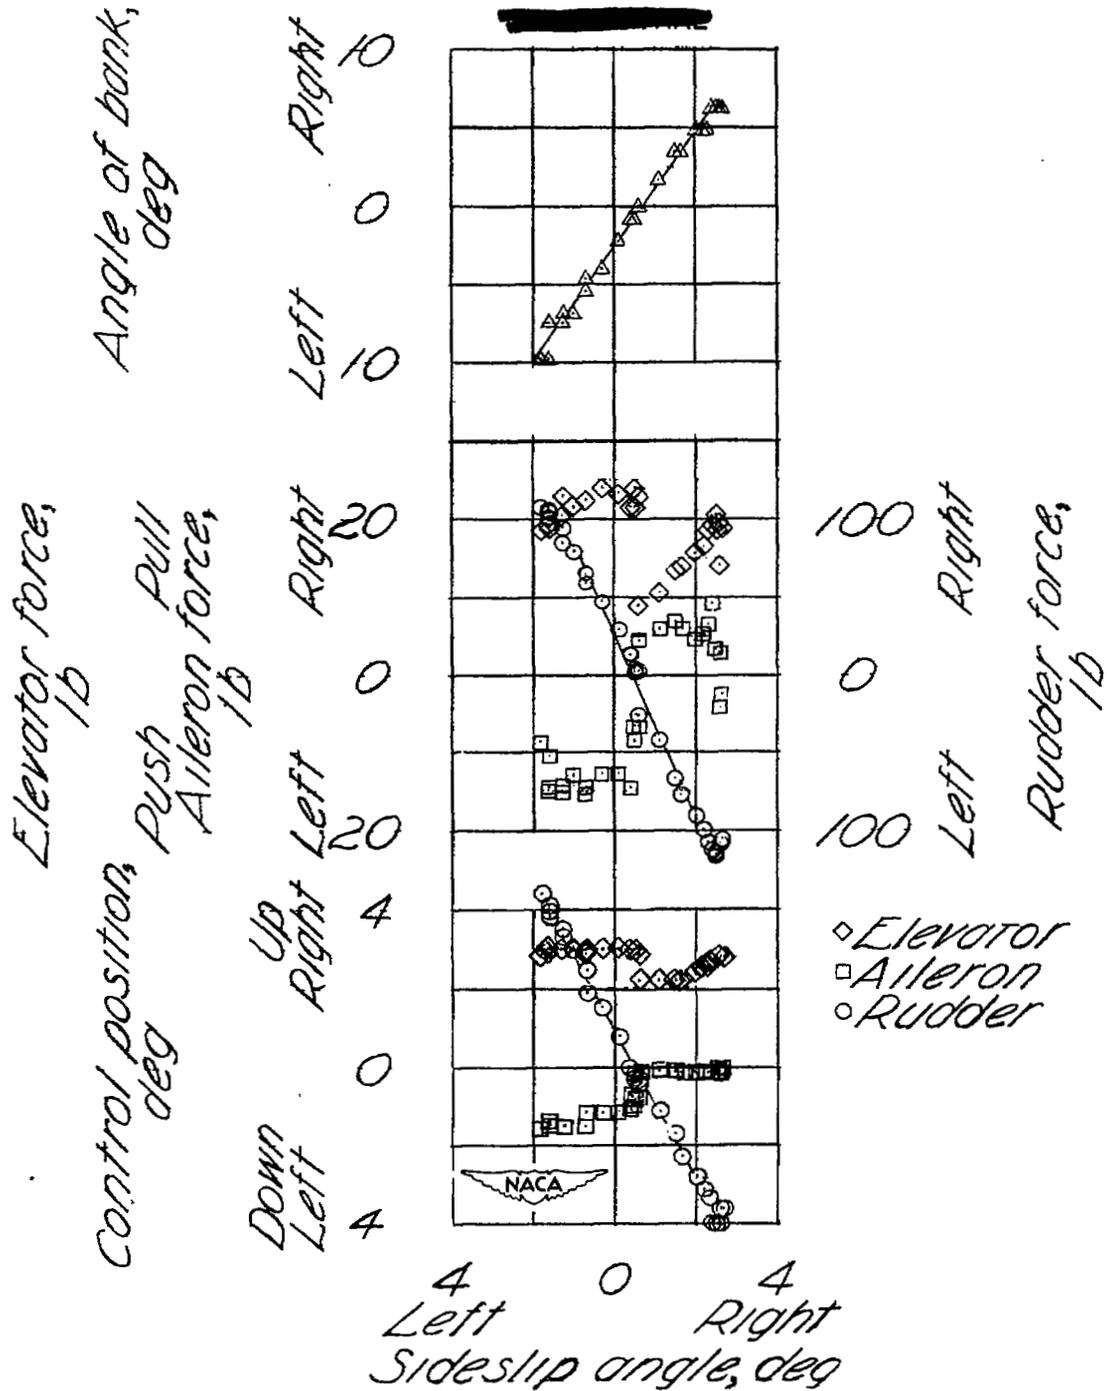
Figure 4.- Steady sideslip characteristics at 30,000 feet altitude.  
D-558-1 airplane.

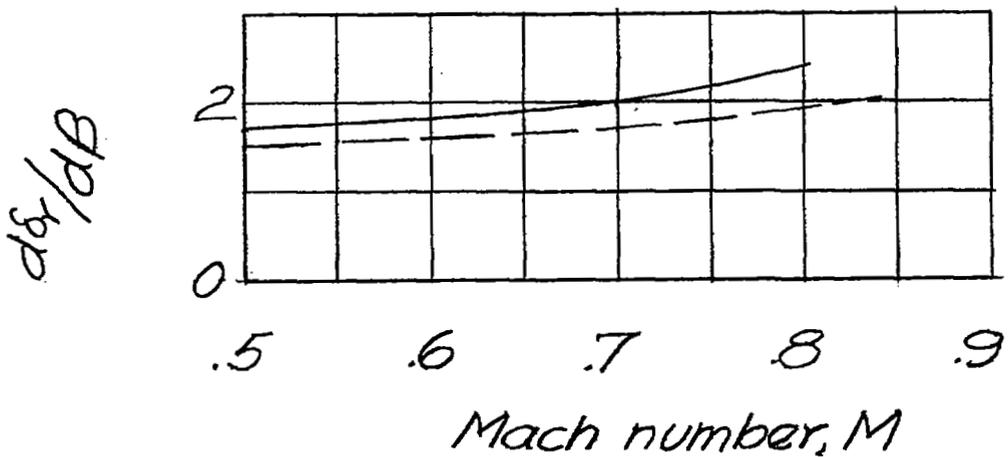
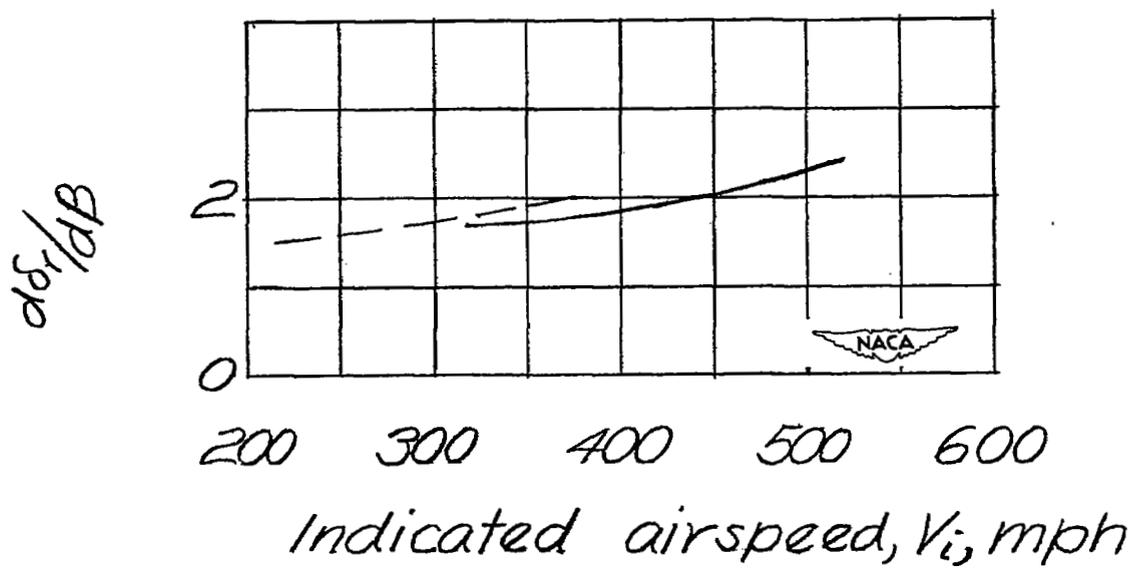
Altitude  
 ——— 10,000 ft  
 - - - 30,000 ft

Figure 5.- Variation of  $d\delta_r/d\beta$  with Mach number and indicated airspeed.

A comparison of the directional stability data presented in figures 3 and 4 shows that there is a variation in the directional stability parameter  $d\delta_r/d\beta$  with Mach number and indicated airspeed. To illustrate this fact, figure 5 was prepared to show the variation of  $d\delta_r/d\beta$  with Mach number and indicated airspeed for the two test altitudes (10,000 and 30,000 ft). In this figure, it can be seen that the increase in the apparent directional stability with increasing speed is a function of Mach number. The increase in apparent directional stability at any given Mach number as the altitude is decreased is probably caused by a decrease in rudder effectiveness. This decrease in rudder effectiveness is probably caused by distortion of the vertical tail and fuselage at the higher values of dynamic pressure encountered at the lower altitude.
