NACA RM E57A15

FOREIGN-OBJECT RETENTION AND FLOW CHARACTERISTICS OF  
RETRACTABLE ENGINE-INLET SCREENS

By Fred W. Steffen and Lewis A. Rodert

WASHINGTON  
July 26, 1957

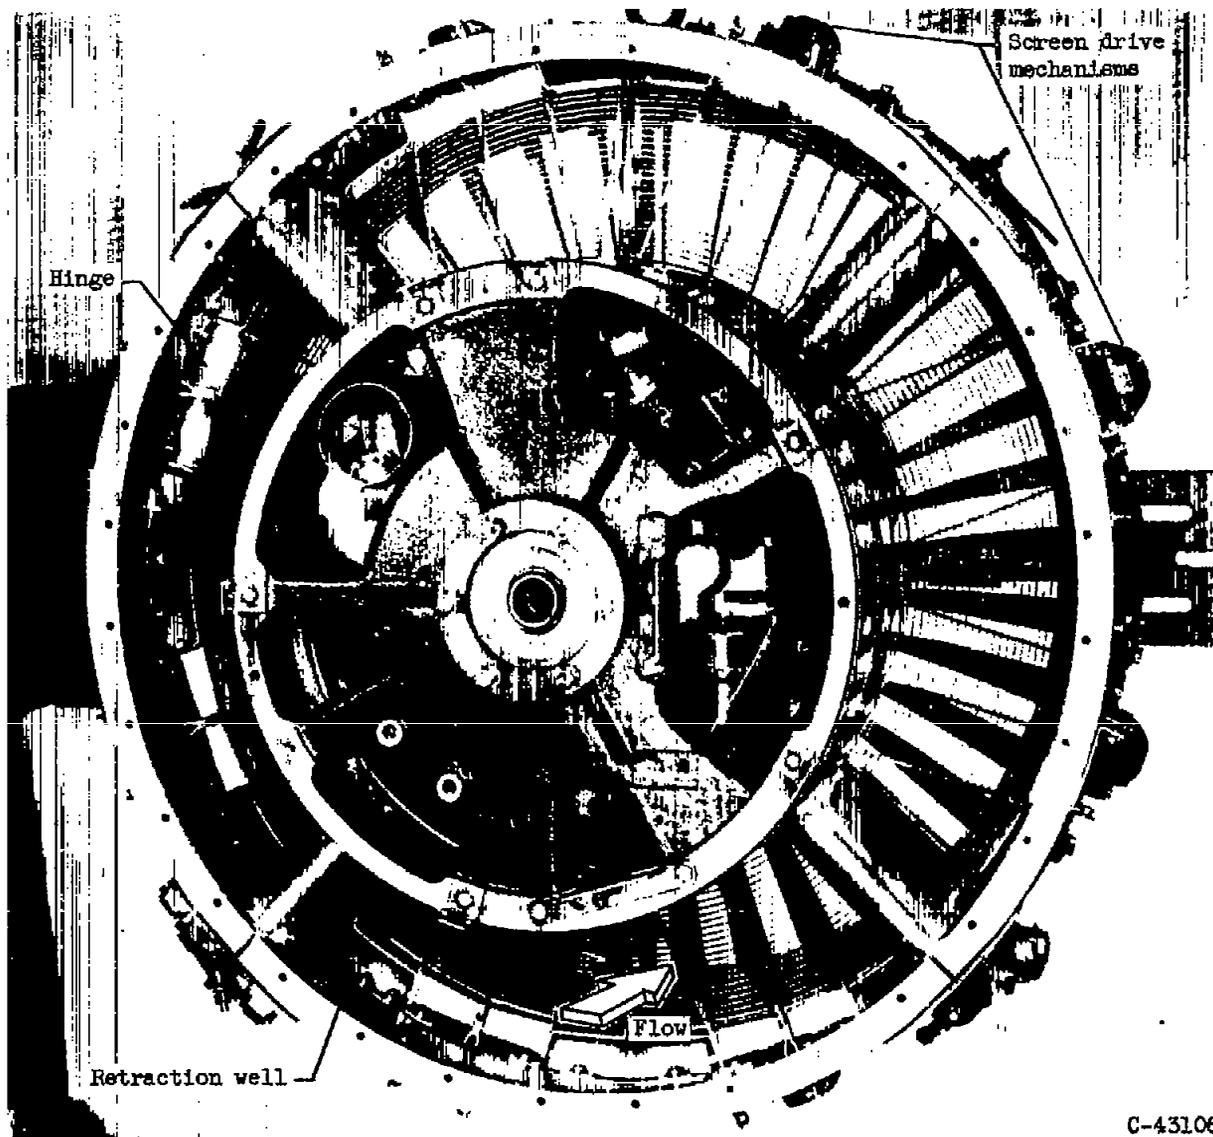
Figure 1. - Screen A installed in inlet section of engine A.

Two retractable engine-inlet screens were used in the investigation. For the tests each screen was mounted in the inlet section of the engine for which it was designed. Screen A, with circumferential elements, was mounted in the inlet section of engine A, as shown in figure 1. Screen B, with radial elements, was mounted in the inlet section of engine B, as shown in figure 2. This particular screen was not equipped with the metal hinge seals that were included on the majority of the production screens of this type.

wells (fig. 2), while the screen section of engine A has a common retraction well (fig. 1). Screen A was retracted electromechanically and required about 3 seconds to move from a fully extended to a fully retracted position. Screen B was hydraulically operated and moved from its extended to fully retracted position in about 0.43 second. Retraction time of either screen was not significantly affected by airflow.

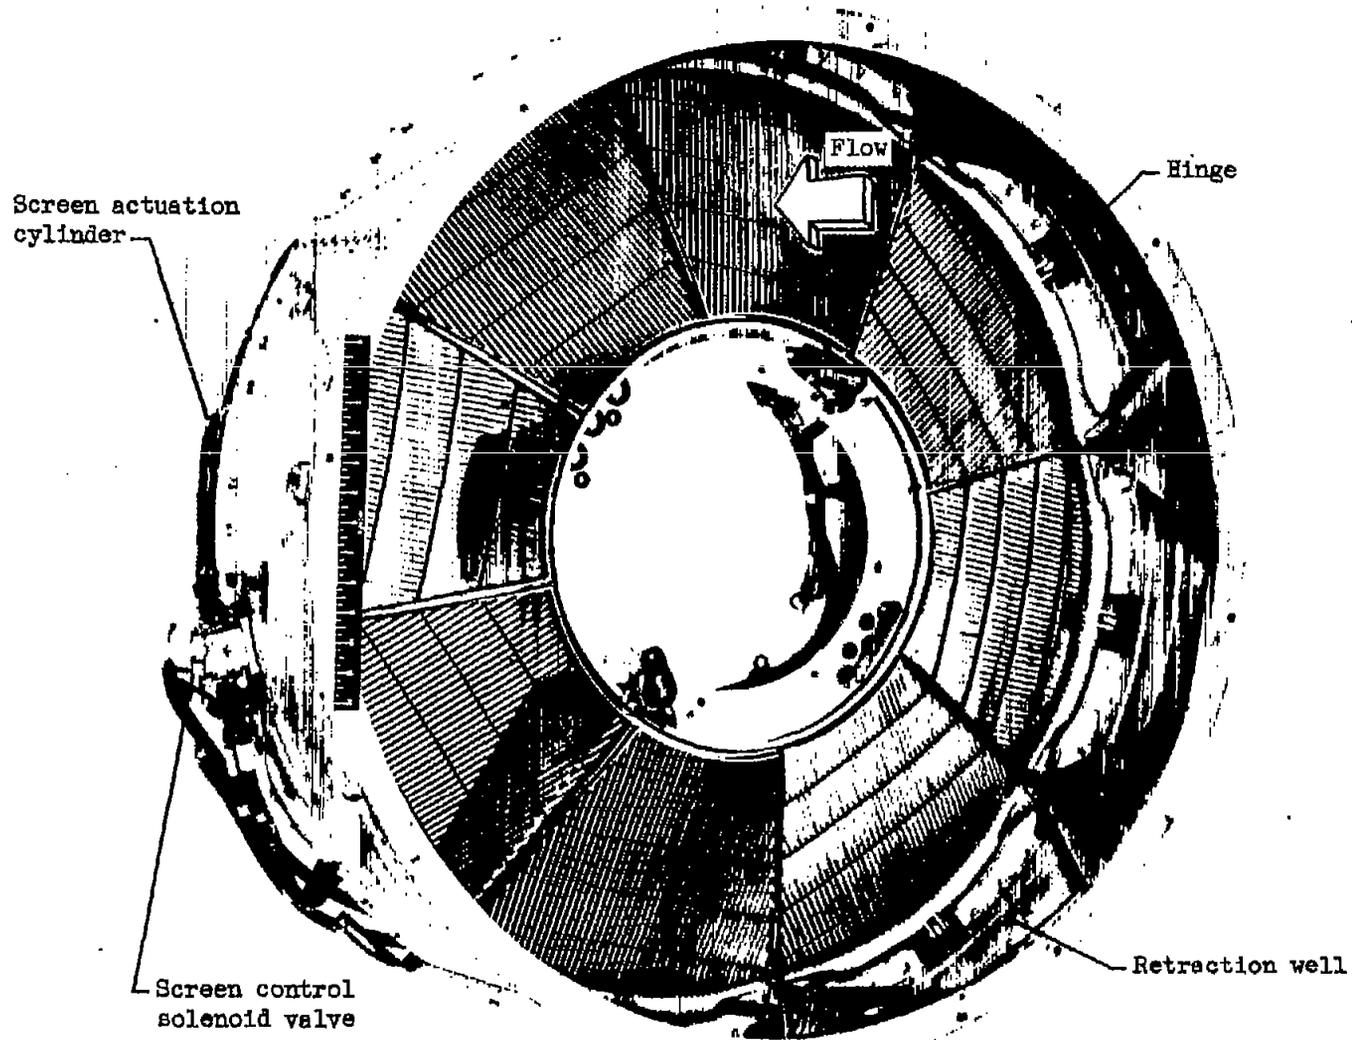
Figure 2. - Screen B installed in inlet section of engine B.

Both screens are divided into segments and are retracted by rotating forward about a hinge line located at the outer edge of the annulus. When the screens are fully retracted, they fit into a recess in the outer surface of the annulus. This recess is referred to herein as the "retraction well." The screen section of engine B has individual retraction

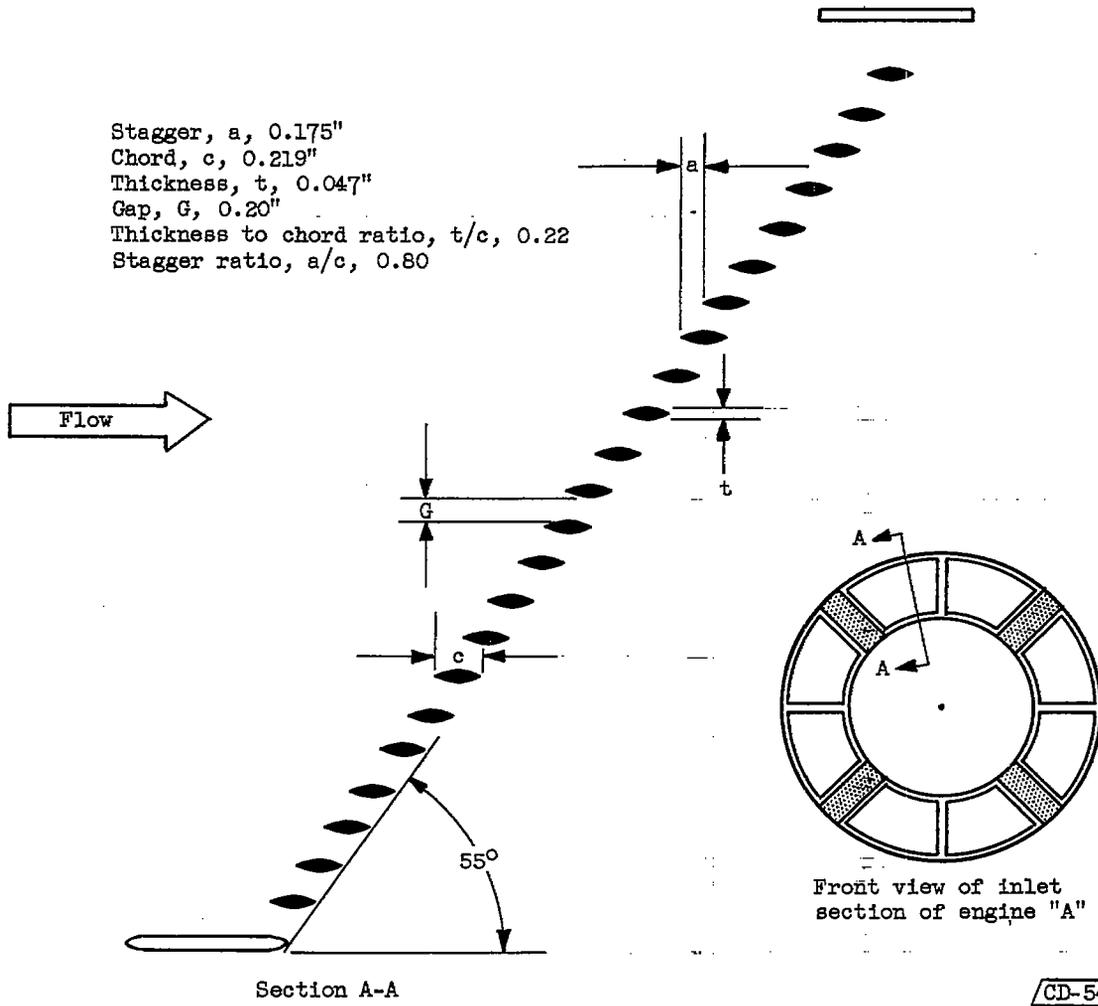
(a) Cross section.

Figure 3. - Cross-sectional views of screen A and installation.

Sketches showing cross-sectional views of these screens and their installations are shown in figures 3 and 4. It will be noted that screen A had an element thickness-to-chord ratio  $t/c$  of 0.22, a gap  $G$  of 0.20 inch, and a stagger ratio  $a/c$  of 0.80. Screen B had a thickness-to-chord ratio of 0.06, a gap of 0.22 inch, a small but variable stagger ratio, and a sweep angle of  $30^\circ$ .

Hinge detail and the location of retraction-well covers are shown in figures 3 and 4 also. The retraction-well covers shown by the dashed lines were pieces of sheet metal added at a later part of the investigation to smooth the outer wall of the inlet annulus.

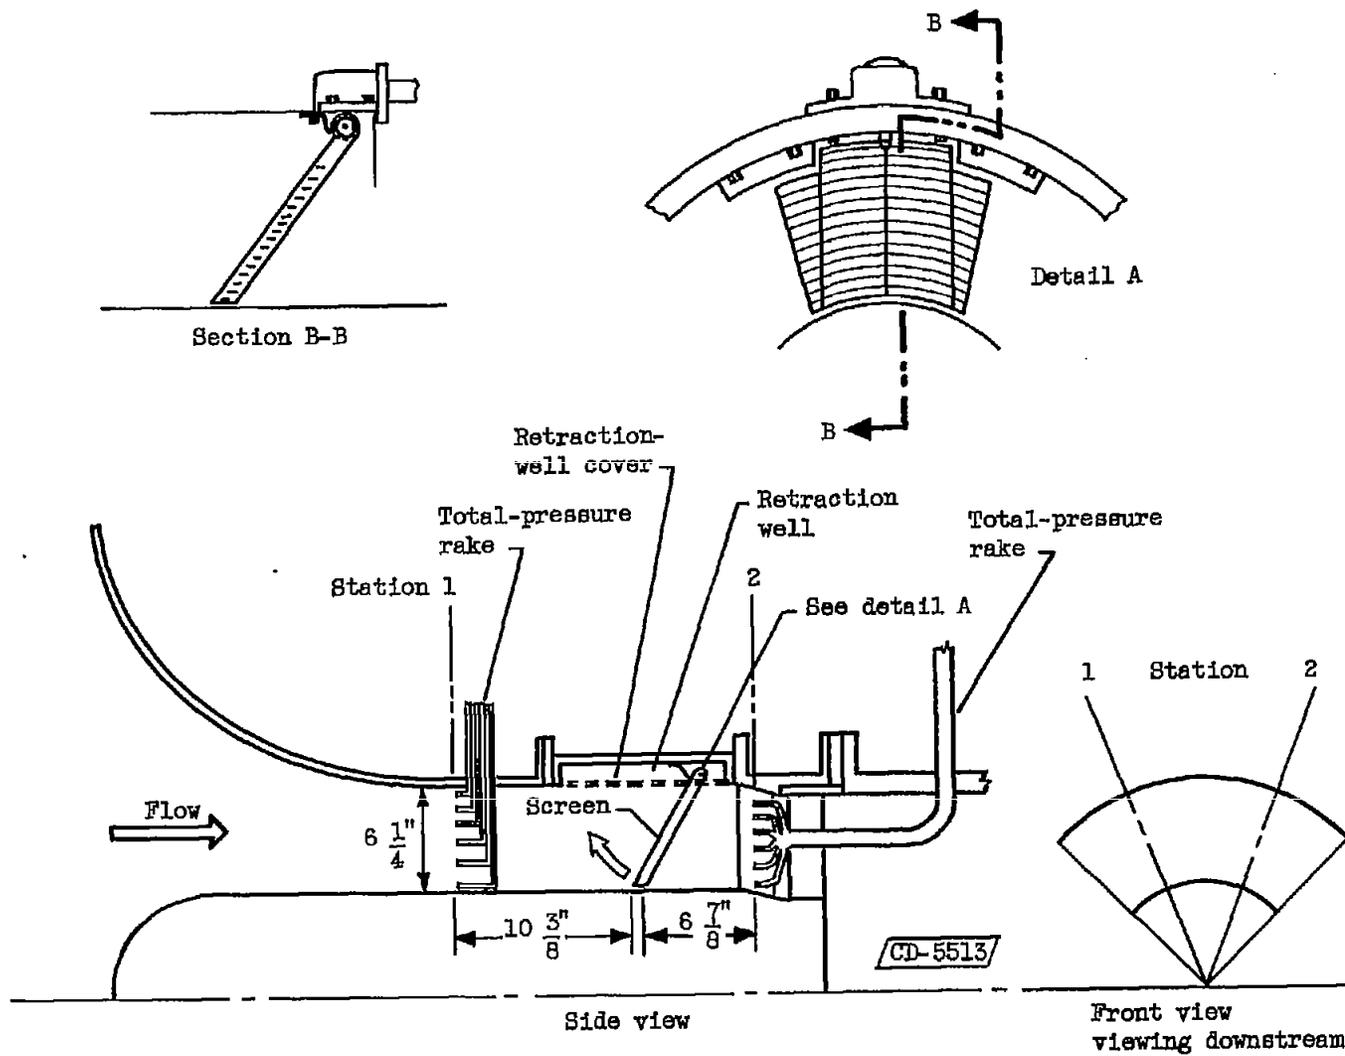
(b) Installation of screen A.

Figure 3. - Concluded. Cross-sectional views of screen A and installation.

Total-pressure rakes were installed upstream and downstream of the retractable screens to measure pressure loss through the screen station. The location of these rakes is shown in figures 3(b) and 4(b). The rakes were removed during the tests in which foreign objects were introduced.

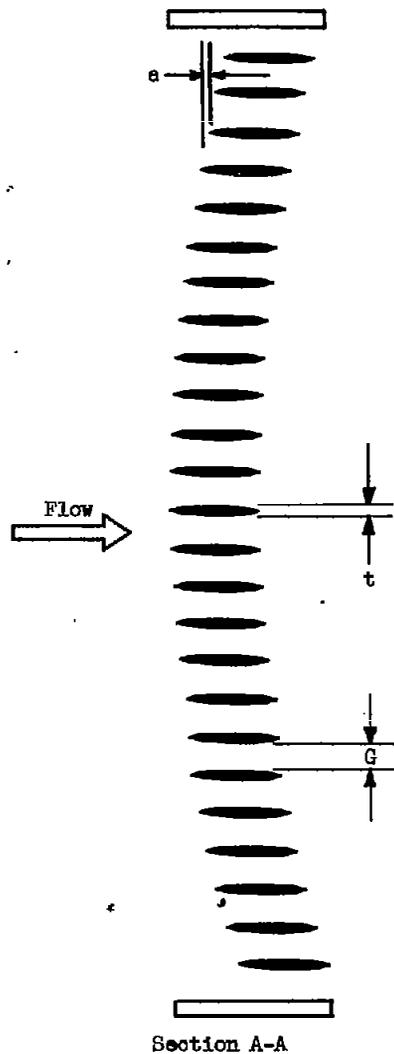
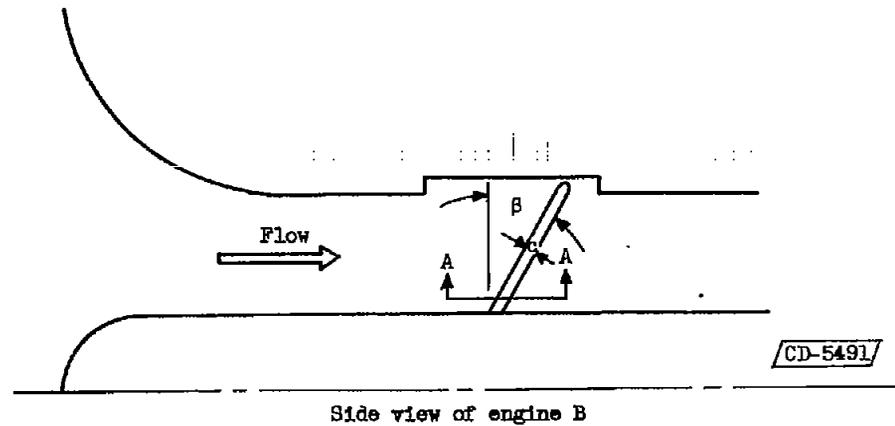
(a) Cross section.

Stagger,  $a$ , variable  
 Chord,  $c$ , 0.50"  
 Thickness,  $t$ , 0.031"  
 Gap,  $G$ , 0.22"  
 Sweep angle,  $\beta$ ,  $30^\circ$   
 Thickness to chord ratio,  $t/c$ , 0.06  
 Stagger ratio,  $a/c$ , variable

Figure 4. - Cross-sectional views of screen B and installation.

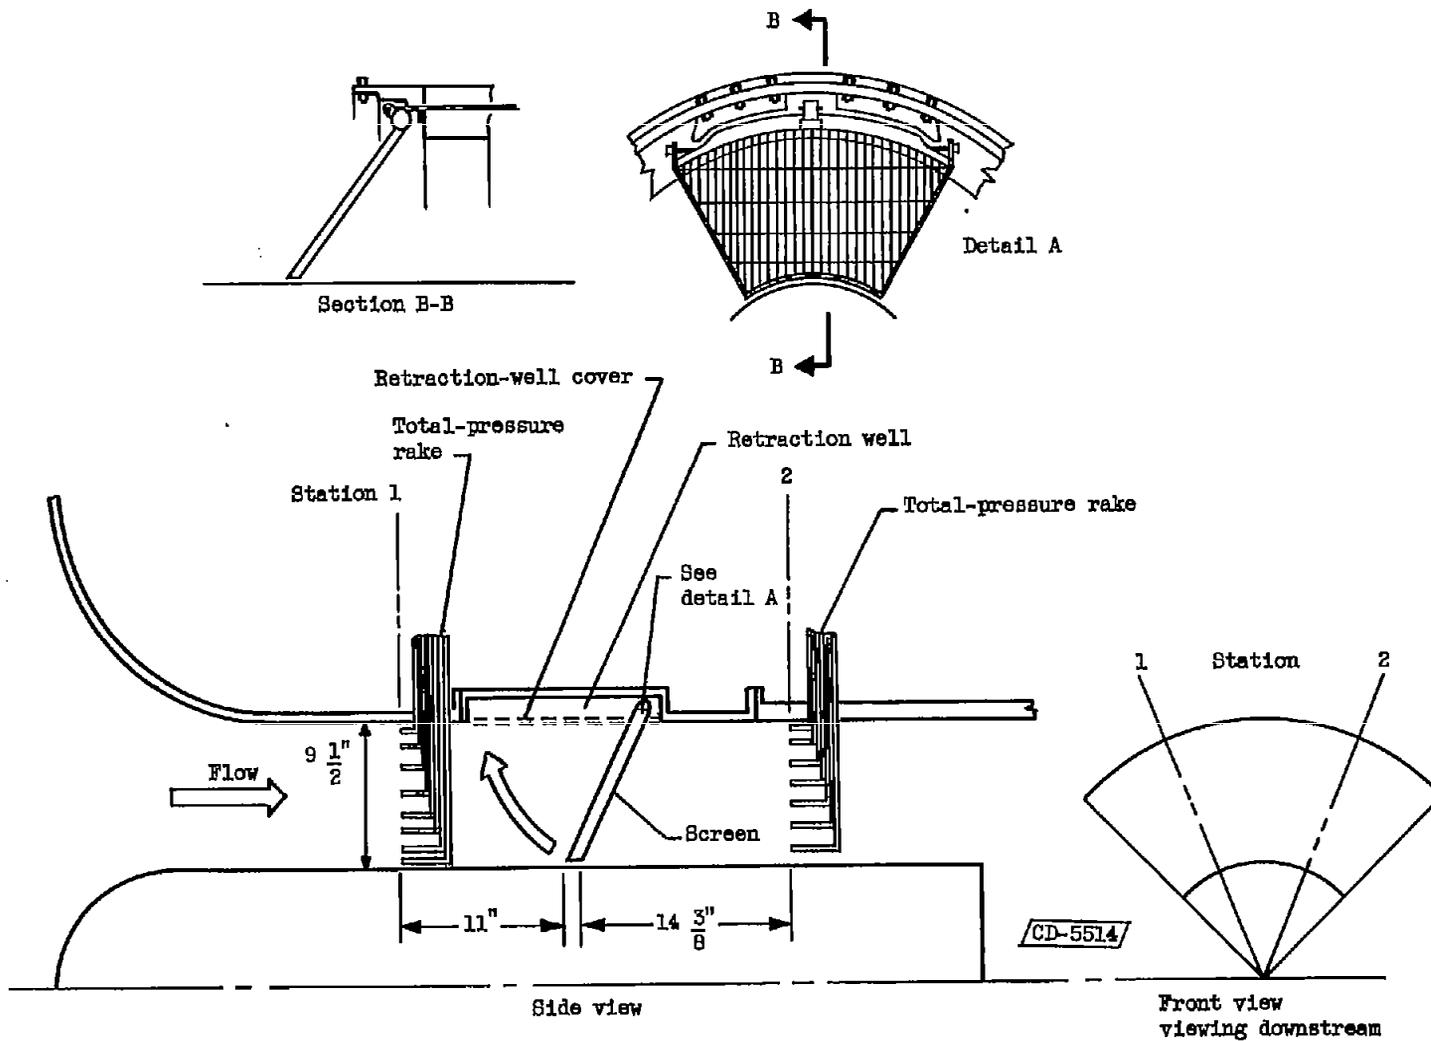
(b) Installation of screen B.

Figure 4. - Concluded. Cross-sectional views of screen B and installation.

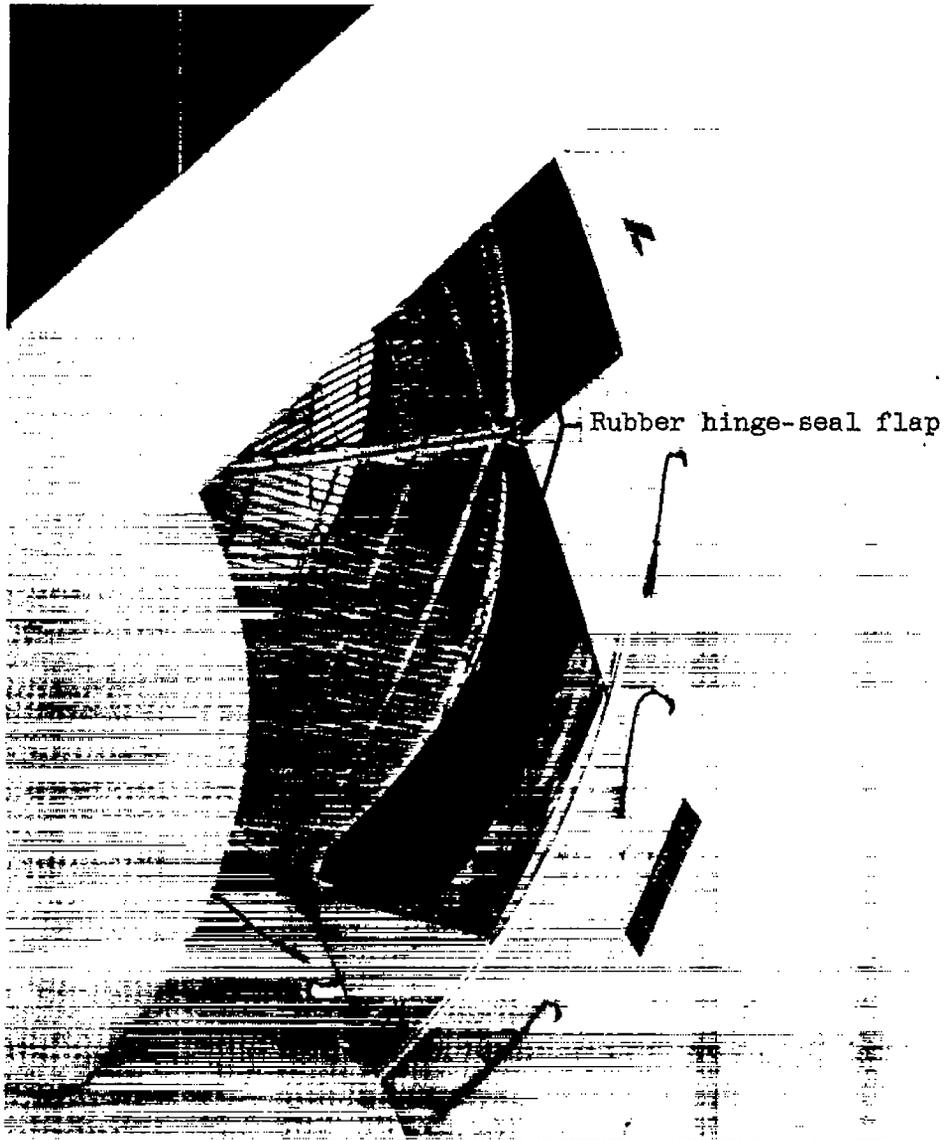
(a) Rubber hinge-seal flaps.

Figure 5. - Screen modifications.

The modifications made to screen B are shown in figure 5. Figure 5(a) shows the rubber hinge-seal flaps cemented in front of the hinge line, and figure 5(b) shows the intersegment gap cover made from wire cloth.

Modified screens. - Because the radial screen (screen B) caused much less turbulence during retraction than the circumferential screen (screen A) and because its major shortcoming was merely a large hinge gap, this screen was selected for modifications. Flexible rubber flaps (fig. 5(a)) were placed in front of the hinge. In addition, as a protection against losses due to turbulence and nonsynchronous retraction of the screen segments, wire cloth was fastened between the screen segments (fig. 5(b)). No objects were lost through this modified screen during the course of testing, which consisted of about 50 cycles of retraction and extension, at airflows ranging from 80 to 100 percent of rated. Although the modifications shown would not be acceptable for a flight installation because of the material and fabrication methods used, their success in preventing losses demonstrates that the retention capabilities of a segmented retractable screen can be considerably improved.

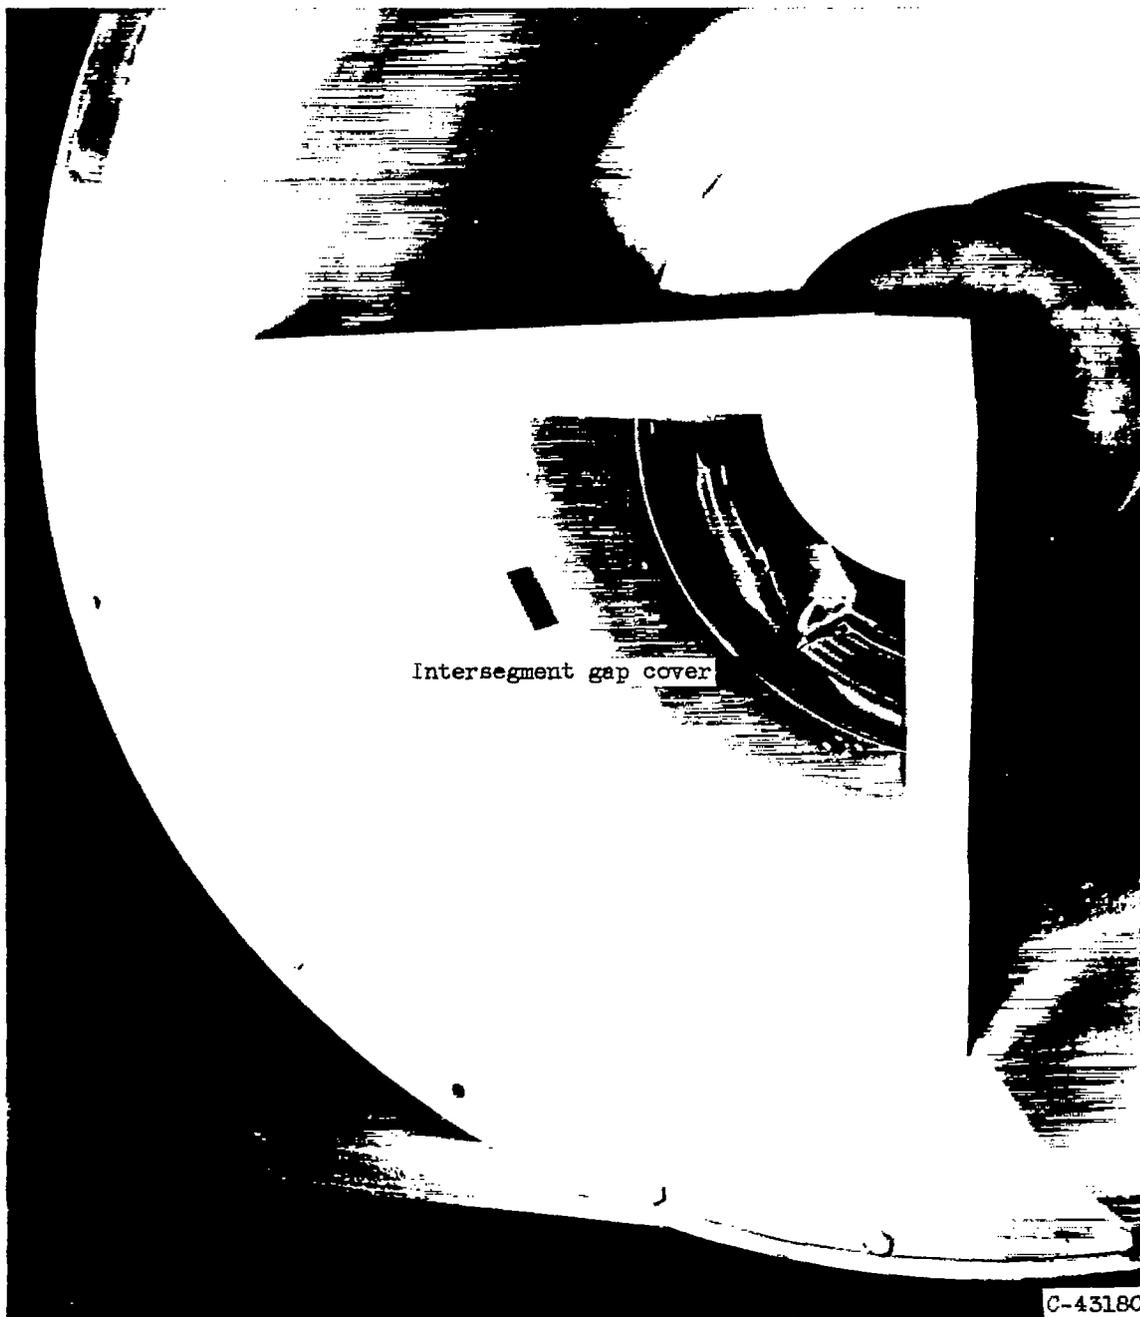
(b) Intersegment gap cover.

Figure 5. - Concluded. Screen modifications.

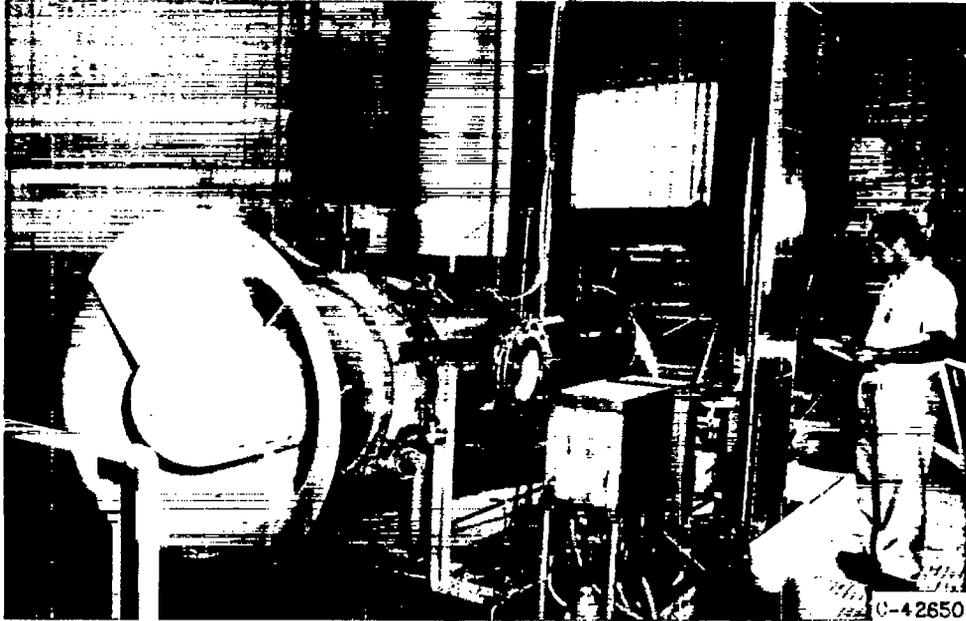
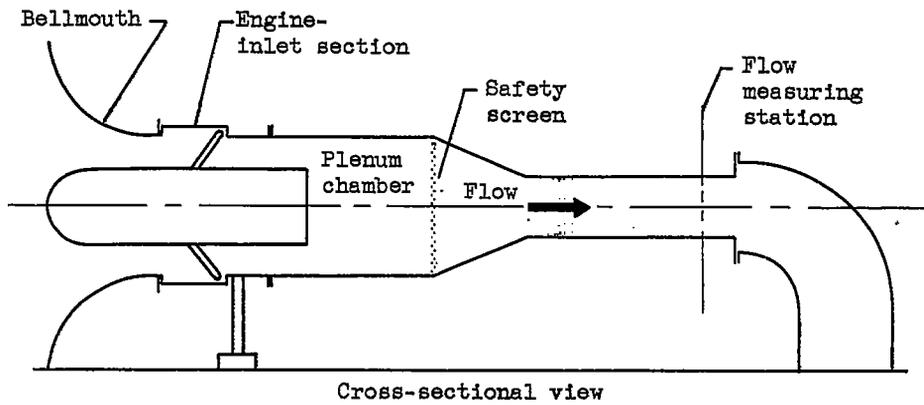
Figure 6. - Engine-inlet-screen test facility.

The test facility used in this investigation is shown in figure 6. The engine-inlet section containing the screens and actuation mechanism was attached to a plenum chamber, which was in turn attached to an exhaust system. A wire safety screen was located at the downstream end of the plenum chamber to recover objects lost by the retractable screens.

Eight total-pressure tubes and two wall static-pressure tubes located in a contracted section of pipe downstream of the plenum chamber (fig. 6) were used to measure airflow through the system.

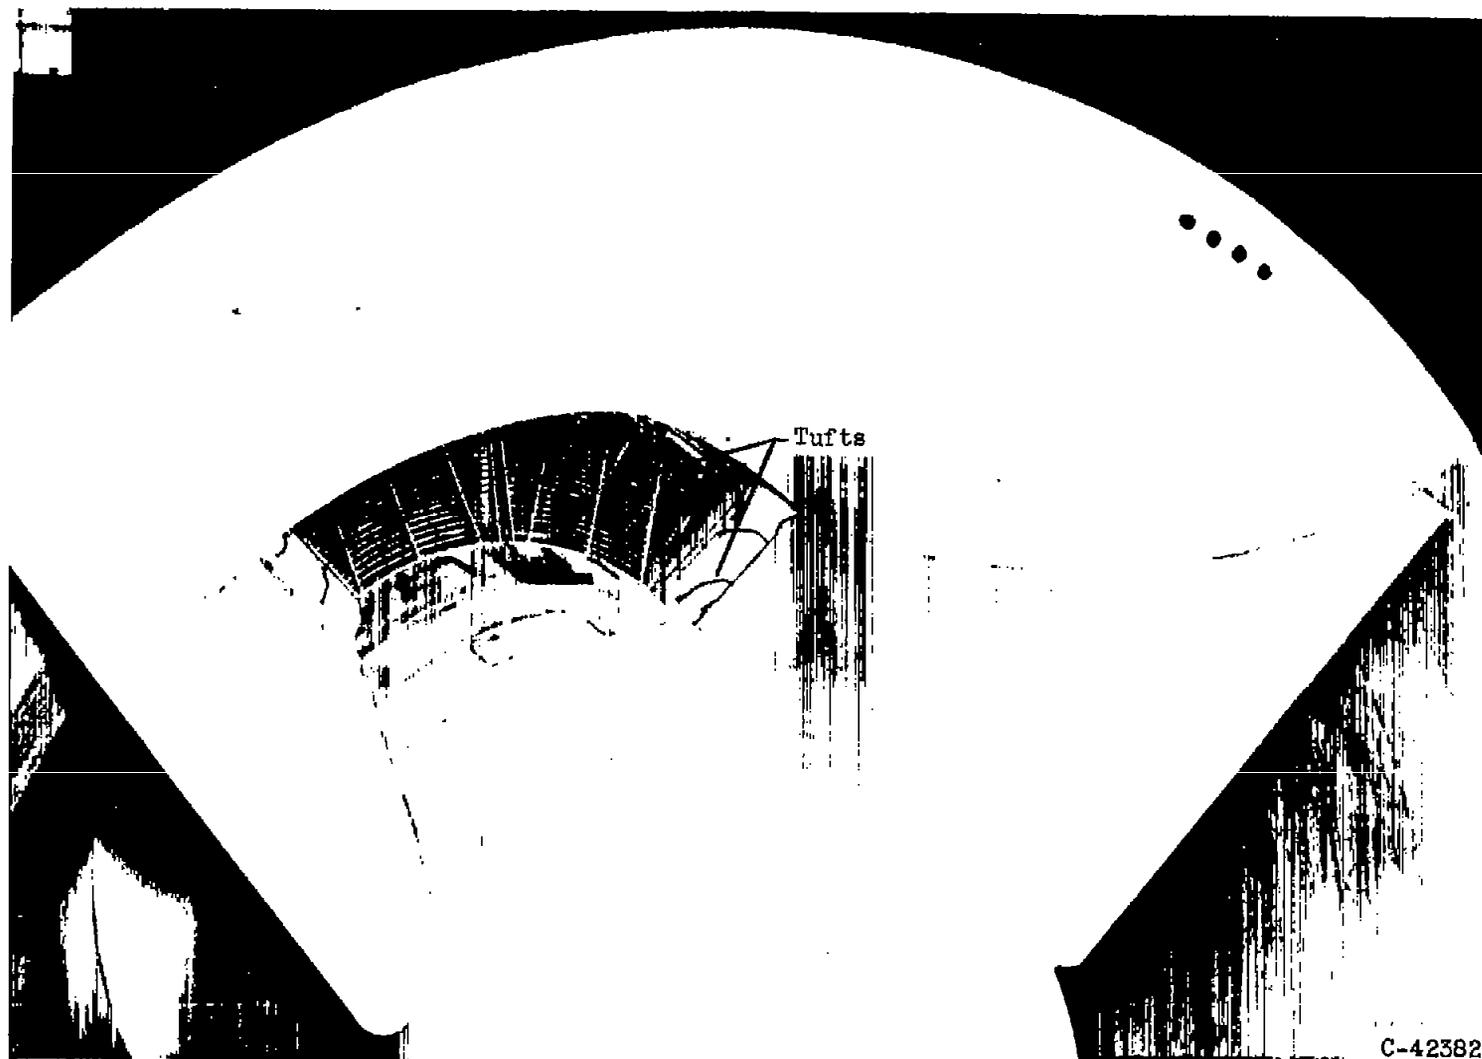
(a) Inlet of engine A.

Figure 7. - Ducting used to limit retention studies to one quadrant of engine inlet.

In order to systematically study the motion of the foreign objects, it was decided to observe only one quadrant of the engine inlet at a time. Three of the quadrants were therefore blocked. The flow to the quadrant being studied was guided by the bellmouth, the two radial sheet-metal walls, and the engine centerbody. This arrangement is shown in figure 7(a) for screen A and in figure 7(b) for screen B. Figure 7 shows the ducting as it was arranged during the testing of the screens in the top quadrant. The ducting was rotated to the side and bottom quadrants during the course of the investigation.

Nylon-yarn tufts were attached to the screens and the duct walls to aid in determining the direction of local flows and turbulence. These tufts can be seen in figure 7.

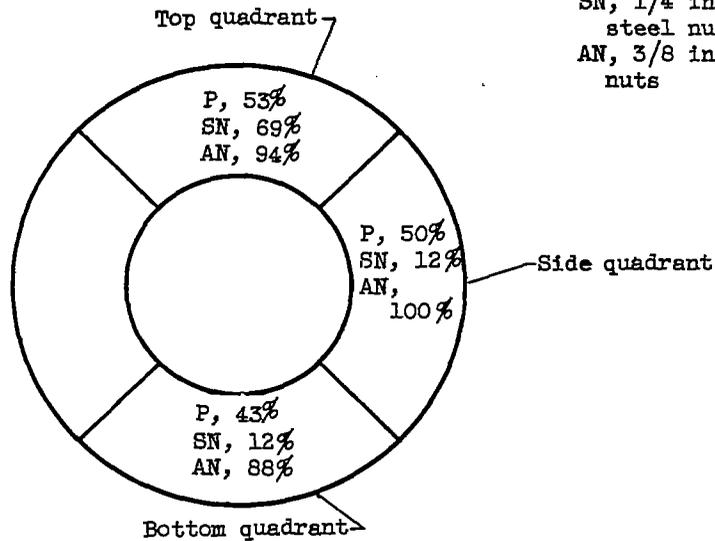
(a) Screen A

- P, 3/8 to 1/2 in. pebbles
- SN, 1/4 in. castellated steel nuts
- AN, 3/8 in. aluminum stop nuts

Figure 10. - Percentage of objects of each type in each quadrant retained by retractable screens A and B.

Unmodified screens. - The percentage of objects retained by screens A and B is shown in figure 10. The percentages shown are those of a particular type object in a particular quadrant retained over the course of the entire investigation. In most cases these percentages are based on about 20 objects of each type in each quadrant. The generally low values in figure 10 demonstrate that both screens A and B in their unmodified form failed to do a satisfactory job of foreign-object retention.

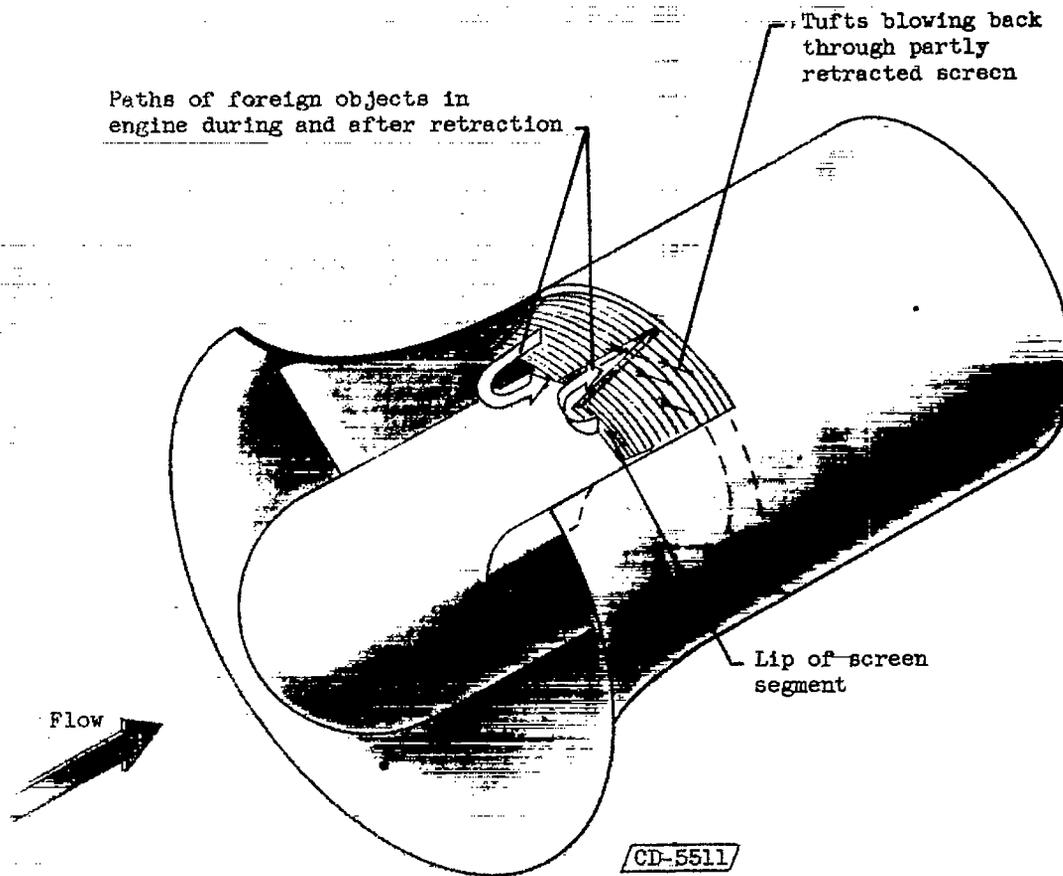
(a) Paths of foreign objects dislodged from circumferential element screens by flow stall and turbulence.

Figure 11. - Types of foreign-object loss.

The screens failed to retain objects in several different ways. It will be recalled from the APPARATUS section that screen A had circumferentially arranged screen elements. Observations of tufts attached to the screens indicated that the circumferential screen elements, which moved to a high angle of attack during retraction, caused the flow through the screen to first stall and then flow turbulently back through the screen, dislodging objects present on the face of the screen. In many instances the dislodged objects were blown over the lip of the screen or between the screen segments. Both paths are shown in figure 11(a). Flow stall loss also occurred as the screen was extended.

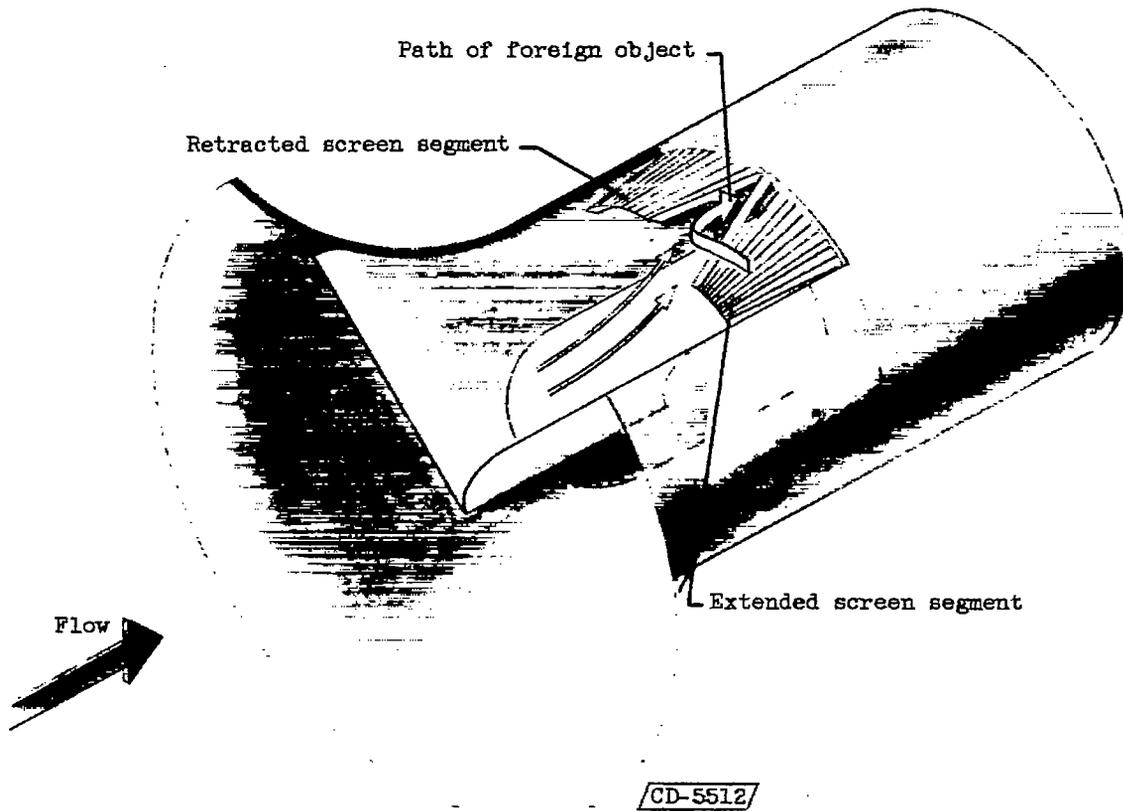
(b) Paths of foreign objects dislodged from screens by circumferential flow resulting from nonsynchronous retraction of screen segments.

Figure 11. - Concluded. Types of foreign-object loss.

The B screens were actuated hydraulically and retracted much faster than the electromechanically operated A screens. Fast retraction appeared to have some advantage since less time was allowed for turbulence to dislodge objects from the screens during retraction. However, the screen segments of screen B retracted individually rather than simultaneously. It is believed that, in a few instances, the resulting circumferential flow blew objects laterally across the face of the extended screen segment and that the objects then escaped through the opening left by the fully retracted segment. The path of a foreign object under these conditions is sketched in figure 11(b). However, relatively few objects were lost in this manner.

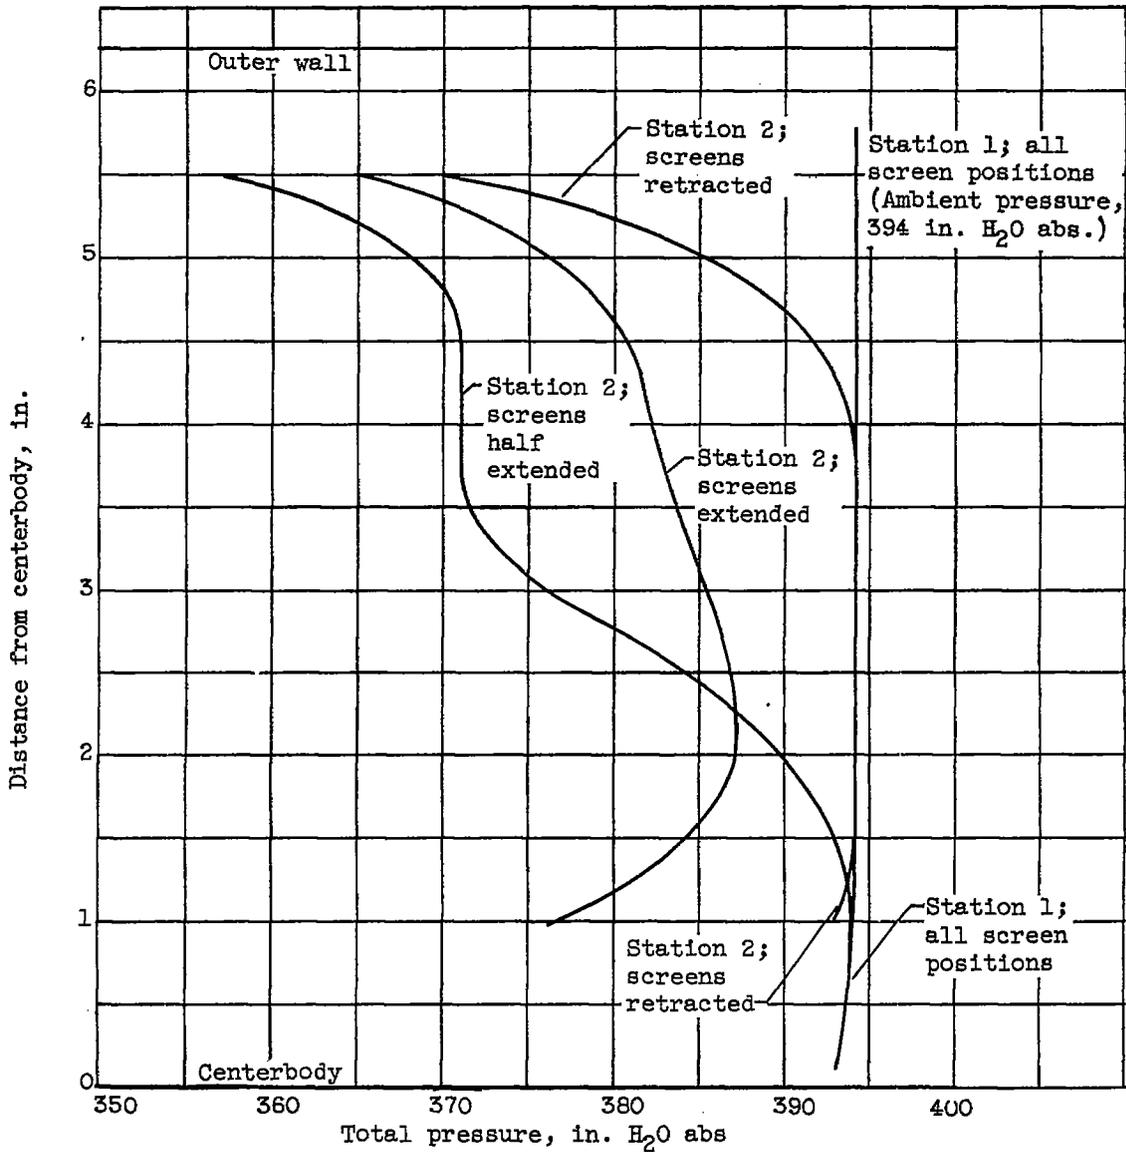
(a) Retraction wells uncovered

Figure 12. - Total-pressure profiles in inlet section using screen A. Mach number, 0.48; airflow about 100 percent of rated sea-level static flow.

screen type. These profiles are shown in figures 12 and 13 where the pressures shown are the mean values of a 3 percent pressure fluctuation, which occurred because of the nature of the ducting. Figure 12(a) shows the profiles for the unmodified screen A. Curves for screens retracted, screens extended, and screens half extended are shown. As would be expected, the pressure at station 2 is less with the screens extended than with the screens retracted, and a flow distortion exists with the screens half extended. Because all the pressure profiles dropped near the outer wall (near the retraction wells), the wells were covered. The resulting profiles, which are shown in figure 12(b), are considerably flatter.

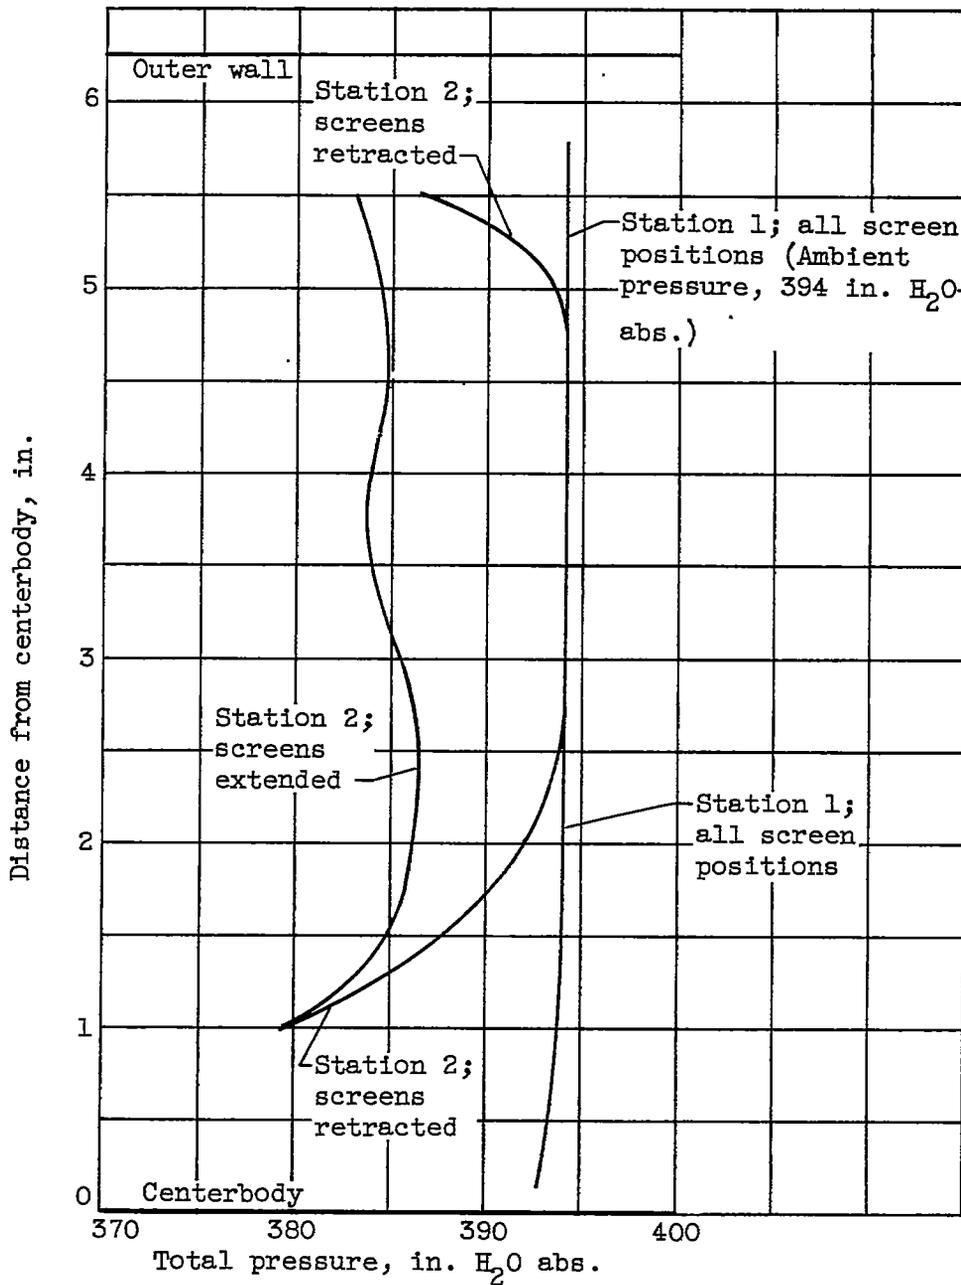
(b) Retraction wells covered

Figure 12. - Concluded. Total-pressure profiles in inlet section using screen A. Mach number, 0.48; airflow about 100 percent of rated sea-level static flow.

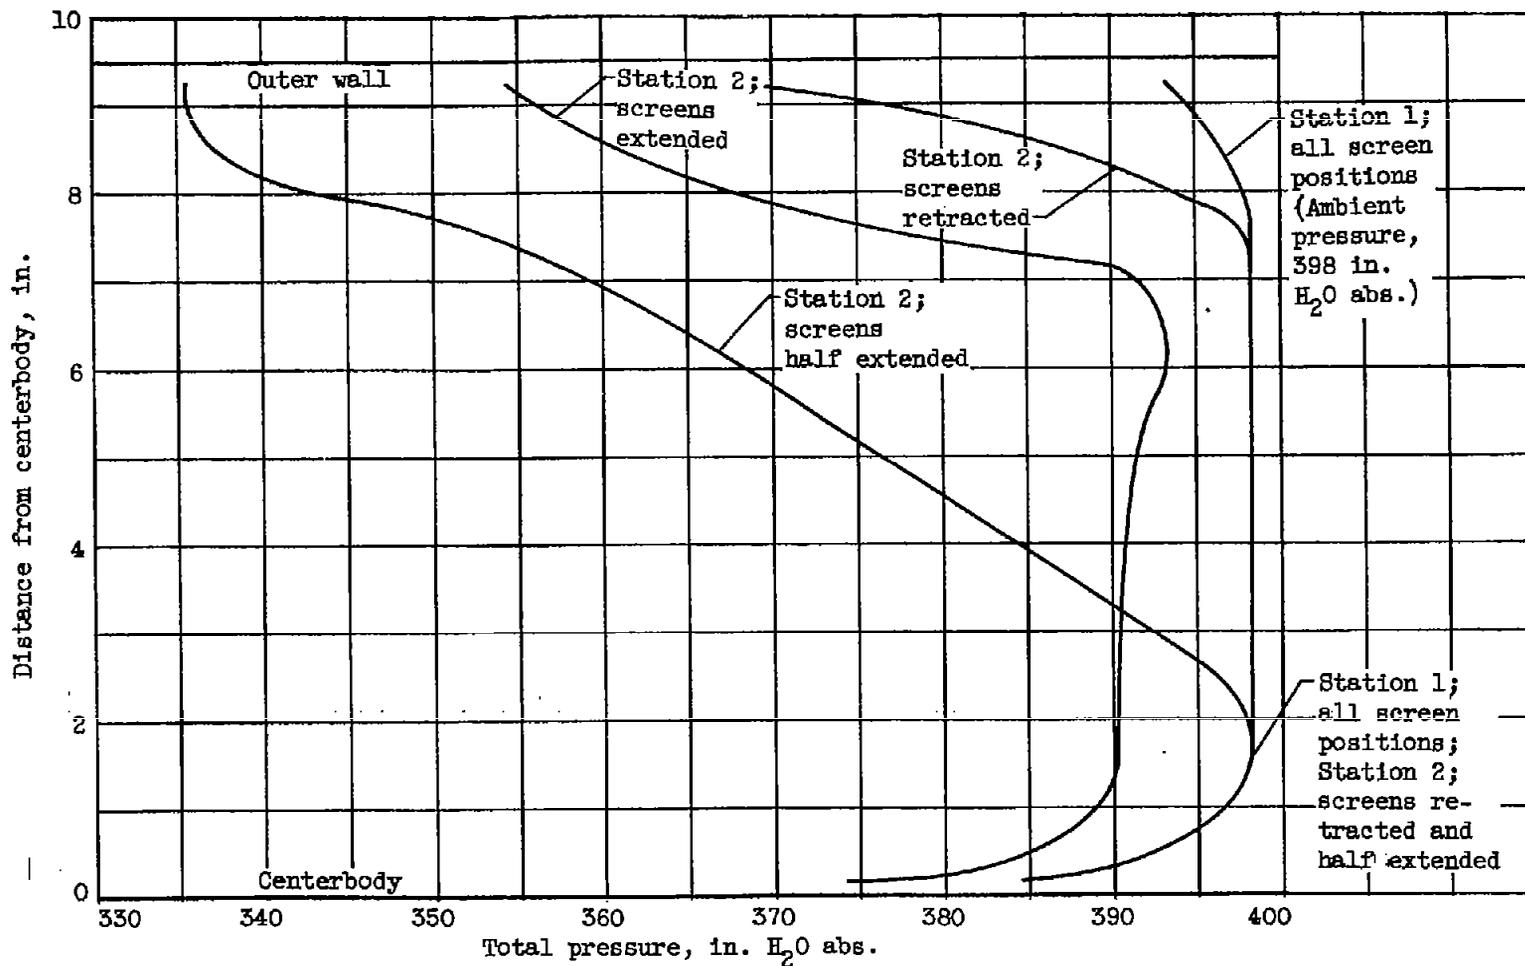
(a) Retraction wells uncovered

Figure 13. - Total-pressure profiles in inlet section using screen B. Mach number, 0.43; airflow about 100 percent of rated sea-level static flow.

The profiles obtained with screen B are shown in figure 13. Figure 13(a) shows the profiles with the unmodified inlet, and figure 13(b) shows the profiles with the retraction wells covered. Covering the retraction wells again raised the pressures toward the outer wall, thus tending to flatten the profiles.

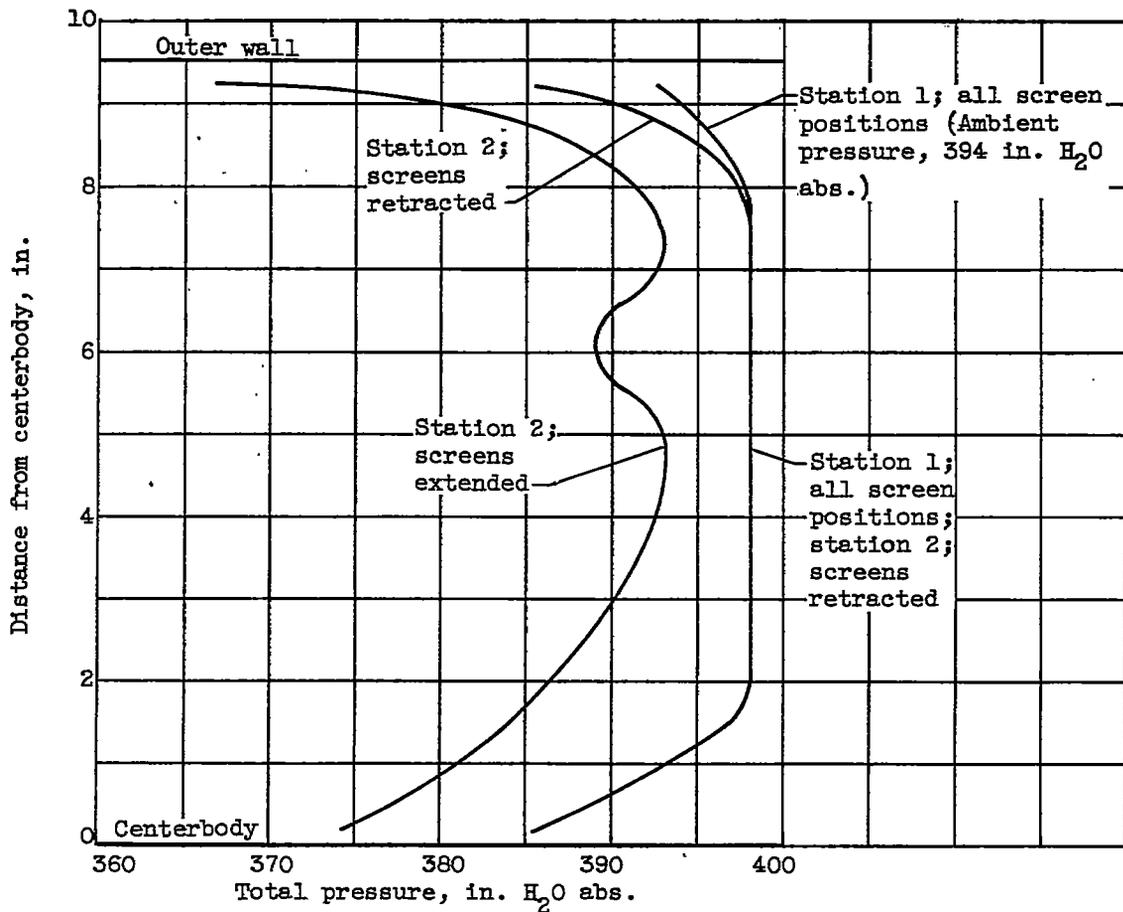
(b) Retraction wells covered

Figure 13. - Concluded. Total-pressure profiles in inlet section using screen B. Mach number, 0.43; airflow about 100 percent of rated sea-level static flow.
