NACA RM E57A15

FOREIGN-OBJECT RETENTION AND FLOW CHARACTERISTICS OF  
RETRACTABLE ENGINE-INLET SCREENS

By Fred W. Steffen and Lewis A. Rodert

WASHINGTON  
July 26, 1957

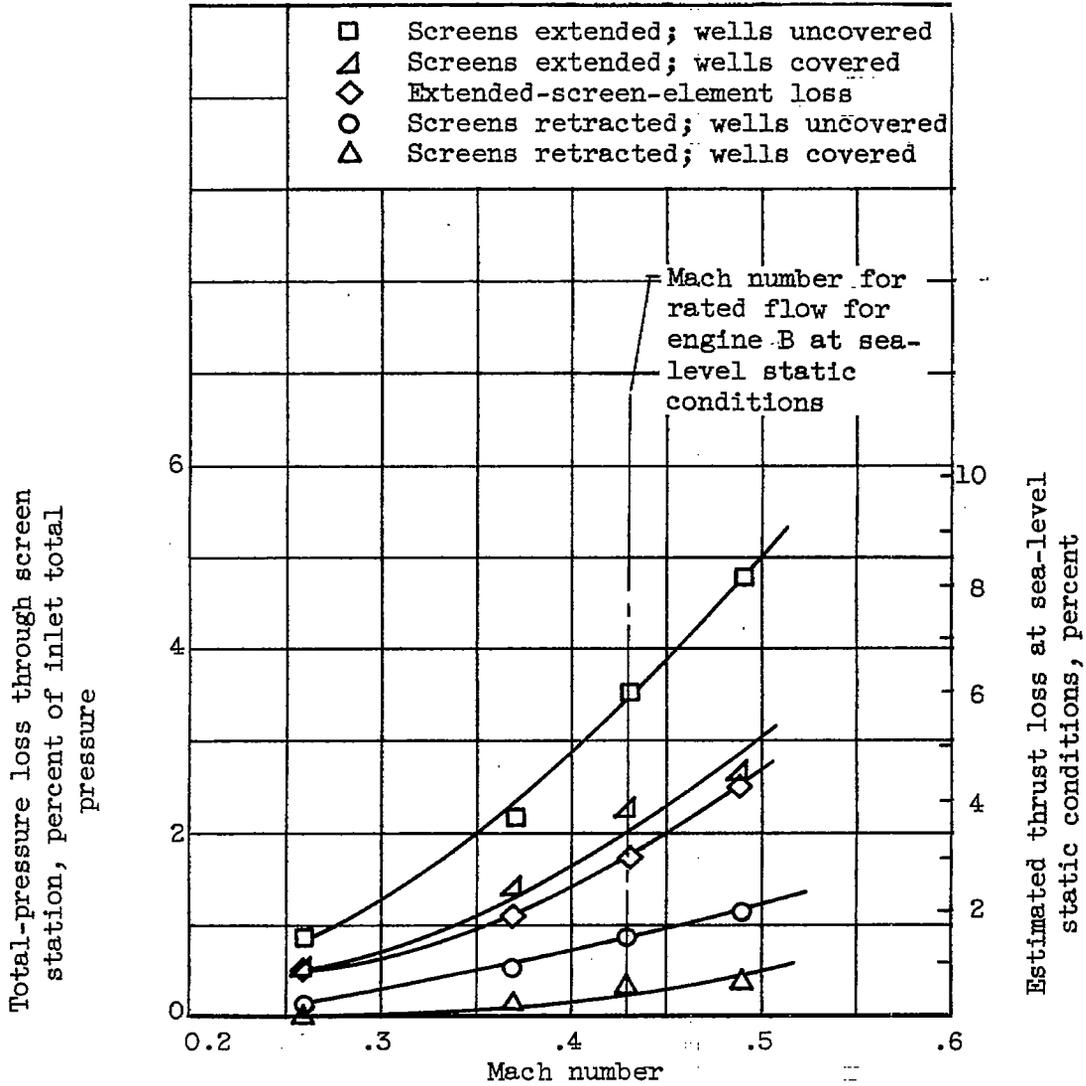
Figure 14. - Variation of total-pressure loss with Mach number in inlet of engine B.

Pressure loss. - Total-pressure loss through the screen station was computed for screen B only, and is shown in figure 14 as a function of Mach number. A mass-flow weighting technique based on measured total pressures, and a static pressure calculated from the total pressures, the flow area, and the weight flow was used to evaluate the average total pressure upstream and downstream of the screen. Similar data for screen A are not shown because its mounting section contained large bearing support struts (fig. 1), which disturbed the air entering the screens, making it impossible to evaluate the losses caused by the screens in that area. On the other hand, the mounting section for screen B was unencumbered by support struts (fig. 2) so that a pressure loss measured at one radial position was closely representative of the loss around the entire screen station. However, it was not certain whether the measured pressure loss was affected by the sharp-cornered ducting leading to the screens. To substantiate the measured pressure loss, an estimated thrust loss at static sea-level conditions was computed from the pressure loss according to the equations of reference 2. The resulting thrust loss compared favorably with thrust losses measured during flight tests with several similar inlet screens as reported in references 3 to 5. A scale of estimated thrust loss at static sea-level conditions is included on the right side of figure 14.

Figure 14 contains curves for the screens retracted and extended with the retraction wells covered and uncovered. A pressure-drop curve for the screen elements alone is also shown. This curve was obtained by measuring the pressure loss in midstream, and represents the minimum loss that could be obtained from this particular screen in its extended position. The screen elements curve falls just slightly below the curve for the screens extended with wells covered, and both of these curves are considerably below the curve of the screens extended with

wells uncovered. Therefore, about half of the pressure loss with the screens extended could be avoided and the pressure loss of the installation reduced to almost the screen element loss by devising some mechanism to cover the retraction wells after the screens have been extended.

The curve for pressure loss with screens retracted and wells uncovered is the loss that would be incurred during cruising flight with the unmodified screen section. This loss could be reduced to less than half by covering the wells after the screens were retracted, as shown by the curve for screens retracted and wells covered.

In general, it is evident from figure 14 that the pressure loss of any configuration could be reduced by locating the screen at a low Mach number station in the duct.
