RM A53G22

# RESEARCH MEMORANDUM

CORRELATION OF FLIGHT AND WIND-TUNNEL MEASUREMENTS OF  
ROLL-OFF IN LOW-SPEED STALLS ON A 35°

SWEPT-WING AIRCRAFT

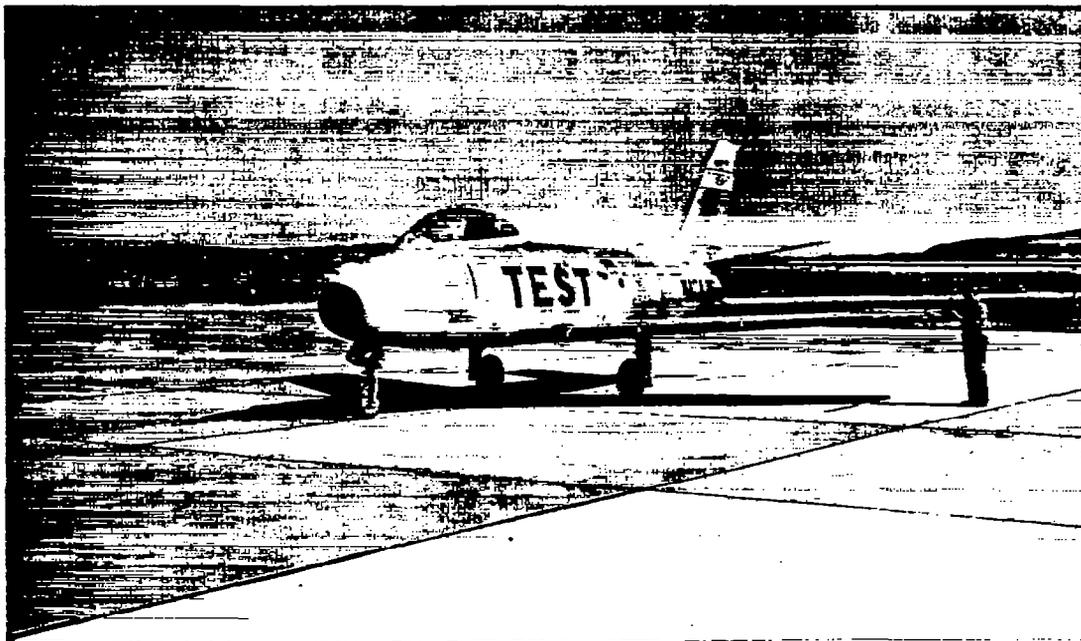
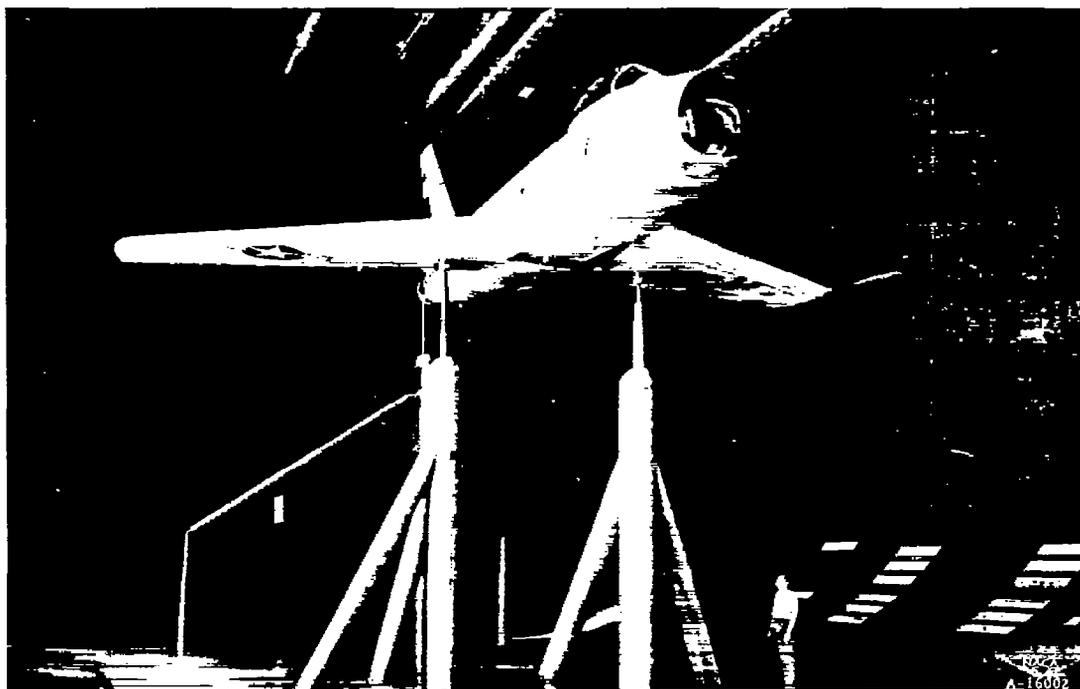
(a) Airplane tested in flight.

(b) Airplane tested in the 40- by 80-foot wind tunnel.

Figure 1.- Photographs of test airplane.

The tests were conducted on a jet-powered fighter aircraft having sweptback wing and tail surfaces. Photographs of similar test airplanes as prepared for flight and wind-tunnel tests are presented in figures 1(a) and 1(b), respectively. Figure 2 is a two-view drawing of the airplane. A description of the geometric details of the airplane is given in table I.

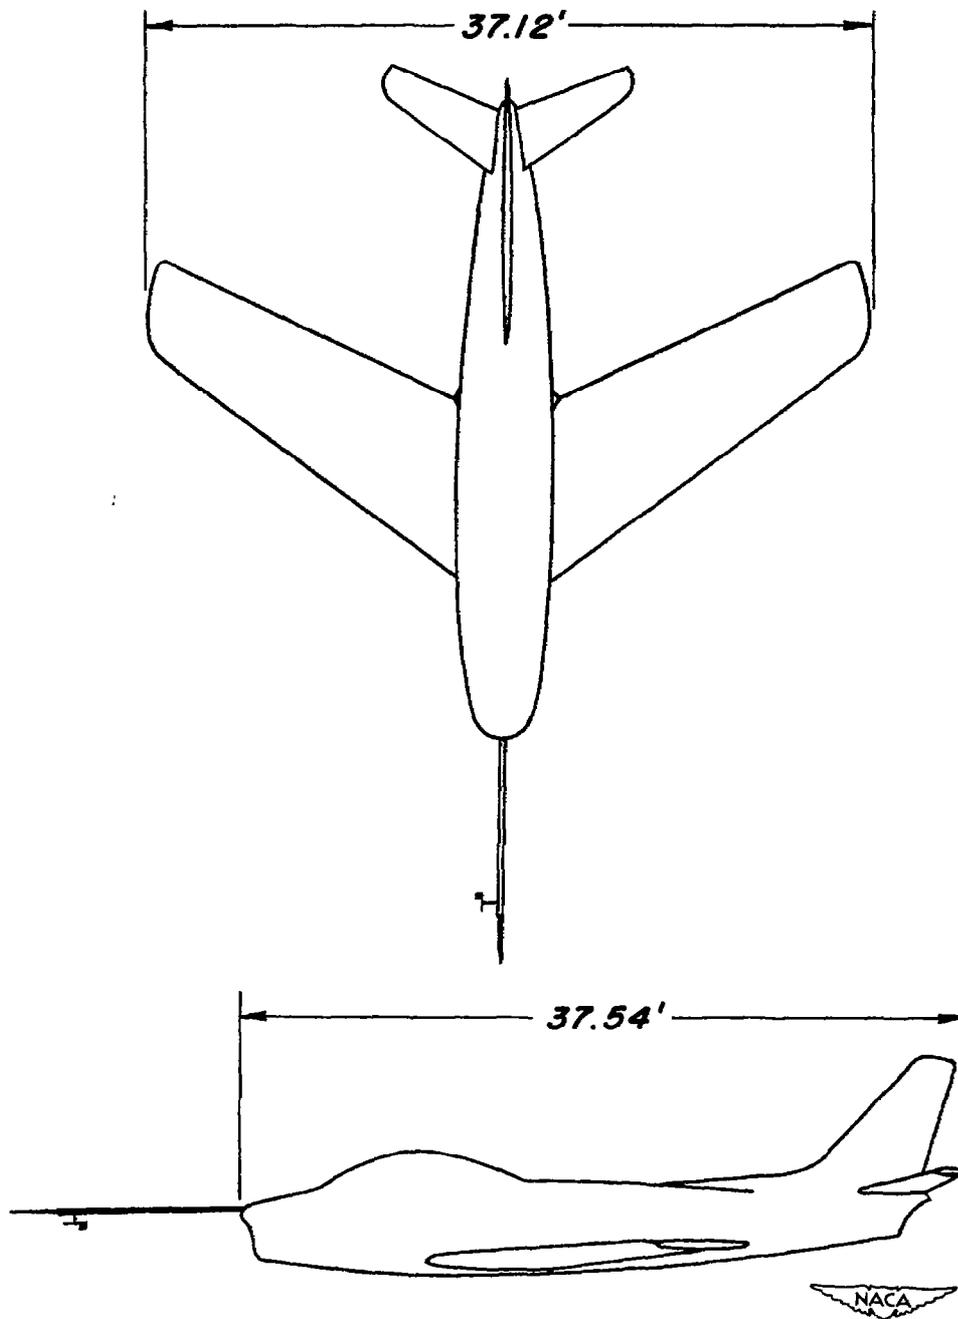
Figure 2.- Two-view drawing of the test airplane.

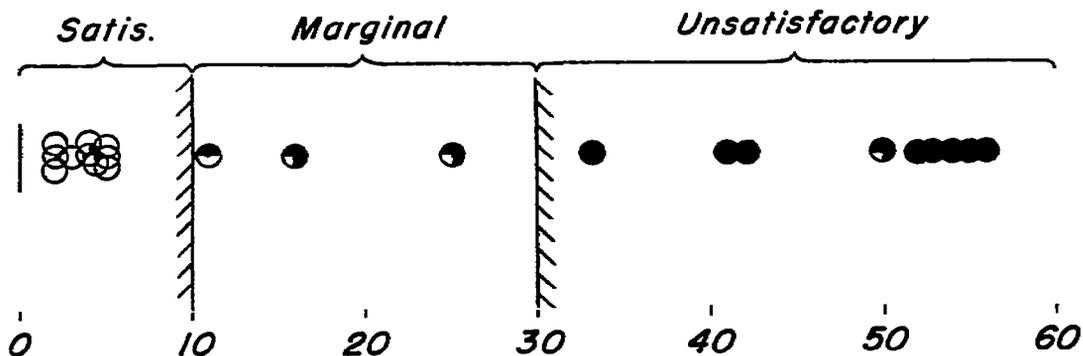
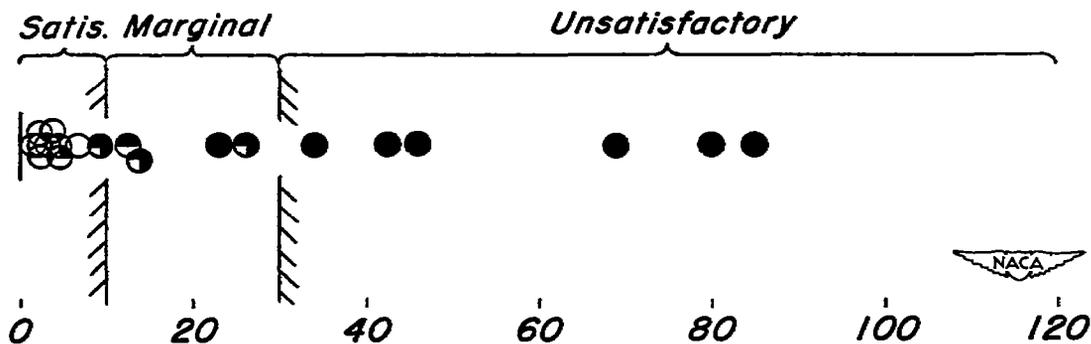
(a) Maximum bank angle resulting from initial roll-off,  $\phi$ , deg.

(b) Maximum rolling velocity resulting from initial roll-off,  $\dot{\phi}$ , deg/sec.

Figure 3.- Correlation of pilots' opinions of stall with various parameters.

the stall. This correlation of pilots' opinions with behavior in the complete stall is similar to a study previously made (ref. 2) for stall warning in which pilots' opinions of stall warning were correlated with quantitative factors producing the warning. It appeared that the primary factors which could influence the pilots' opinions in the complete stall were the initial bank angle inadvertently attained and the maximum rolling velocity during the initial roll-off. The initial values of these quantities were examined since it was known that the wind-tunnel balance system would not give representative rolling-moment measurements in the dynamic phase of roll behavior occurring later in the stall. A correlation of these quantities with pilots' opinions is shown in figure 3. These results show that a bank angle of the order of  $10^\circ$  or less and a rolling velocity of  $10^\circ$  per second or less represented a satisfactory stall, while values of angle of bank of  $30^\circ$  or more and rolling velocities of  $30^\circ$  per second or more represented unsatisfactory stall behavior. These values are in accordance with those presented in the German flying-qualities requirements of reference 3 and those proposed for military aircraft in reference 4. The German requirements specify, however, a time duration of 10 seconds of stalled flight for which  $\pm 30^\circ$  bank angle should not be exceeded, while the results in figure 3 are presented only for the initial angle of bank at the start of the stall.

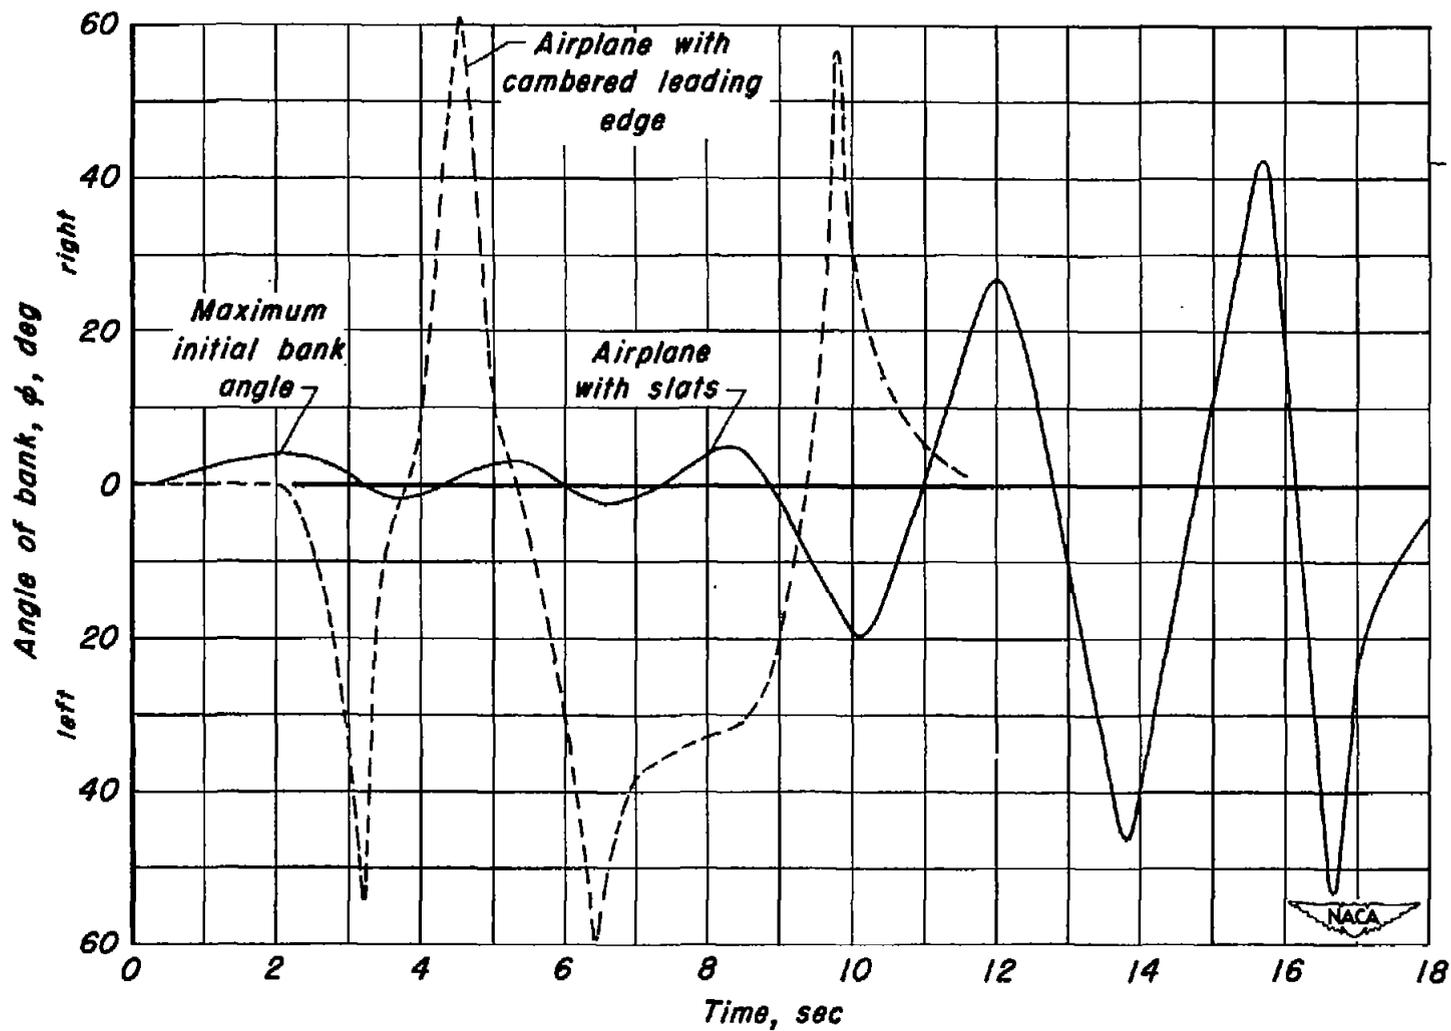
Figure 4.- Time histories of stalls for various configurations in which the pilot attempted to maintain wings level flight by use of the controls. Flaps down.

The significance of the initial departure from wings-level flight and the effect of time duration in the stall are illustrated by comparing time-history data (fig. 4) of angle of bank for the airplane with a cambered leading edge (judged unsatisfactory by the pilots) and for the normal airplane with slats open (judged satisfactory). These data show that although each configuration reached an angle of bank slightly greater than  $50^\circ$ , the initial departure from wings-level flight was more gradual for the airplane with slats. The build-up of rolling motions with time for the airplane with slats is felt by the pilot to be due to the inability to operate the controls with the proper phase relationship in the stalled region where control effectiveness is reduced and the rolling moments due to sideslip and yawing velocity may be large.

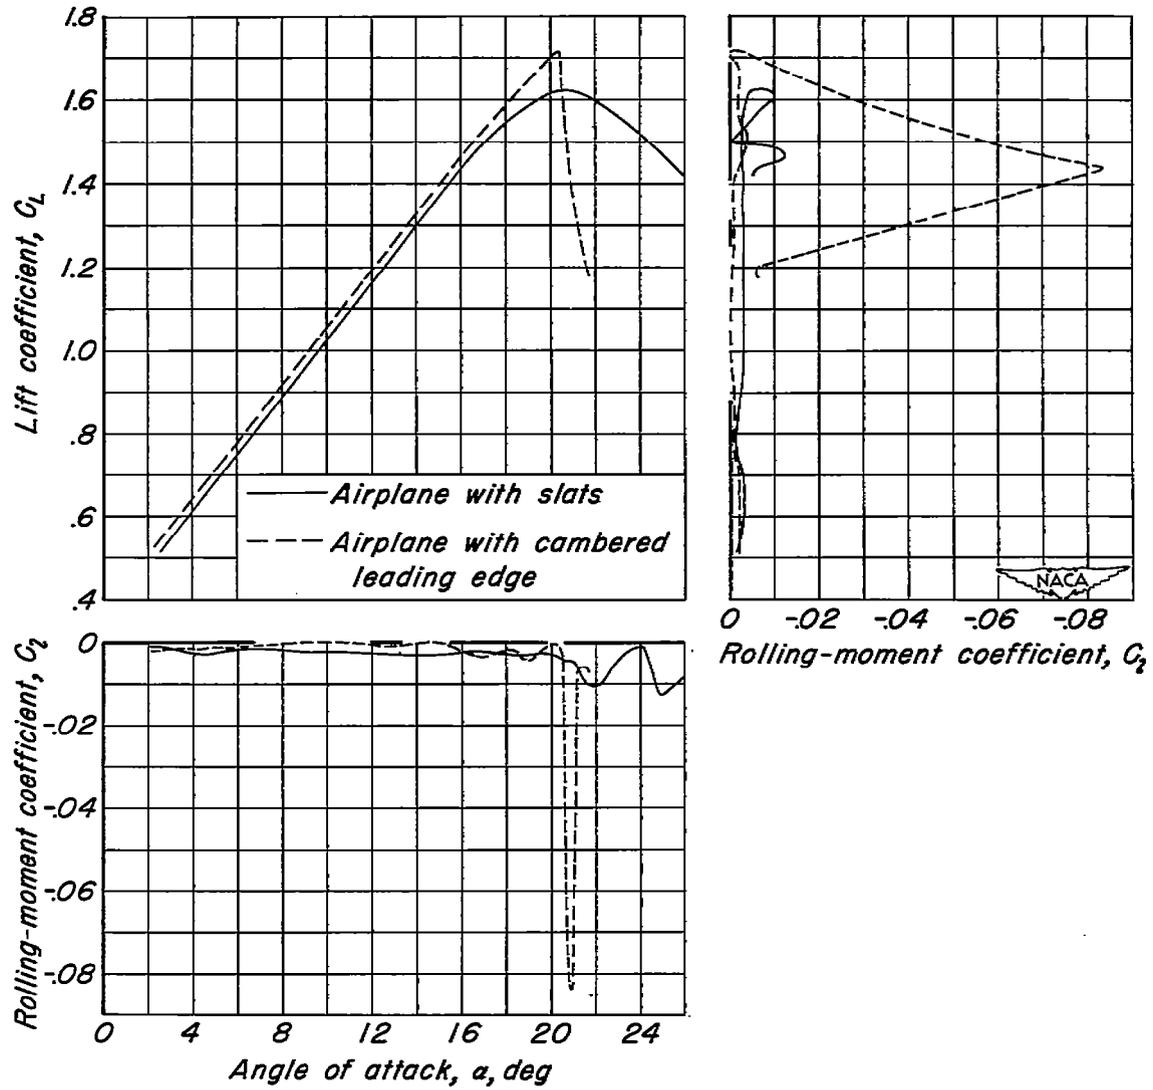
Figure 5.- Lift and rolling-moment characteristics for various configurations.

Examination of the wind-tunnel force data showed that both of the afore-mentioned configurations were characterized by a rolling-moment increment at maximum lift. An example of the relationship between the lift-curve peak and the rolling moment as measured in the wind tunnel is shown in figure 5. These results show for the cambered leading edge a sharp lift-curve peak and an abrupt rolling-moment break of large magnitude at maximum lift. In contrast, the slats-open case showed a rounded lift-curve peak and relatively small variations in rolling moment in the region above maximum lift. It is also shown in figure 5 that the large magnitude of rolling-moment increment for the cambered leading-edge configuration existed only over a relatively small angle-of-attack range. It should be pointed out that to obtain wind-tunnel data of this type, the stall must be approached at angle-of-attack increments no greater

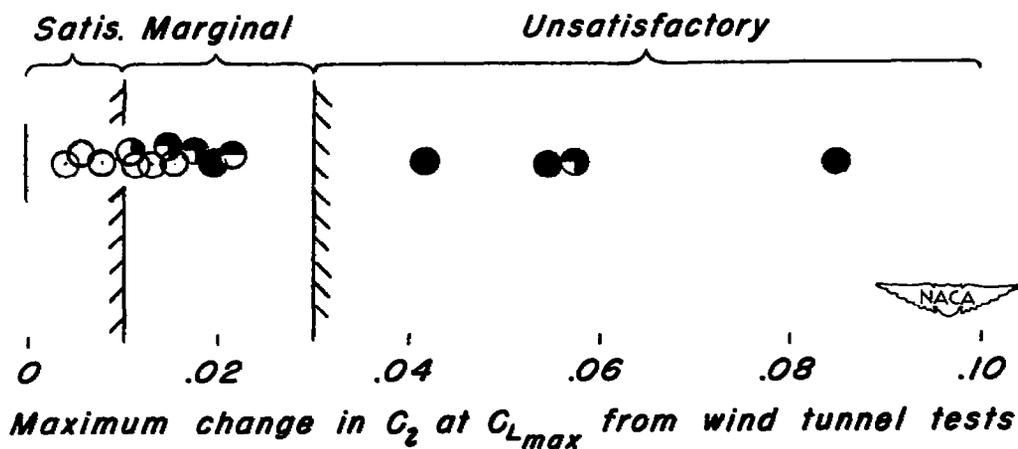
Figure 6.- Correlation of pilots' opinions of stall with changes in  $C_2$  at  $C_{L_{max}}$ .

The results of all wing configurations tested in flight and in the wind tunnel (see table II) are correlated in figure 6 on the basis of maximum increment in rolling-moment coefficient at the stall measured in the wind tunnel at zero sideslip. Wind-tunnel results were available for a limited number of configurations at other than zero sideslip. These results showed that the magnitude of the change in rolling-moment coefficient at the stall was approximately the same when the stall was approached at various constant values of sideslip (up to  $8^\circ$ ) as for the zero sideslip case. Judging from the results presented in figure 6, changes in  $C_l$  of 0.01 or less at the stall were satisfactory in flight; changes between 0.01 and 0.03 were marginal; and changes greater than 0.03 were unsatisfactory. Presumably, the maximum rolling-moment break tolerable is related in some manner to the rolling moments producible by manipulation of the rudder and aileron; however, the effects of this variable are difficult to evaluate in a quantitative manner and were not considered in this report.

It should be noted that the rolling-moment criteria shown in figure 6 are limited to the type and size of the aircraft tested and are intended to be used as a preliminary indication of satisfactory stalling characteristics. A discussion of the effect of airplane size and sideslip angle at the stall may be found in reference 5.

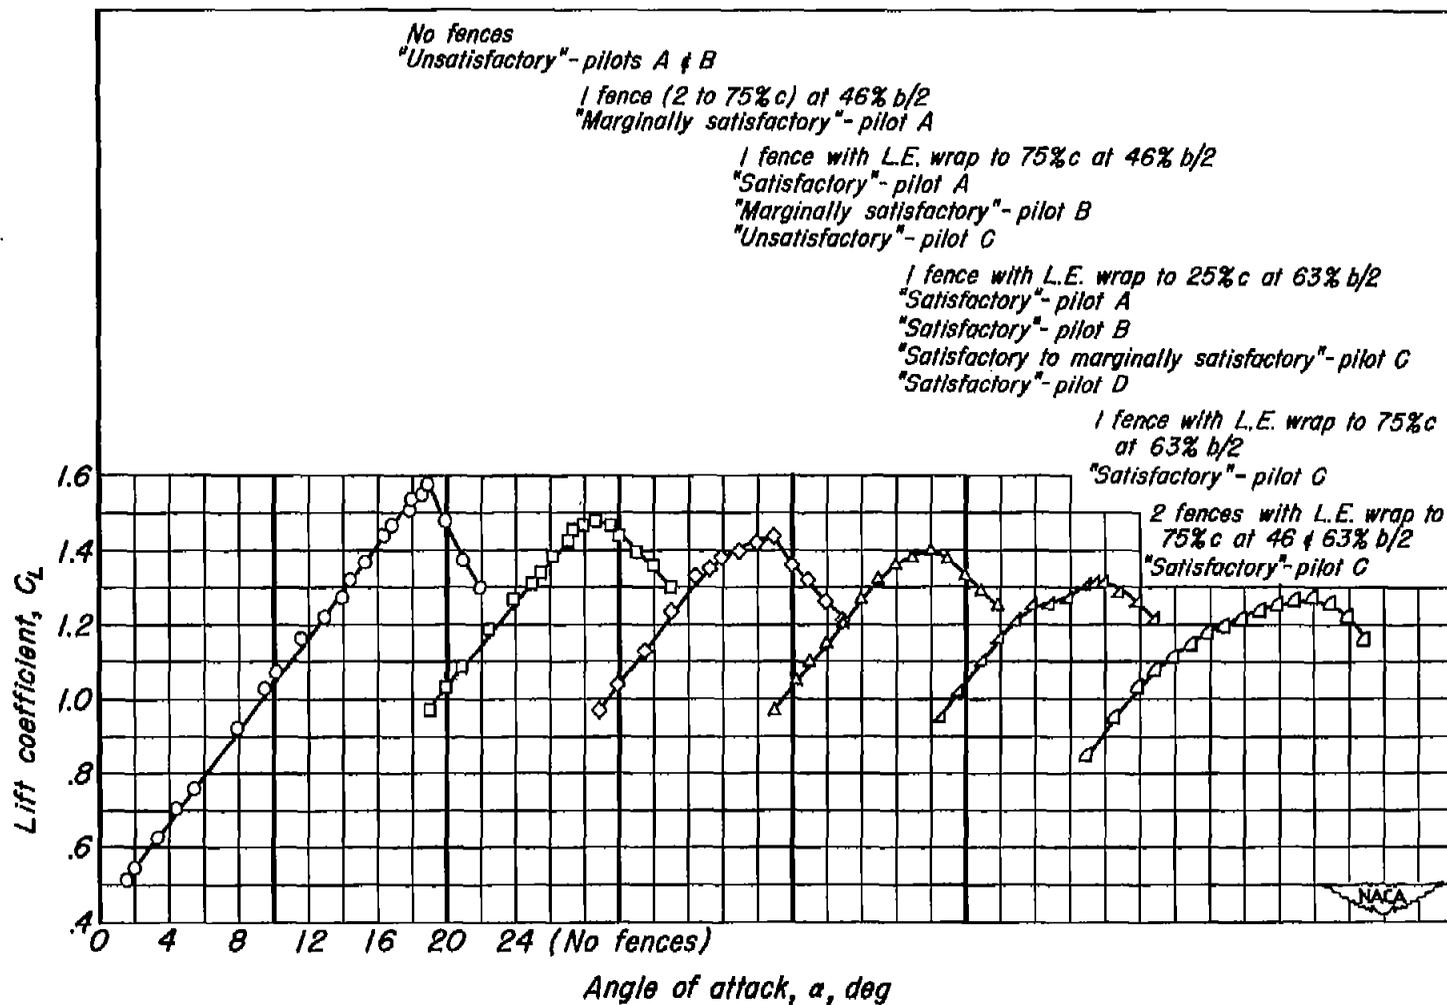
Figure 7.- Lift curves for various configurations measured in flight with cambered leading edge. Flaps down.

The lift curves of the airplane with the cambered leading edge and a series of fence modifications designed to improve the stalling characteristics are presented in figure 7 for the flaps-down case and the results are tabulated in table III. These fence modifications were tested in flight only. It will be noted that the lift-curve peak for the cambered leading edge was sharp and, as noted previously, the stall was reported as unsatisfactory by the pilot because of a severe roll-off. Tuft studies indicated that separation was a combined leading-edge and trailing-edge type, initiating outboard near the wing tip and spreading inboard rapidly. The addition of a fence at 46-percent semispan

(2- to 75-percent chord extent) improved the lateral characteristics at the stall slightly to a rating of "marginally satisfactory" by pilot A. As shown in figure 7, this configuration resulted in rounding the lift-curve peak somewhat and reducing maximum lift about 5.5 percent. The addition of a leading-edge "wrap" to this fence further improved the stalling characteristics to a rating of "satisfactory" by pilot A; however, the other pilots graded the stall from marginally satisfactory to unsatisfactory. Observation of tufts indicated that although this fence installation produced areas of separation inboard and to the rear of the fence, separation still occurred abruptly over a large area outboard of the fence. By moving the fence outboard to 63-percent semi-span it was possible to reduce the chordwise extent of the fence to 25 percent and still retain lateral characteristics at the stall which were acceptable to all four pilots with a decrement in maximum lift of about 11 percent. Extending this fence to 75-percent chord or using large chord fences (to 75-percent chord) at both 46- and 63-percent semispan resulted in further improvements in stalling characteristics beyond that felt necessary, with pronounced rounding of the lift-curve peaks and large reductions in maximum lift (19.5 percent). It will be noted that the pilots tended toward agreement on a satisfactory stall as the lift-curve peak was rounded more and more.
