RESEARCH MEMORANDUM

SUPPLEMENTARY DITCHING INVESTIGATION OF A $\frac{1}{18}$ - SCALE

MODEL OF THE NORTH AMERICAN B-45 AIRPLANE

By Lloyd J. Fisher and William C. Thompson

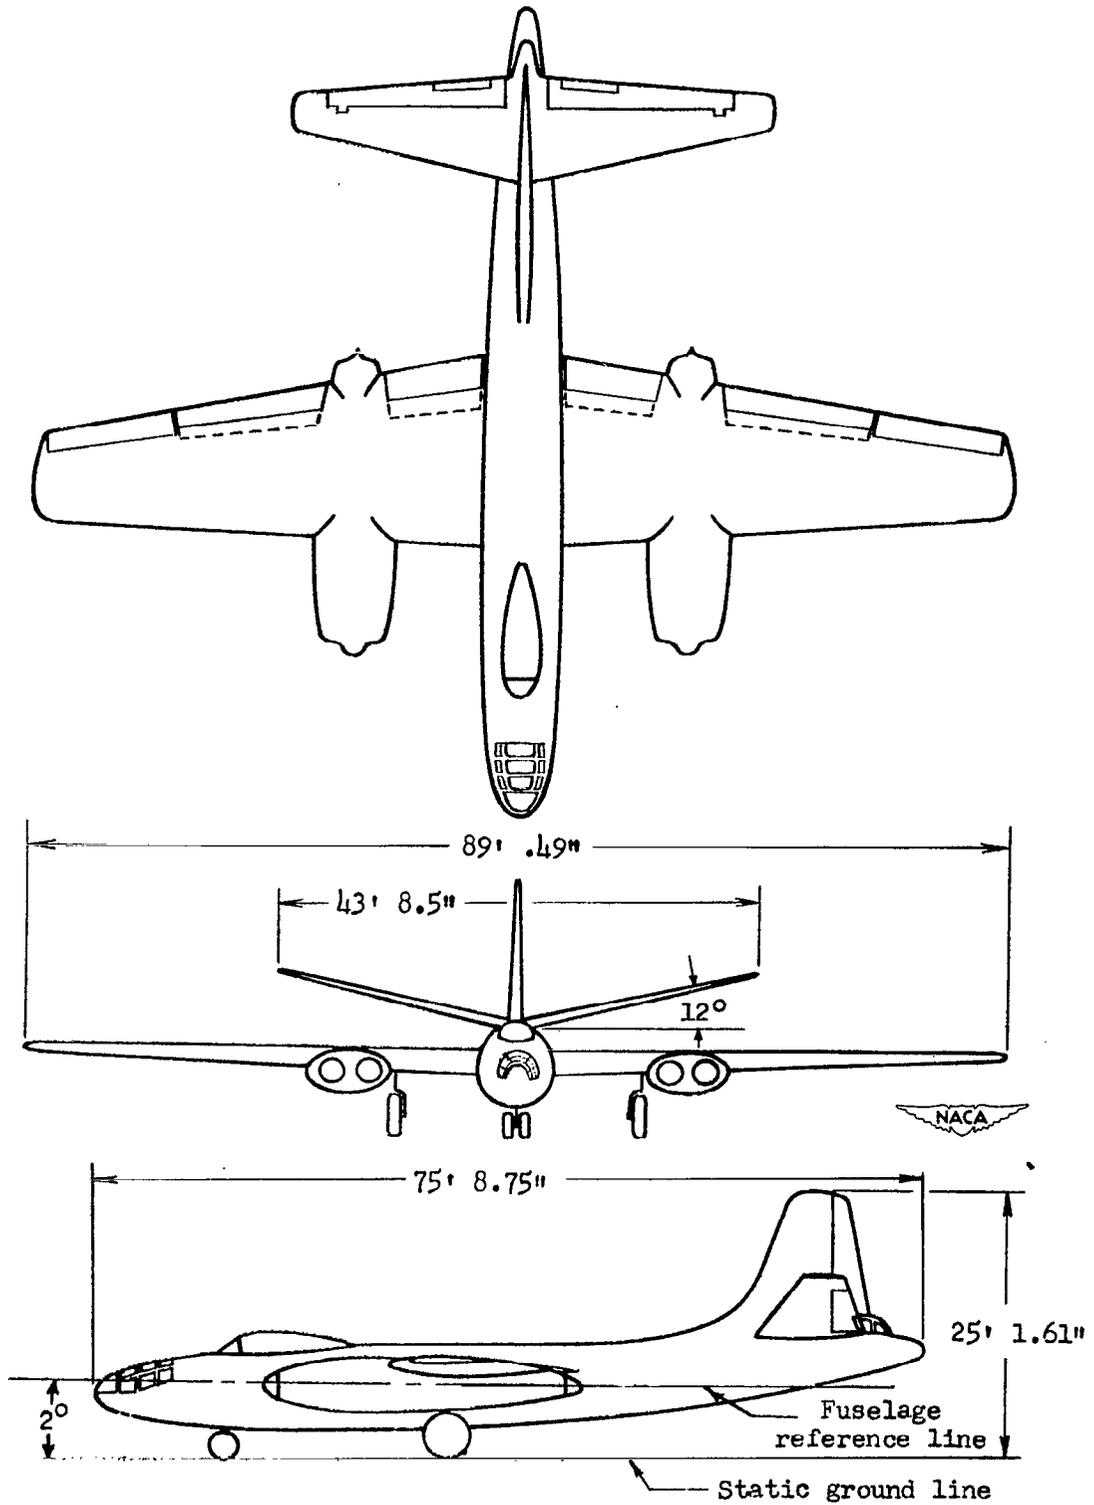
Figure 1.- Three-view drawing of the North American B-45 airplane.

In seeking methods to alleviate the diving it was found that when a part of the fuselage just aft of the bomb bay was removed from the model it did not dive. Strength data obtained from North American Aviation, Inc. since the publication of reference 1 indicated that the bulkhead and fuselage bottom just aft of the bomb bay might fail in a ditching. A supplementary model investigation was therefore made in calm water at the Langley tank no. 2 monorail with the area in question approximately scale strength. A three-view drawing of the B-45 airplane is shown in figure 1.

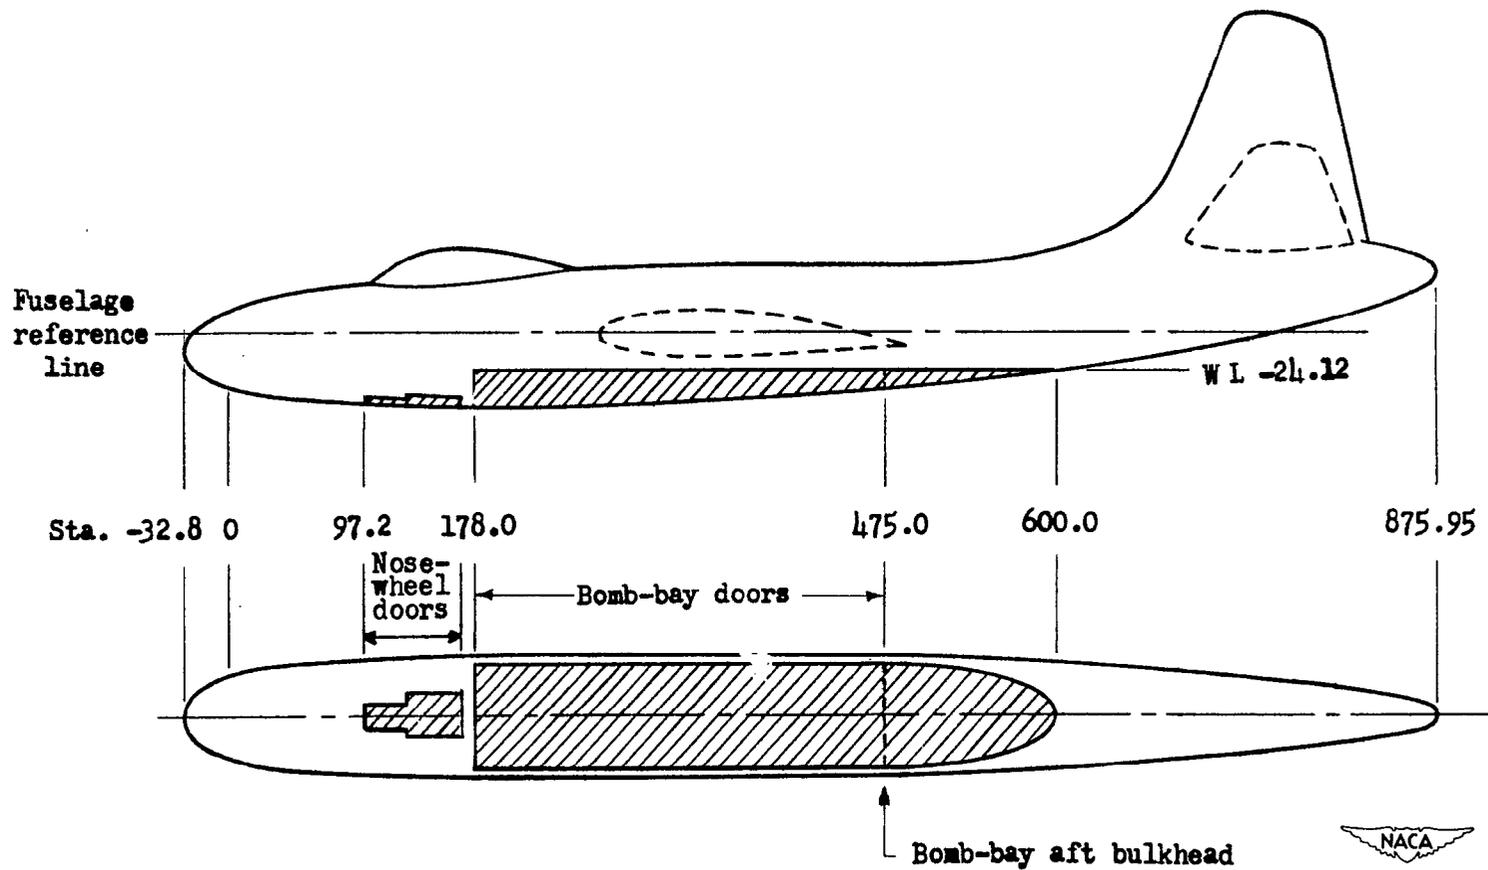
Figure 2.- Model fuselage showing scale-strength sections. Dimensions are in inches; all values are full scale.

The $\frac{1}{18}$ -scale dynamic model of the B-45 airplane described in reference 1 was used in the present investigation. As in the previous tests, the bomb-bay doors and nose-wheel doors were removed and replaced by approximately scale-strength sections. To investigate the effect of further damage, part of the under surface of the fuselage between fuselage stations 475 and 600 was removed and replaced by an approximately scale-strength section. (See fig. 2.) The full-scale ultimate strength of this section was estimated by the manufacturer as 2.8 pounds per square inch. Part of the bomb-bay aft bulkhead (station 475) below water line -24.12 (see fig. 2) also was attached so that it would fail at approximately scale strength. The manufacturer estimated the bulkhead to have a full-scale ultimate strength of 2.1 pounds per square inch.

Model configuration.- The model was tested with the nose-wheel doors, bomb-bay doors, part of the aft under surface of the fuselage, and bomb-bay aft bulkhead approximately scale strength (see fig. 2).

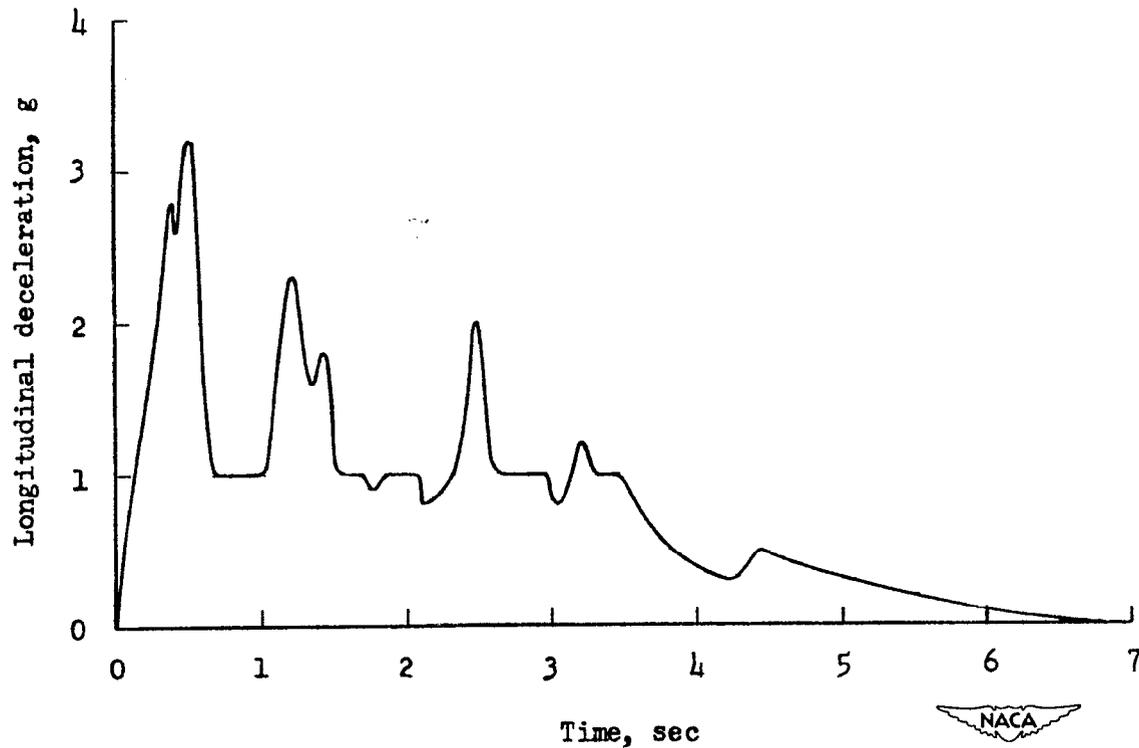
Figure 3.- Longitudinal deceleration for typical ditching with scale-strength nose-wheel doors, bomb-bay doors, aft fuselage section, and bomb-bay aft bulkhead. Landing attitude, 6° ; landing speed, 137 miles per hour. All values are full scale.

In the present investigation, the model porpoised during the first third of the landing run and then ran smoothly, gradually settling into the water as the forward velocity decreased. The maximum longitudinal deceleration was about 3g (see fig. 3) and the total length of landing run was about 600 feet (full scale). Sequence photographs of a typical run are shown in figure 4. Usually, the scale-strength covering was torn from the nose-wheel doors, bomb-bay doors, and aft fuselage section and the scale-strength section of the bomb-bay aft bulkhead was torn away. (See fig. 5.) It is possible that further damage might occur in a ditching, but unless the fuselage breaks in two (which seems unlikely), the behavior is not expected to be substantially different. When damaged, the fuselage aft of the pilots' compartment filled with water very rapidly making it undesirable as a ditching station.

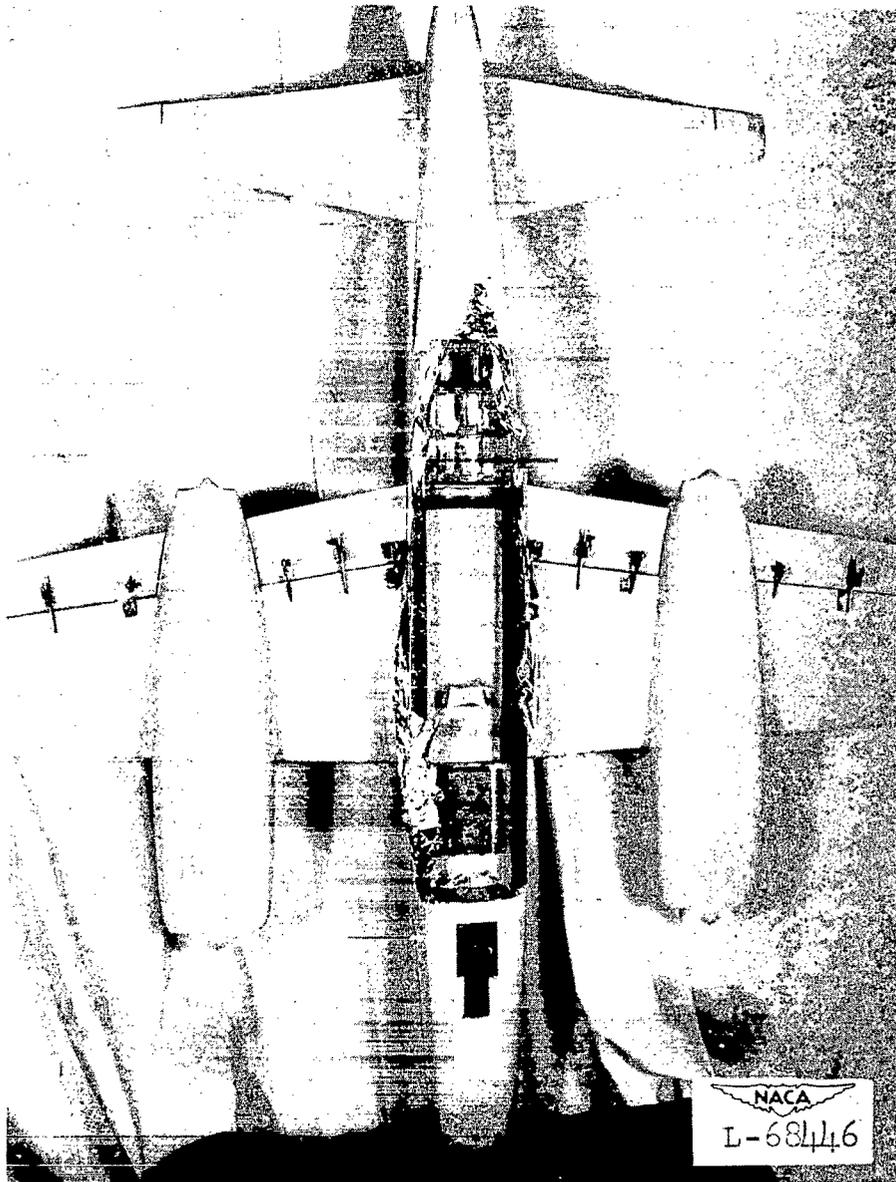
Figure 5.- Typical damage which occurred to the scale-strength sections.

1. During the ditching, the nose-wheel doors, bomb-bay doors, under surface of the aft fuselage, and lower part of the bomb-bay aft bulkhead will be torn away.
2. When such damage occurs, the diving found in the previous tests will not occur and the airplane will porpoise during the first third of the landing run and then run smoothly.
3. Because of the extensive damage which occurs, the fuselage aft of the pilots' compartment will fill with water very rapidly making it undesirable as a ditching station.
