**REPORT No. 209**

**CHARACTERISTICS OF A SINGLE FLOAT SEAPLANE  
DURING TAKE-OFF**

By J. W. CROWLEY, Jr., and K. M. RONAN  
Langley Memorial Aeronautical Laboratory

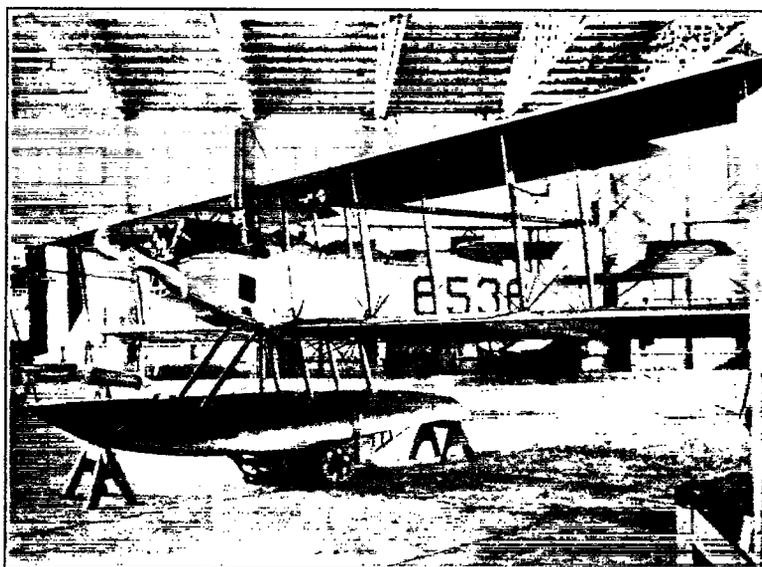
FIG. 2.—N-9H ready for planing test. Angle of attack controller vane in the foreground.

The angle of attack was measured by the N. A. C. A. angle of attack recorder.<sup>3</sup> The controller vane was mounted on an outrigger, 5 feet in front and on a line midway between the wings (fig. 2). To check this recorder, a sliding pointer was attached to a center section

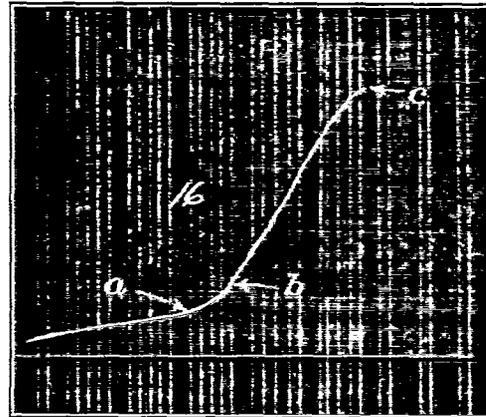
FIG. 3.—Recorded waterspeed pressure curves  
 RUN 16  
 a—First change in slope.  
 b—Second change in slope.  
 c—Take-off.

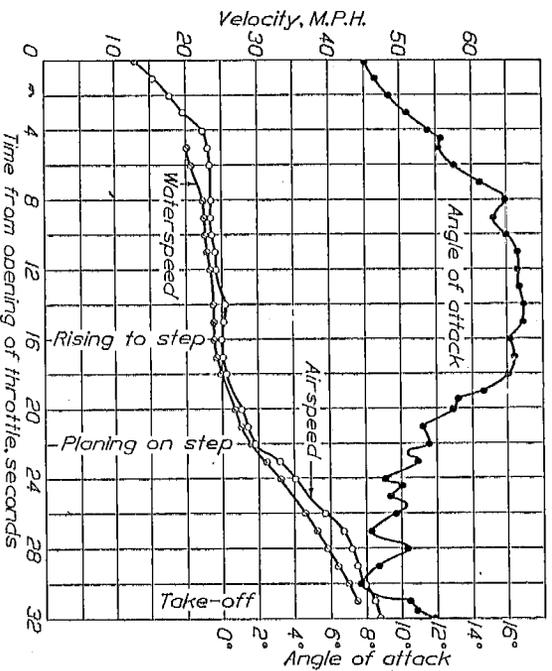
(NOTE.—The seaplane needed assistance to get on step, and was pulled off)

Fig. 4.—Run 1, Method—Control free

The curves of the control free method are shown in Figures 4 to 7. It is noticeable that the range of slope of the velocity curve is small and it has no abrupt changes. Curve No. 4 was taken on very smooth water which delayed getting on the step and taking off and the pilot assisted in both cases. In this particular run it will be noted that before the planing

condition is reached the velocity curves have a much smaller slope than in any of the other runs. This indicates that smooth glassy water offers the greatest impediment to rising on the step. The angle of attack curve shows that the seaplane was very stable until planing, when an unstable oscillation appeared. The runs plotted in Figures 5 to 7 were made on slightly rippled water and, contrary to that shown in Figure 4, have oscillations until planing, when they are highly damped. It appears that under favorable conditions the seaplane supplies its own rocking motion to get on the step.

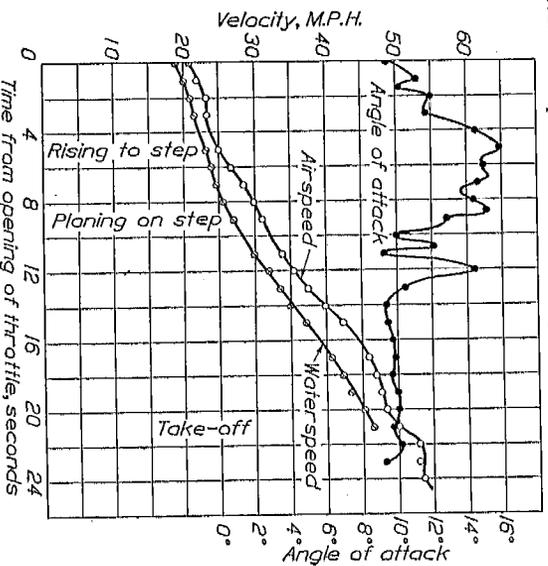
(NOTE.—Pilot assisted seaplane in getting on step by rocking slightly)

Fig. 6.—Run 10, Method—Control free

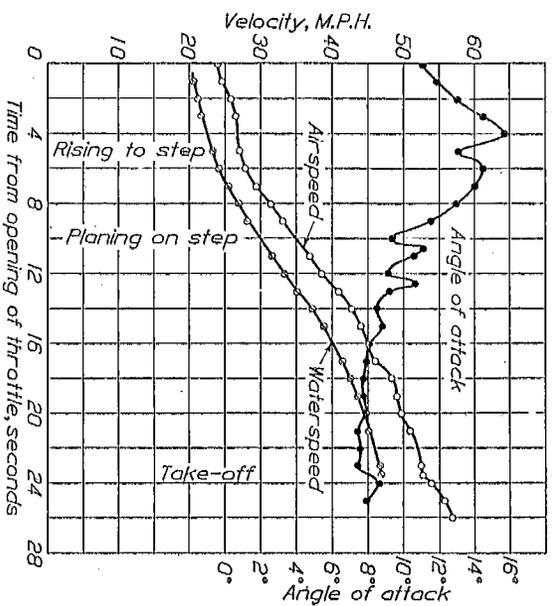
Fig. 5.—Run 7, Method—Control free

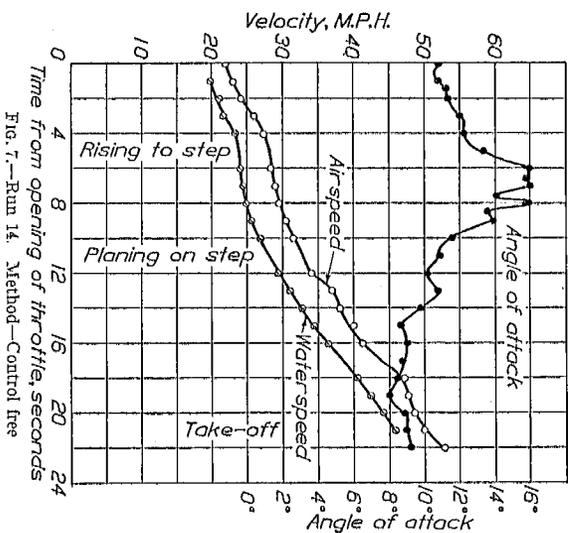
Fig. 7.—Run 14, Method—Control free

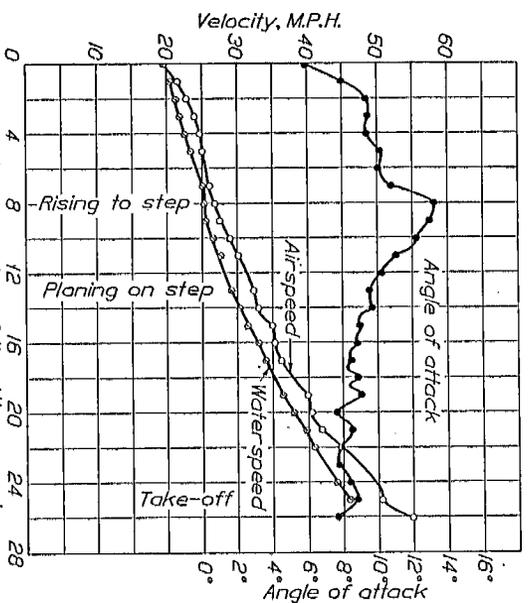
(NOTE.—Pilot had to let control back in order to get on step)

Fig. 8.—Run 4, Method—Control held forward

Figures 8 and 9 show the effects of holding the control forward. It delays but does not prevent the trimming aft. Practically the same planing angle is obtained as with the control free. The slope of the velocity curve approaches zero abruptly at the point of rising to the step, which indicates an appreciable hump in the resistance curve. This method of control damps the natural rocking until planing, when small oscillations are induced.

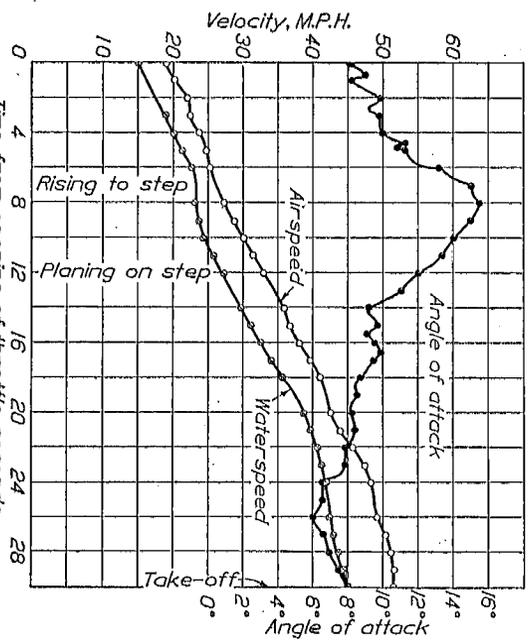
(NOTE.—The control was pulled back slightly in order to take-off)

Fig. 9.—Run 12, Method—Control held half forward

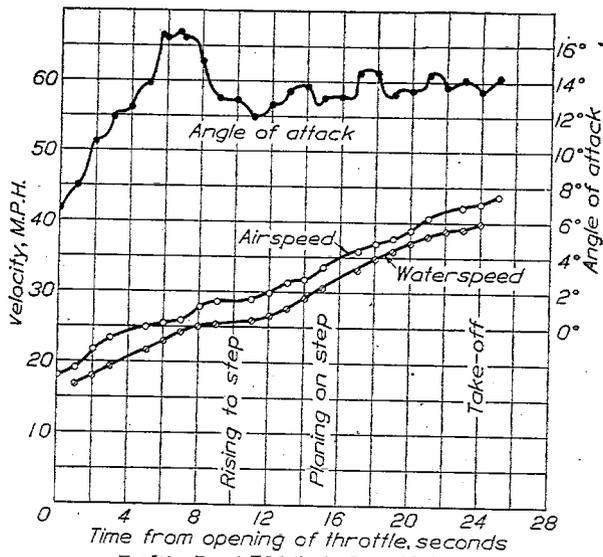
FIG. 10.—Run 3. Method—Control held back

The results of holding the control back are given in Figures 10 to 13. The slopes of the velocity curves are quite similar except in Figure 11. The latter indicates that the pilot was able to hold a high angle after starting to plane which has decreased the slope, indicating an increased resistance. In this run the angle was brought up to about  $17^\circ$ , probably aided by a wave, and a take-off was made, but the angle could not be held and the seaplane settled back. In this method, as in the preceding, the larger rocking oscillations are damped out at first, leaving smaller ones, the latter being particularly noticeable in Figure 12. Planing oscillations are also set up. Figure 10 shows the presence of a highly damped planing oscillation.

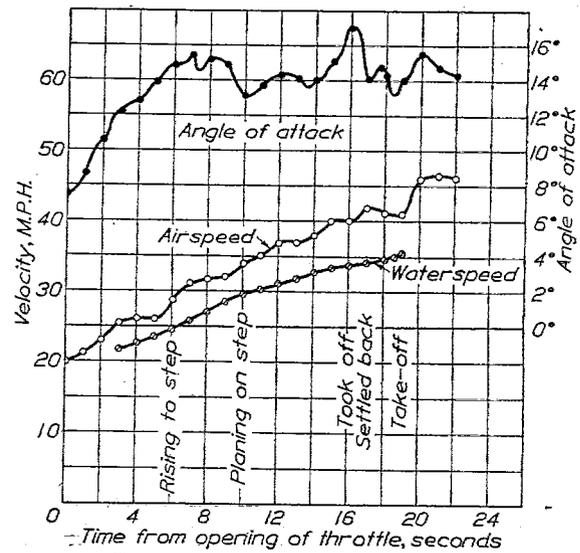
FIG. 11.—Run 5. Method—Control held back  
(Note the high angle of the first take-off, which could not be held)

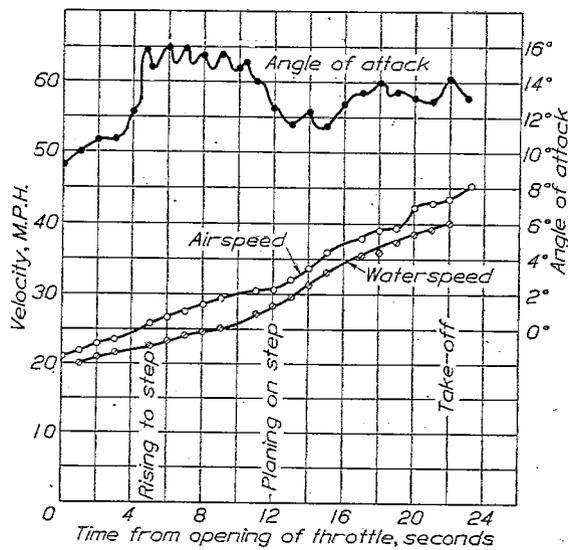
FIG. 12.—Run 9. Method—Control held back

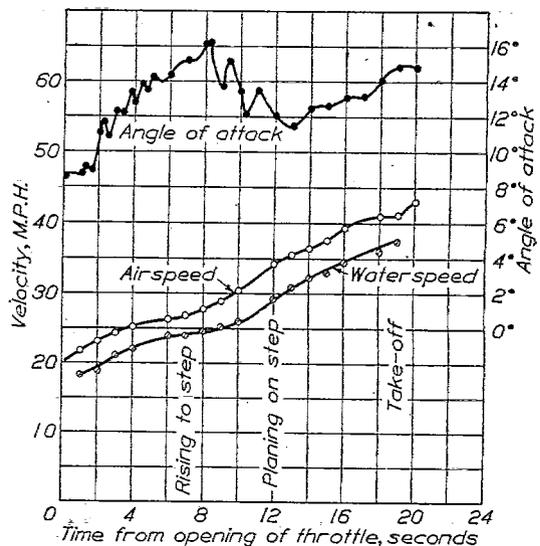
FIG. 13.—Run 13. Method—Control held back

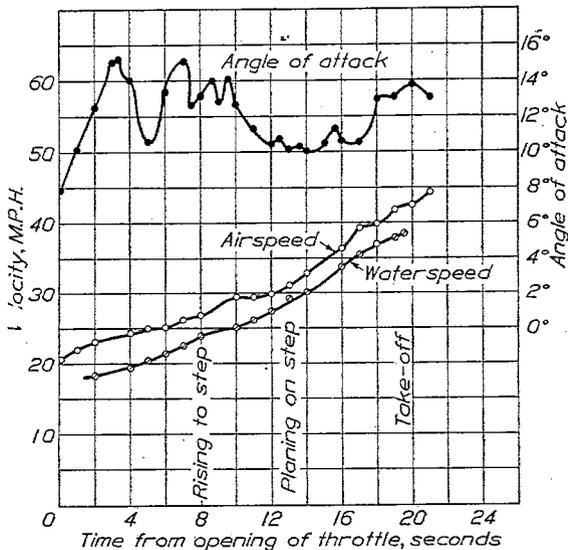
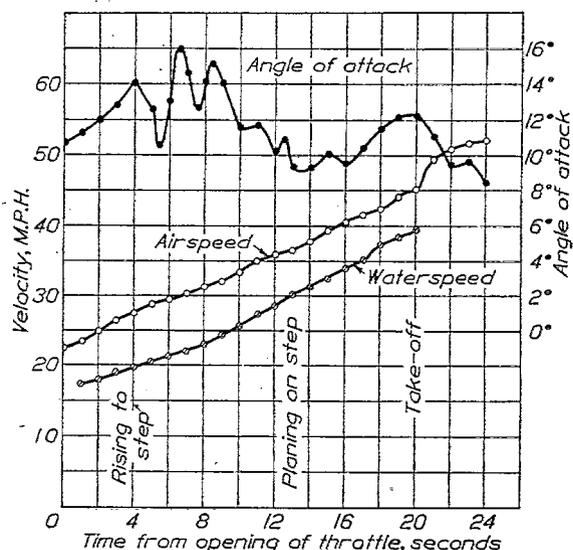
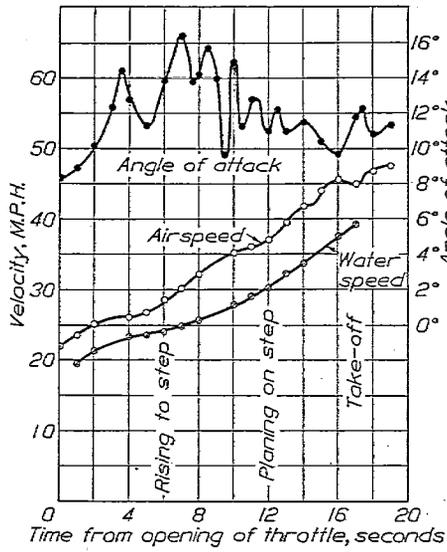
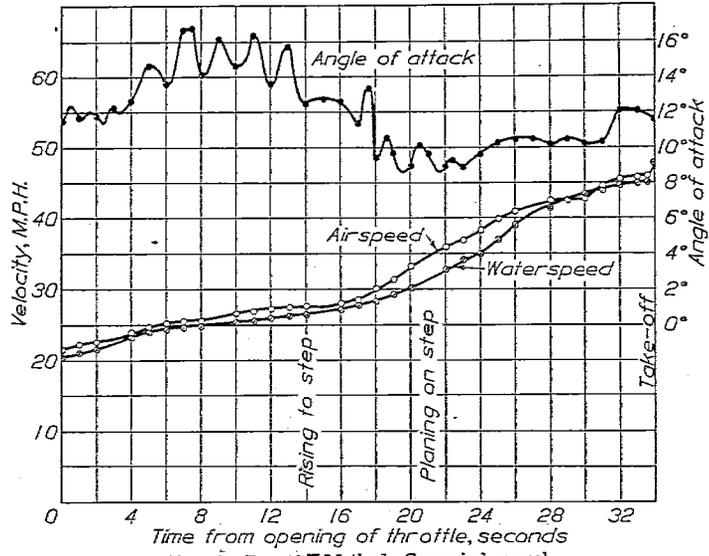
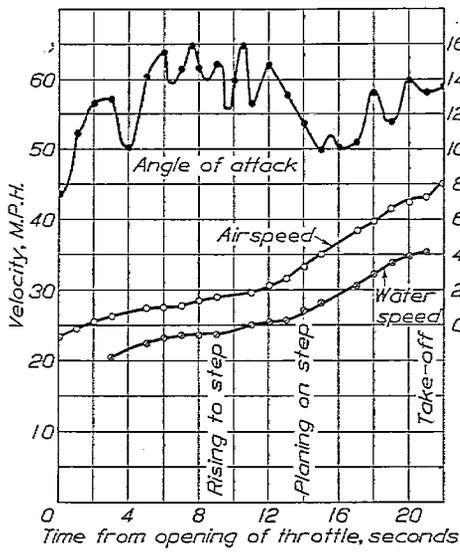
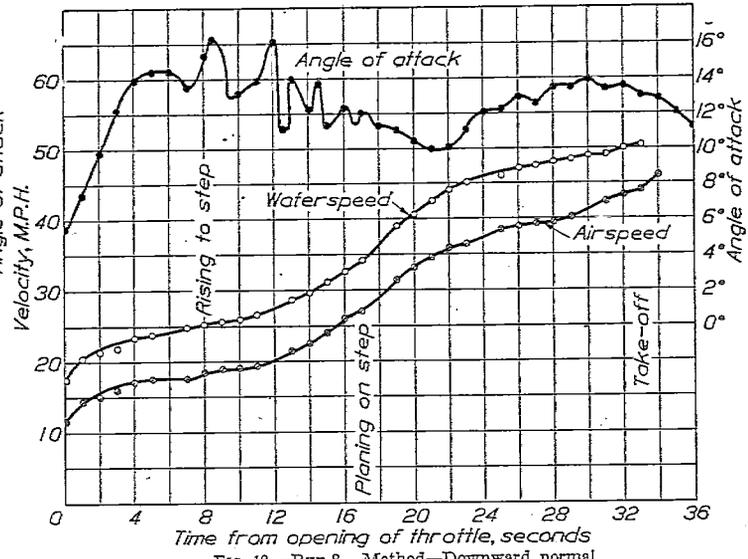
FIG. 14.—Run 2. Method—Normal

FIG. 15.—Run 6. Method—Normal

FIG. 16.—Run 11. Method—Normal

FIG. 18.—Run 16. Method—Crosswind normal

FIG. 17.—Run 15.—Method—Normal

FIG. 19.—Run 8. Method—Downward normal

The normal method of control gives the results shown in Figures 14 to 19. As is to be expected where a personal factor is present, the shape of the velocity curves are not similar. The angle of attack curves, however, have a general similarity showing that the pilot followed a set procedure. Oscillations are so broken up by the control movements that they are of no definite period. This shows that the pilot did not rock the seaplane in phase with its natural oscillations and therefore lost the assistance of this inherent asset. The cross-wind and down-wind take-offs are interesting variations. The steepest slope on the velocity curves occurs on the cross-wind take-off where an acceleration of  $1/9g$  occurs while planing. The down-wind curves show that the waterspeed is the dominating factor in a take-off until the planing condition is reached. This is shown by the fact that although the airspeed is low, the first two stages are passed through at about the same waterspeed as in the previous runs. This fact is further shown by a curve of waterspeed against airspeed, where for the "rising to step" condition the slope of the curve is 1:7, i. e., an increase of 1 M. P. H. water speed is equivalent to 7 M. P. H. increase of airspeed, while for the "planing" condition the slope is 1:1.

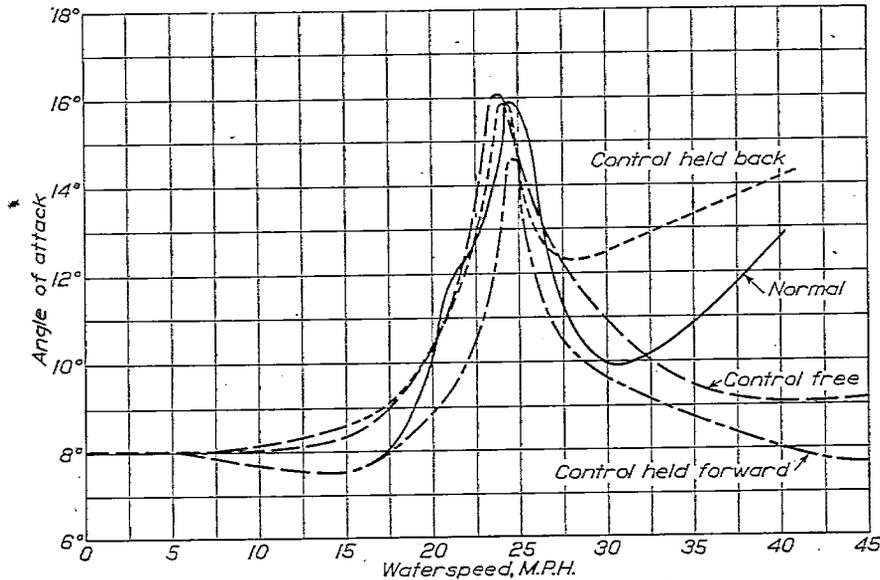
FIG. 20.—Variation in angle of attack with waterspeed

Figure 20 shows the variation in angle of attack with waterspeed by the different control methods. These curves are faired from all the points obtained on each method. They are quite similar in shape until the planing condition is reached, when the control becomes more effective. The normal control curve has a hump at about 21 M. P. H., which is caused by rocking the seaplane. The peaks of these curves represent the critical point in the take-off. They occur at a place on the velocity curves where the slope is very small and where an increase of about 3 M. P. H. (three-fortieths of the total range of waterspeed) takes one-fifth of the total time. If the seaplane gets past this point it has plenty of reserve power to take off.

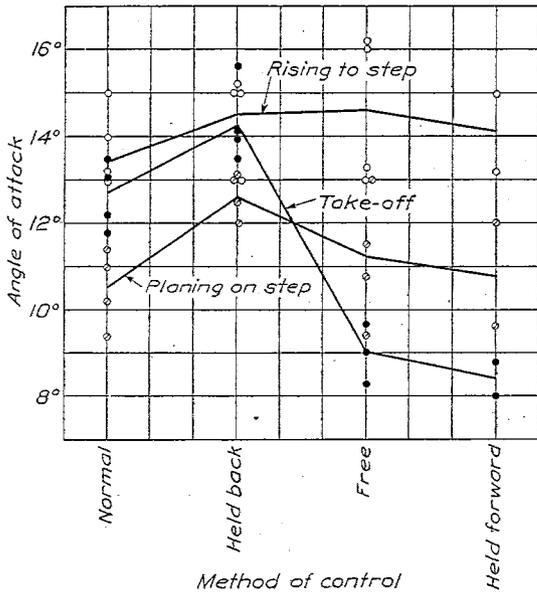
FIG. 21.—Angle of attack for each stage by different take-off methods

Figure 21 shows the angle of attack at the different stages obtained by the different methods of control. This gives additional information on the effect of control.

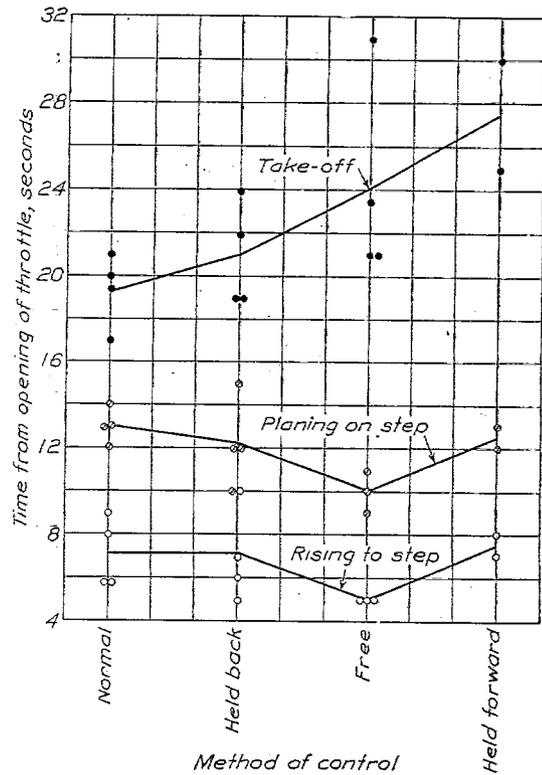
FIG. 22.—Time used for each stage by different take-off methods

Figure 22 gives the time consumed for each stage by the different methods. In the first stage the free control is best. The control makes little difference during the second stage. The normal being slightly the longest, however, indicates that the forced rocking by interfering with, rather than assisting, the natural tendency, has been disadvantageous. The normal method is the quickest for the planing stage. The time gained over the other methods is undoubtedly due to nosing the seaplane down and decreasing the resistance.

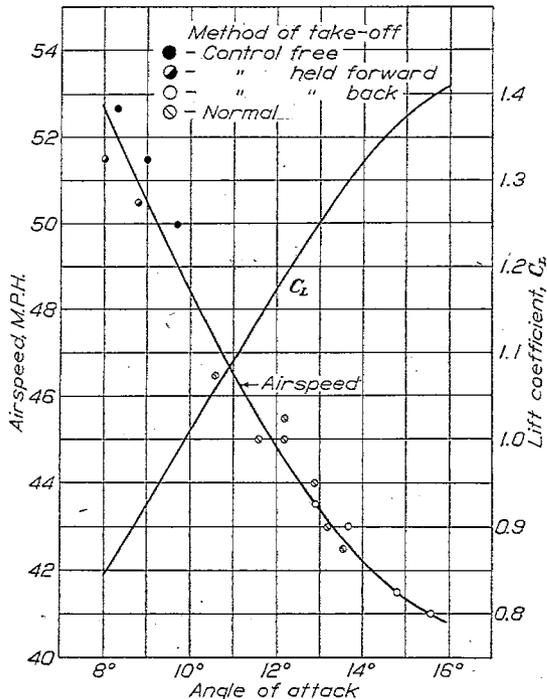
FIG. 23.—Velocity and lift coefficient at various angles of take-off

In Figure 23 the airspeed and angle of attack at the take-off are plotted. As far as the lift is concerned the take-off is a level flight condition, though somewhat in error due to ground interference. The absolute lift coefficient,  $C_L$ , is derived from the velocity curve and is also plotted in Figure 23. The range of take-off speeds is here shown to be from 41 M. P. H. to 53 M. P. H. As the top speed of this seaplane is about 75 M. P. H., the range of take-off speeds is cut down by planing resistance to about 40 per cent of the total speed range.

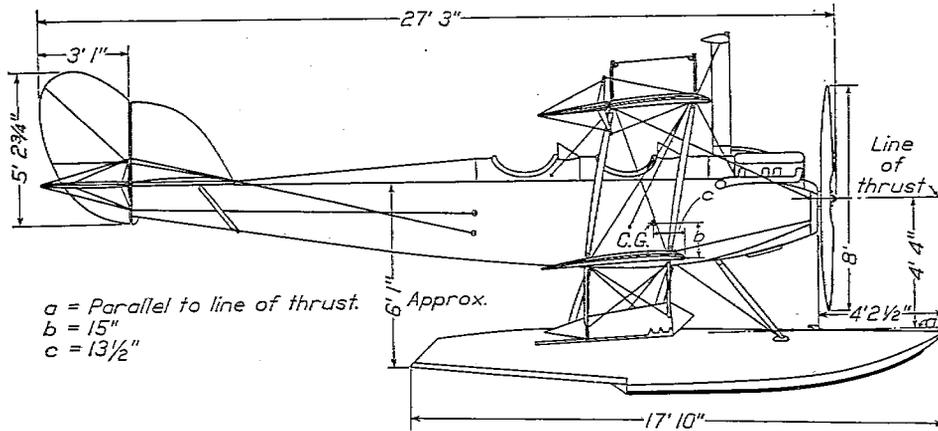
FIG. 24.—N-9H seaplane

Type.....	Single-pontoon tractor biplane.
Wing area.....	496 square feet.
Angle of incidence of wings.....	4 degrees.
Weight, as tested.....	2,970 pounds.
Engine.....	Hispano-Suiza I, 150 horsepower at 1,475 revolutions per minute.
Wing loading.....	6.00 pounds/square foot.
Power loading.....	19.8 pounds/brake horsepower.
Center of gravity location.....	13 1/2 inches aft and 15 inches above leading edge of lower wing, and 10 3/4 inches forward of step.
Propeller.....	8 feet diameter.

Pontoon.....	17 feet 10 inches in length.
Angle of incidence <sup>5</sup> .....	2 1/2 degrees.
Step.....	11 feet 8 inches from bow.
Markings.....	Burgess float, 19-2523.
