REPORT No. 727

A STUDY BY HIGH-SPEED PHOTOGRAPHY OF COMBUSTION AND KNOCK IN A SPARK-IGNITION ENGINE

By CEARCY D. MILLER

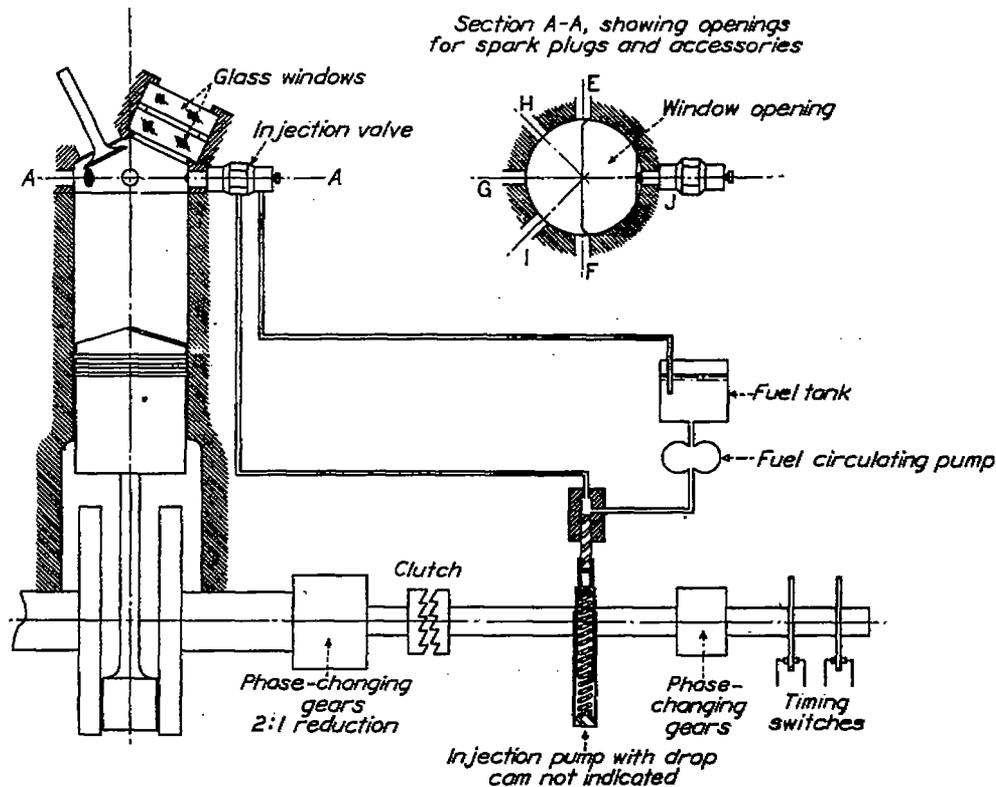
FIGURE 1.—Diagrammatic sketch of NACA combustion apparatus.

reference 1. Figure 1 shows the NACA combustion apparatus diagrammatically. At the time of taking all the photographs of combustion with four spark plugs presented in this report, the injection valve was placed in opening H of the cylinder head. (See fig. 1.) At the time of taking all the photographs presented in reference 1 and those of this report in which the combustion was with one spark plug, or with one spark plug and a hot spot, the injection valve was in opening J. For the photographs of combustion with four spark plugs, spark plugs were used in each of the openings J, F, G, and E, whereas for the photographs of combustion with only one spark plug, this plug was in position E, as in reference 1. When a hot spot was used, it was in opening F, as in reference 1. No other changes were made in either the combustion apparatus or the optical set-up between the time of taking photographs presented in reference 1 and the taking of those given in the present report.

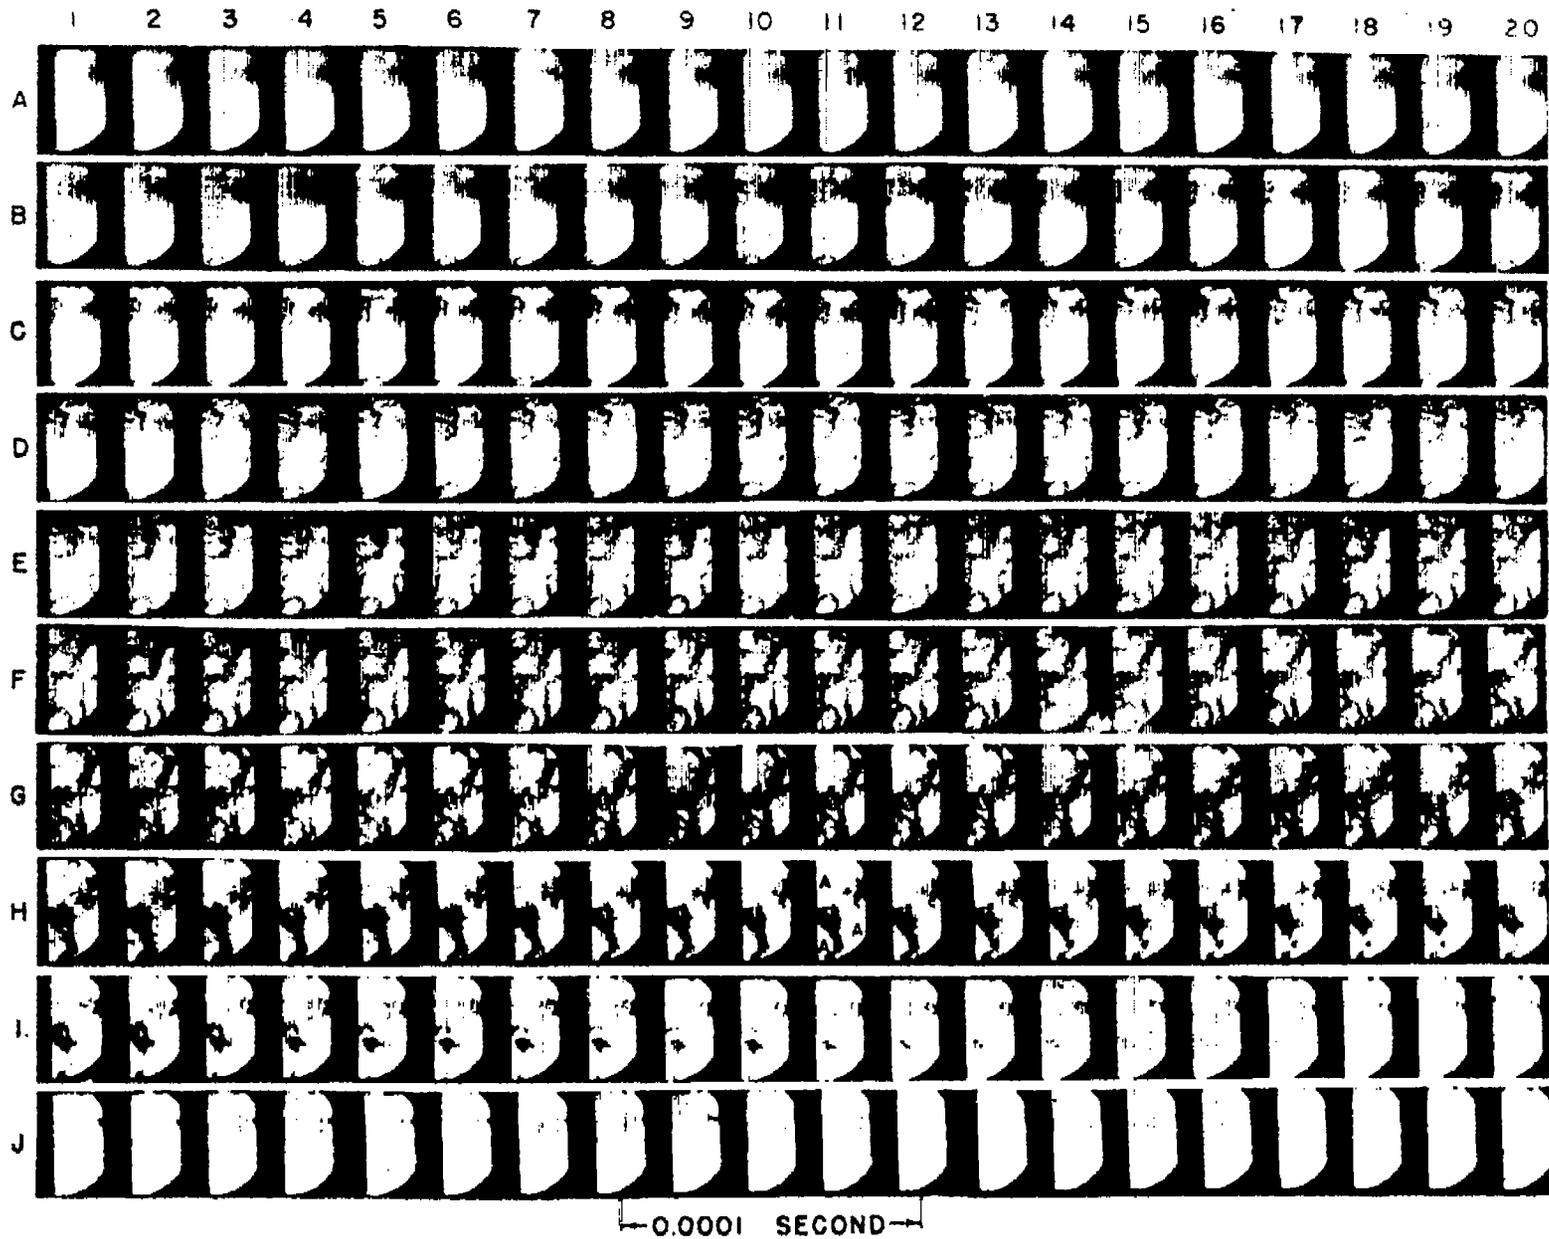
FIGURE 2.—High-speed motion pictures of a nonknocking explosion in a spark-ignition engine. Fuel, S-1; four spark plugs; spark advance, left-hand plug, 27° ; other three plugs, 20° ; A, regions already traversed by flame.

Figure 2 is a series of photographs showing nonknocking combustion with four spark plugs. This figure is comparable with figure 3 of reference 1, which was taken under similar conditions but with only one spark plug. The pictures are read from left to right through row A, then from left to right through row B, and so on. Thus, the order in which the pictures were taken is: A-1, A-2, A-3, . . . A-19, A-20, B-1, B-2, . . . J-19, J-20. In frame A-1 of figure 2 the flame that originated at the spark plug in opening F (fig. 1) has just come into view. The dark area in the upper right portion of this frame, which is visible throughout rows A, B, and C, was caused by uneven illumination of the schlieren field and has no other significance. The uneven illumination was caused by imperfection in the optical set-up, possibly by warping of the mirror on the piston top. The flame coming from the spark plug in opening G (fig. 1) first comes into view at about frame B-4 and the flames from spark plugs in E and J positions at about frame C-1.

At about frame H-11 in figure 2, all parts of the combustion chamber have been reached by the flame fronts. The light regions marked A in this frame are areas in which temperature gradients apparently no longer exist and combustion may be assumed to have been completed. These areas, however, are still extremely hot and would appear incandescent in any photograph that depended for its exposure on light originating in the combustion chamber. The mottled areas do not completely disappear from the pictures until about the end of row J, about 0.0012 second after the flame fronts have apparently reached all parts of the combustion chamber in frame H-11. This time interval is in great contrast with the corresponding period in a knocking combustion as shown in figures 6 and 7.

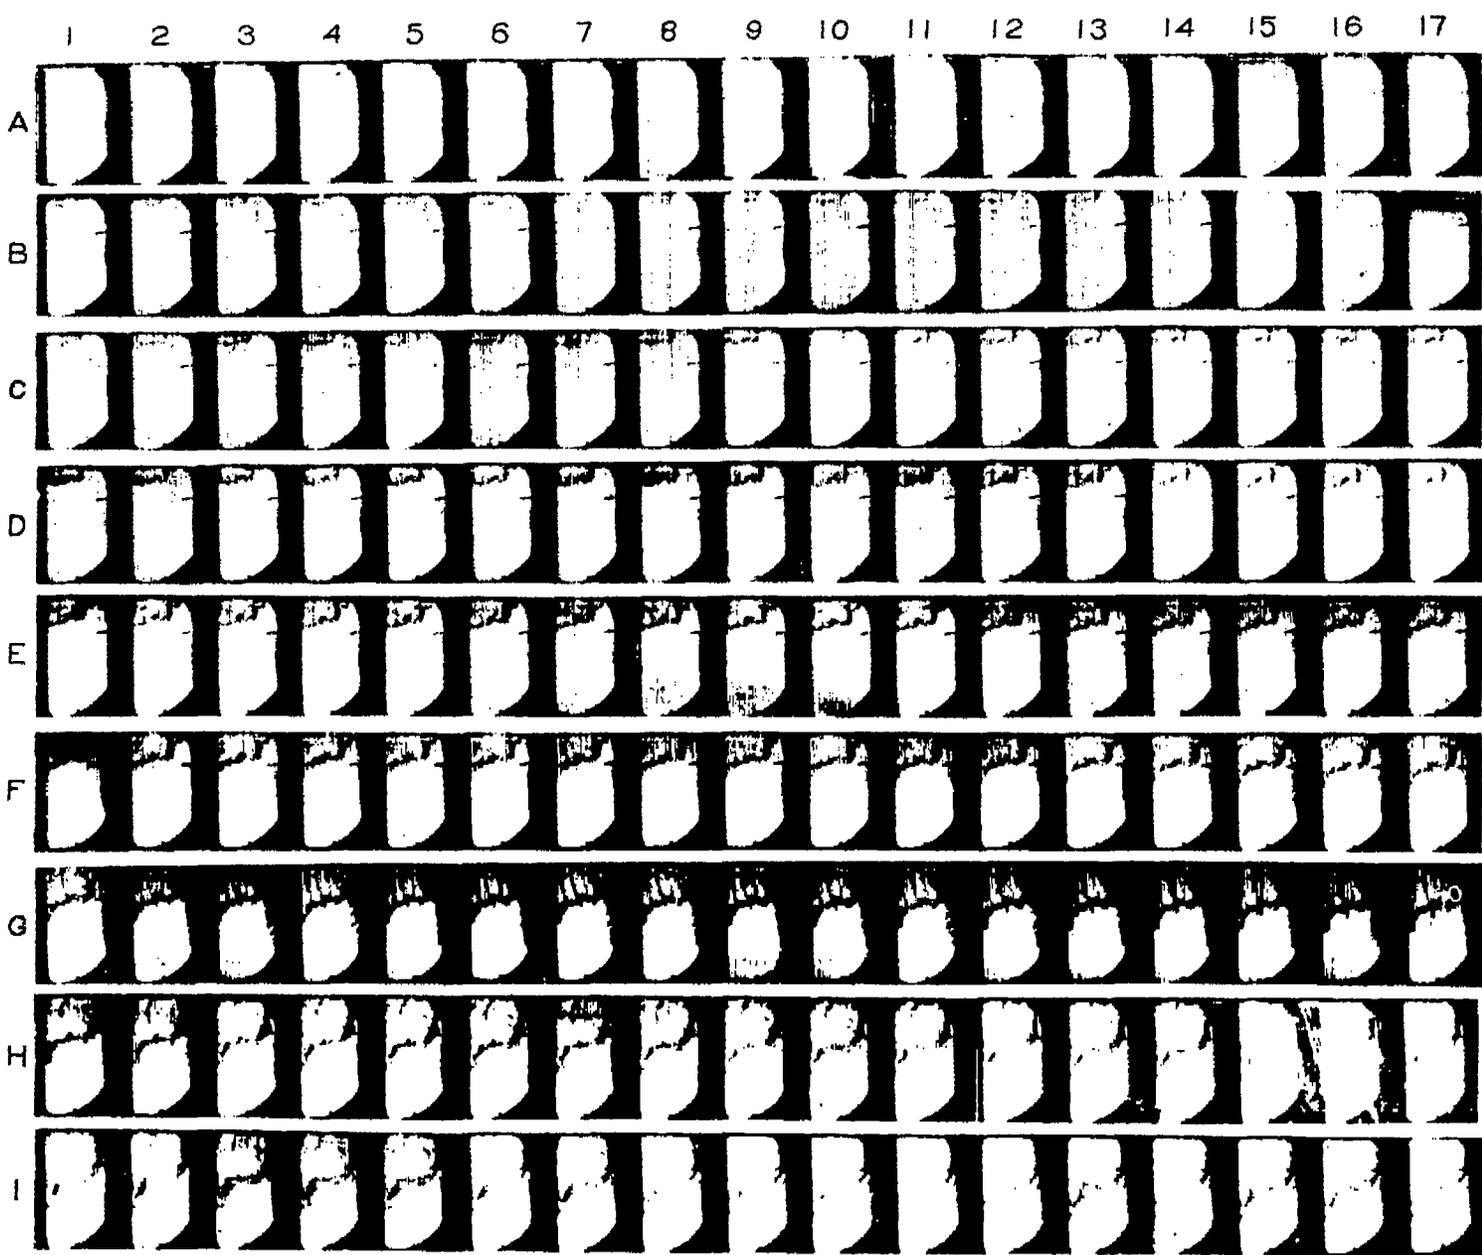
FIGURE 3.—High-speed motion pictures of a nonknocking explosion in a spark-ignition engine. Fuel, 80 percent A-1 with 20 percent M-2; one spark plug, spark advance, 0°.

Figures 3 and 4 of this report, figure 3 of reference 1, and figure 5 of this report constitute a series of substantially comparable records with spark advance of 0° , 10° , 20° , and 30° , respectively. For figures 3 and 4 of this report, the fuel was a blend of 80 percent S-1 with 20 percent M-2; for figure 3 of reference 1 and figure 5 of this report, the fuel was S-1. In figure 4 of this report, moreover, there was very late after-ignition from a hot spot in F position (fig. 1), a condition that did not exist in the other three figures. The flame from the hot spot is first clearly visible at about frame 1-7, at the lower edge of the frame. It is believed, however, that none of the differences other than spark advance are important as concerns the depth of the mottled zone in the direction of flame travel.

In figures 3 and 5 of this report, with spark advance of 0° and 30° , respectively, the mottled zone never becomes so narrow as it does in figure 4 of this report and in figure 3 of reference 1, with spark advance of 10° and 20° , respectively. In figure 3 of this report, moreover, the entire combustion took place after top center, while in figure 5 the combustion was completed about 10° before top center. In figure 4 of this report the extreme narrowing of the combustion zone occurred substantially earlier in the flame travel than in figure 3 of reference 1, and this narrowing of the combustion zone did not persist to the end of the flame travel as it did in figure 3 of reference 1. The later broadening of the combustion zone in figure 4 is typical of the records taken under the conditions of figure 4 and has also been observed in a few cases with 20° spark advance. A consistent difference between the two conditions in this respect would be difficult to explain.

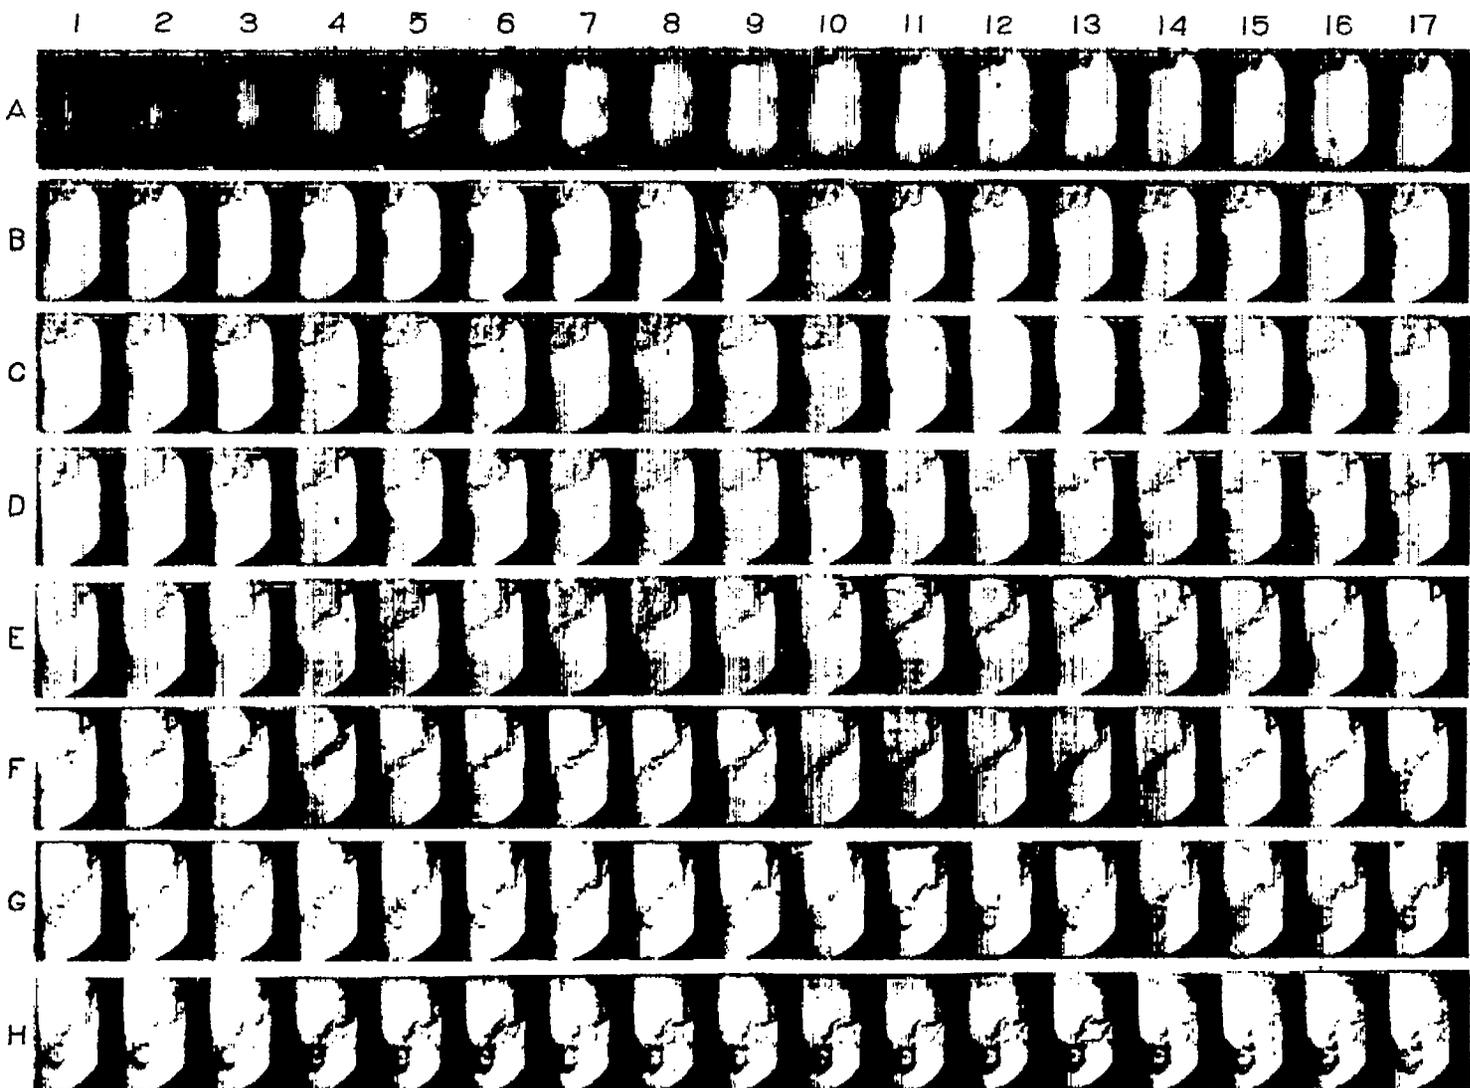
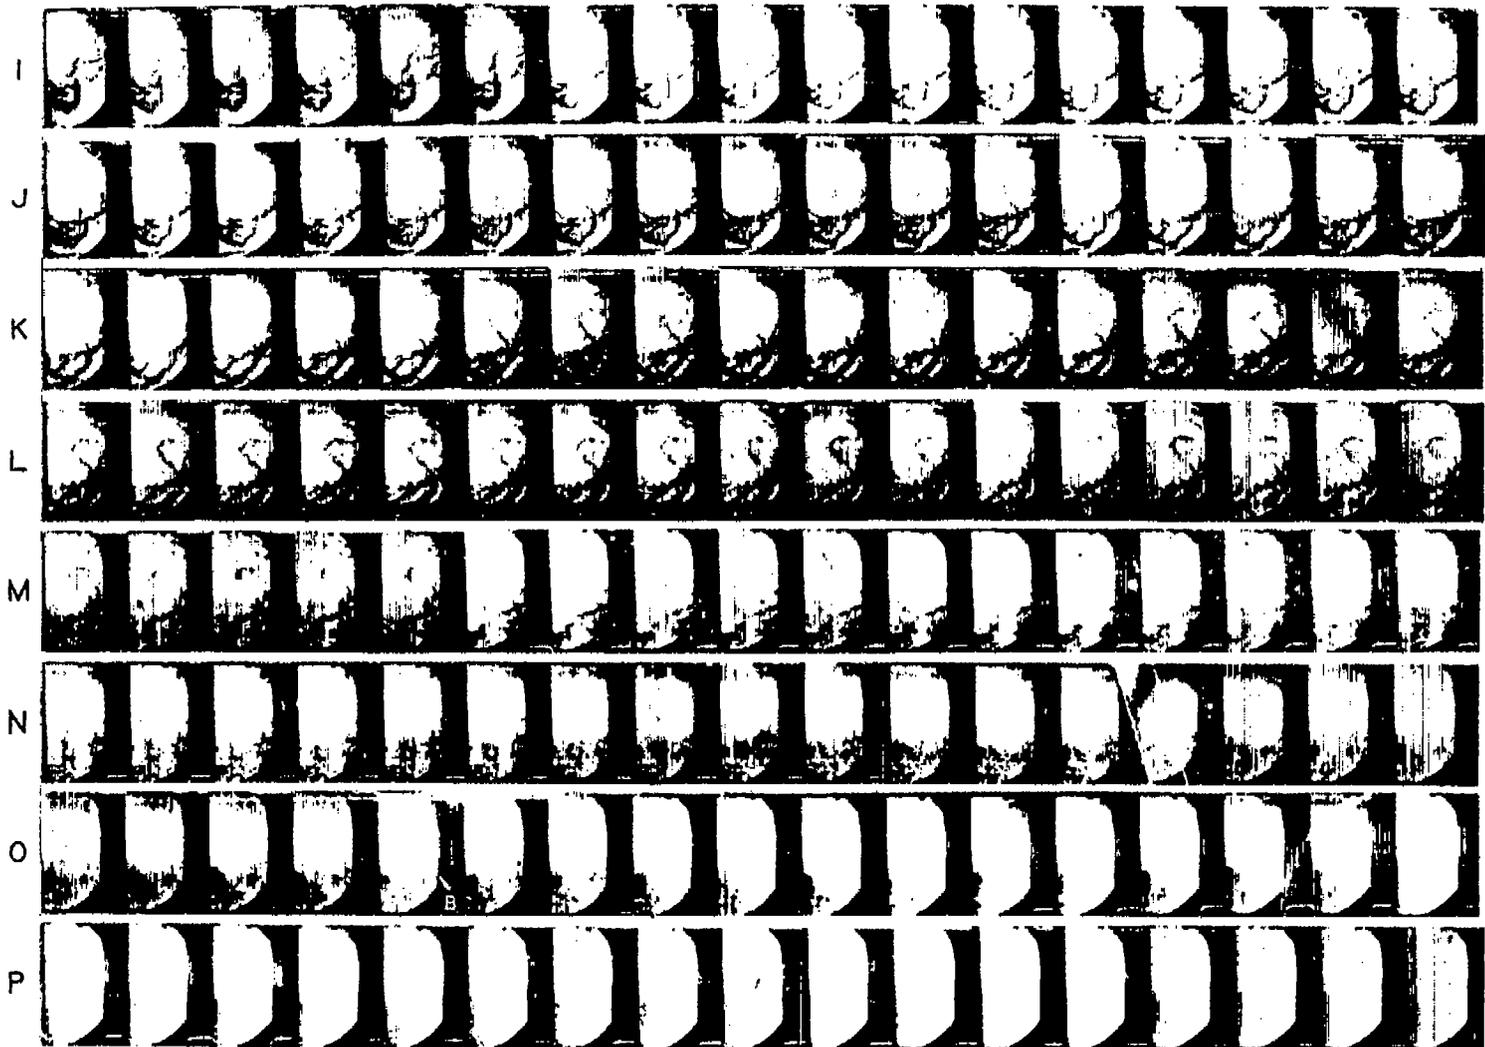
FIGURE 4.—High-speed motion pictures of an explosion in a spark-ignition engine with afterignition from hot spot and with very light knock. Fuel, 80 percent S-1 with 20 percent M-2; one spark plug; spark advance, 10°.

An extremely light knock occurred in the combustion shown in figure 4. This knock resulted in a very slight blur in the region indicated by B in frame O-5. This blur can scarcely be detected in the reproduction shown in this report. When the original photographs of figure 4 are projected as motion pictures, however, the blur is seen to be unquestionably there. This knock occurred so late in the combustion process, and the ignition was so late, that the piston must have been far beyond top center. It would appear even possible that the conditions at the time of this knock were not so severe as they had been earlier in this same combustion process.

It is particularly important to note that the knock which appears at frame O-5 of figure 4 did not have the effect of eliminating the mottled zone as did the heavier knocks previously discussed. This fact does not seem to be consistent with the theory that the knock is simply a sudden completion of the burning. It is a considerable distortion of this theory to assume that in figure 4 at about frame O-5 the combustion suddenly partly completed itself, then slowed down again, and proceeded at the normal rate of nonknocking combustions. When the photographs of figure 4 are viewed as a motion picture, the impression is that a reaction occurs in the vicinity of frame O-5 which is very quickly completed and which leaves the gases bouncing but does not interfere with the normal combustion. This reaction, during the very short time of its existence, may have accelerated the normal process of combustion. Either it did not do so appreciably, however, or the normal combustion process dropped back to about the previous rate as soon as this reaction was over. With the heavier knocks, either the knock reaction so accelerates the normal combustion that it is very quickly completed or the knock is itself a very quick completion of the normal combustion.

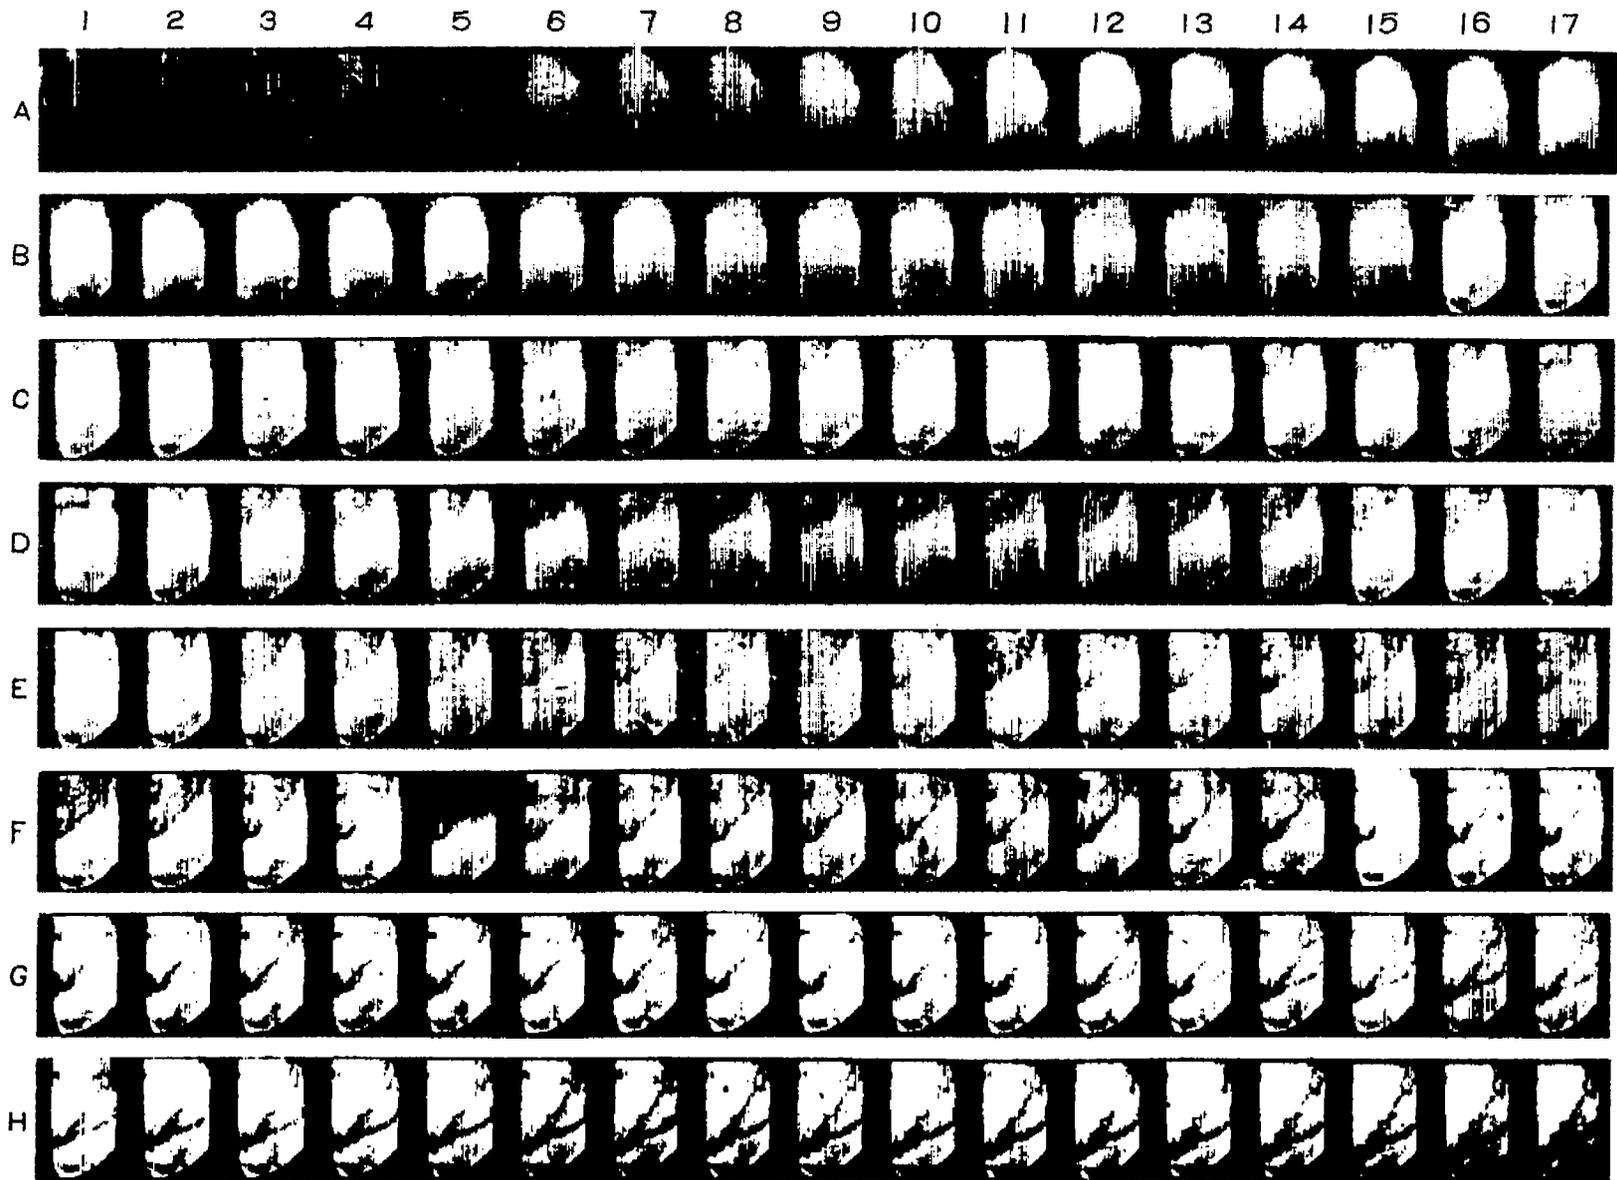
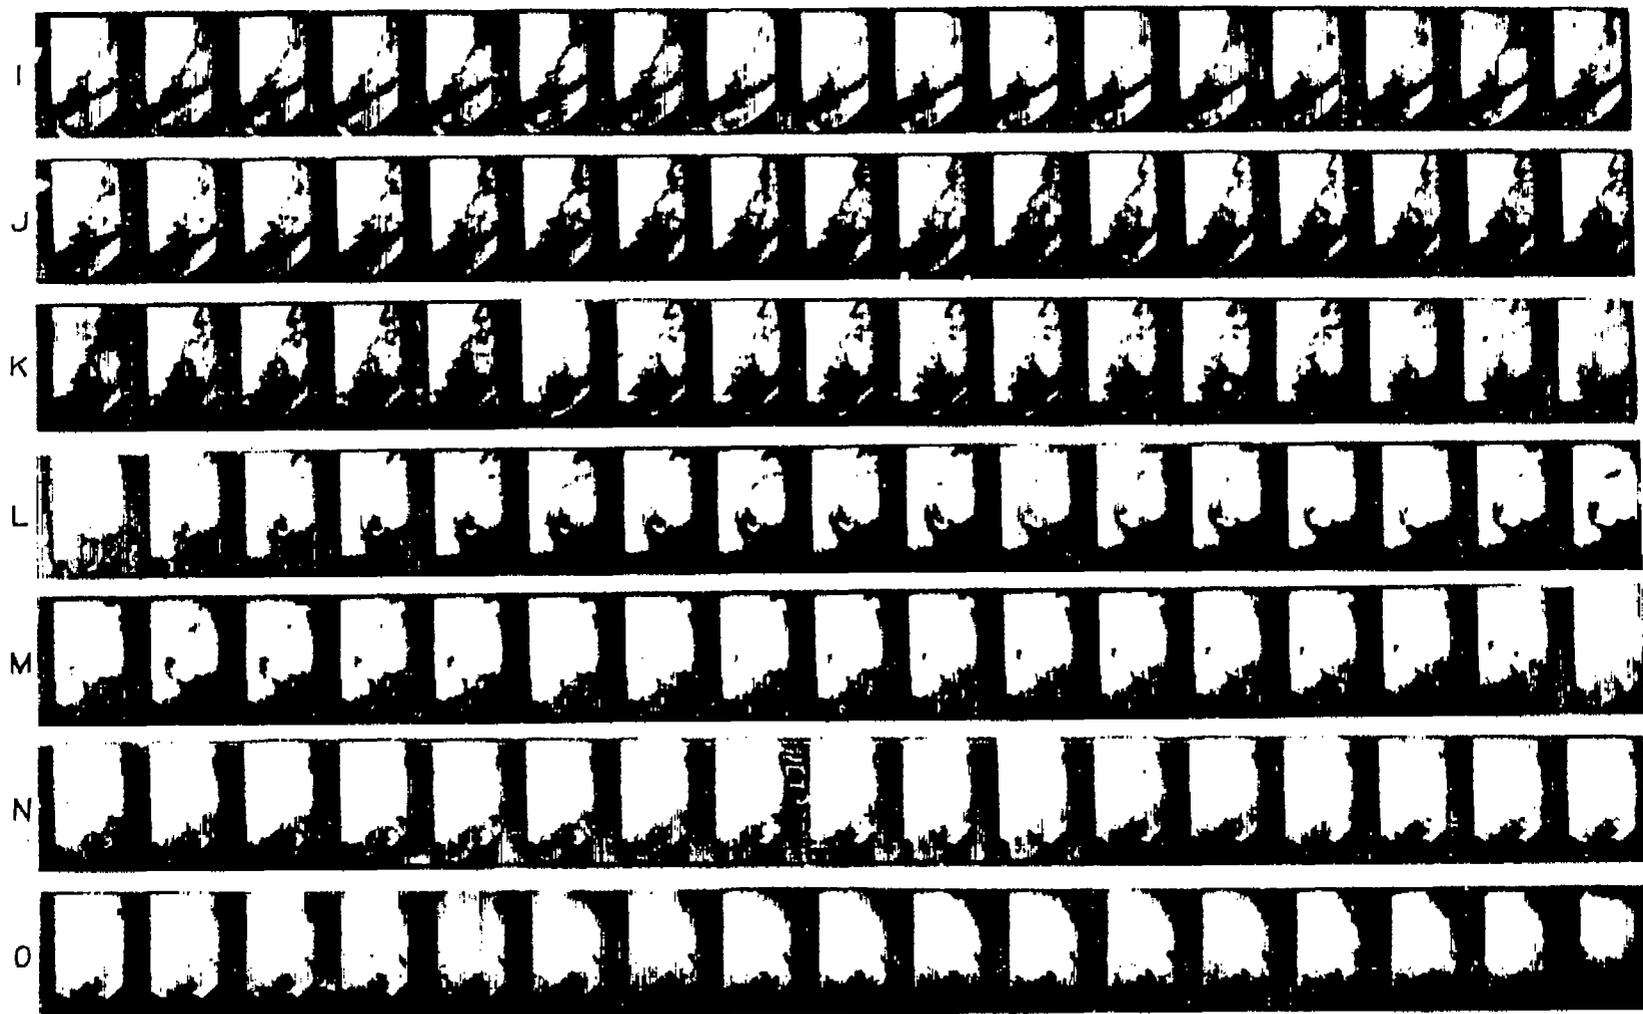
FIGURE 8.—High-speed motion pictures of a nonknocking explosion in a spark-ignition engine. Fuel, B-1; one spark plug; spark advance, 30° .

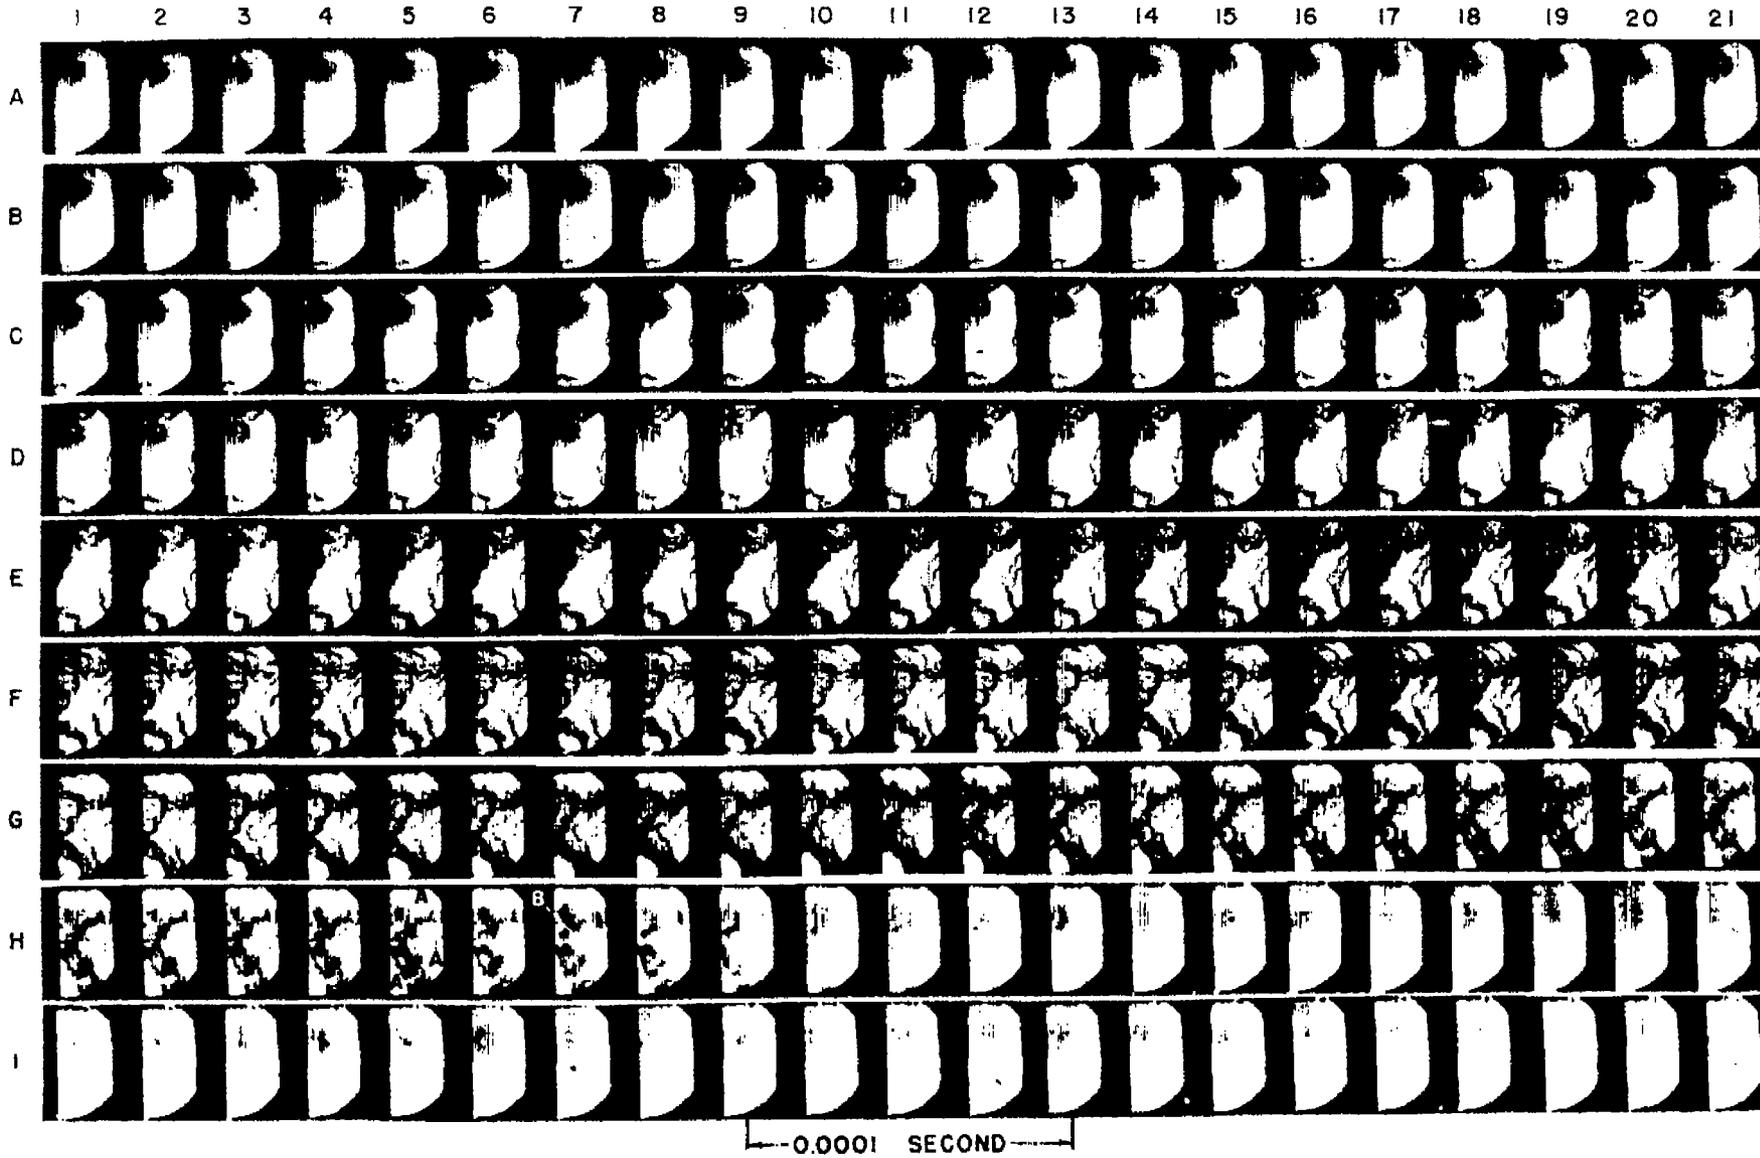
FIGURE 6.—High-speed motion pictures of a knocking explosion in a spark-ignition engine. Fuel, 80 percent 95-octane gasoline with 50 percent M-2; four spark plugs: spark advance, left-hand plug, 27°, other three plugs, 20°; A, regions already traversed by flame; B, blurring caused by knock.

Figures 6 and 7 were taken under the same conditions as figure 2 but with fuels of progressively lower antiknock value. The fuel used for figure 6 was a blend of equal volumes of a 95-octane gasoline and C. F. R. reference fuel M-2. This blend was the same as used for figure 5 of reference 1, incorrectly reported in that reference as a blend of S-1 and M-2. Figure 6 of this report and figure 5 of reference 1 are comparable. The difference between them is in the number of spark plugs used and in the earlier ignition at one of the plugs in figure 6.

The areas marked A in figure 6, frame H-5, are regions in which temperature gradients have apparently ceased to exist and where combustion is probably complete. The knock is first visible in frame H-7 as a blur in the region designated by the letter B. By frame H-13 the knock has completely eliminated the mottled zone. This elimination of the mottled zone in $7/40000$ (0.000175) second is in strong contrast with the very gradual fade-out of the mottled zone in the nonknocking explosion shown in figure 2. In figure 5 of reference 1, the mottled zone was eliminated by the knock in $1/40000$ (0.000025) second, frames M-11 and M-12. It is obvious from the photographs that the knock in that case was much more violent than in figure 6 of this report. The difference, however, may possibly not be directly due to the use of one or of four spark plugs. Combustion began much earlier in the case of figure 6 and, in view of the very low engine speed, combustion may have proceeded much nearer to completion before severe conditions were reached a few degrees before top center, so that less energy was available for release during knock.

Figures 6 and 7 show knocking combustions of very unequal severity. In figure 6, the last unignited portion of the fuel charge disappears in frame G-17, which is 11 frames previous to the first appearance of knock. On the other hand, in figure 7, which shows the more severe knock, the flame fronts never completely merge. Instead, beginning at about frame G-2, the unignited area becomes mottled spontaneously. In frame G-11 this spontaneous mottling of the unignited area has become so complete that this area cannot be distinguished from the area behind the flame fronts. Knock, however, did not occur until frame G-12. An entirely similar spontaneous darkening of the unignited zone, before knock occurred, is evident in figure 5 of reference 1. In that figure, in frame M-10, the darkening of this

In figure 6 it may be argued that at the time knock occurred in frame H-7 there were pockets of unignited gas not visible because of tonguing of the flames and that the knock is due to autoignition of these pockets. On the other hand, in frame G-11 of figure 7 of this report and in frame M-10 of figure 5 of reference 1, it does not appear reasonable to suppose that there are any pockets that have not autoignited or that, if there were such pockets, their autoignition would be any different from the autoignition that was seen to take place pre-

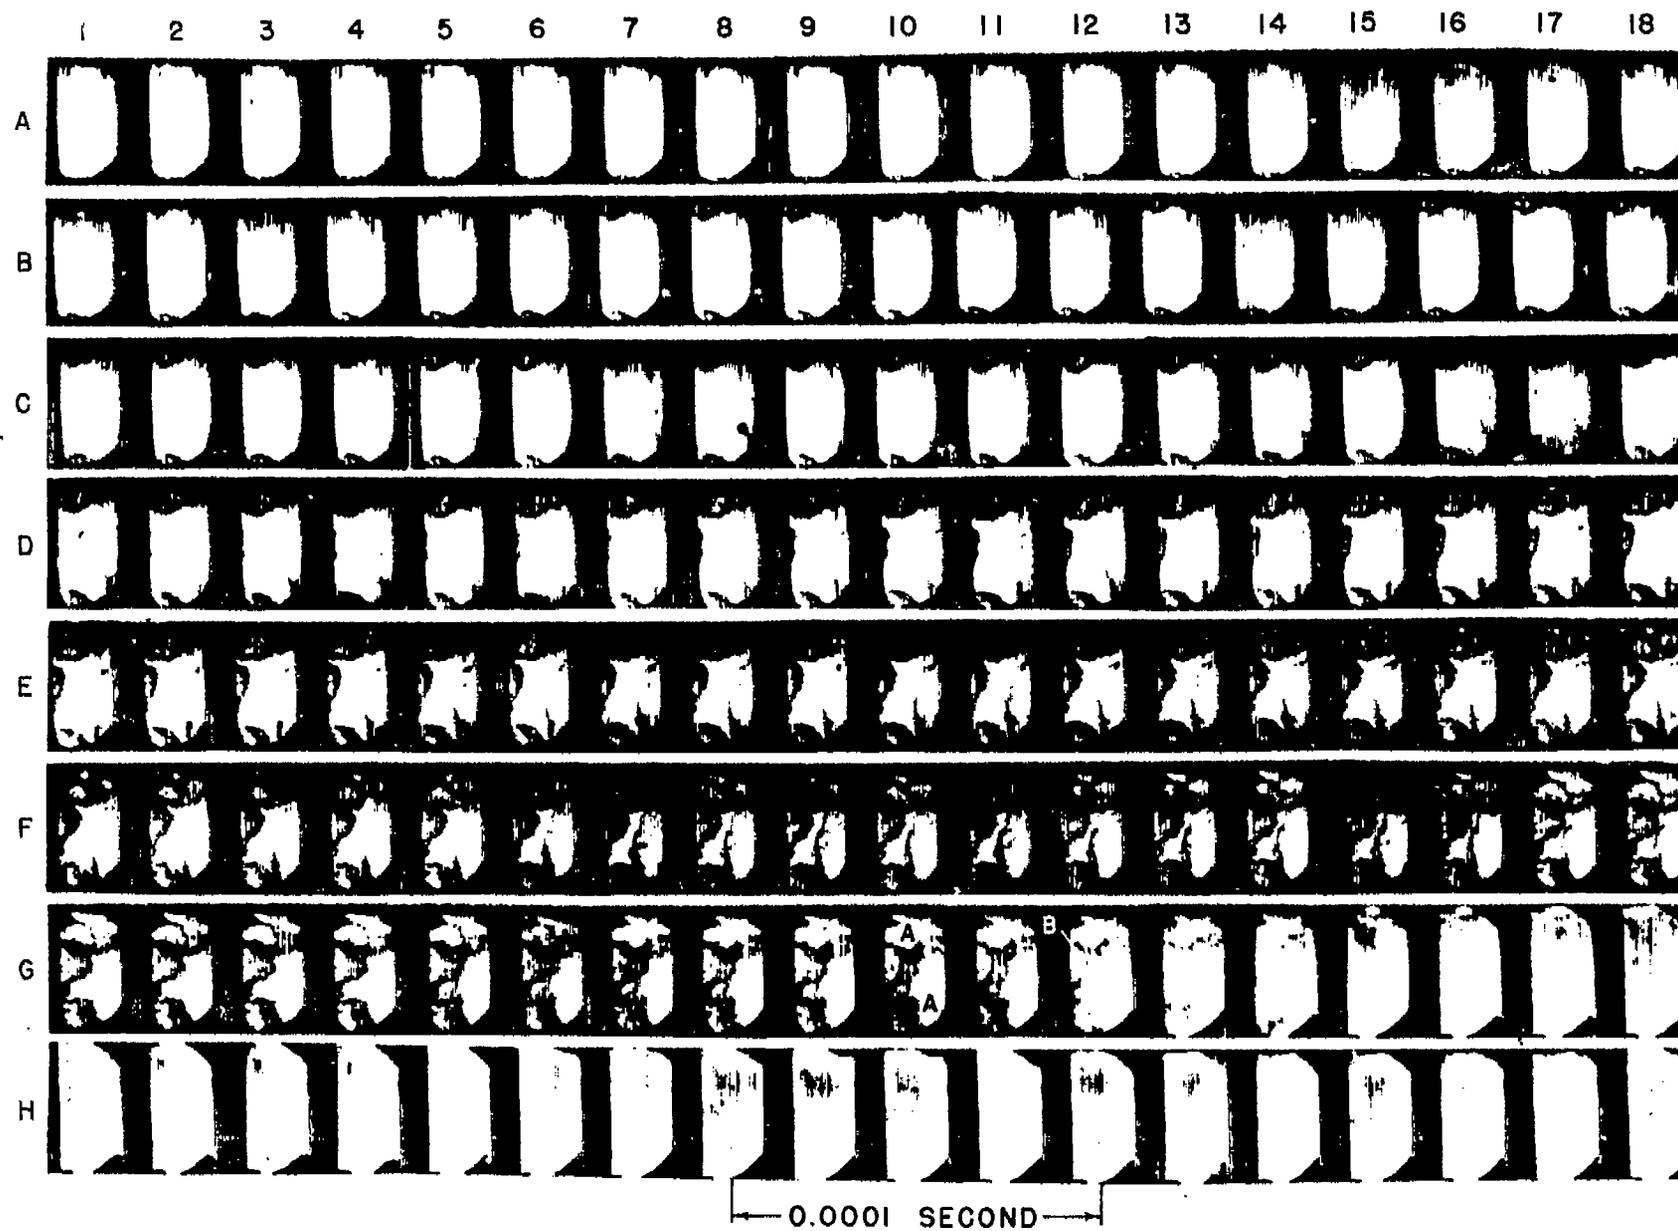
FIGURE 7.—High-speed motion pictures of a knocking explosion in a spark-ignition engine. Fuel, M-2; four spark plugs; spark advance, left-hand plug, 27°, other three plugs, 20°; A, region already traversed by flame; B, blurring caused by knock.

Figure 7 was taken under the same conditions as figure 6 except that a fuel, M-2, of still lower antiknock value, was used. In this figure knock is first visible in frame G-12 as a blurring in the region designated B. In this case the knock eliminates the mottled zone more quickly than in figure 6. At about frame G-13, moreover, a brilliant luminosity appears and this luminosity quickly develops throughout the visible portion of the chamber. This luminosity was not noticeable in figure 6. In frame G-13 and in some of the other frames, this luminosity is also visible below and to the right of the chamber. The appearance of the luminosity in this region and in the combustion chamber generally, with the heavier knocks, was explained in reference 1.

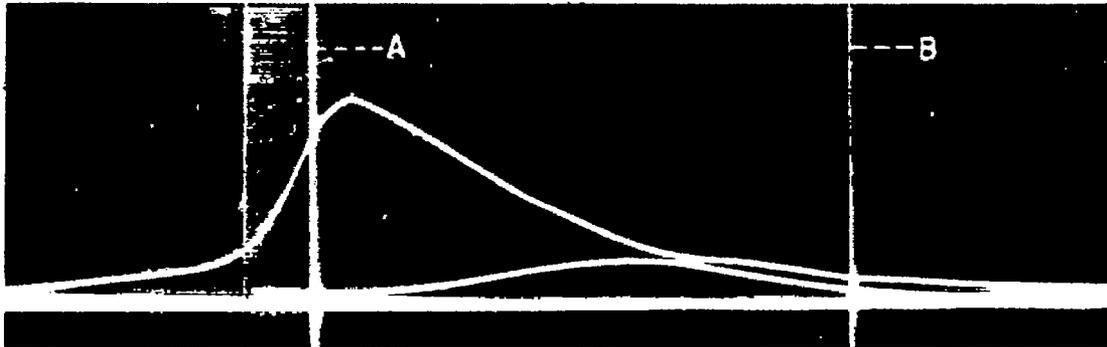
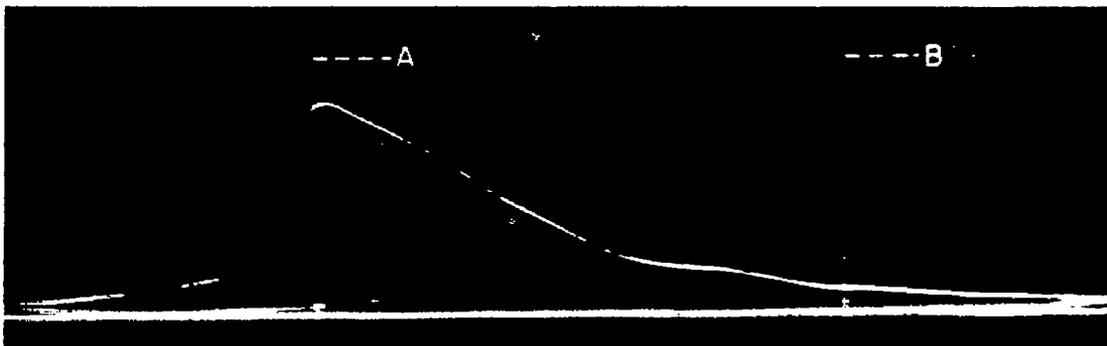
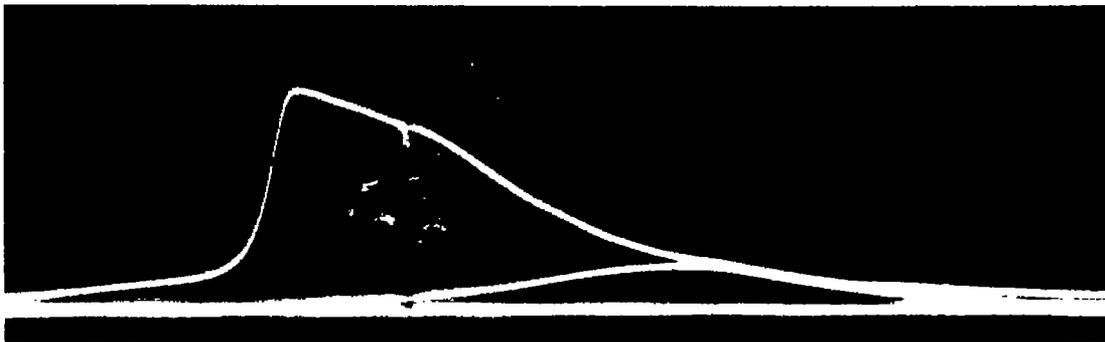
(a) Fuel, S-1; one spark plug; spark advance, 20°.

(b) Fuel, S-1; one spark plug with preignition from hot spot; spark advance, 20°.

(c) Fuel, S-1; four spark plugs; spark advance, 20° on three plugs, 27° on fourth plug.

FIGURE 12.—Indicator cards for nonknocking explosion in a spark-ignition engine.

cycles. In any of the time-pressure records where vertical lines A and B appear, the line A is the record of a spark marking top center and the line B is the record of a spark marking the crank position 90° after top center.

The conditions of the record of figure 12 (a) correspond to those of figure 3 of reference 1; the record of figure 12 (b), to those of figure 7 of reference 1; and the record of figure 12 (c), to those of figure 2 of this report. As far as the time-pressure records or the

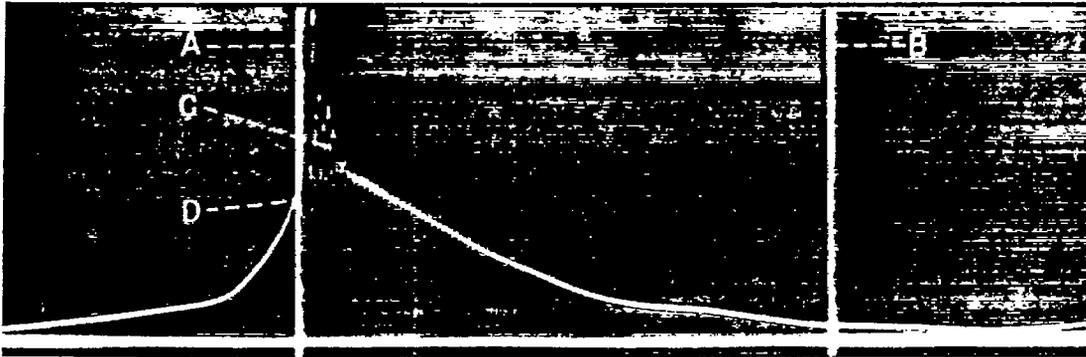
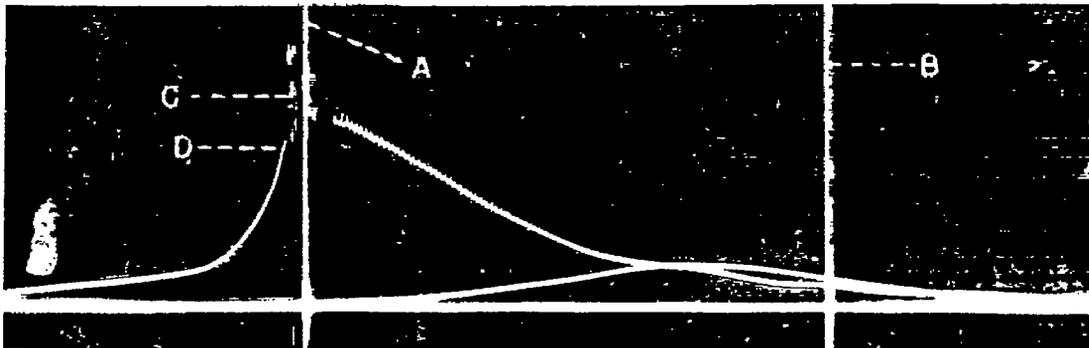
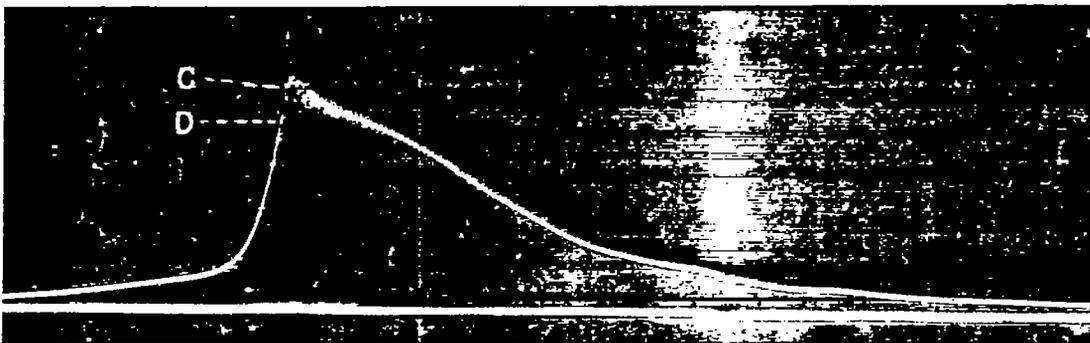
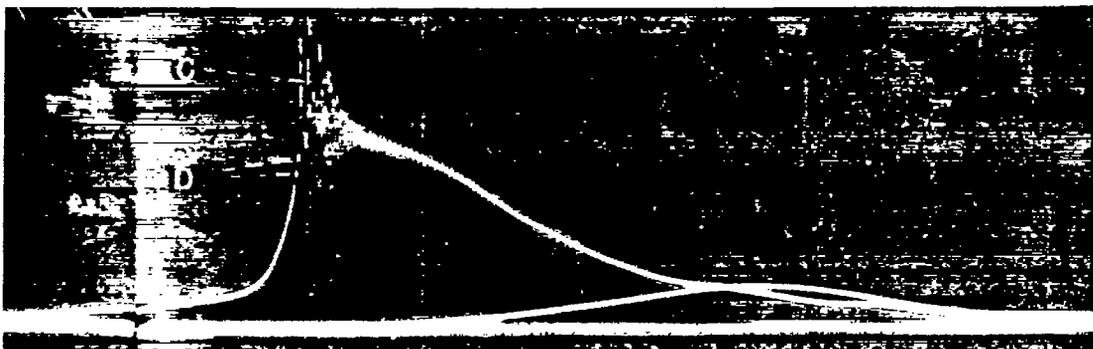
(a) Fuel, 50 percent 95-octane gasoline with 50 percent M-2; one spark plug; spark advance, 20°.

(b) Fuel, 50 percent 95-octane gasoline with 50 percent M-2; one spark plug with preignition from hot spot; spark advance, 20°.

(c) Fuel, 50 percent 95-octane gasoline with 50 percent M-2; four spark plugs; spark advance, 20° on three plugs, 27° on fourth plug.

(d) Fuel, M-2; four spark plugs; spark advance, 20° on three plugs, 27° on fourth plug.

FIGURE 13.—Indicator cards for knocking explosion in a spark-ignition engine.

The time-pressure records of figure 13 are for knocking explosions. The correspondence of conditions is between figure 13 (a) and figure 5 of reference 1, between figure 13 (b) and figure 8 of reference 1, between figure 13 (c) and figure 6 of this report, and between figure 13 (d) and figure 7 of this report.

records of figures 13 (a) and 13 (c) shows that the hot spot again has the same effect as a spark plug in causing a steepening of the pressure rise and an advance of the position of maximum pressure. The comparison also shows that the hot spot has caused the knock to occur earlier in the record of figure 13 (b) than in that of figure 13 (a).

The violent pressure fluctuations, designated C in the four knocking time-pressure records, are characteristic of knocking explosions in a spark-ignition engine. Some of the fluctuations in these records have been touched up with white ink. The white ink has been placed, however, only on points where a trace is unmistakably present on the original film but too faint to reproduce in the prints. In agreement with the photographs, the time-pressure records show very violent and about equal amplitudes of vibration for the case of one spark plug with an equal mixture of 95-octane gasoline and M-2 and the case of four spark

The slope appears to be constant through the three spots of figure 13 (c); yet the second and third spots are farther apart than the first and second. The distance between the first and second spots corresponds to the natural frequency of 9000 cycles per second, so that these two spots might have been caused by a single shock except that, in that case, the first spot should have been the brighter. The distance between the first and the third spots corresponds to the fundamental frequency of the vibrations following the knock in this trace, which is presumably the natural frequency of vibration of the gases in the combustion chamber. On the basis of this reasoning, the indicator diaphragm appears to have received at least two and probably three separate shocks just before the first violent pressure fluctuation.

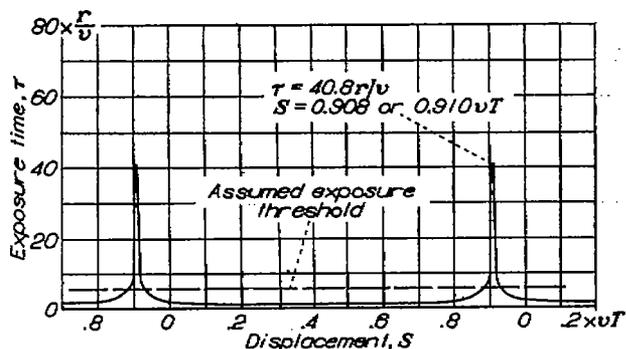
FIGURE 14.—Variation of displacement with exposure time for oscillatory motion superposed on constant-velocity motion. Maximum velocity of oscillatory motion equal to the constant velocity.
