## REPORT NO. 761

# IDENTIFICATION OF KNOCK IN NACA HIGH-SPEED PHOTOGRAPHS OF COMBUSTION IN A SPARK-IGNITION ENGINE

By CEARCY D. MILLER and H. LOWELL OLSEN

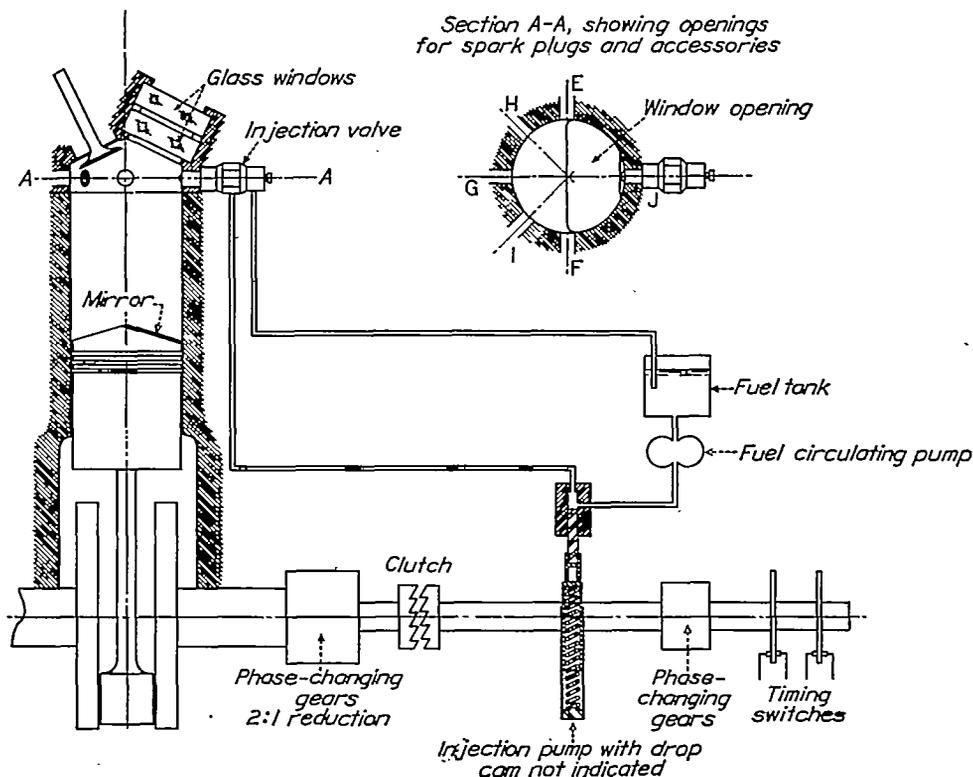
FIGURE 1 — Diagrammatic sketch of NACA combustion apparatus.

**Combustion apparatus.**—The NACA combustion apparatus is described in detail in reference 1. Figure 1 of this report shows this combustion apparatus diagrammatically. At the time of taking all the photographs presented in this report an injection valve was placed in opening H. (See fig. 1.) For some of the photographs, spark plugs were placed in openings E, G, F, and J and a piezoelectric pickup was placed in opening I, its diaphragm being flush with the combustion-chamber wall. For other pictures, the spark plug was removed from opening J and the piezoelectric pickup was placed in this opening.

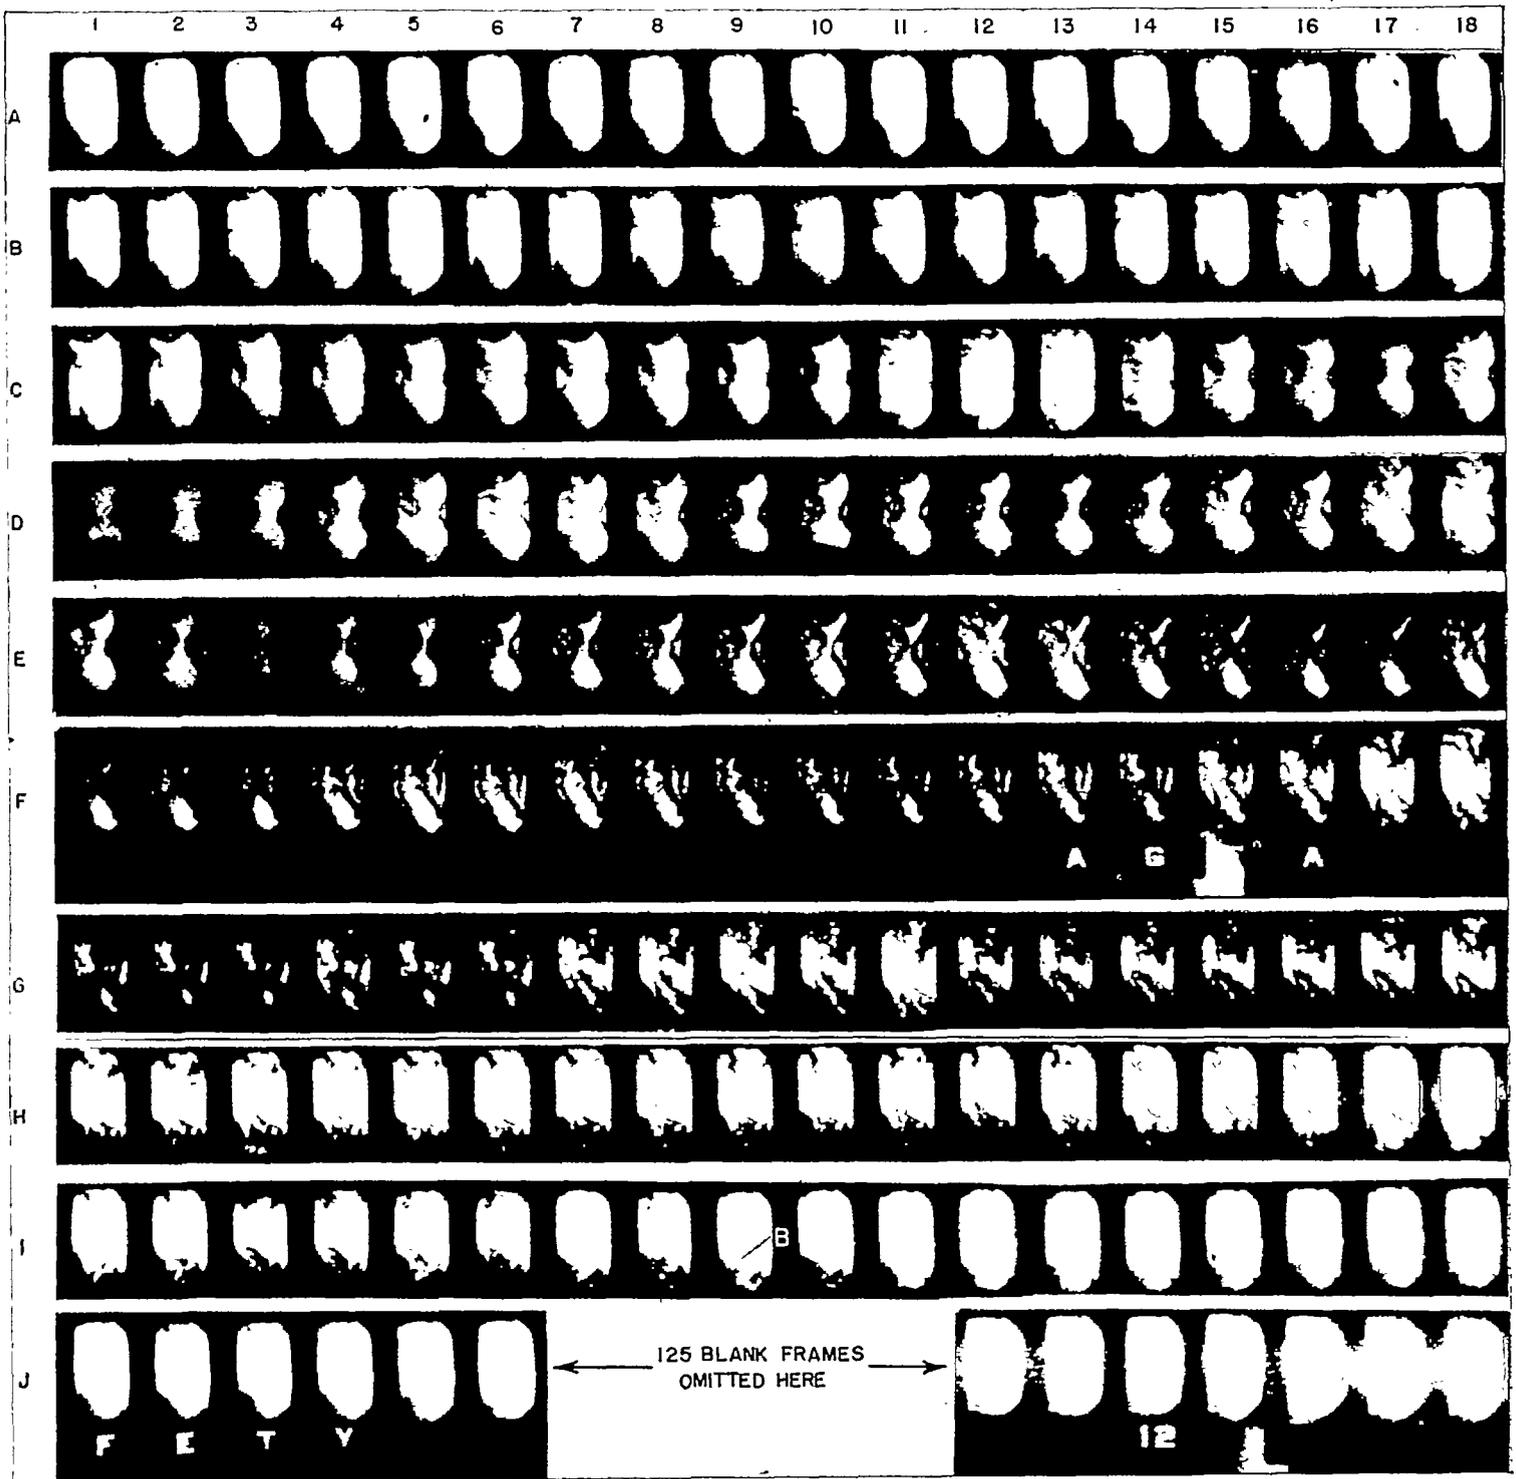
FIGURE 2.—High-speed motion pictures of an explosion in a spark-ignition engine with light knock. Fuel, 90 percent S-1 with 10 percent M-2; four spark plugs; spark advance, left hand plug, 23°, other three plugs, 22°; B, blurring caused by knock

The perforated edge of the film was reproduced in the figure only in rows F and J. The timing sparks caused exposures on the perforated edge in these rows. The exposure between frames J-15 and J-16 resulted from the first timing spark; the exposure at frame F-15, from the second timing spark. In the time between the first and second timing sparks, the film drum turned sufficiently to carry  $551\frac{1}{2}$  frames past the picture-taking point of the camera, or about  $1\frac{1}{2}$  turns.

not readily noted by the inexperienced observer. A painstaking comparison of frames I-8 and I-9, however, will reveal a difference in the region designated B, which has no counterpart in a comparison of frames I-7 and I-8. When the photographs are projected as motion pictures, the blurred region shows unmistakably.

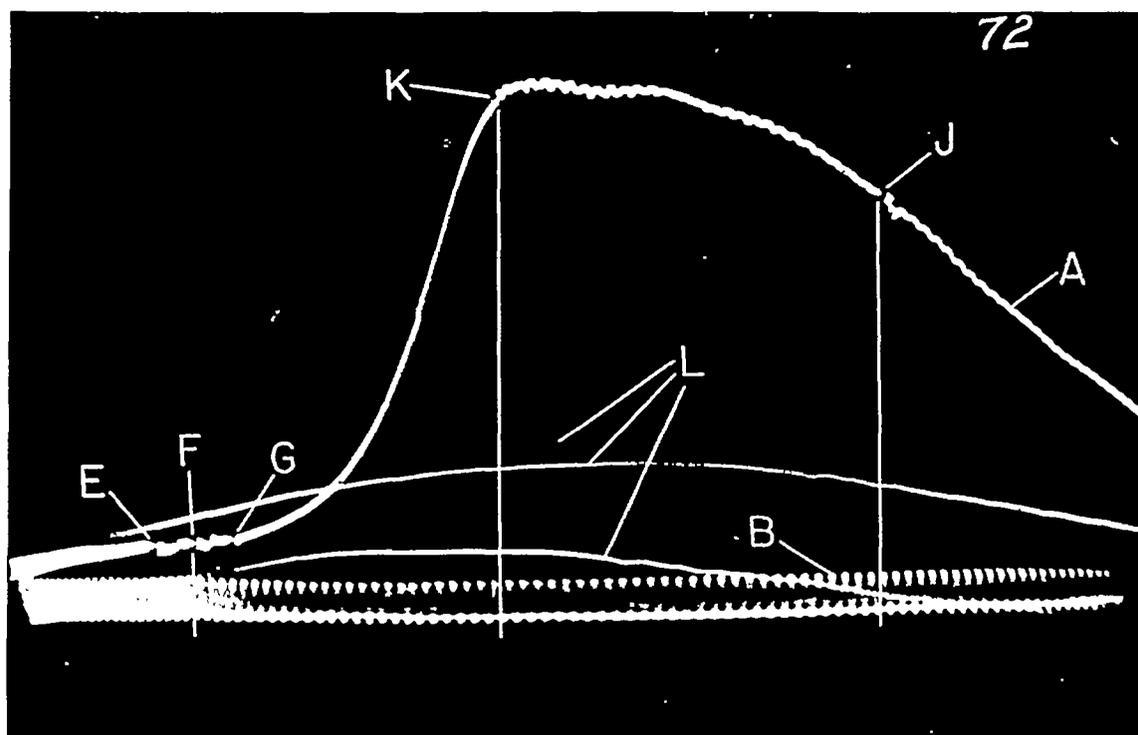
FIGURE 3.—Indicator card with oscillograph trace for explosion of figure 2 in a spark-ignition engine with light knock. Fuel, 90 percent 8-1 with 10 percent M-2; four spark plugs; spark advance,  $22^\circ$  on three plugs,  $29^\circ$  on fourth plug; piezoelectric pickup in opening 1. (See fig. 1.)

Figure 3 is a photograph of the oscillograph screen showing the time-pressure record for the combustion cycle photographed in figure 2. In figure 3, as in the later figures, A designates the time-pressure trace; B, the oscillator trace; and L, motoring traces that were accidentally exposed before or after the single power cycle. The letter E designates a break caused in the time-pressure trace by pickup from the earliest ignition spark, and G designates a break by pickup from the three later ignition sparks. A break in the trace caused by the first timing spark is designated F and a break caused by the second timing spark is designated J. The letter K designates the place on the time-pressure trace at which knocking vibrations first become visible.

In figure 3, lines have been drawn from points F, K, and J to the points in the oscillator trace that correspond with them

An examination of figure 3 reveals that the initial frequency of the knocking vibrations is about 8000 cycles per second, a value that checks with a sound velocity of about 3000 feet per second if the vibrations are assumed to be transverse with one displacement node at the center of the chamber. Using a speed of sound of 3000 feet per second, the time interval of  $2\frac{1}{2}$  frames between the exposure of frame 1-9 and the beginning of knocking vibrations is found to be only about half enough for the knocking disturbance to travel from the point at which the knocking blur is observed in frame 1-9 of figure 2 to the diaphragm of the piezoelectric pickup in opening 1 of the cylinder head. (See fig. 1.) Results presented later, however, indicate that the  $2\frac{1}{2}$ -frame value of lag is erroneous.

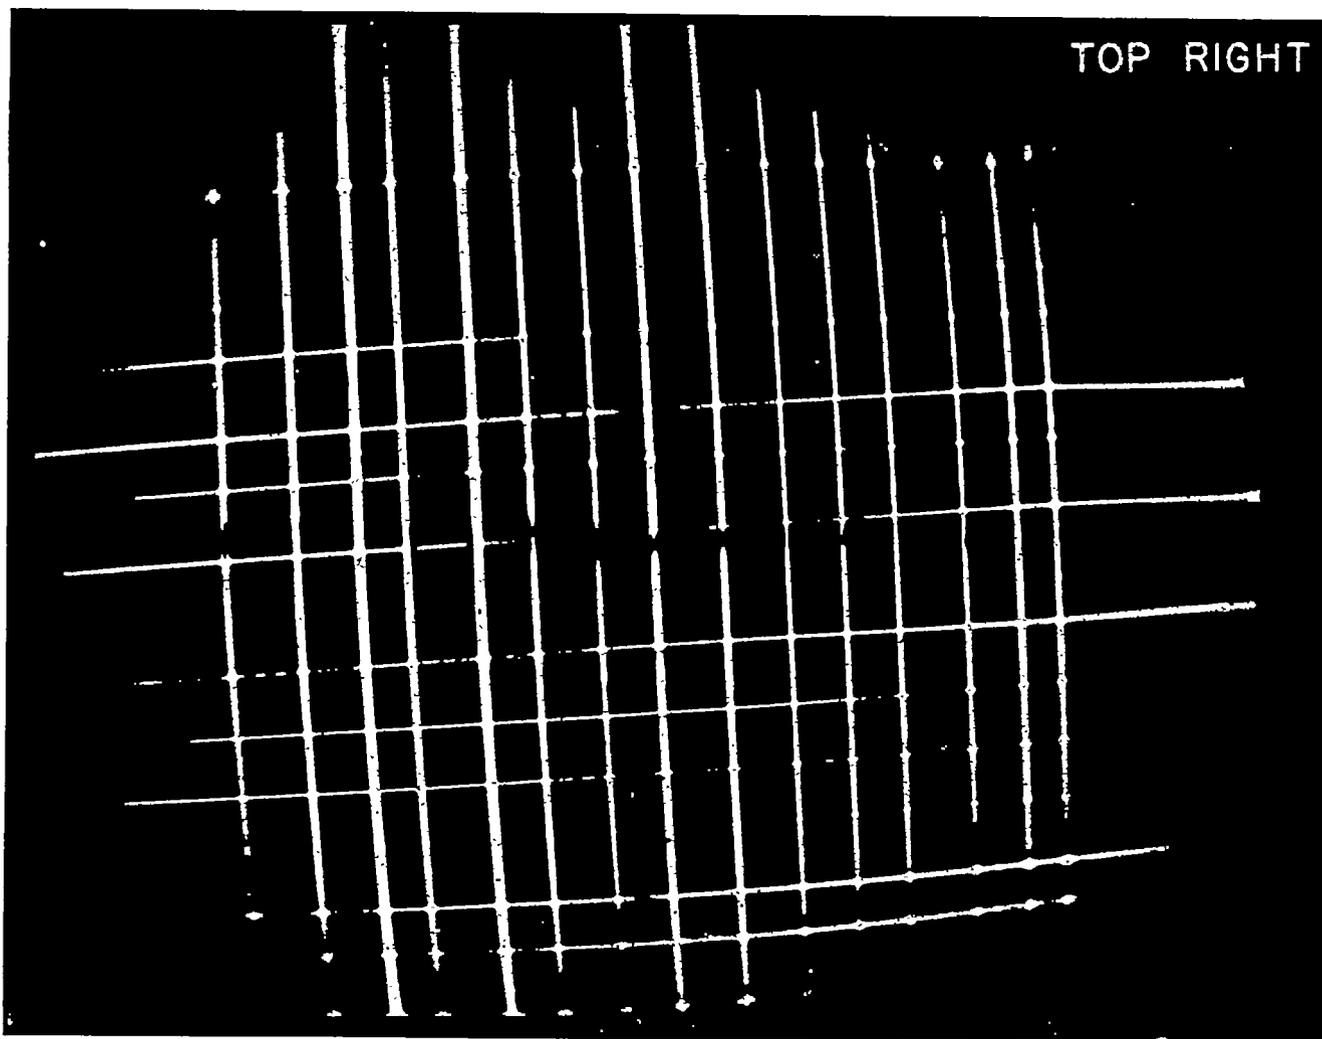
FIGURE 4.—Grid pattern for use in constructing constant-time lines on time-pressure records.

in time. These lines have not been drawn parallel, but each line has been drawn in a direction conforming to the grid pattern shown in figure 4.

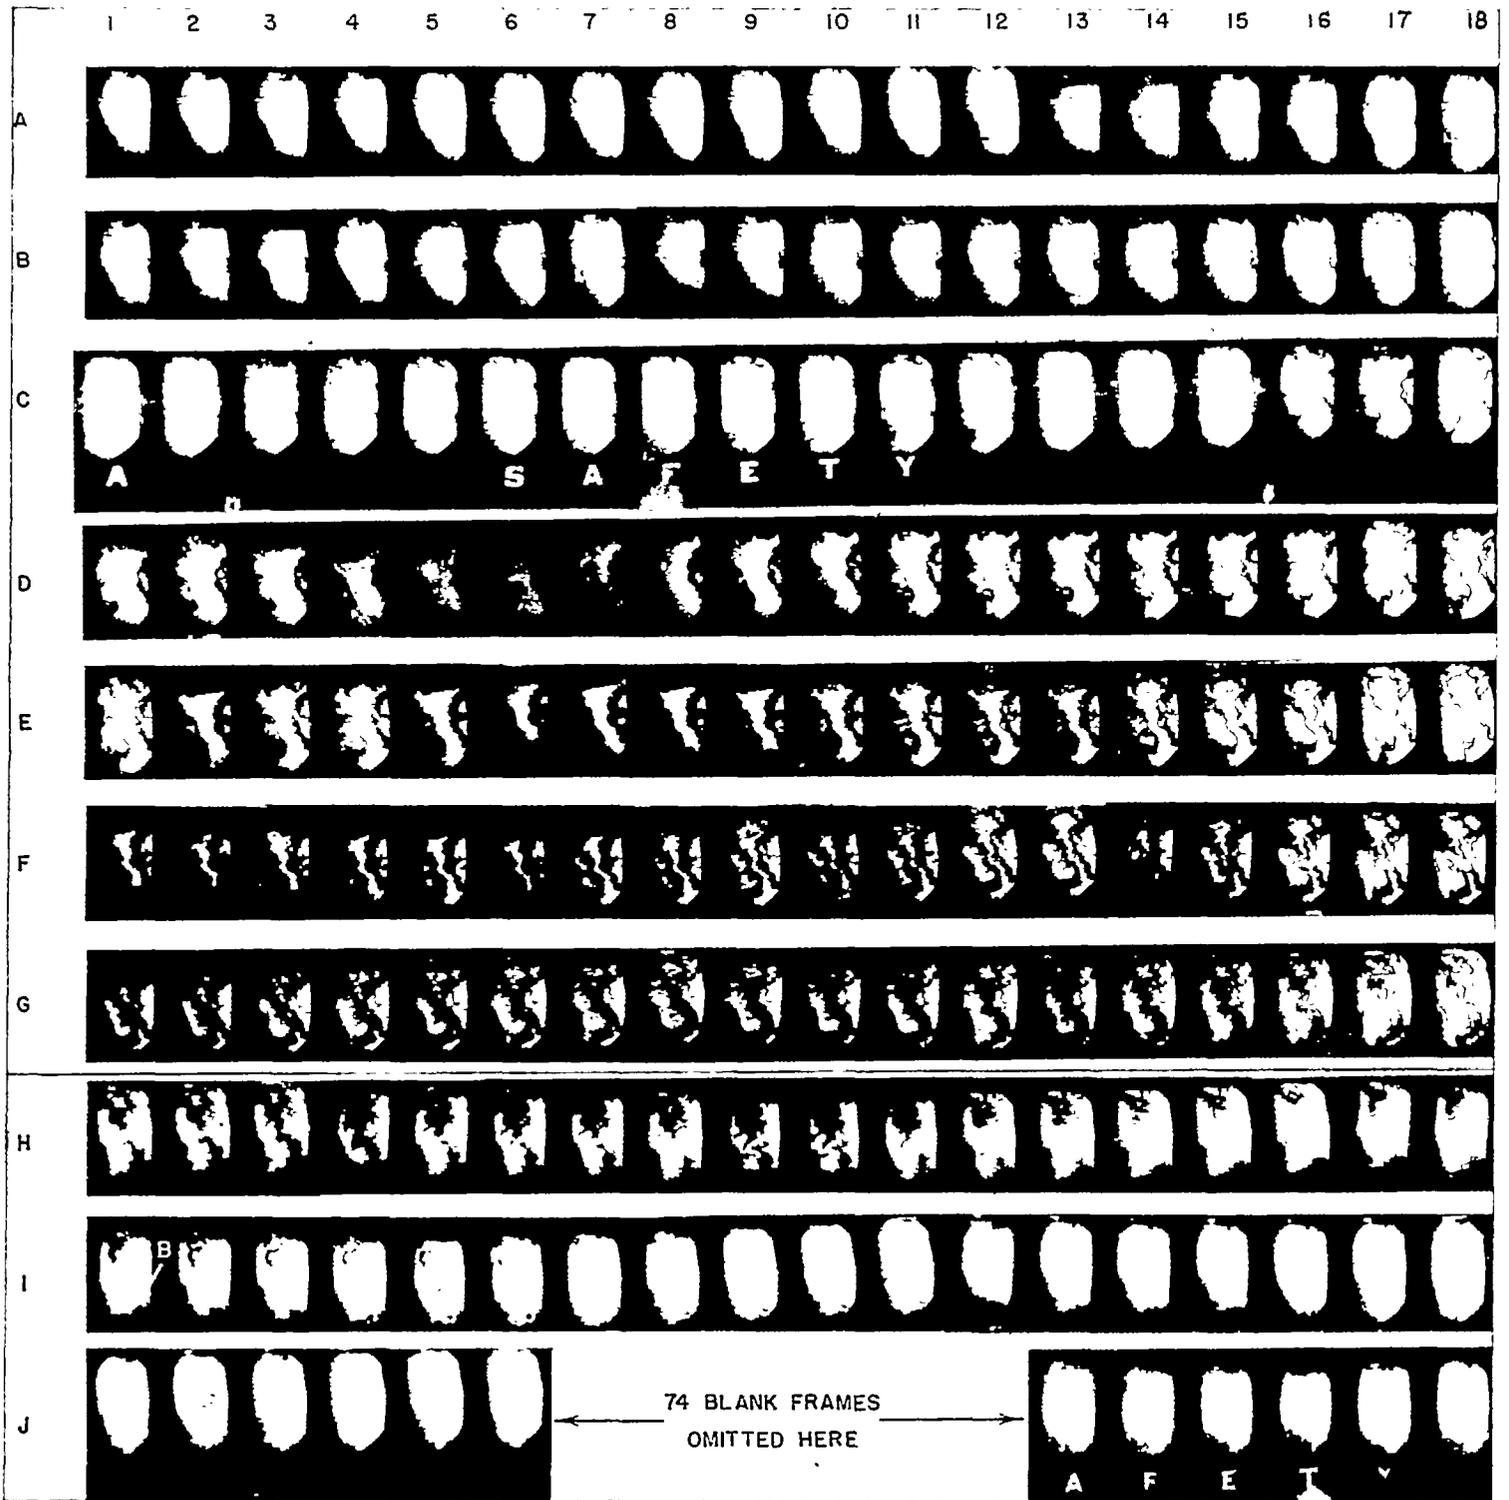
FIGURE 5.—High-speed motion pictures of an explosion in a spark-ignition engine with light knock. Fuel, 80 percent 8-1 with 20 percent M-2; four spark plugs; spark advance, left-hand plug, 29°, other three plugs, 22°; B, blurring caused by knock.

Figure 5 is a shot of knocking combustion taken under the same conditions as figure 2 but with a blend of 80 percent S-1 and 20 percent M-2 fuels, and figure 6 is the time-pressure record for the same combustion cycle. In this case the knocking blur is first visible at B in frame 1-1 of figure 5. One hundred and twenty-three frames are omitted in figure 5 after frame J-18 or before frame A-1.

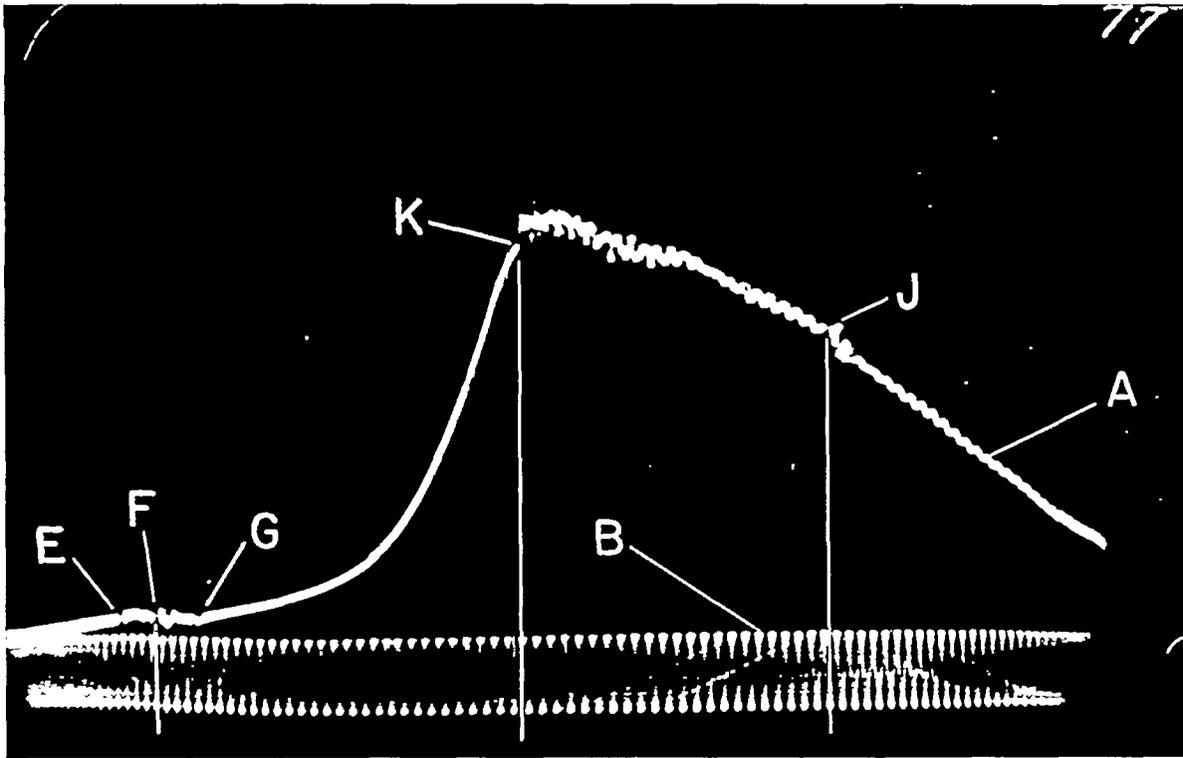
FIGURE 6.—Indicator card with oscillator trace for explosion of figure 5 in a spark-ignition engine with light knock. Fuel, 80 percent S-1 with 20 percent M-2; four spark plugs; spark advance, 22° on three plugs, 29° on fourth plug; piezoelectric pickup in opening 1. (See fig. 1.)

The computations of lags between the appearance of blur and the beginning of violent pressure fluctuations for the case of figures 5 and 6 and the case of figures 7 and 8 will be found in table I (a) opposite tests 77 and 95, respectively. The results are 4 frames and 2½ frames, respectively.

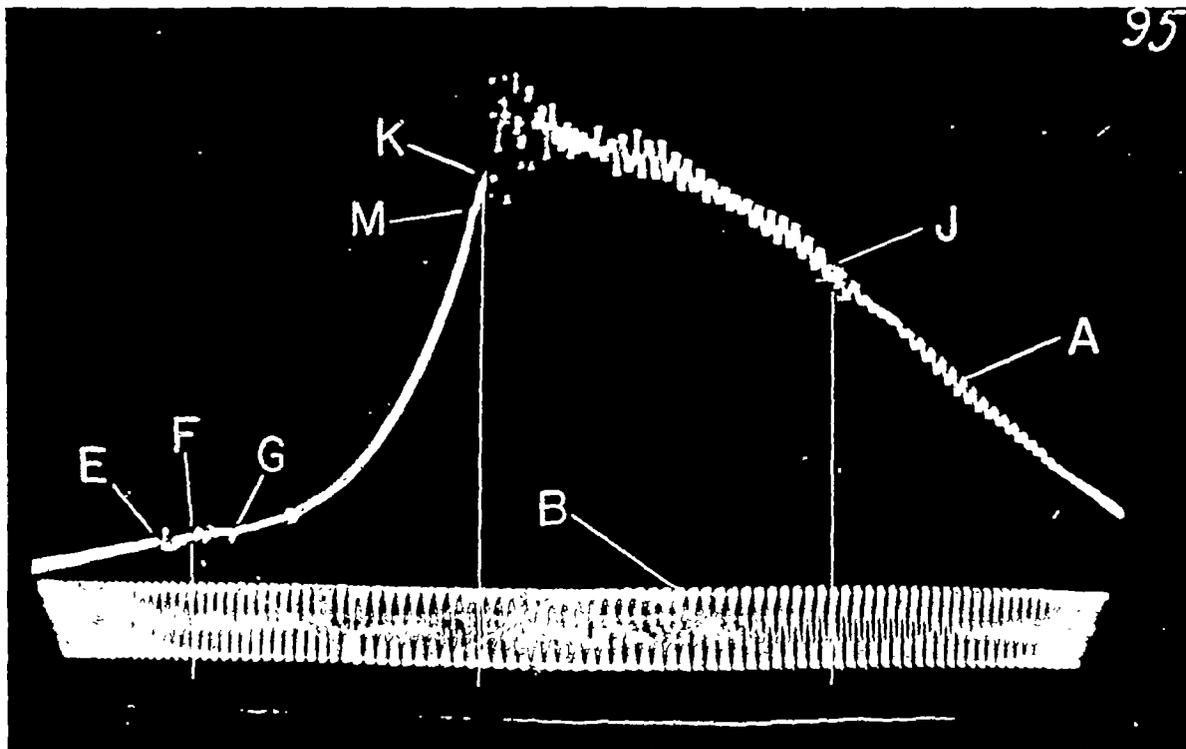
FIGURE 8.—Indicator card with oscillator trace for explosion of figure 7 in a spark-ignition engine with violent knock. Fuel, 50 percent S-1 with 50 percent M-2; four spark plugs; spark advance, 22° on three plugs, 29° on fourth plug; piezoelectric pickup in opening 1. (See fig. 1.)

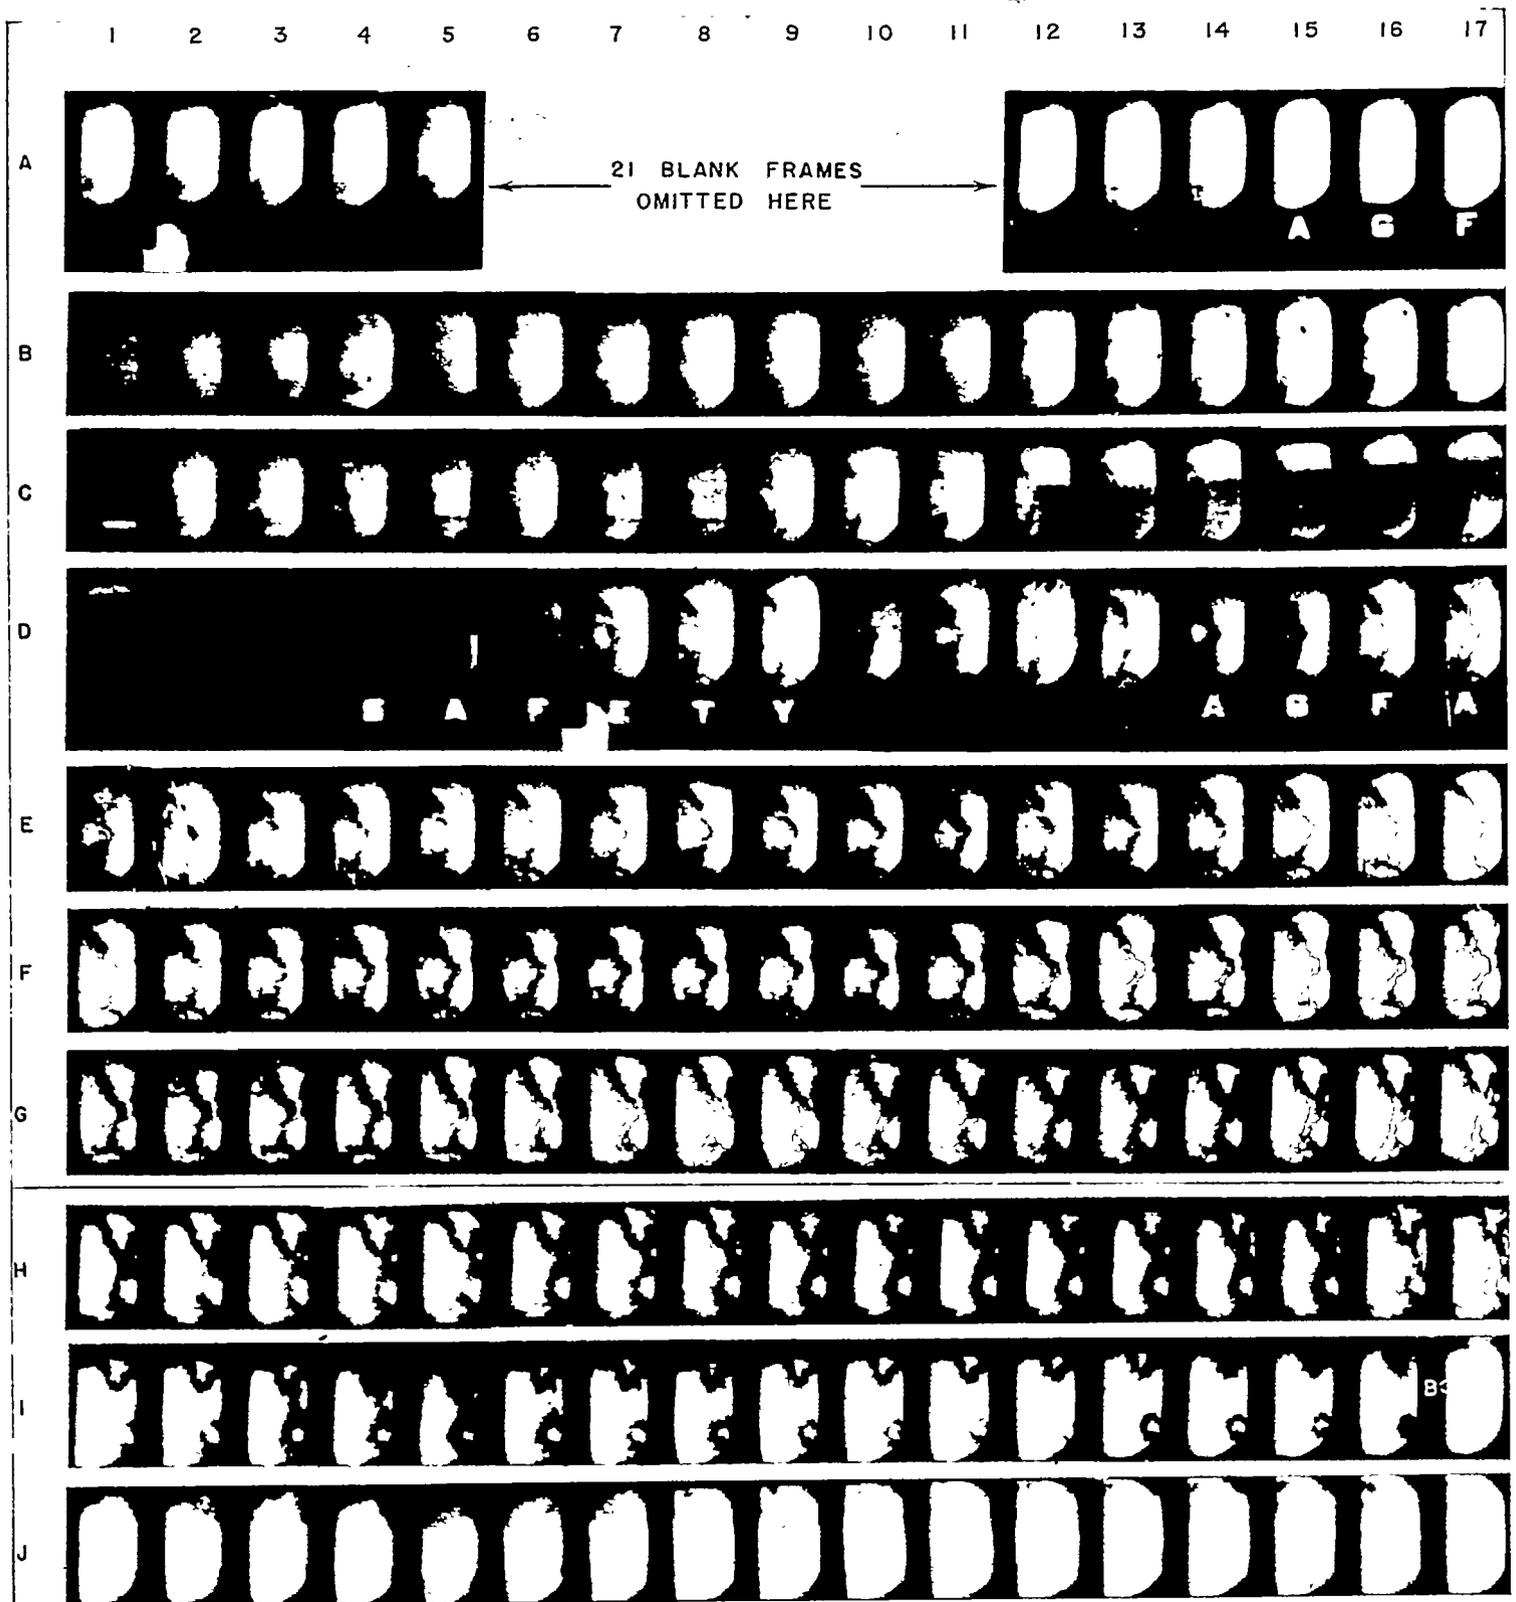
FIGURE 9.—High-speed motion pictures of an explosion in a spark-ignition engine with violent knock. Fuel, 50 percent S-1 with 50 percent M-2; four spark plugs; spark advance, left-hand plug, 29°, other three plugs, 22°; B, blurring caused by knock.

**Time relationship of schlieren blur to gas vibrations—second method.**—Figure 9 is a photographic series of violently knocking combustion taken under the same conditions and with the same fuel blend as figure 7 but with the two-oscillograph method of establishing time relationship. The characteristic knocking blur occurs in frame 1-17 of figure 9. One frame was lost at the splice at frame E-2 and 186 frames are omitted after frame J-17 or before frame A-1. The number of frames between timing sparks is 301, having been reduced, upon changing from the first to the second method, from about  $1\frac{1}{2}$  turns of the film drum to a little less than one complete turn of the drum. The first timing spark appears at frame D-7; the second, at frame A-2.

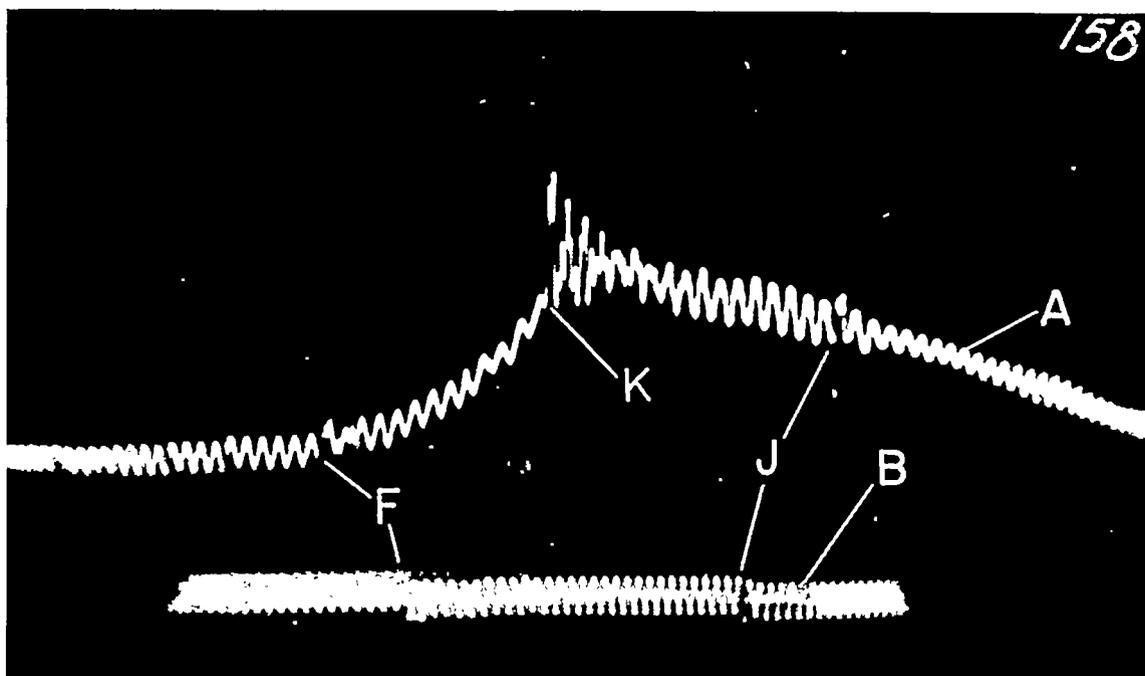
FIGURE 10.—Indicator card combined with oscillator trace and with separate oscillator trace for explosion of figure 9 in a spark-ignition engine with violent knock. Fuel, 50 percent S-1 with 50 percent M-2; four spark plugs; spark advance, 22° on three plugs, 29° on fourth plug; piezoelectric pickup in opening I. (See fig. 1.)

Figure 10 shows the time-pressure record of the combustion cycle photographed in figure 9 combined with the voltage wave delivered by the oscillator. This composite curve is designated A. The oscillator trace alone, also appearing in this figure, is designated B. In each trace the break caused by the first timing spark is designated F and the break caused by the second timing spark is designated J. The break in the time-pressure record caused by the first violent pressure fluctuation is designated K.

From trace A of figure 10, a count of the number of oscillator cycles between the first timing spark at F and the break due to violent pressure fluctuation at K yields a value of 12.9. All other steps in the determination of lag between blur in the photographs and the beginning of intense pressure fluctuations at the piezoelectric pickup are the same as with the first method. The determination for the case of figures 9 and 10 may be found in table I (b) opposite test 158. The value of lag is six motion-picture frames.

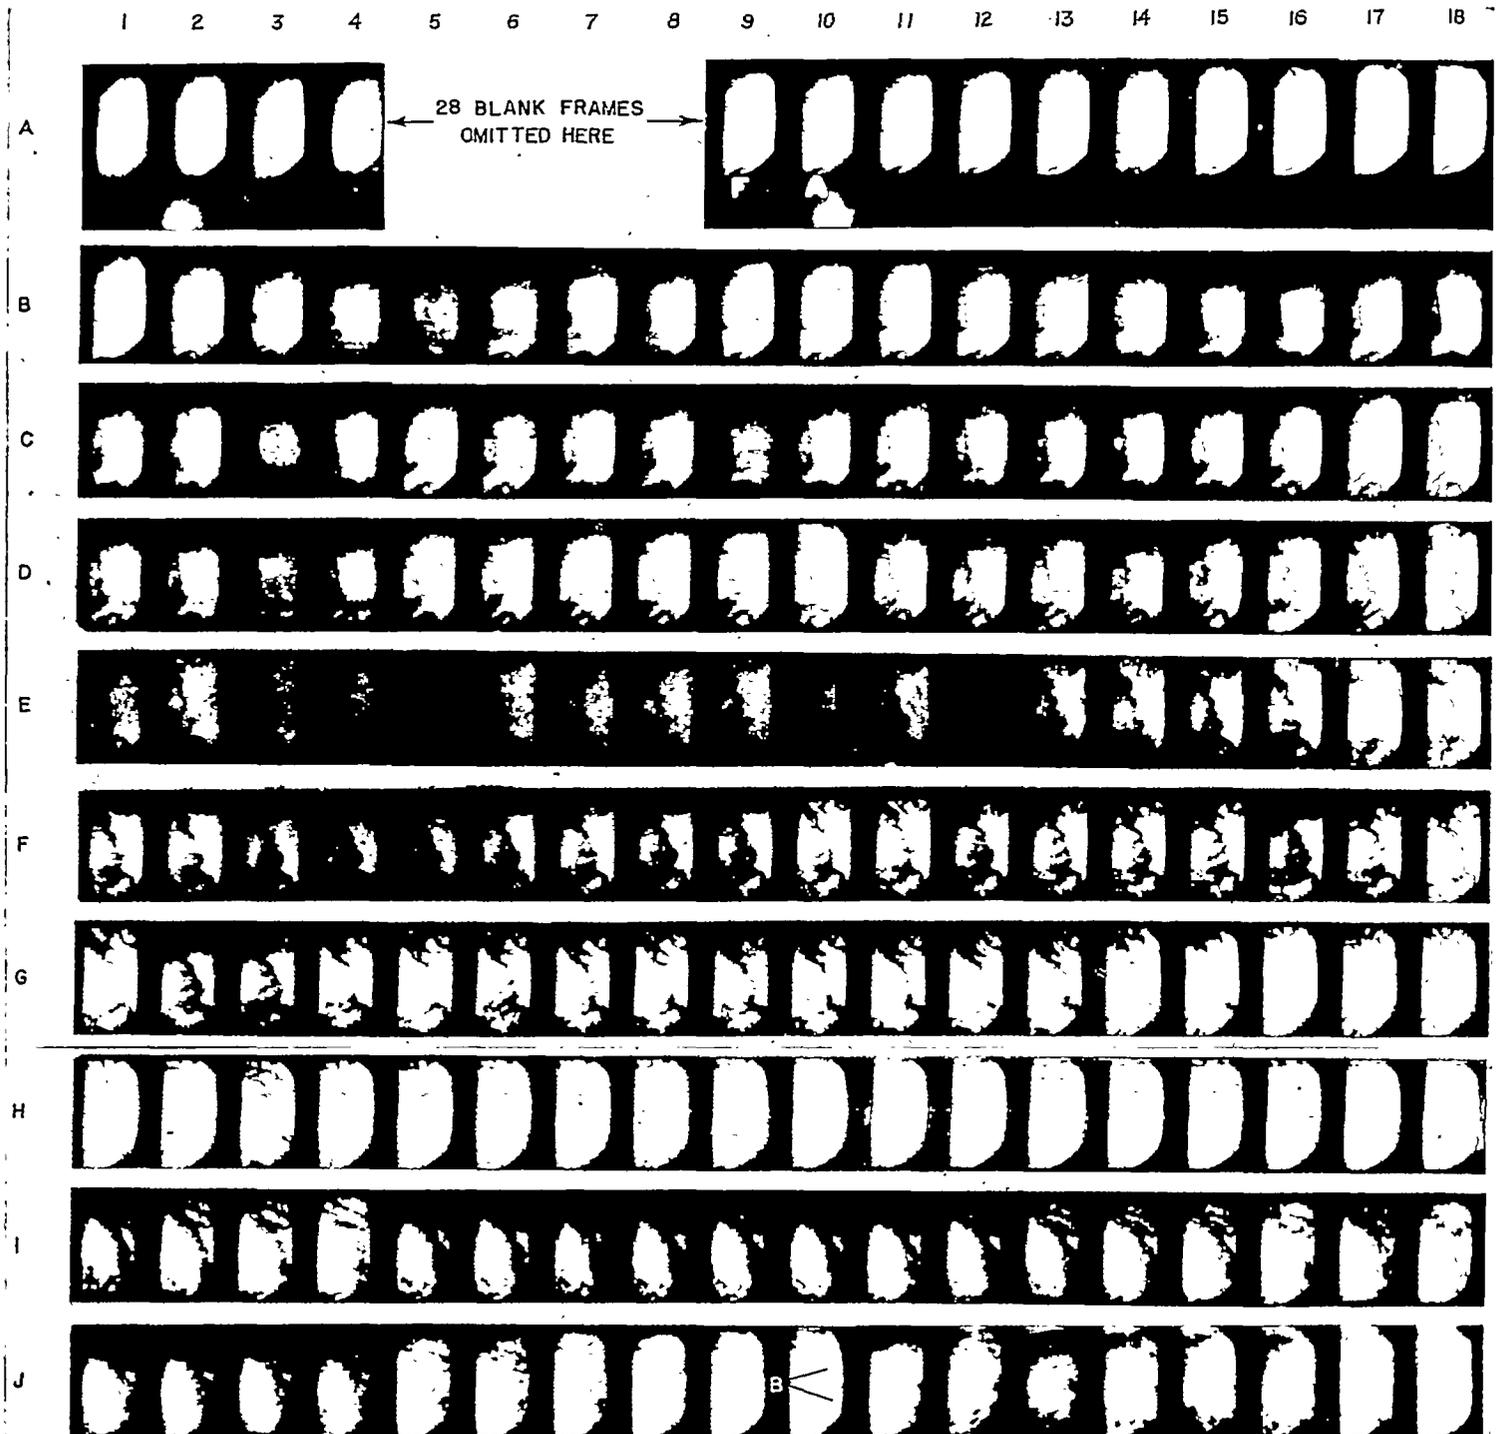
FIGURE 11.—High-speed motion pictures of an explosion in a spark-ignition engine with moderate knock. Fuel, 80 percent 8-1 with 20 percent M-2; three spark plugs; spark advance, left-hand plug, 29°, other two plugs, 22°; B, blurring caused by knock.

The determination of lag between appearance of blur and beginning of violent pressure fluctuations for the case of figures 11 and 12 may be found in table I (c) opposite test 166. The value of lag in this case is two motion-picture frames.

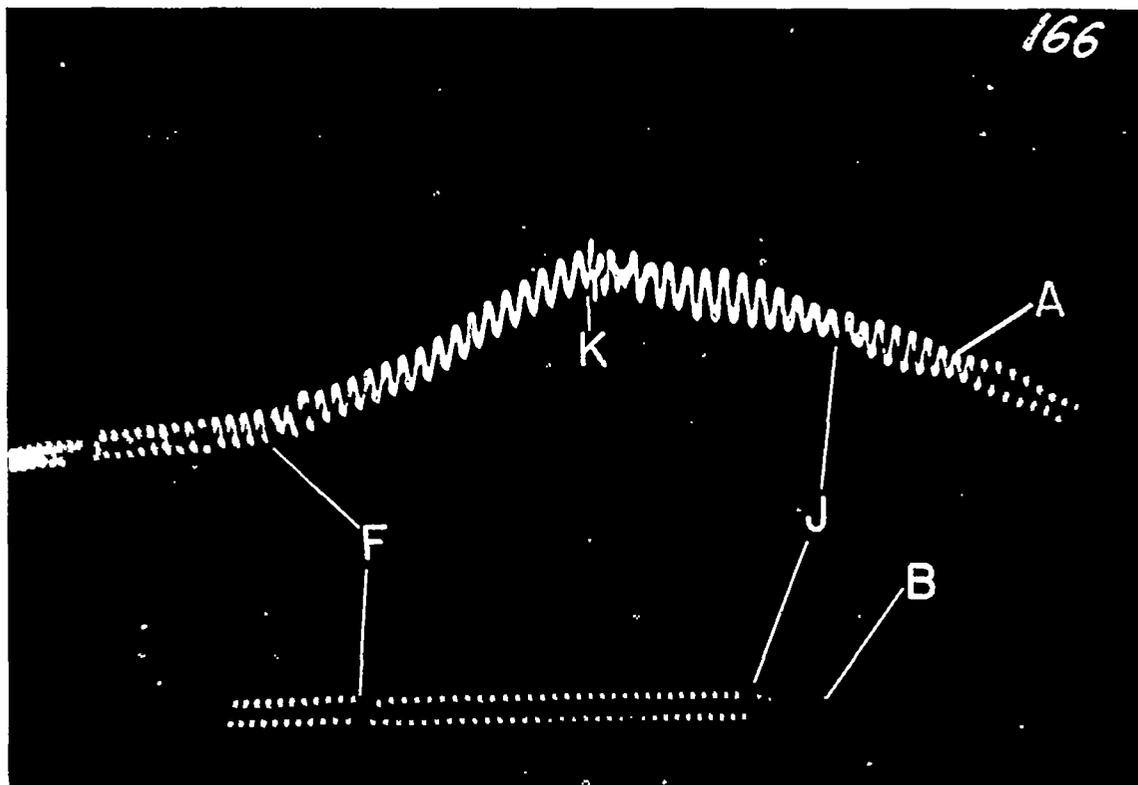
FIGURE 12.—Indicator card combined with oscillator traces and with separate oscillator traces for explosion of figure 11 in a spark-ignition engine with moderate knock: Fuel, 80 percent S-1 with 20 percent M-2; three spark plugs; spark advance, 22° on two plugs, 27° on third plug; piezoelectric pickup in opening J. (See fig. 1.)

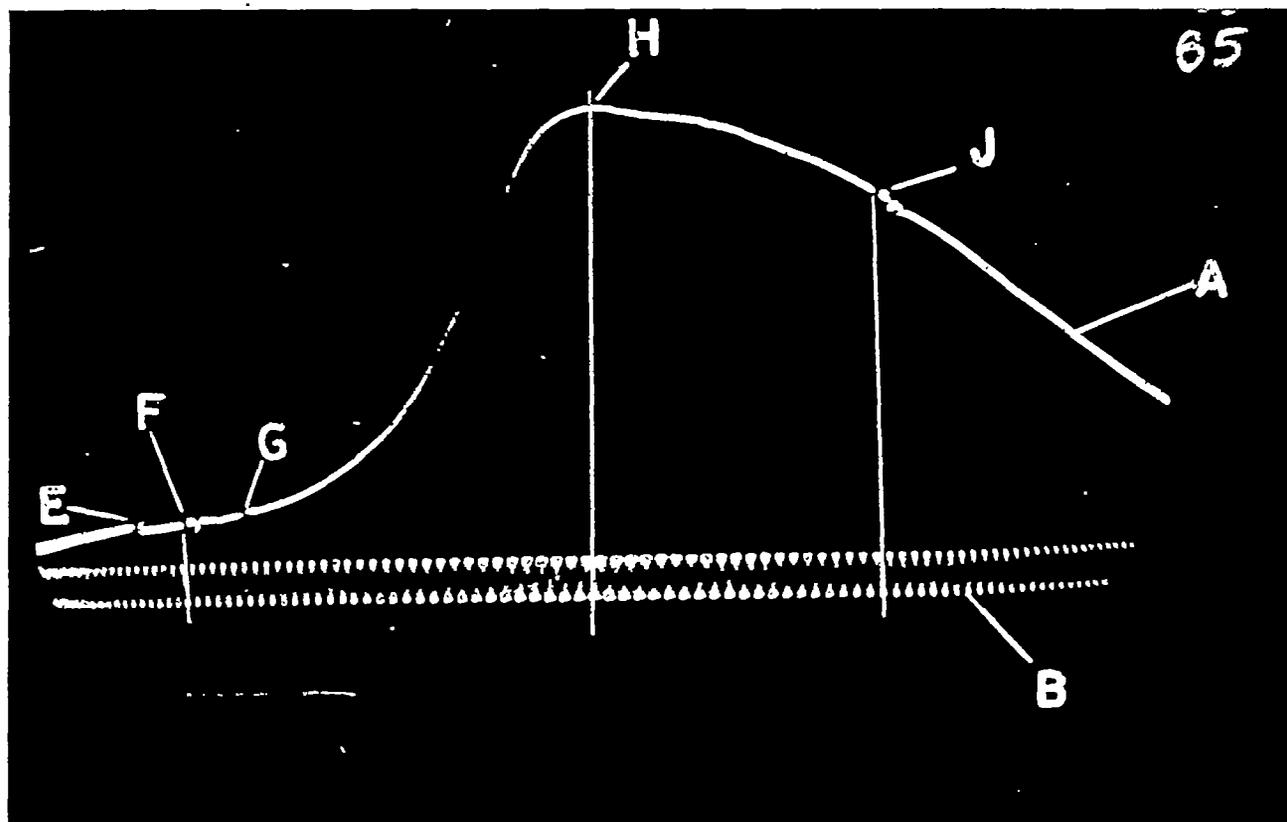
FIGURE 16.—Indicator card with oscillator trace for nonknocking explosion in a spark-ignition engine. Fuel, S-1; four spark plugs; spark advance,  $22^\circ$  on three plugs,  $29^\circ$  on fourth plug.

and 16. All these tests were made with S-1 fuel. Four spark plugs were used in each case and the end zone was always within the field of view. In all cases the spark advance and the crank angles at which the timing sparks occurred were the same as in figures 15 and 16. Peak pressure was reached in each case within  $1^\circ$  or  $2^\circ$  of top center. The table includes all tests made under these conditions. The original selections of point of peak pressure and motion-picture frame of final fade-out of mottled zone were adhered to in each case.
