# REPORT No. 491

## VIBRATION RESPONSE OF AIRPLANE STRUCTURES

By T. THEODORSEN and A. G. GELALLES

*This report presents test results of experiments on the vibration-response characteristics of airplane structures on the ground and in flight. It also gives details regarding the construction and operation of vibration instruments developed by the National Advisory Committee for Aeronautics.*

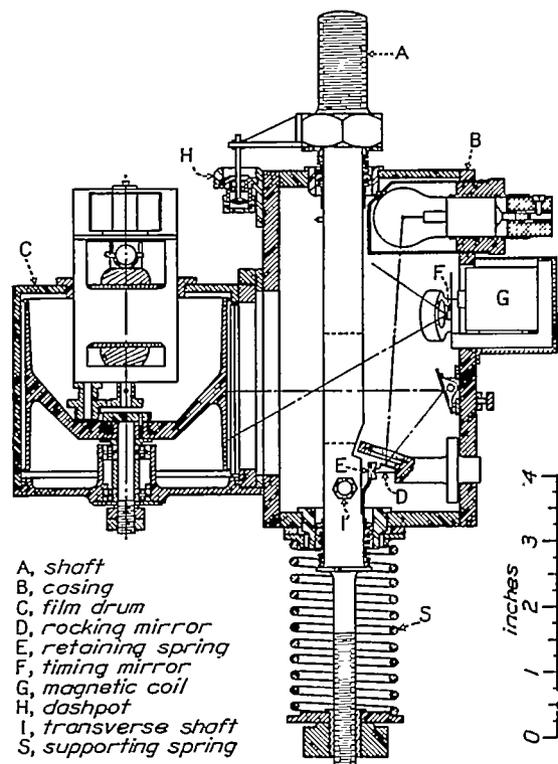
A sectional view of the vibrograph is shown in figure 1. This instrument consists chiefly of a short piece of shafting A attached to the vibrating body, and a casing B with a film drum C mounted on the shaft through a helical spring. Floating bearings permit a sliding motion between the shaft and the casing. The casing with film drum and accessories constitutes the suspended weight.

An optical method is used for recording the vibration and for timing. A mirror D, held between the shaft and the casing by a spring E, is rocked along the shaft axis as the shaft vibrates. A light beam directed onto the mirror through a lens and then reflected back to a film drum records the rocking motion of the mirror; only vibrations parallel to the shaft are recorded.

Similarly, a light beam, from a lamp not shown, is directed onto a mirror F, which is mounted on a high-frequency vibrating reed and records the timing along the lower edge of the film. The frequency of vibration of the reed is controlled by an independent timer which makes and breaks the circuit of the magnetic coil G at definite intervals.

Damping is obtained by means of the dashpot H. Liquids of varying viscosities are used in the dashpot, depending on the temperature at which the tests are conducted. A small shaft I, with a roller properly fitted in a slot in the casing, limits the circumferential and the maximum axial motion of the suspended casing. A locking device (not shown), which is simply a spring-loaded latch, locks the casing rigidly to the shaft when the instrument is not in use.

FIGURE 1.—Diagrammatic sketch of N.A.C.A. vibrograph.

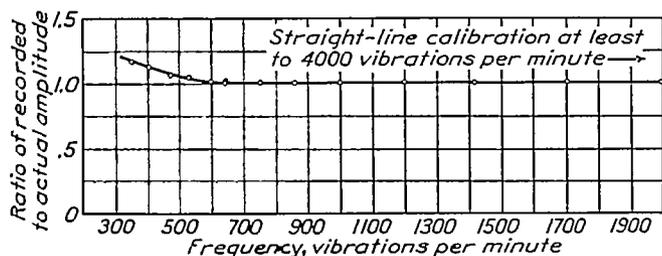
FIGURE 2.—Calibration curve of N.A.C.A. vibrograph.

The sensitivity of the vibrograph depends mainly on the distance between the knife-edge pivots of mirror D. For the tests presented in this report 2 mirrors having 2 different widths between knife-edges were used. The sensitivity with the smaller mirror

was of the order of 0.50-inch amplitude recorded for 0.01-inch actual amplitude. With the larger mirror the ratio was 0.27 to 0.01. This sensitivity was constant over the whole range of amplitudes.

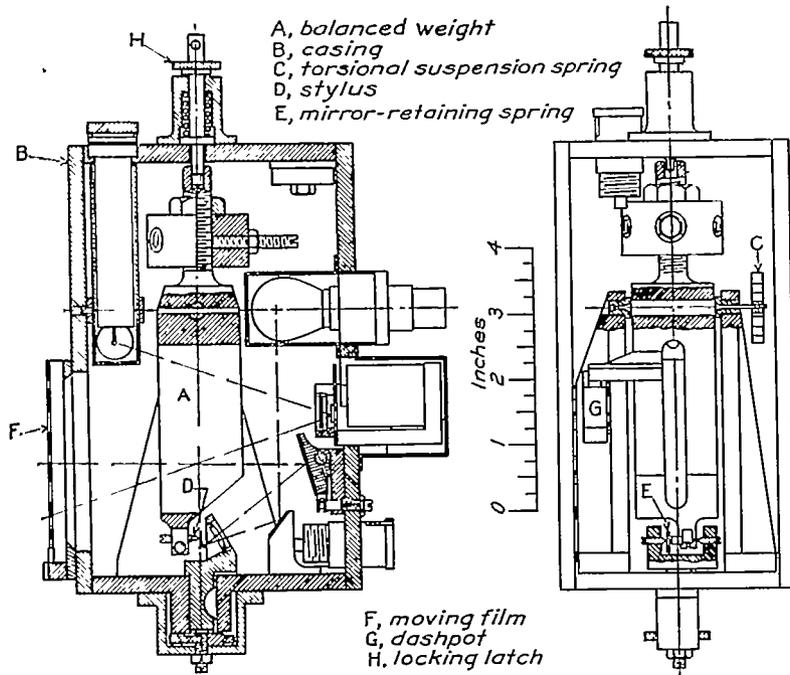
Sectional views of the torsio-graph are shown in figure 3. With this instrument torsional vibrations

FIGURE 3.—Diagrammatic sketch of N.A.C.A. torsio-graph.

in any given plane may be recorded. Like the vibrograph, it consists primarily of a suspended weight A and a casing B, which in this case is attached to the vibrating body. The weight A is suspended as a perfectly balanced flywheel and is held in its zero setting by the spiral spring C. For the useful range of torsional-vibration frequencies the casing vibrates with the body, while the suspended weight or flywheel remains stationary in its center position. Only tor-

sional relative motion is possible between the weight and the casing. A stylus D at the lower end of the suspended weight rocks a mirror mounted on pivots. A spiral spring E retains the mirror in continuous contact with the stylus. The recording of the torsional motion and timing is accomplished optically in the same manner as that of the vibrograph. The motion recorded on the moving film F is proportional to the angular twist of the casing with respect to the stationary flywheel. Liquid damping is obtained by means of the dashpot G. A spring-loaded latch H holds the suspended weight rigidly to the casing when the instrument is not in use and limits the angular motion when it is operating.

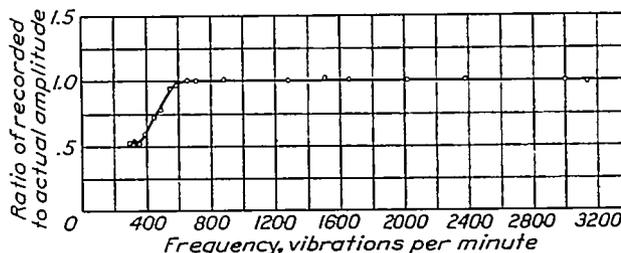
FIGURE 4.—Calibration curve of N.A.C.A. torsio-graph.

A calibration curve of the torsio-graph is shown in figure 4. From this curve it is seen that for frequencies below about 600 vibrations per minute corrections must be applied to the amplitude recorded by the torsio-graph. Frequencies as low as 400 per minute may be recorded if proper corrections are applied to the amplitudes. No vibration tests were conducted to determine the upper limit of reliability of the torsio-graph, as the calibration table in use was not suitable for very high frequencies. The natural frequency of the mirror-staff unit, which is the limiting

factor for the upper range of the instrument, was determined by tests to be about 9,000 per minute.

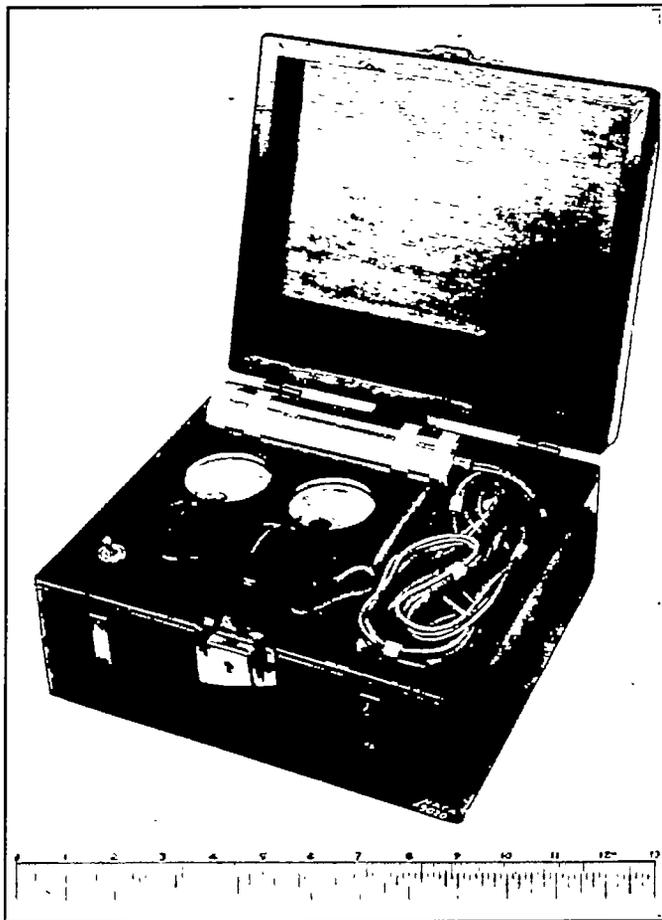
A photograph of the vibration indicator is given in figure 5, and figure 6 is a sketch of the "feeler" unit of the indicator and a diagram of the wiring. With this instrument a quick survey of the effective amplitude of vibration in any part of the structure may be made. In common with the other two instruments, the underlying principle of its operation is the seismograph; but the hot-wire principle is utilized for recording the vibration.

FIGURE 5.—N.A.C.A. vibration indicator.

The vibration indicator consists of two separate units—the feeler unit, which may be held with a slight pressure or clamped to any part of the aircraft; and the recording unit, in which the observer may read the effective magnitude of vibration. As shown in figure 6 (a), the feeler unit consists of a weight A suspended on a spring B, a piston C connected rigidly to the weight, a nozzle D, and two hot-wire elements E and F of the same electrical resistance. In the recording unit are housed electrical resistances, flashlight batteries, a voltmeter, and a milliammeter.

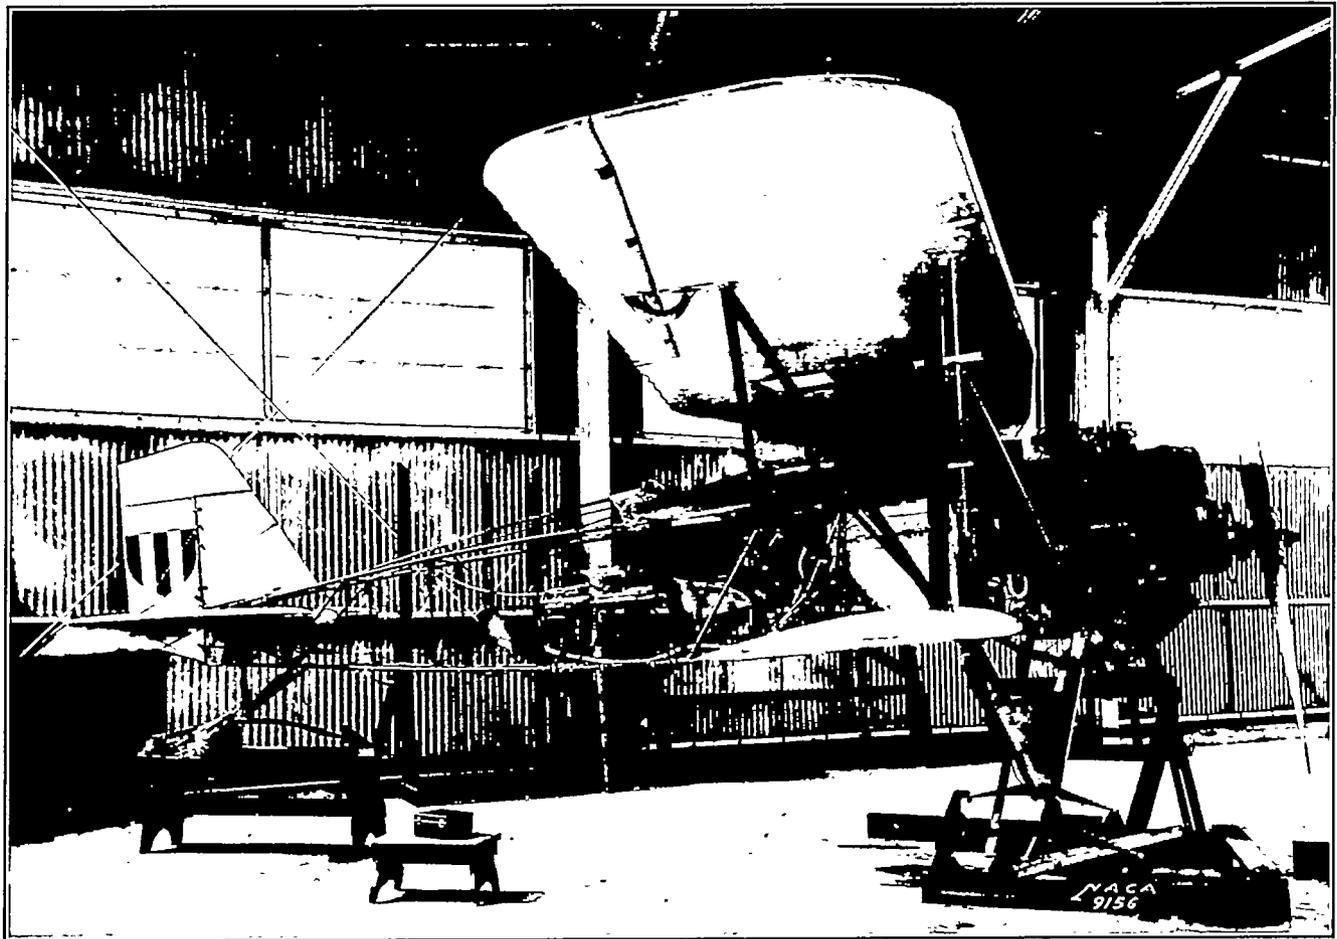
FIGURE 8.—Flexible mounting of PW-9 airplane for vibration-response tests.

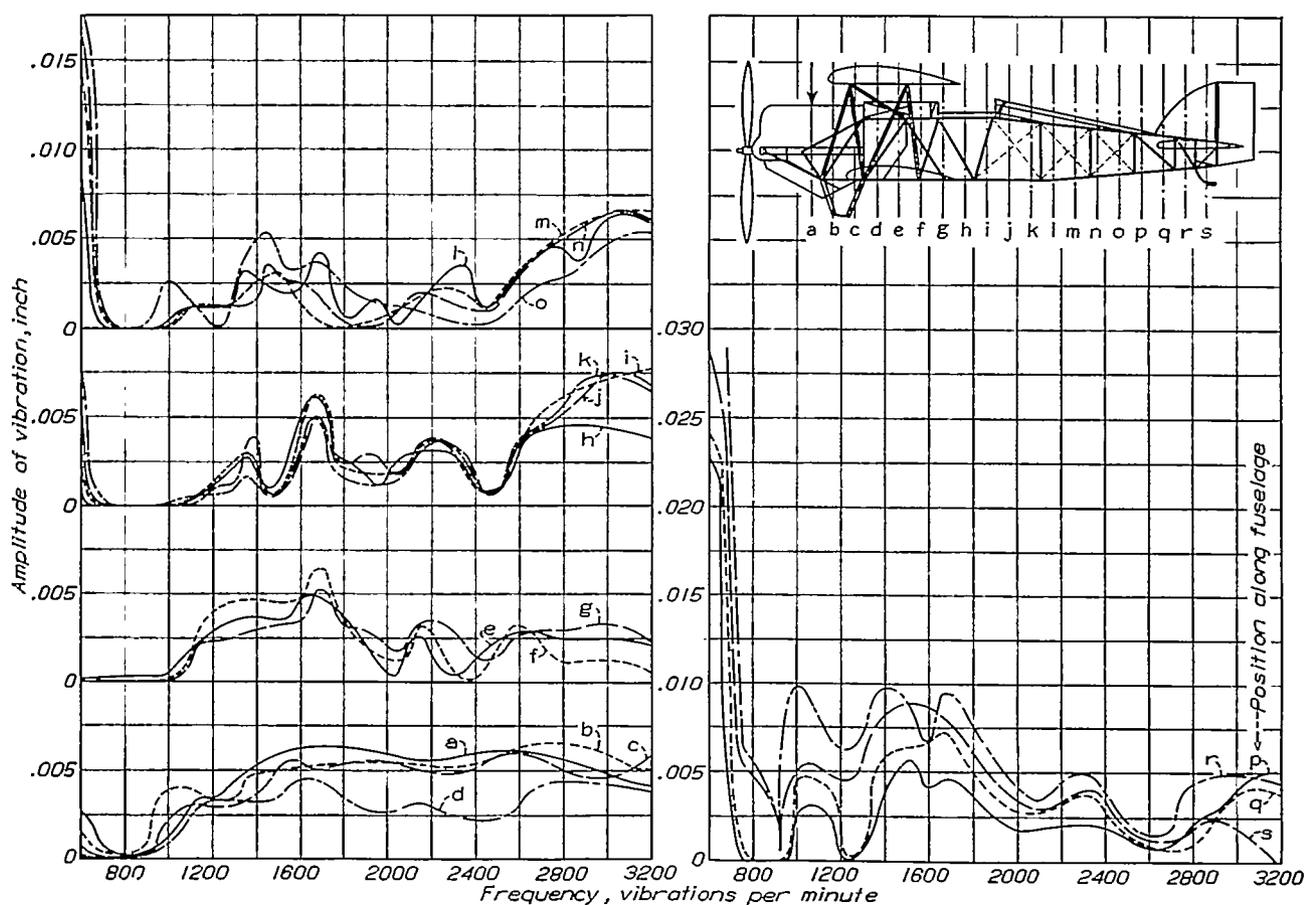
FIGURE 9.—Vibration response along the lower longeron of the PW-9 airplane

Additional tests for the determination of the fundamental mode of the PW-9 fuselage.—The results of figures 9 to 12 have shown two critical frequencies of the fuselage, one at 600 vibrations per minute and the other at 3,100 with the wings attached, or at 2,500 with the wings replaced by an equivalent weight. Theoretical considerations show that the airplane being flexibly mounted, the fuselage may be considered as a free-end beam of nonuniform elasticity and weight distribution. The elastic curve of a free, uniform beam gives for the mode of lowest frequency very nearly three-fourths of a full wave corresponding to  $3\pi/2$  radians, the second mode  $5\pi/2$ , the third  $7\pi/2$ , etc. The frequencies of these 2-, 3-, 4-node, etc., vibrations bear the relation to each other of 1,  $(5/3)^2$ ,  $(7/3)^2$ , etc., or 1, 2.77, 5.44, etc. Beams having stiffness and weight distributions comparable to those of an airplane fuselage are expected to give larger frequency ratios between the fundamental and the higher principal modes of vibration. The ratio of the lower to the higher critical frequency for the fuselage of the PW-9 (figs. 9 to 12) was found to be 5.1 with the wings on and 4.1 without the wings. Further tests on other airplanes supplementing these results are considered desirable.

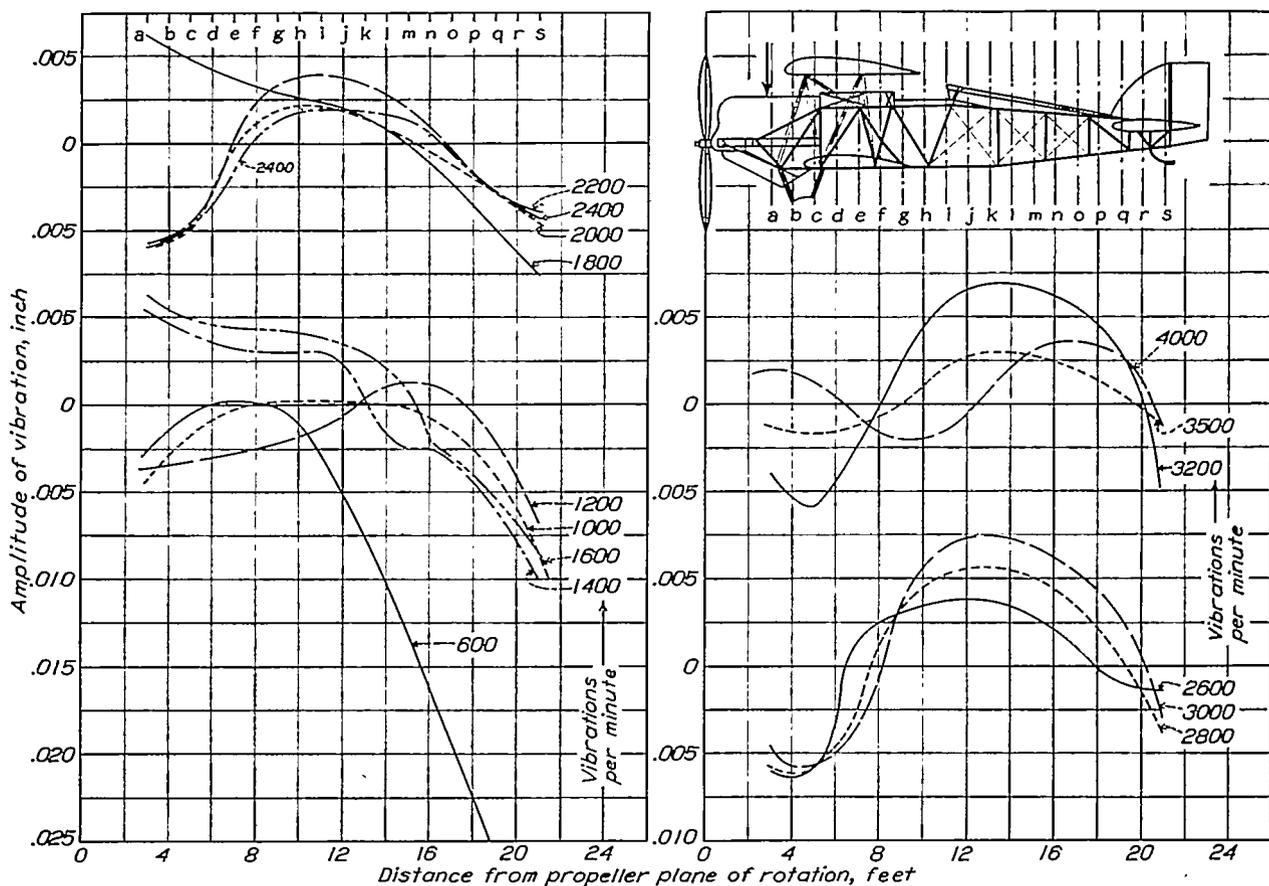
FIGURE 10.—Elastic curves of the lower longeron of the PW-9 airplane at different frequencies.

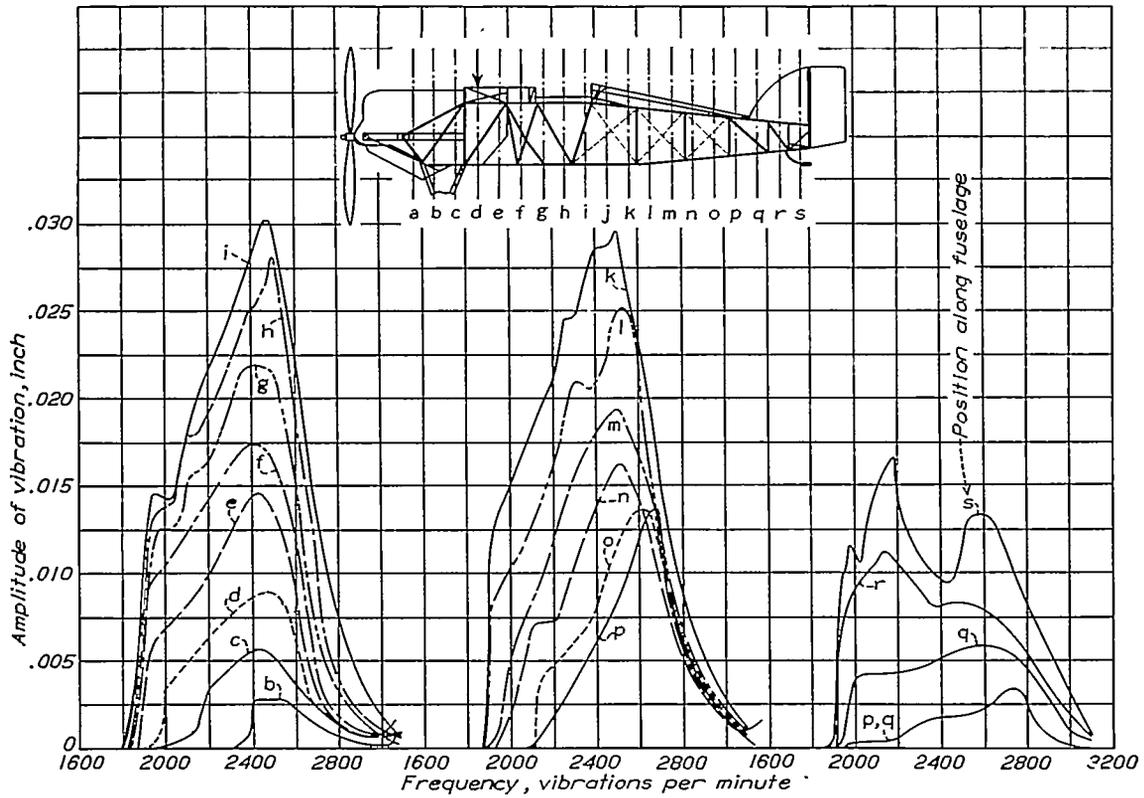
FIGURE 11.—Vibration response along the lower longeron of the PW-9 airplane. No wings nor stabilizer. Vibrator mounted at the center of gravity of the airplane.

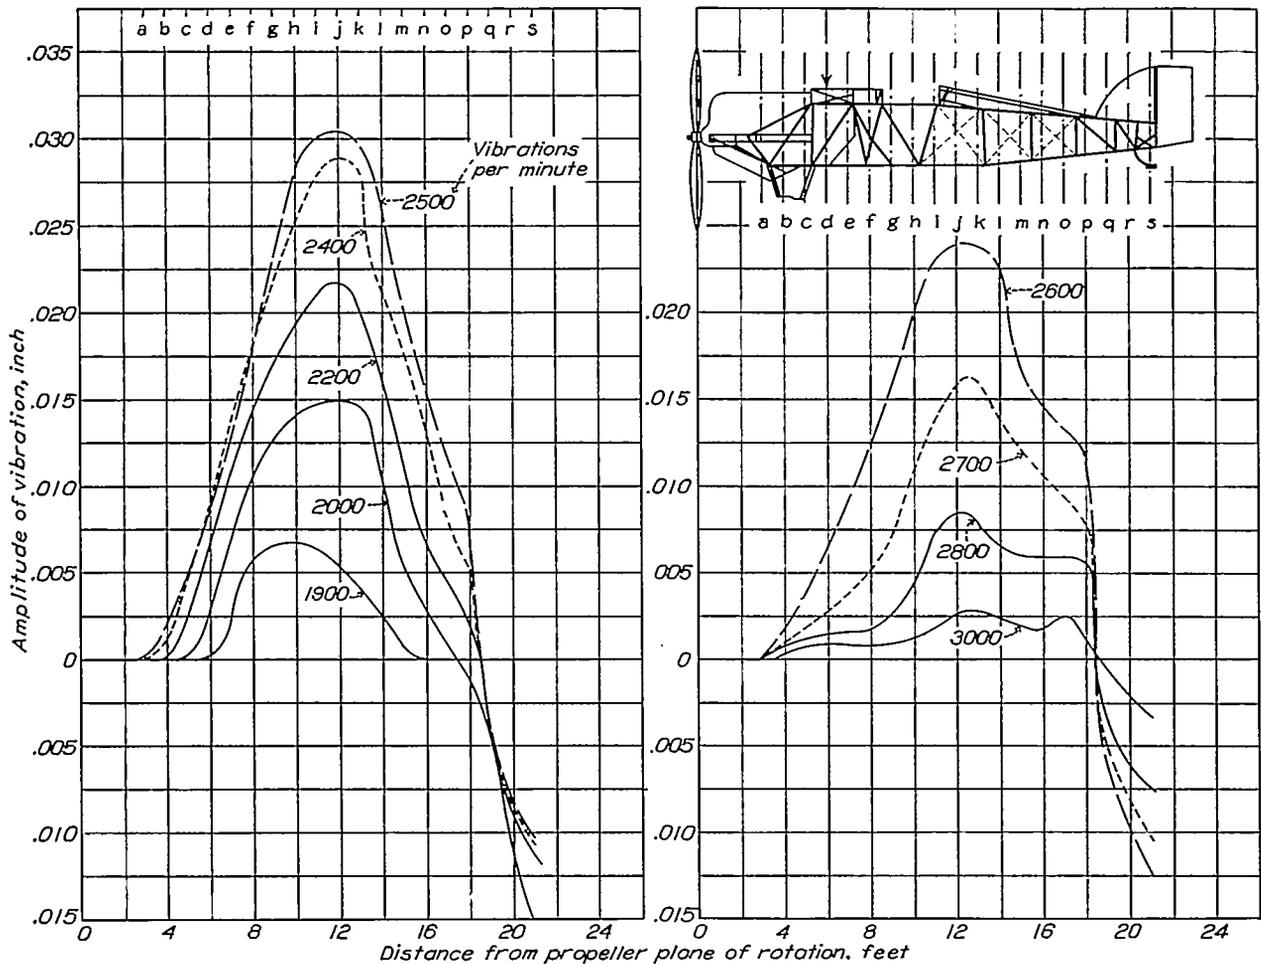
FIGURE 12.—Elastic curves of the lower longeron of the PW-9 airplane at different frequencies. No wings nor stabilizer. Vibrator at center of gravity of airplane

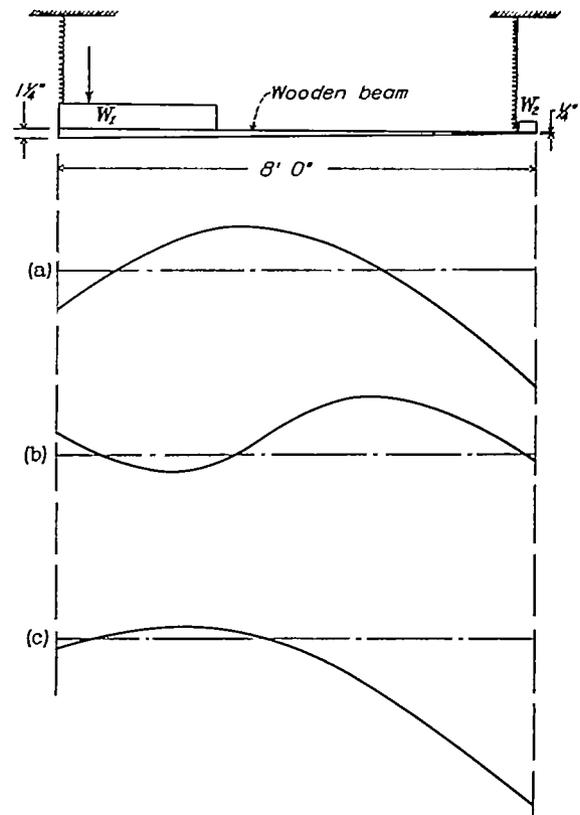
In order to obtain an unquestionable evidence whether the disturbance at 600 vibrations per minute was the fundamental mode of vibration of the fuselage, tests were conducted with a wooden-beam model of proportional elasticity and weight distribution. In figure 13 the forms of vibration obtained at different conditions are given. Weights were mounted on the forward part to represent the power-plant unit and wings, and a small weight on the other extreme end to represent the tail unit. With the amount and location of fixed weights, given in the figure, a fundamental mode of vibration of two nodes was obtained at the frequency of 460 per minute, and a second mode of three nodes at 1,550 per minute. These values give the ratio of the second mode to the fundamental as 3.4. One of the nodes of the fundamental frequency was located near the center of gravity of the forward weights, and the other one about two-thirds the distance toward the tail. As the ratio of the weights of the forward part to those at the tail was increased,

FIGURE 13.—Test results with a model beam.  
 a. Fundamental mode of vibration— $W_1=70$  pounds,  $W_2=2.5$  pounds  
 Frequency=460 vibrations per minute.  
 b. Second principal mode— $W_1=70$  pounds,  $W_2=2.5$  pounds.  
 Frequency=1,550 vibrations per minute.  
 c. Fundamental mode— $W_1=150$  pounds,  $W_2=1$  pound.  
 Frequency=650 vibrations per minute.

The model and static tests proved beyond doubt that the 2-noded fundamental mode of vibration of this particular fuselage is at 600 per minute. The elastic curves of figure 10 indicate that the 3-noded second principal mode of vibration must lie in the range of frequencies between 2,500 and 4,500 per minute. Since no critical frequencies other than that at 3,100 per minute with the wings and 2,500 without the wings were observed up to frequencies of 4,500 per minute, it is logical to conclude that these frequencies are the second principal modes of vibration of the

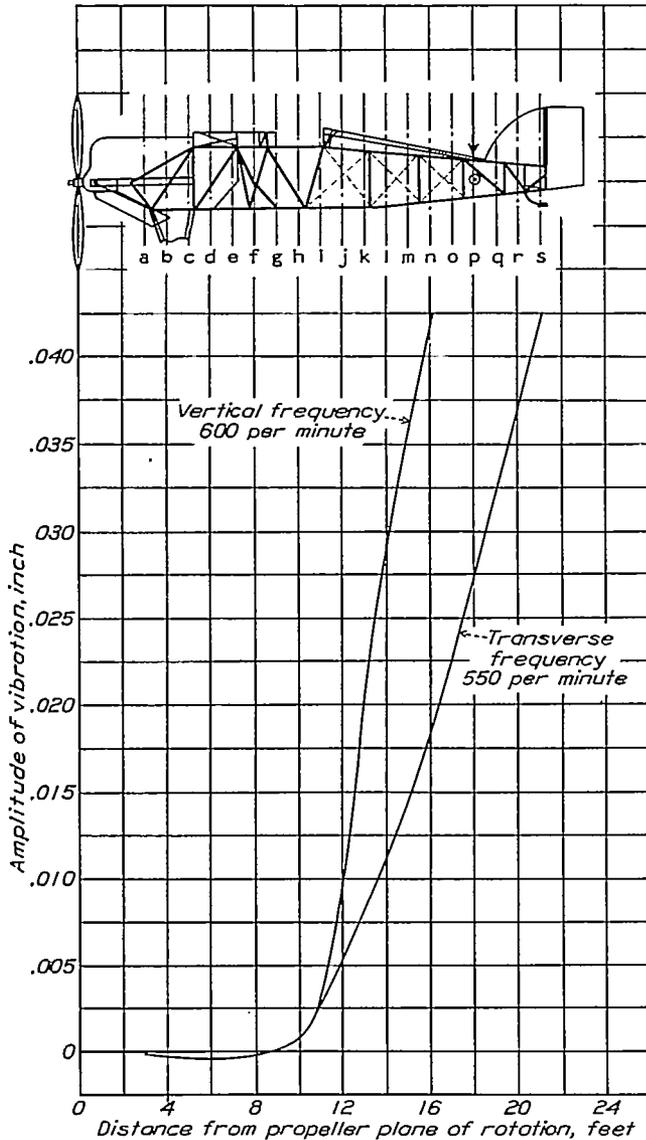
FIGURE 14.—Resonant response of the fuselage of the PW-9 airplane. Vibrator on tail of airplane.

1. A resonant vibration of the fuselage in flexure in the vertical direction was found to exist at a frequency of about 600 per minute.
2. A resonant vibration of the fuselage in flexure in the transverse direction was found to exist at about 550 per minute.

The resonant vibrations of the fuselage in flexure and in torsion at the frequencies of 600, 550, and 1,700 per minute are shown in figures 14 and 15. The elastic curve in torsion at 500 per minute was similar to that at 1,700 per minute shown in figure 15. The mode of vibration having a frequency of 600 cycles per minute is undoubtedly the fundamental mode of the fuselage in flexure in the vertical direction that was determined in the previous tests; that at 550 is a flexure in the transverse direction; and that at 500 a torsion. It was practically impossible to distinguish the nodes of vibration forward of about 9 feet from the propeller axis, the vibration amplitudes being very small and within the limits of experimental error. The large inertia of the engine block, accessories, and wings damped any normal response of the fuselage structure.

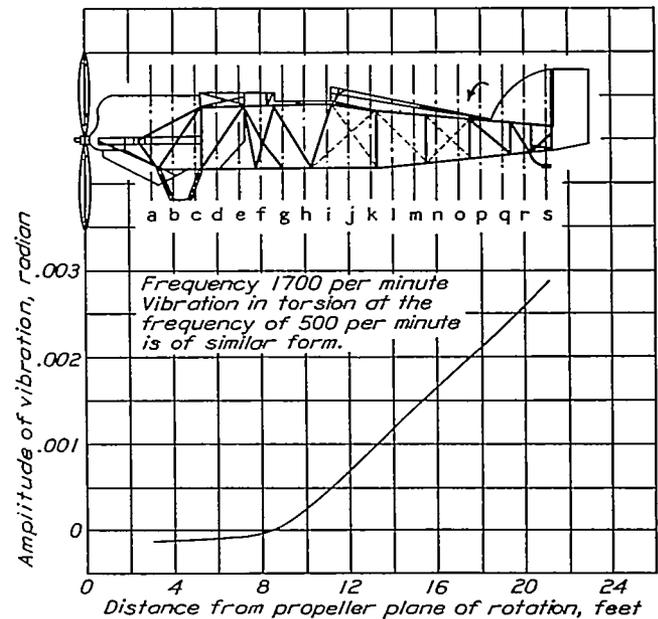
FIGURE 15.—Resonant response in torsion of the fuselage of the PW-9 airplane. Vibrator on tail of airplane.

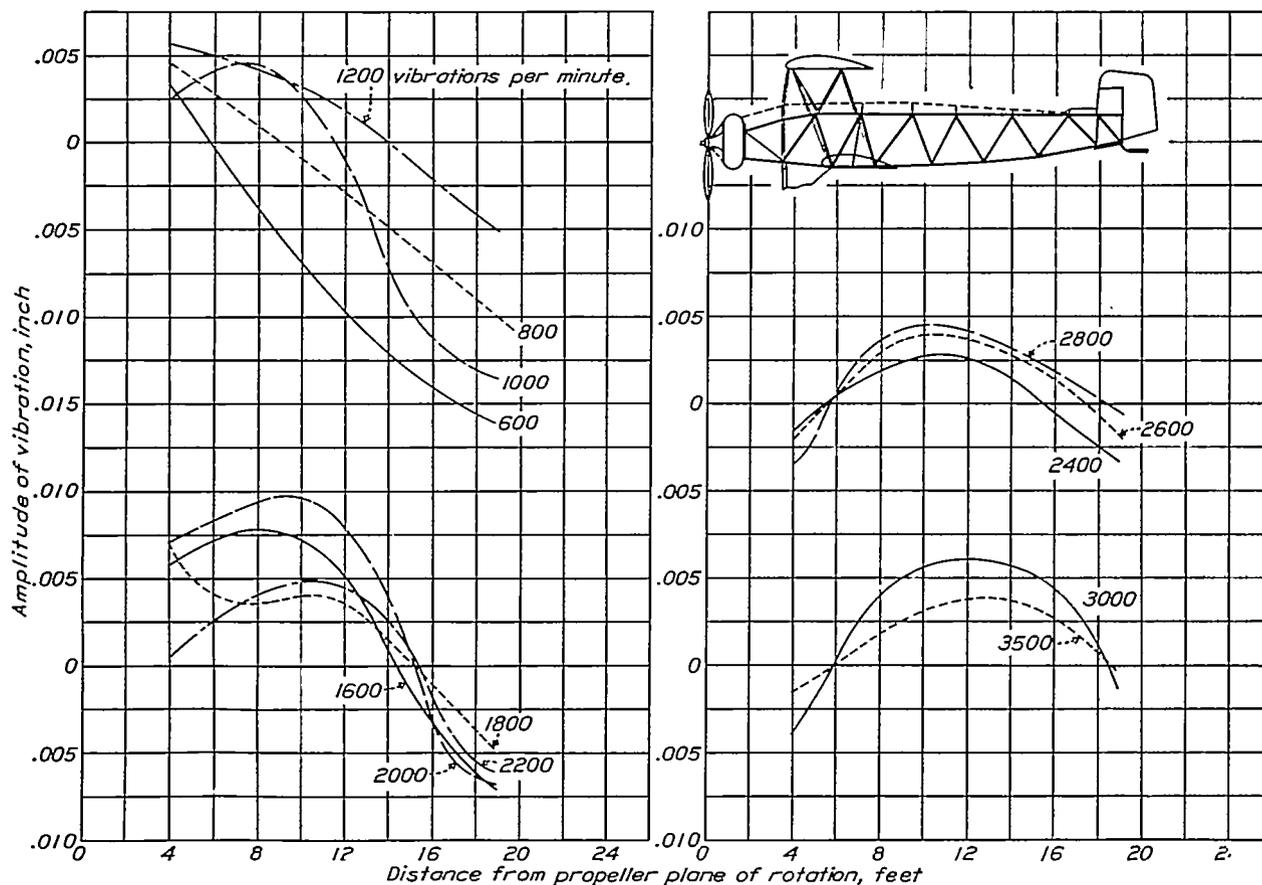
FIGURE 16.—Elastic curves of the lower longeron of N2Y-1 airplane.

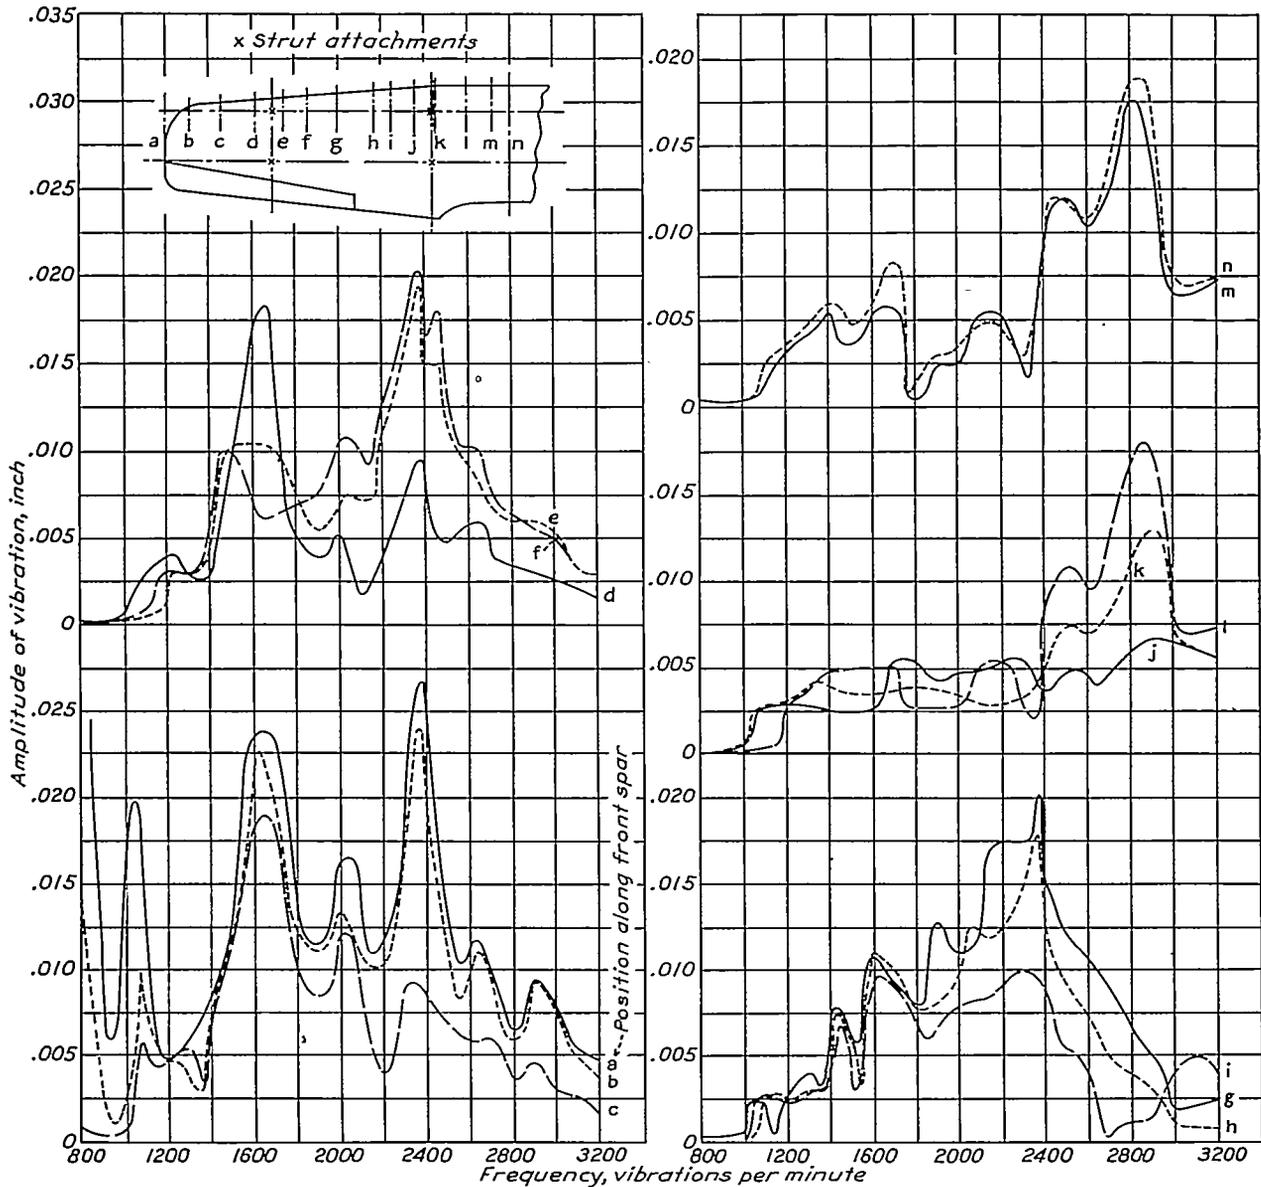
FIGURE 17.—Vibration response along the front spar of the upper wing of the PW-9 airplane.

Vibration response of upper and lower wings of the PW-9.—In figures 17 to 20, the vibration responses of the upper and lower wings of the PW-9 airplane in the vertical direction are shown. A vertical force was applied at the engine block, as for the tests on the fuselage. The amplitudes were measured along the front spar of the right wings. Check tests on the left half of the wings indicated that there was no appreciable difference in the deflections at corresponding symmetrical positions. Particular attention was given

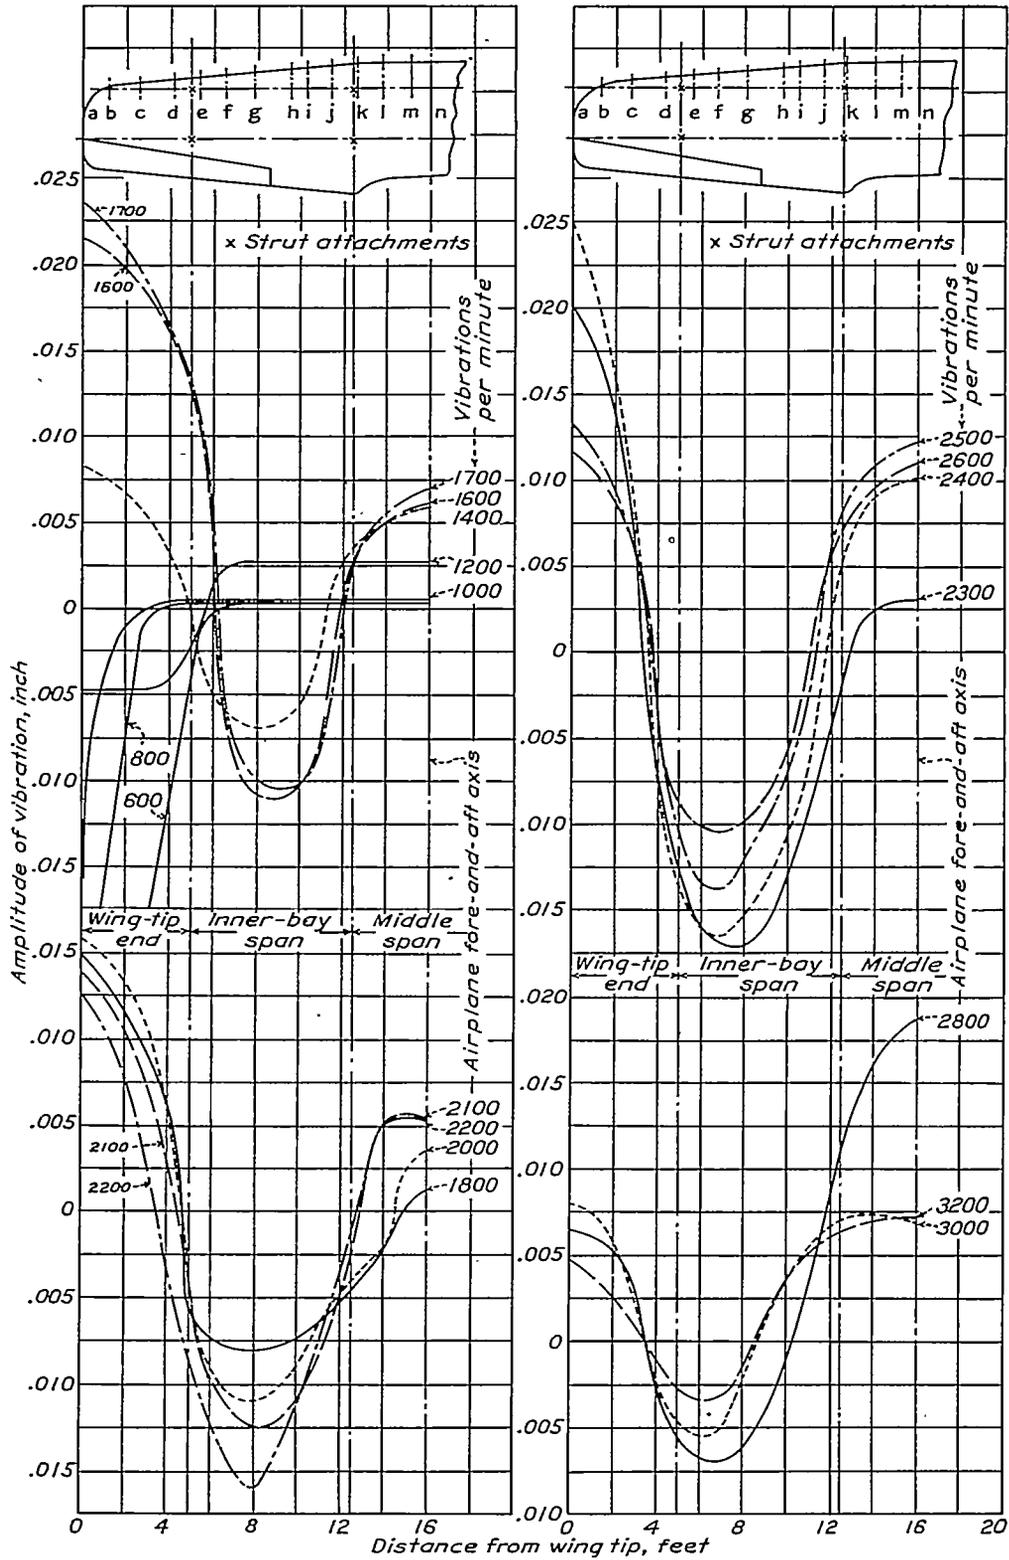
FIGURE 18.—Elastic curves of the front spar of the upper wing of the PW-9 airplanes at different frequencies.

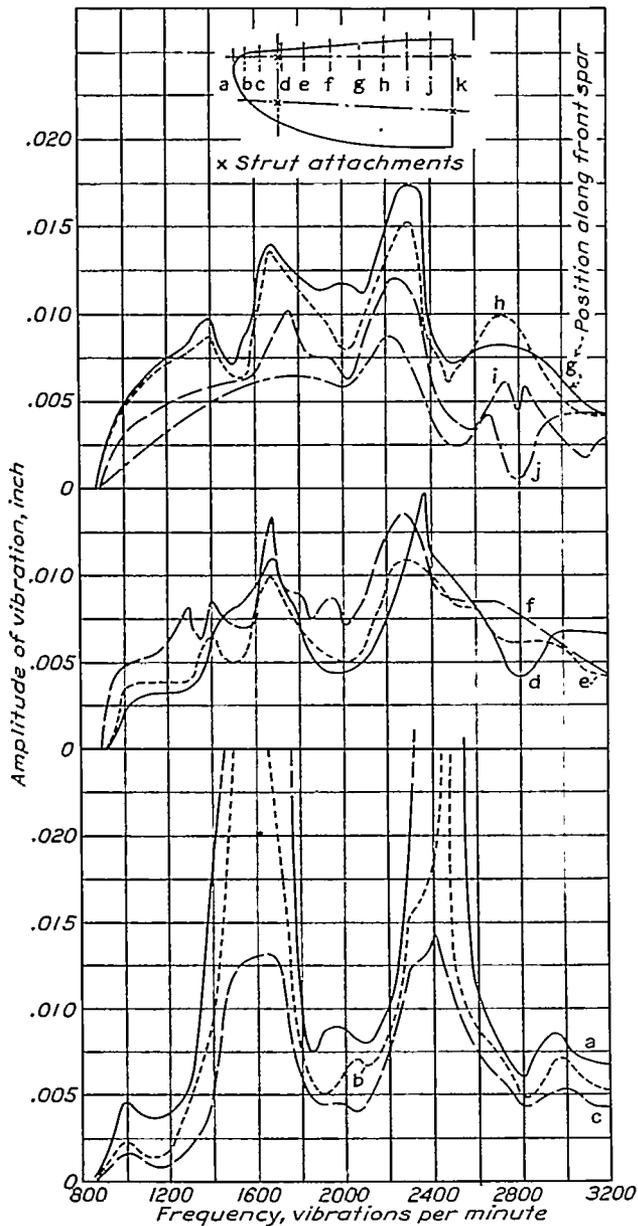
FIGURE 19.—Vibration response along the front spar of the lower wing of the PW-9 airplane.

observed amplitudes at the trailing edge at the frequency of 1,400 per minute exceeded the range of the available instruments. From figures 19 and 20 it is seen that the vibration of the entire lower wing appears to be largely influenced by vibrations in the upper wing and the fuselage. The tips of both wings are in a state of continual disturbance throughout almost the whole range of speeds.

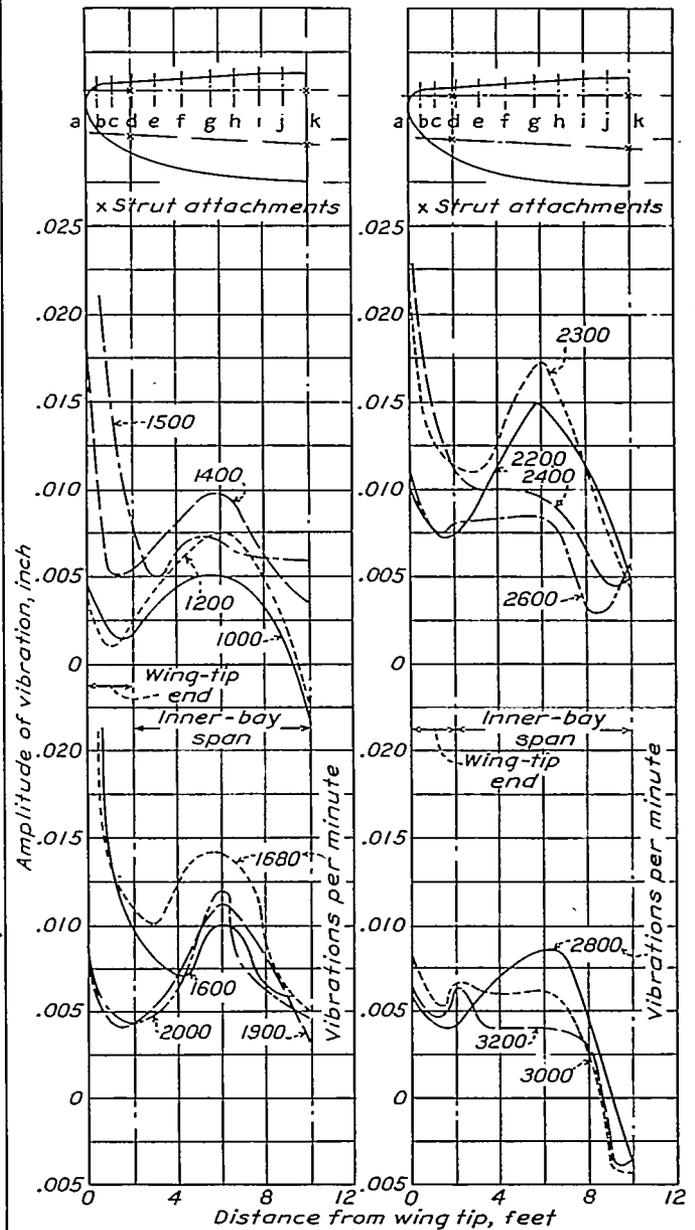
FIGURE 20.—Elastic curves of the front spar of the lower wing of the PW-9 airplane at different frequencies.

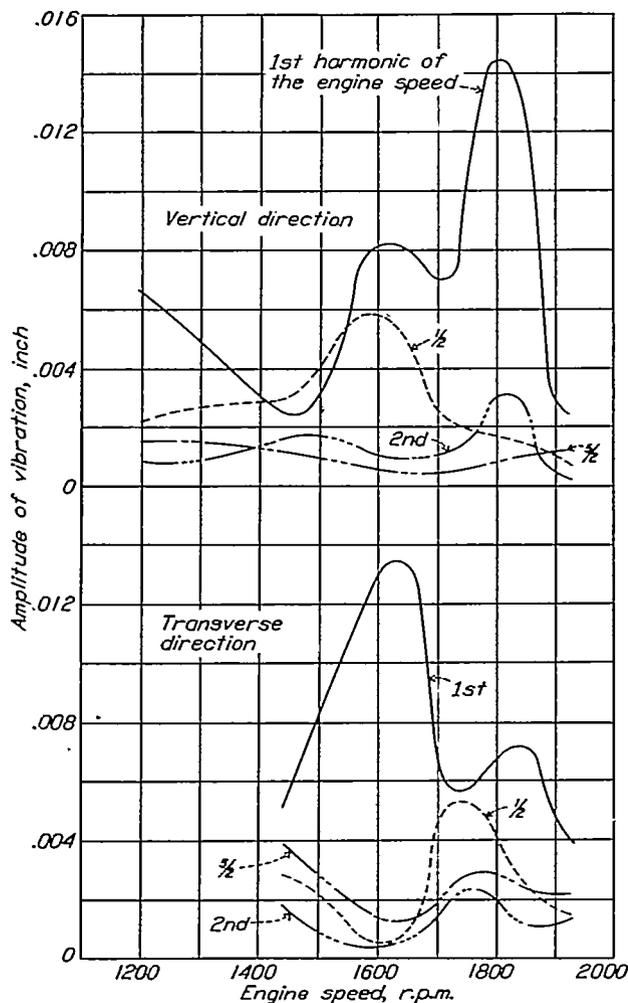
FIGURE 21.—Vibration in the rear cockpit of the N2Y-1 airplane in flight.

In figure 21 the vibration of the upper longeron in the rear cockpit in the vertical and transverse directions is given. The flights were made with the airplane in a level attitude. The principal amplitude peaks are at 1,630 and 1,800 revolutions per minute. Since the frequency of these peaks coincides with the engine speed, the cause of the excessive vibration at these speeds can confidently be attributed to the engine or propeller.

The amplitude peak at 1,800 revolutions per minute was determined by visual observations to be due to a flexure in the inner bay span of the wings in

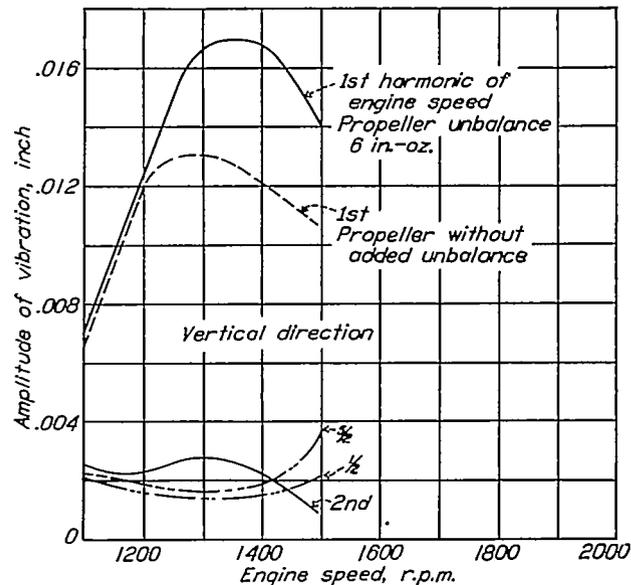
FIGURE 22.—Vibration of engine block of N2Y-1 airplane on the ground with propeller unbalance.

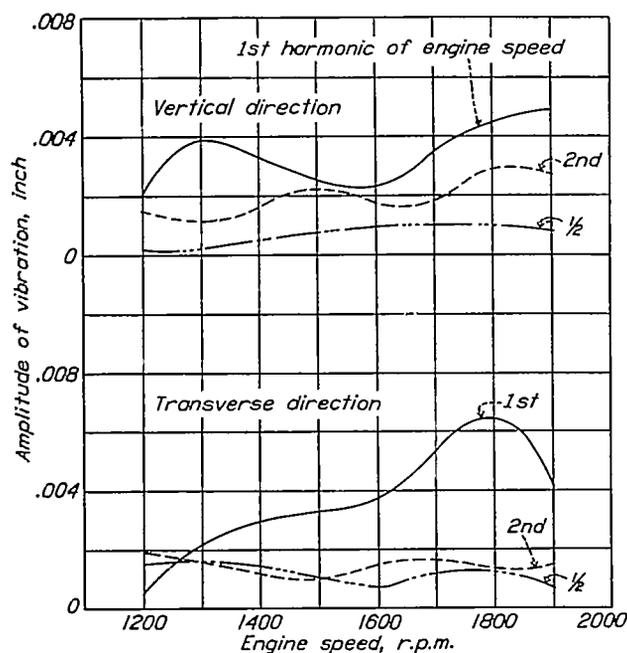
FIGURE 23.—Vibration forward of the front cockpit of the NY-2 airplane in flight.

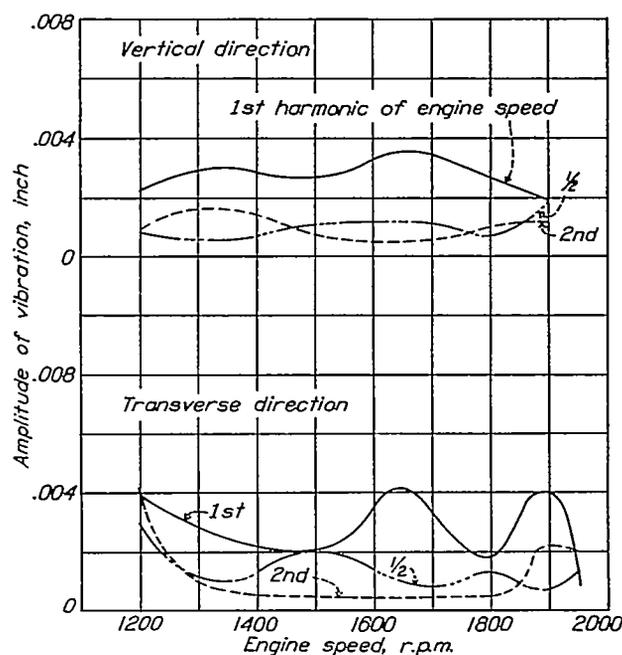
FIGURE 24.—Vibration in the rear cockpit of the NY-2 airplane in flight.

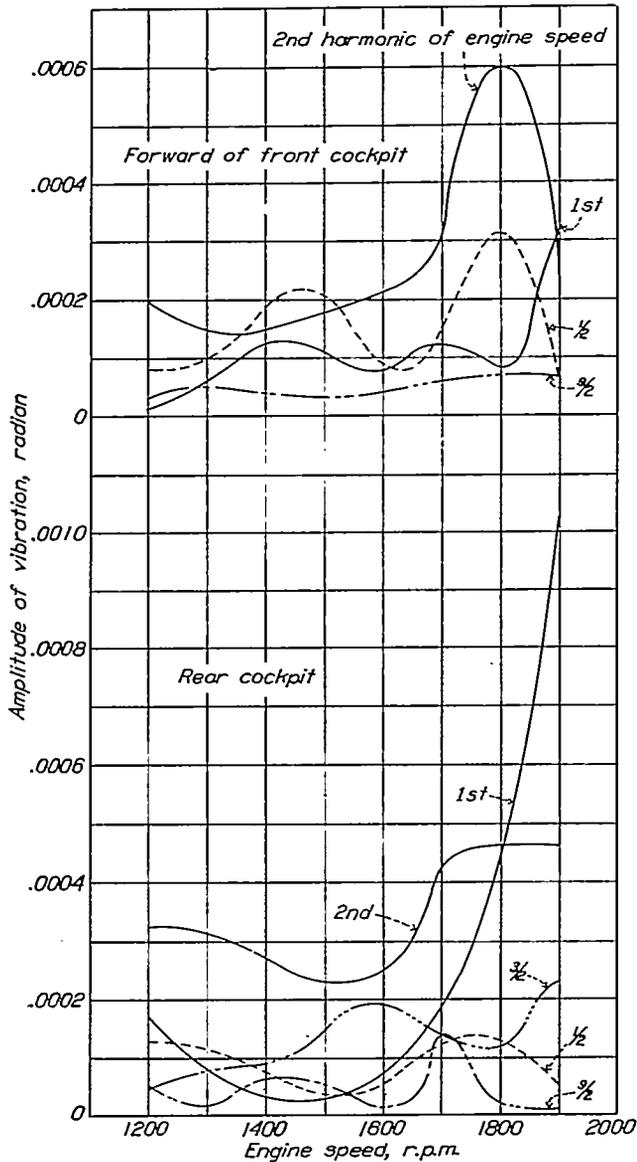
FIGURE 25.—Torsional vibration in the front and rear cockpits of the NY-2 airplane in flight.
