NACA RM E56K30

SURVEY OF MICROSTRUCTURES AND MECHANICAL PROPERTIES OF
OVER-TEMPERATURED S-816 TURBINE BUCKETS

FROM J47 ENGINES

By S. Floreen and R. A. Signorelli

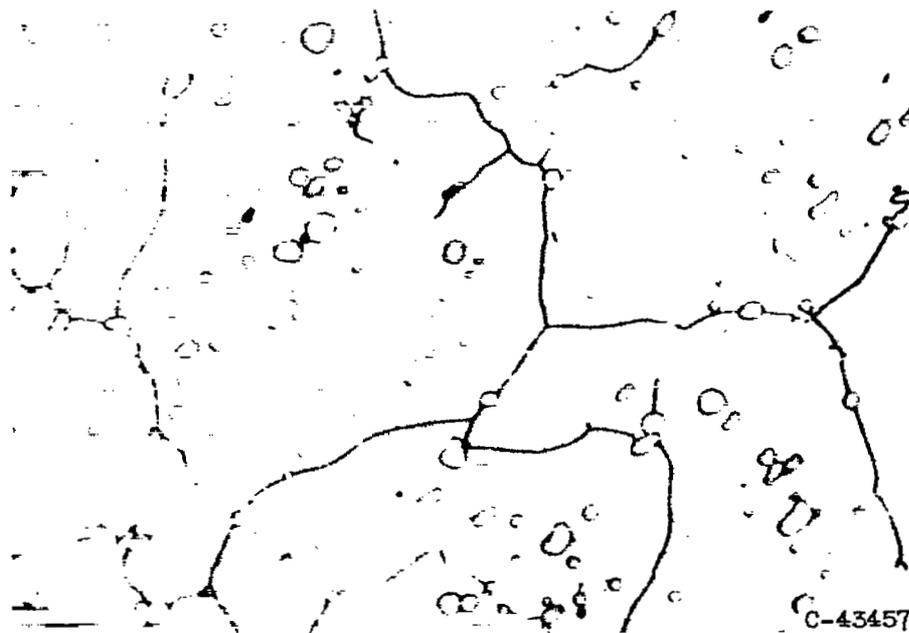
Figure 4. - Microstructure of S-816.

The microstructure of heat-treated S-816 is presented in figure 4(a). Aside from the residual columbium-tantalum-type carbides, the carbides that precipitate in aging are very fine. When subjected to increasingly higher temperatures, these fine carbides tend to coalesce and spheroidize, producing what is termed an overaged microstructure as illustrated in figure 4(b). At still higher temperatures, these carbides tend to redissolve into the matrix until the alloy becomes predominantly a solid solution with the exception of the very stable columbium-tantalum carbide precipitate.

(a) Normal. Reduced 6 percent in printing.

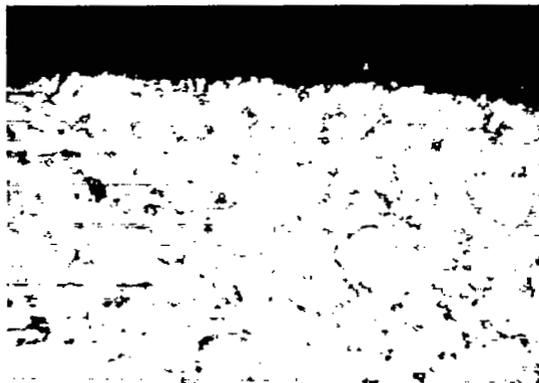
Figure 6. - Microstructures
Etch, aqua regia plus

The microstructures found in the overtemperated buckets are presented in figure 6. In general, the microstructure varied from the leading edge to the trailing edge of these buckets. The leading edge usually shows the greatest degree of overaging, as exemplified by the hyphenated or spheriodized structures found in this region, while the trailing edge shows much less overaging. The middle of the bucket

generally shows very little overaging. The microstructure also varies somewhat from the hub to the tip of the buckets. That is, the leading edge at the hub is slightly different from the leading edge at the tip, and so on. In most cases, however, these variations are of much smaller magnitude than those from the leading edge to the trailing edge.

(a) Bucket 1. Reduced

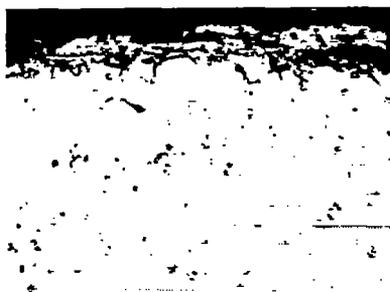
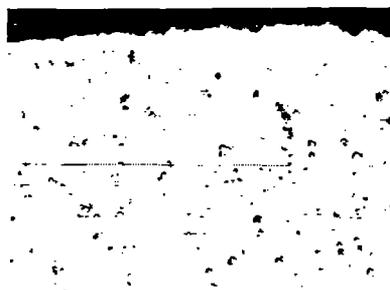
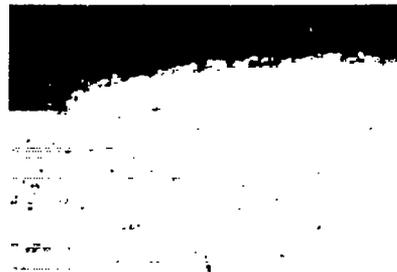
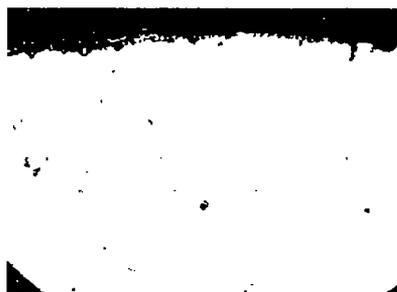
of overtemperated buckets.
X750.

Figure 6. - Continued. Microstructures
Etch, aqua regia plus glycerine.

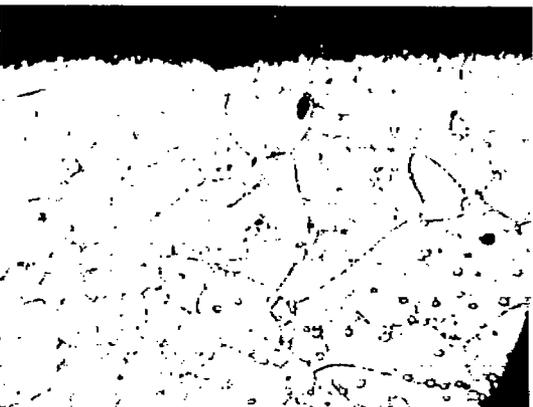
of overtemperated buckets.
X750.

Figure 6. - Continued. Microstructures
Etch, aqua regia plus glycerine.

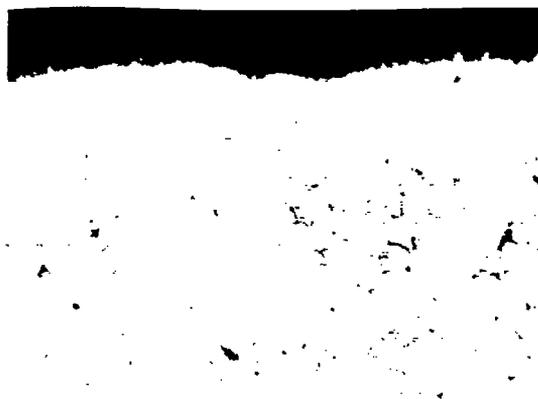
(h) Bucket 8. Reduced

of overtemperated buckets.
X750.

Figure 6. - Continued. Microstructures
Etch, aqua regia plus glycerine.

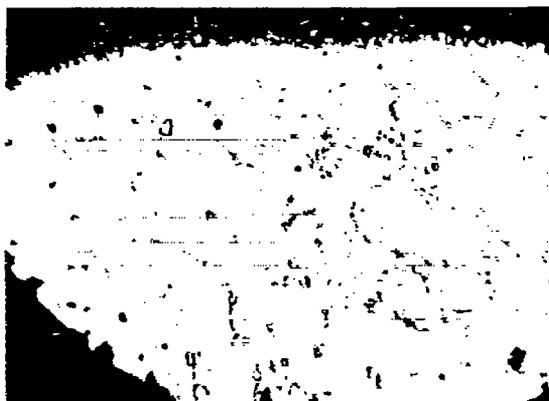
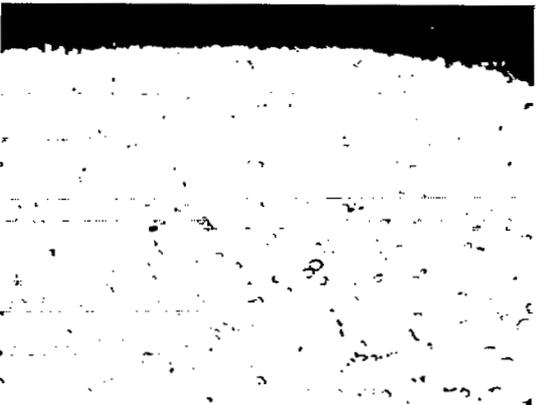
of overtemperated buckets.
X750.

Figure 6. - Continued. Microstructures
Etch, aqua regia plus glycerine.

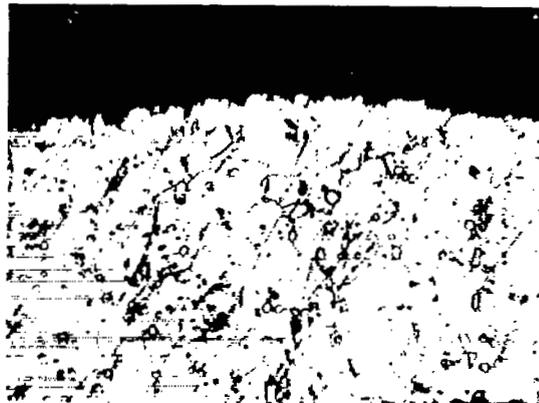
of overtemperated buckets.
X750.

Figure 6. - Continued. Microstructures Etch, aqua regia plus glycerine.

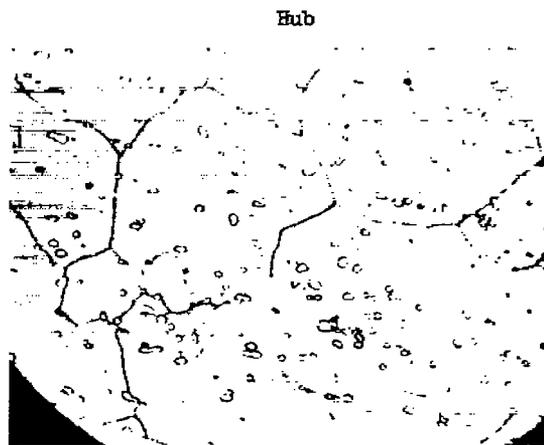
Figure 6. - Concluded. Microstructures
Etch, aqua regia plus glycerine.
